FAIRHAVEN TOWN HALL HISTORIC STRUCTURES REPORT

Prepared for:
Fairhaven Board of Selectmen
40 Center St.
Fairhaven, MA

Prepared by:
J. M. Booth & Associates, Inc Architects
47 N. 2nd St
New Bedford, MA

January 31, 2019

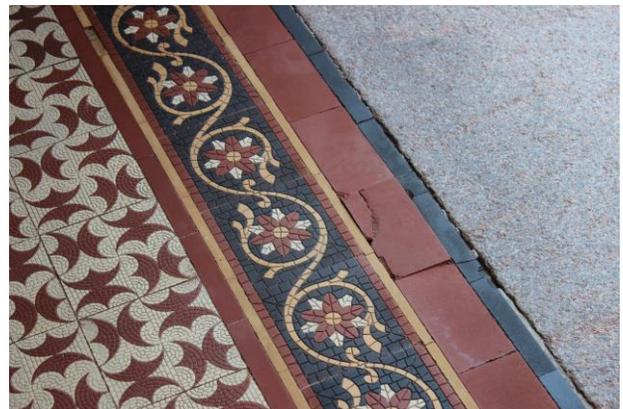
Restoration of entrance foyer ceramic tile. The tiles at the main entrance have several decayed and broken tiles. These will need to be custom made to replicate the original 100 year old tiles. The recessed entrance masonry was recently restored, however, the tilework was not. The granite stairs leading up to the entry are likewise original and are starting to show signs of structural failure. Although the granite blocks are in good conditions, these steps appear to be sloping towards the building a condition which could cause snow and ice to form on the stair. This condition is indicative of the sub-structure supporting the stairs to be decaying

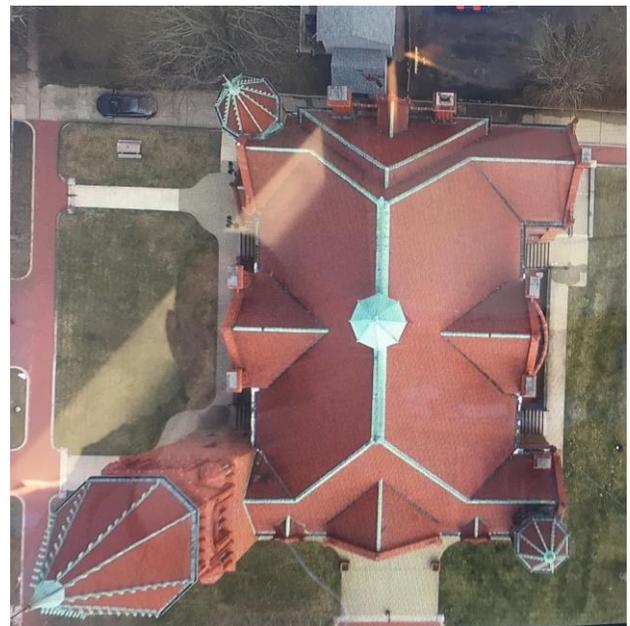
The slate roof continues to present problems. Slate tiles are becoming detached and falling to the gutters at the eaves and in our opinion will continue to present a problem in the coming years. Resetting of these tiles will maintain a watertight roof, however, the process of repairing the roof is becoming expensive. In our opinion the slate tiles are in good conditions, the nails holding the tiles on are failing. The problem is compounded by the pitch of the roofs. The roof slope which is 18 inches vertical in 12 inches horizontal, creates unnecessary stress on the 100 year old nails. We recommend removal of the slate tiles, storing them on perimeter staging, introducing a new layer of plywood over the existing sheathing and reinstalling the slate tiles. In addition, by completely removal and reinstallation of the roof we can introduce new slate tile into the field of the roof which will lessen the appearance of the new tile. By dispersing the new red tile within the

field it will be less noticeable. Copper detailing can be saved and reinstalled as well.

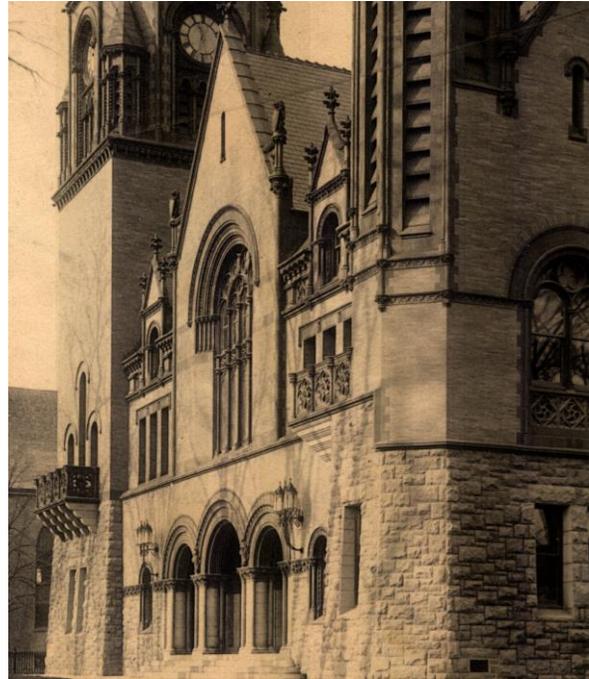
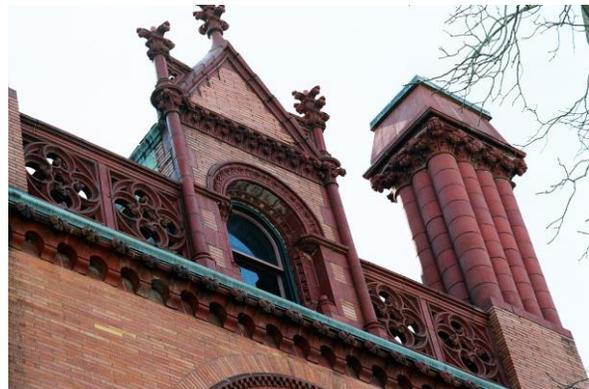
Many of the terra cotta decorative elements on the building façade have either been damaged or removed. The replacement of these will be the most important element of the building restoration. The photograph to the right, obtained from the Millicent Library Historic Archive, shows the building when it was completed in 1892. The two balconies on the front of the building have terra cotta balustrades which were removed in the past. It is unclear when, or why they were removed. These two significant elements, restored to their original details, would add to the restoration of the Center Street elevation of the building. The final terra cotta detail which is currently missing are the finials on top of the dormer pediments, and the gargoyle elements at the eaves of the main gable end at the center of the elevation. There are many modern materials that could be utilized to replicate these missing elements while minimizing the cost to recreate these important details. In fact a balustrade on the north elevation of the building, seen at the right, could be used as a template for the two balcony railings.

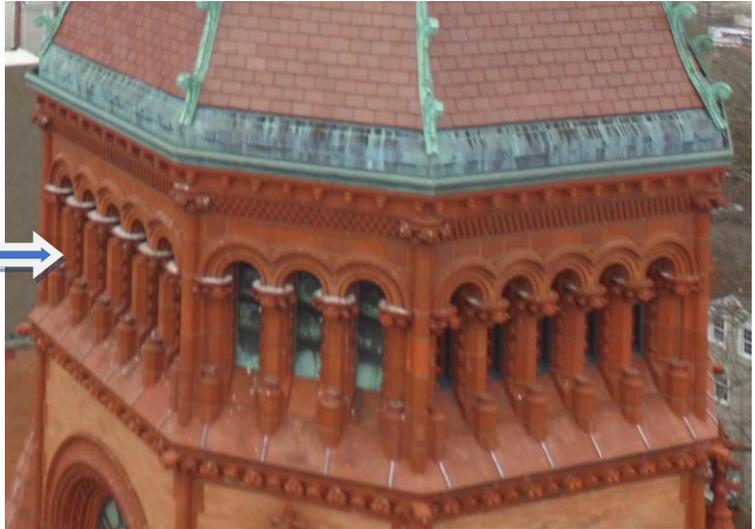
The Clock Tower has many missing terra cotta columns around its perimeter. These columns separated the various louvers and windows. In the photo to the right the arrow is pointing to the missing column shaft. This occurs on all the longer window walls, while the diagonal columns are intact. We are concerned that the column capitals at the top of the column were not intended to be a cantilevered terra cotta shape and could eventually fail due to the weight of the masonry above. These column shafts could be replicated from modern materials, and tinted to match the existing terra cotta.

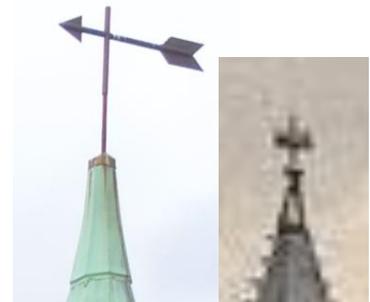
The Clock Tower weathervane has been lost and replaced with a simple arrow. This arrow and its shaft is fabricated from iron which when in contact with copper can corrode due to a galvanic reaction. The rust stains seen in the photo to the right is an indication that this is in process. A 1906 postcard give us a glimpse of the original weathervane, however, the enlarged view seen in the lower right is not clear enough to see the actual configuration of the original weathervane.

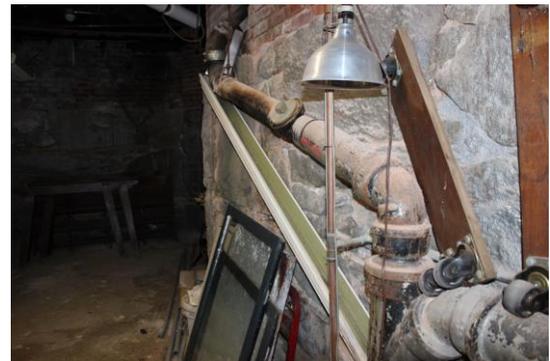
There are two internal roof drains located on the Center St elevation. These drains have been plagued with leaks and are currently leaking within the wall cavity. These leaks will create a problem with mold and mildew if left up repaired. The repairs will require the wall of the second floor stair to be opened and the pipe examined and repaired. The current cast iron drain seen at the right rises up in the wall in a brick shaft. The white gutter seen in the photo below the cast iron is a temporary solution allowing the leaking water to be channeled to the drain located at the floor below. This pipe, governed by the plumbing code, needs to be repaired and is considered a code violation in its current state. There is a similar pipe at the west side of the building which is not leaking.

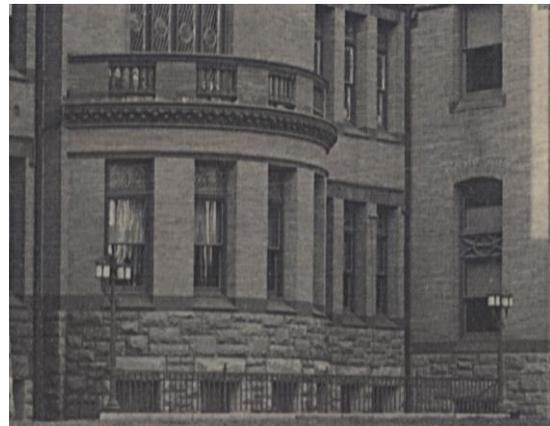
There are missing light fixtures at the east and west areaway stairs. The original poles remain and the conduit for the wiring is still visible, a careful replication of these lights would provide adequate light for these areas which provide egress from the basement offices. The light fixtures seen in this historic photo, provided by the Millicent Library, will provide enough detail to recreate the fixtures. The poles are still standing and can be used as the support for the fixtures.

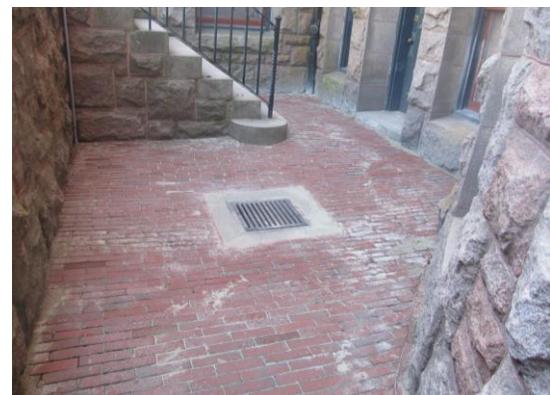
In 2012, the areaways located on the east and west elevations of the building were restored. The existing brick paving was removed, the foundations were excavated and the foundations walls were waterproofed to minimize water infiltration to the office areas in the Basement. The photo to the right shows the completed east areaway with the sand joint filler being installed. At that time the storm water piping that runs under the west lawn was examined with a camera and several problems were noted. The cost to repair was restrictive and the work was not done.

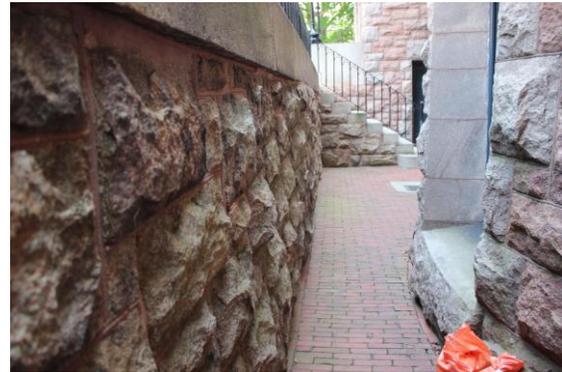
The retaining walls of both areaways need to be rebuilt. The walls are tilting into the areaway from the top to the bottom and will continue to move if the masonry is not restored. The wall in the photograph to the right, has a bulge in the wall visible by the reveal of the cap stone. The stone retaining wall originally had an overhang if the cap stone to the stone masonry, this disappears in the center of the wall. Many of the stone masonry joints are cracked from the wall movement. We recommend complete excavation of the retaining walls on both east and west elevations and reconstruction to alleviate the hydraulic pressure being exerted on the wall.

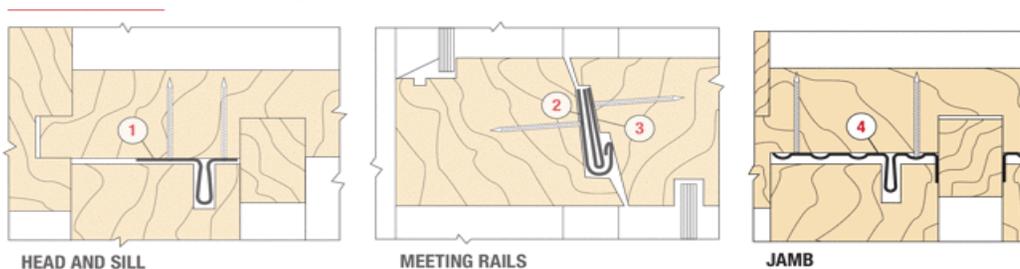
At the bottom of the lower sash, a bulb type weatherstripping was installed. We recommend removal of this weatherstripping and installing a bronze tee shape weatherstripping. This type of weatherstripping extends up into a kerf cut in the bottom of the sash effectively sealing the sash. The kerf cut exists so the installation of the weatherstripping would be an economical repair. The recommended weatherstripping are shown below.

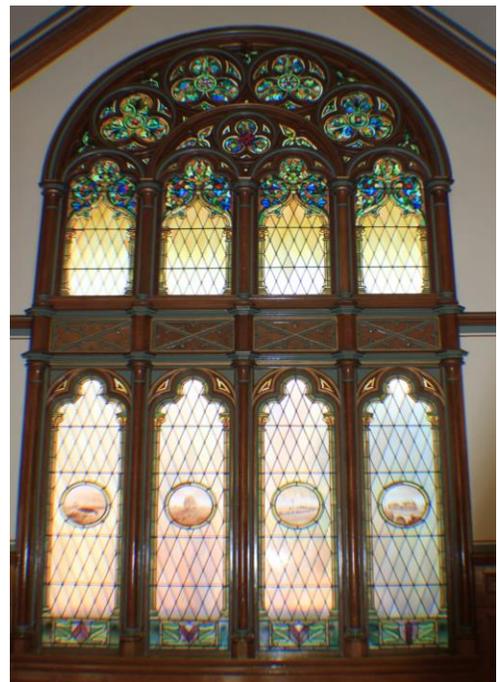
These windows will need to be carefully evaluated by a stained glass conservator as many of the lead comes, the “h” shaped lead that holds the glass together, have evidence of failure. This report excludes this work as we are not capable of evaluating the window glazing. A budget line item will be carried in the statement of probable construction cost, but it will need to be confirmed by a conservator.

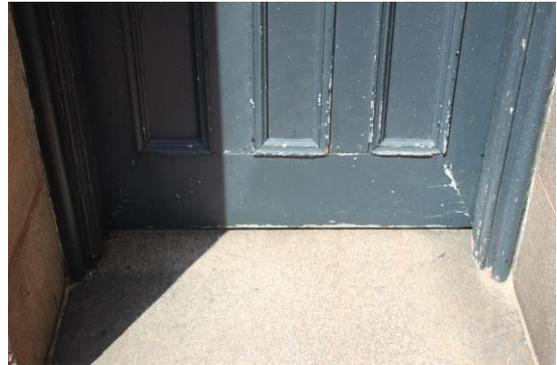
The two egress doors out of the basement to the east areaway have been repaired inappropriately. The original stiles, or vertical members, at each side of the door were modified. The stiles and bottom rail were cut on a diagonal angle and a new bottom rail installed. It is unclear why this was done, but it creates an unstable structural condition for the bottom rail. The original doors would have had the stiles extend to the bottom of the bottom rail with the bottom rail mortised and tenoned into the stiles. The doors will need to be removed and replaced with new units that meet the structural design of the original doors.

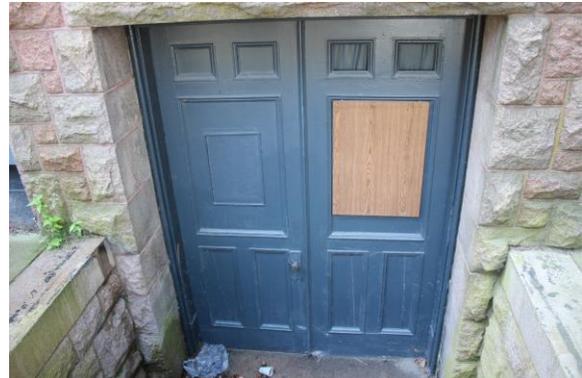
The North side of the building has the entrance to the basement mechanical room. The original doors have been modified with the original wood panel removed. A plywood panel was recently installed to replace the missing panel. This door should be restored with the proper panel. The door should be carefully inspected and repaired including the installation of new weatherstripping and repair of any decayed wood.

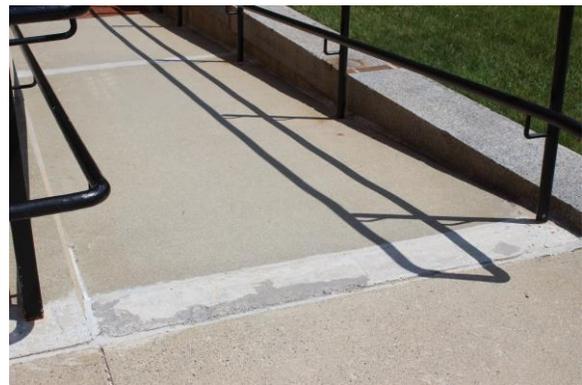
The Handicap Accessible ramp, constructed over 20 years ago has several problems with the concrete ramp surface. The ramp is constructed of both slab on grade and slab over galvanized steel decking and has several movement cracks visible. There is evidence of movement in both forms of slab. An attempt to grind irregularities in the slab height is evident, but the primary cause for this movement was not determined. Grinding the slab reduces the thickness of the slab and will only hasten further deterioration. The slab on grade can be removed and a new slab poured. The slab on metal decking will need further investigation to determine the cause and appropriate method of repair.

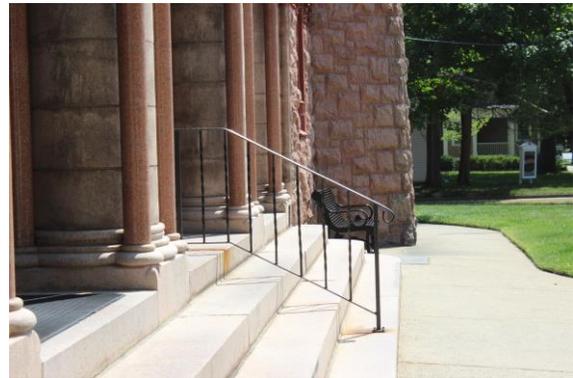
The granite stairs at the Center Street Elevation require removal and resetting. These stairs should be set so that the rainwater drains off towards the street. Unfortunately, the structure below the stairs that support the heavy granite slab has apparently deteriorated to the point where the stairs actually pitch towards the building allowing water to pond on the stair creating a hazard in the colder months.

Additional handrails should also be considered. Current codes require handrails to be set a maximum of 5 feet apart so that a rail is within 30 inches of reach.

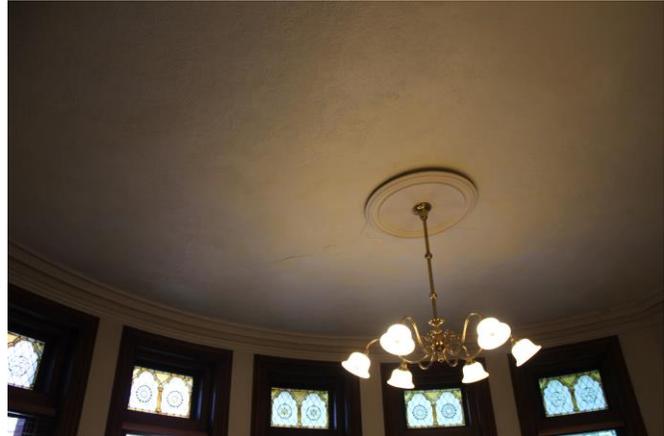
Many areas of the interior need to be restored, most immediately is the Assessor's Office where the ceiling is in a state of partial collapse. This ceiling, located on the west side of the building, has several large cracks. The medallion, seen at the right, is actually out of level due to the plaster failure. This room will require immediate repair and we recommend that the areas directly under the plaster failure be blocked off from the staff to avoid an accident. The plaster will need to be removed and replaced in the immediate future. The cause of this plaster failure is unclear. There are no water stains which would indicate a roof leak. In our opinion, the keying of the old horsehair plaster has failed. Although there are ways to consolidate this plaster, it can never be made level again which is why we recommend removal of the damaged area and a new skim coat plaster system installed on the existing structure.

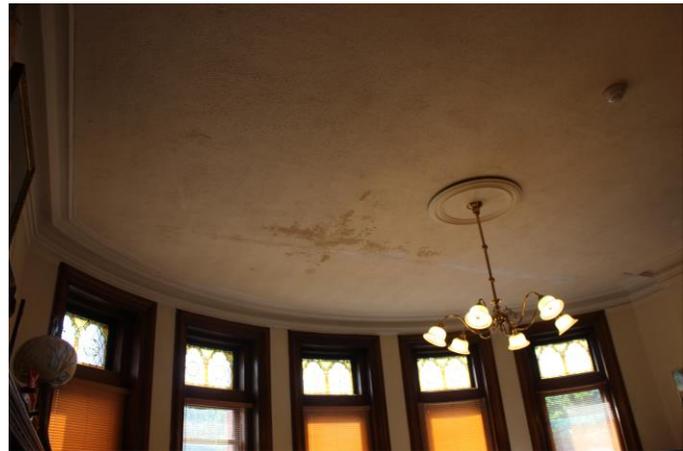
In the selectmen's office the water damage to the ceiling continues. We were informed that the ceiling does still show new water damage during rain events. The repair of the copper roof was effective, but we believe that there is a problem within the brick wall and ornate window wall of the second floor. The windows as seen on our previous inspections had a failed sealant bed at the window frame connection to the brick wall. In addition, there are several areas of the wood frame that need to be sealed. This work should take place in the immediate future to avoid the collapse of the selectmen's ceiling.

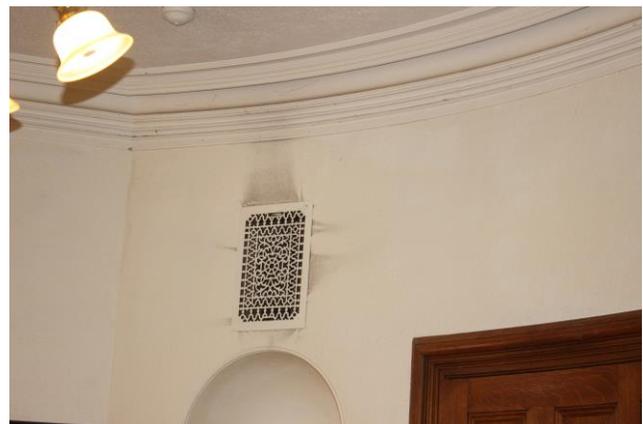
A problem also exists with the building ventilation system. In the photograph to the right the staining at the perimeter of the vent grille is an indication that the system requires filters. In addition, the ductwork should be cleaned of any contaminants that could affect the air quality within the building.

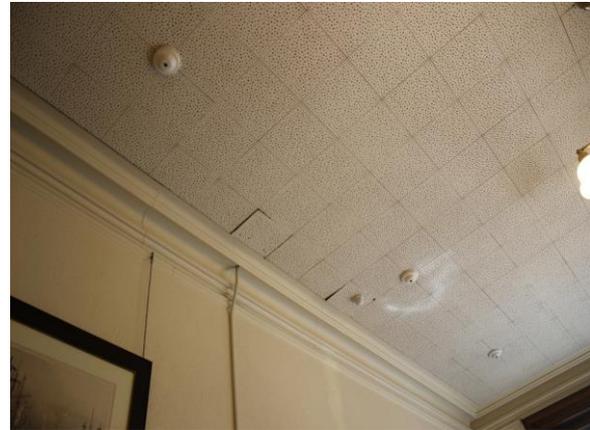
The building inspector's office ceiling is an old acoustic tile ceiling. According to Wayne Fostin, the Building Commissioner, the original plaster ceiling in that area fell and was removed and replaced with the acoustic tile ceiling. It is unclear when this happened. The ceiling separates the second floor auditorium from the first floor and needs to have a fire rating. Many of these tiles are loose and appear to be ready to fall to the floor below. The tiles will need to be tested for hazardous materials before any work is performed on the ceiling.

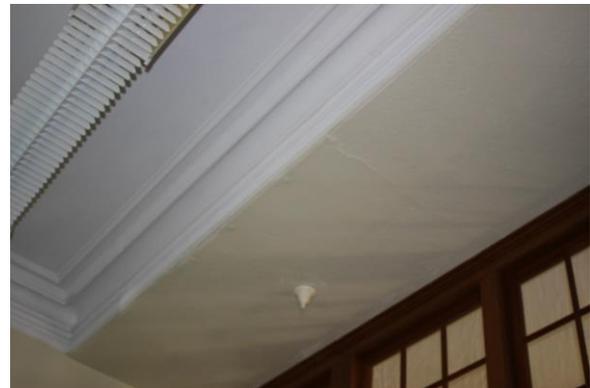
The tax collector's office, has a soffit in the private office with damaged plaster, which appears to have been repaired with a plastic washer system. This system is designed to be covered in plaster, but these washers were left exposed. Visible in the photograph to the right, a crack in the plaster exists at the last washer. We recommend replacing the ceiling with a new skim coat plaster system.

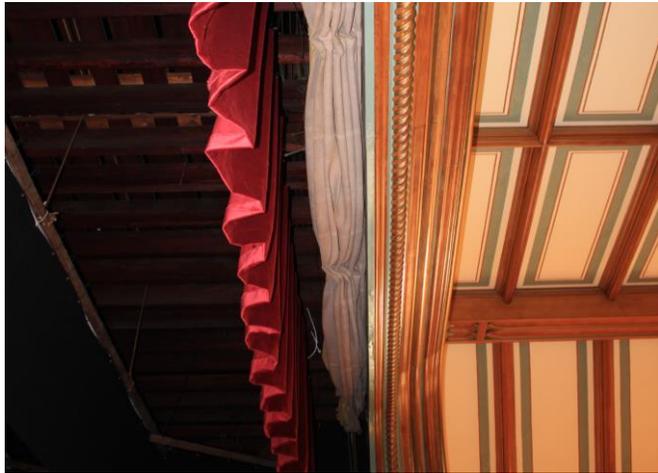
A fire Curtain exists at the proscenium opening but it is difficult to operate and lacks the required fusible link and counterweight system designed to minimize smoke and fire from rising up the stagehouse into the attic. This curtain should be modernized, although the curtain itself should be acceptable for its intended purpose. We also found the stage curtain rigging system to be in poor condition. A modern rigging system should be considered for this curtain as well. The curtain can be seen in the photograph to the right as a gray folded curtain behind the wood proscenium in front of the maroon curtain. This curtain is essential in safeguarding the building in the event of a fire.

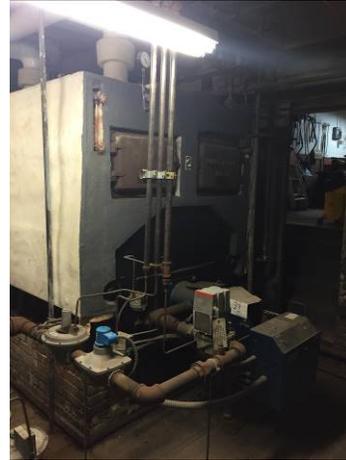
Abandoned Boiler

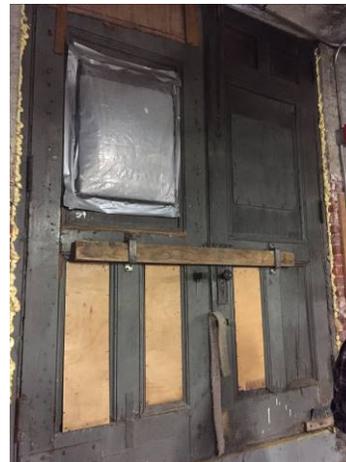
Combustion gases generated from the boiler exhaust to an existing masonry chimney through a galvanized steel breeching system, with combustion fan. Combustion air is provided to the space utilizing a Tjerland supply fan. On a call for the boiler to fire, the fan starts and provides the necessary combustion air to the space. Originally, the outside doors to the room had a louver installed in the door, and was opened to the atmosphere at all times. This was covered up, and replaced with the supply fan.

Existing Combustion Air Covered
