Cushman Park

Town of Fairhaven ADA Transition Plan

November 2024

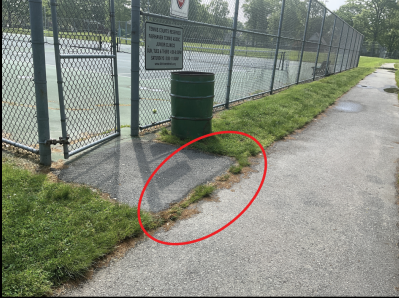
Surface openings > 1/2" Route not maintained in operable working condition	-	Repair the gap. Trim the grass to ensure the accessible route is maintained in operable working condition.	1	-	-
2	Play Area	Ext.		Exterior Access Route	Exterior

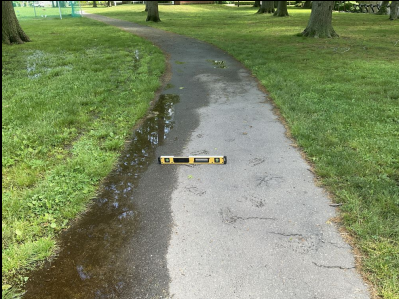
Cross slope > 1:50 (2.00%)	5.2%	Reduce cross slope to be no steeper than 1:50 (2.00%). Recommendation applies to entire park where there is excessive slope.	1	-	-
3	Near Parking	Ext.		Exterior Access Route	Exterior

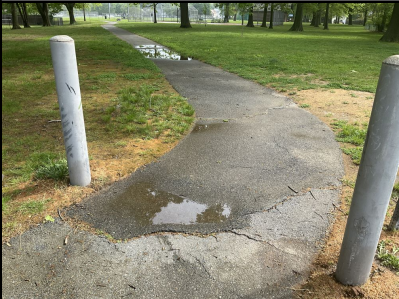
Does not prevent accumulation of water	-	Repair surface.	1	-	-
4	Near Concessions/ Toilet Room	Ext.		Exterior Access Route	Exterior

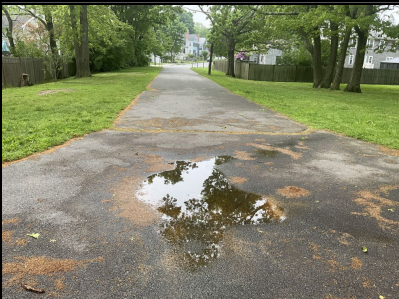
Does not prevent accumulation of water		Repair surface.	1	-	-
5	Band Shell	Ext.		Exterior Access Route	Exterior

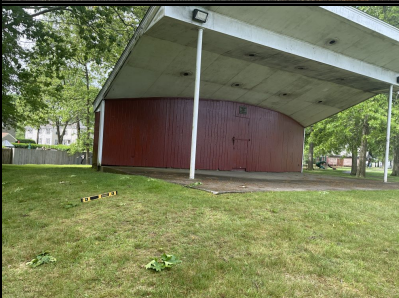
Accessible route not provided	18.5%	Ensure an accessible route is provided to the band shell.	1	-	-

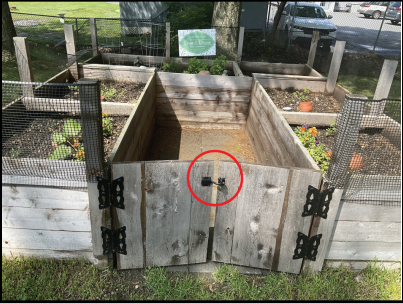
Hardware not compliant	-	Provide hardware that can be operable with one hand and not require tight grasping, pinching, or twisting of the wrist.	1	-	-
Signage												
12	Women's and Men's Single-User Toilet Rooms	Ext.		Signage	Designation

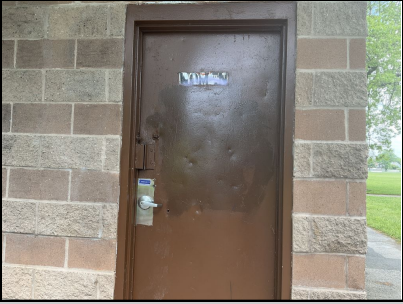
Raised characters not provided on sign Braille not provided on sign Location of tactile sign not compliant	- - -	Provide text with raised characters duplicated in braille on the sign. Provide braille on the sign. Locate sign alongside the door on the latch side.	2	450	\$900
Service Counter											900	
13	Concessions Stand	Ext.		Service Counter	N/A

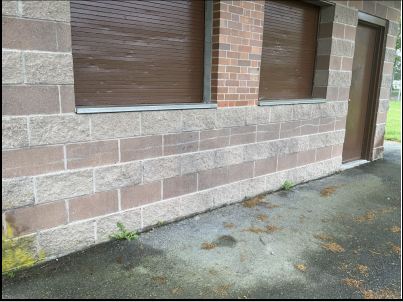
Counter > 36" high	43"	Provide a counter that is 36" max. above the ground.	1	1144	\$1144
Exterior Benches											1144	
14	Bench Near Swing Set	Ext.		Exterior Benches	N/A

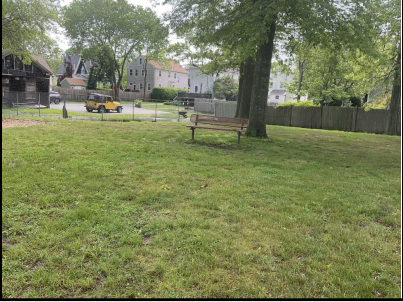
No accessible route to one bench in area	-	Relocate one bench to an accessible route or provide an accessible route to one bench in this area.	1	-	-

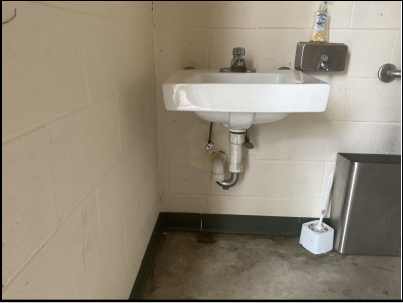
Plumbing underneath is exposed	-	Insulate or otherwise configure pipes to prevent contact at the lavatory. Recommendation also applies to the men's single-user toilet room.	2	150	\$300
												300
Single-User Toilet												
16	Women's and Men's Single-User Toilet Rooms	Ext.		Single-User Toilet	N/A

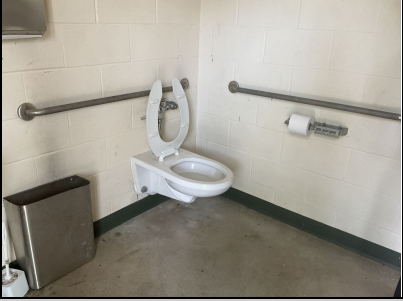
Clearance at toilet < 60" clear width	34"	Relocate the trash can to maintain a 60" wide min. clear floor space at the toilet. Recommendation also applies to the men's single-user toilet room.	2	-	-
Portable Toilet												
17	Portable Toilets	Ext.		Portable Toilet	N/A

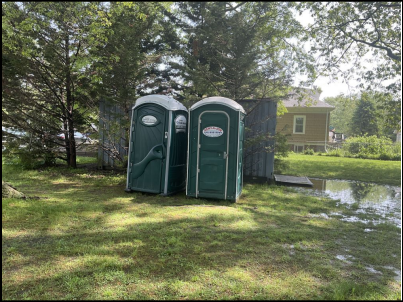
Not located on an accessible route Accessible portable toilets not provided	- -	It was not clear at the time of survey whether these portable toilets were in use. If they are used, locate at least one portable toilet on an accessible route and ensure that at least 5% of portable toilets is accessible. (Cost estimate is for an accessible portable toilet.)	1	4600	\$4600

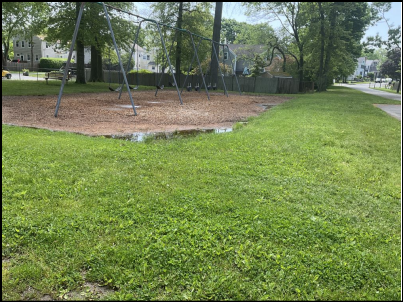
Accessible route not provided to playground Accessible route not provided around playground Accessible route not provided to play components	- - -	Install an accessible route to and around the playground. Provide an accessible route around the play area. Provide a compliant impact-attenuating surface to and around the play components.	1	-	-

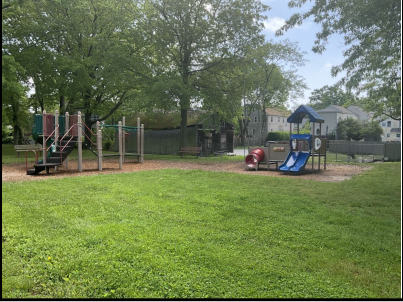
Accessible route not provided to playground Accessible route not provided around playground Accessible route not provided to play components	- - -	Install an accessible route to and around the playground. Provide an accessible route around the play area. Provide a compliant impact-attenuating surface to and around the play components.	1	-	-
Field												
20	Southwest Softball Field - Third and First Base Side	Ext.		Field	Baseball

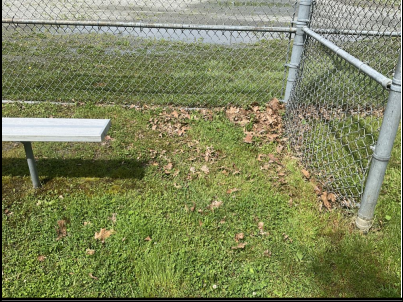
Accessible spaces not provided at team seating	-	Provide a firm, stable and slip-resistant 36" x 48" clear floor space at team seating. Provide an accessible route to this space. Recommendation also applies to the northeast softball field.	2	-	-
21	Southwest Softball Field - Third and First Base Side	Ext.		Field	Baseball

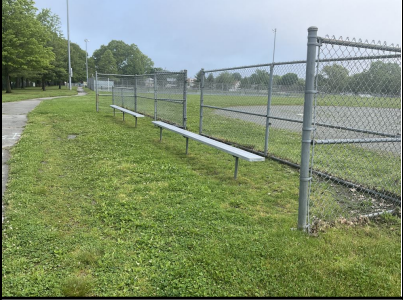
Accessible spaces not provided at team seating No accessible route to all areas of sport activity	- -	Provide a 36" x 48" clear floor space at team seating. Provide an accessible route to this space. Install an accessible route between all areas of sport activity. Recommendation also applies to the northeast softball field.	2	-	-

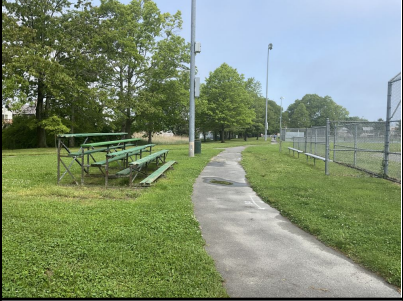
Accessible spaces not provided at sidelines seating	-	Provide a 36" x 60" clear floor space at sidelines seating. Provide an accessible route to this space. Recommendation also applies to the northeast softball field.	1	-	-
23	Southwest Softball Field - Third and First Base Side	Ext.		Field	Baseball

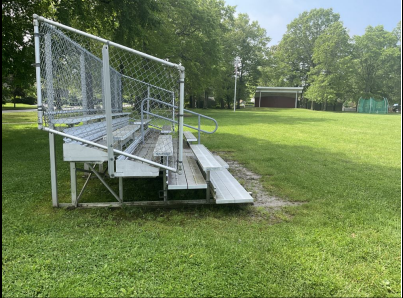
Accessible spaces not provided at sidelines seating	-	Provide a 36" x 60" clear floor space at sidelines seating. Provide an accessible route to this space. Recommendation also applies to the northeast softball field.	1	-	-

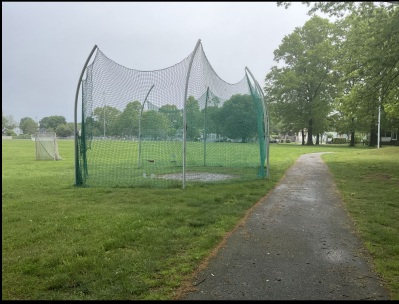
Practice areas are not on an accessible route	-	Provide an accessible route to practice areas, including the batting cage.	1	-	-	
25	Southwest and Northeast Softball Field	Ext.		Field	Baseball

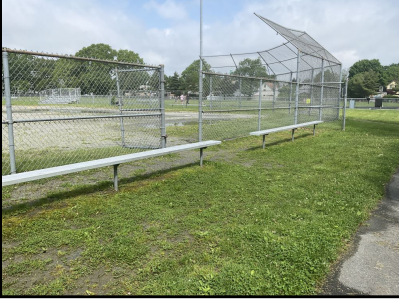
No accessible route to all areas of sport activity	-	Install an accessible route between all areas of sport activity including the field and team seating areas.	1	-	-	
Court													
26	Basketball Court	Ext.		Court	Basketball

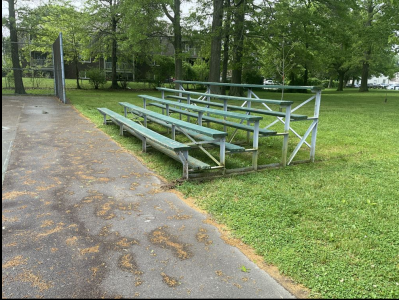
Accessible spaces are not provided at sidelines seating	-	Provide a 36" x 60" clear floor space at sidelines seating. Provide an accessible route to this space.	1	-	-	
27	Basketball Court	Ext.		Court	Basketball

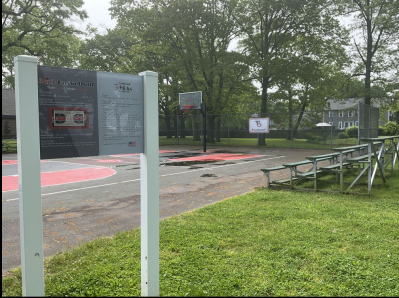
Accessible spaces are not provided at sidelines seating Seating is not connected to an accessible route	- -	Provide a 36" x 60" clear floor space at sidelines seating. Provide an accessible route to this space. Provide an accessible route to the sidelines seating.	1	-	-

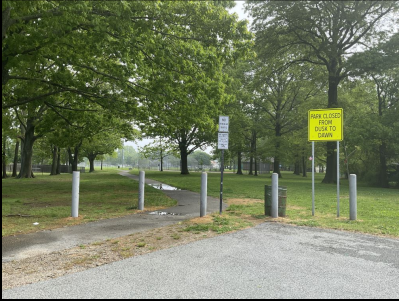
Recommend increasing the lighting on the path	1	-	-

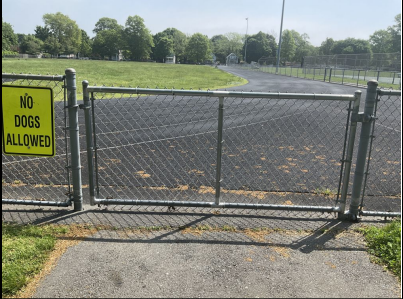
The metal fence currently is hitting the ground and making it difficult to open. Ensure that it is kept in operable working condition.	1	-	-
30	Near Track	Ext.

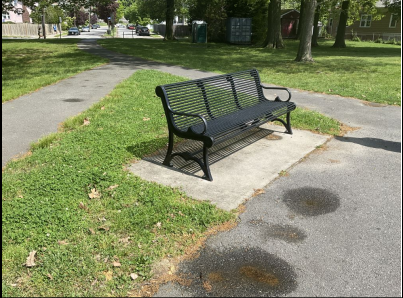
Recommend providing a 36" min. by 48" min. stable, firm and slip-resistant surface adjacent to at least one bench in each area where benches are provided positioned to allow a person in a wheeled mobility device and a person sitting on the bench to have their shoulders aligned in a manner that is substantially similar to what is shown in the narrative report.	1	-	-
31	Track	Ext.

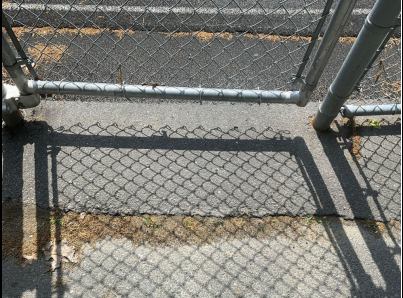
4"	Recommend providing a 10" high smooth surface on the push side of the gate extending the full width of the door or gate.	1	-	-
