East Fairhaven Elementary School

Town of Fairhaven ADA Transition Plan

October 2024

Institute for Human Centered Design

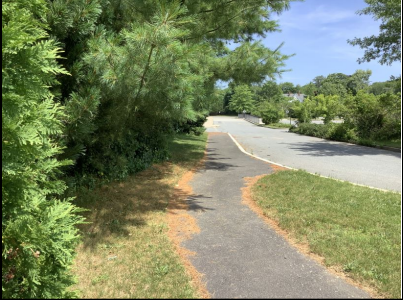
Obstructed by protruding objects	53.5"	Trim low hanging branches in trees.	1	-	-
2	Marked Aisle Between All Accessible Parking Spaces in East Parking Lot	Ext.	-	Exterior Access Route	Sidewalk

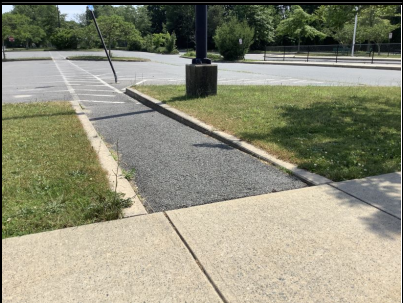
Surface openings > 1/2"	1"	Ensure that the surface opening is no greater than 1/2" max. Applies to both sides where paths connect.	2	-	-
3	Entry Gate to Playground Closest to Parking	Ext.	-	Exterior Access Route	Walkway

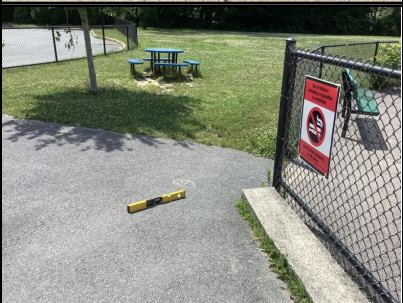
Running slope > 1:20 (5.00%)	9.5%	Reduce running slope to be no steeper than 1:20 (5.00%).	1	-	-
4	Path From New Boston Road to Drop Off Entrance	Ext.	-	Exterior Access Route	Exterior

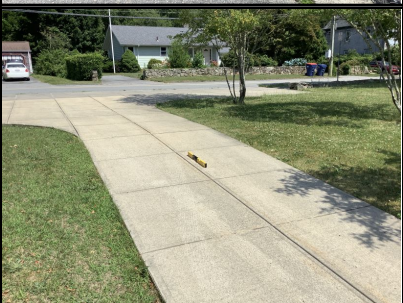
Running slope > 1:20 (5.00%)	6.4%	Reduce running slope to be no steeper than 1:20 (5.00%).	1	-	-

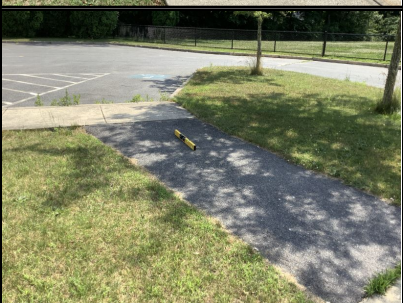
Running slope > 1:20 (5.00%)	5.9%	Reduce running slope to be no steeper than 1:20 (5.00%).	1	-	-

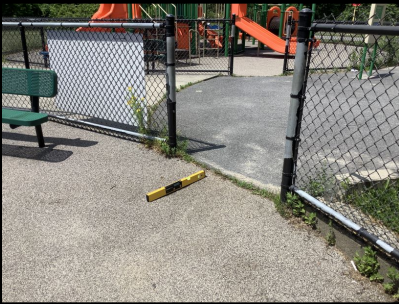
Running slope > 1:20 (5.00%) Level changes > 1/4"	7.3% 1.5"	Reduce running slope to be no steeper than 1:20 (5.00%). Alter change in level to be 1/4" high max.	1	-	-
7	Entry Gate to Playground Closest to Parking	Ext.	-	Exterior Access Route	Walkway

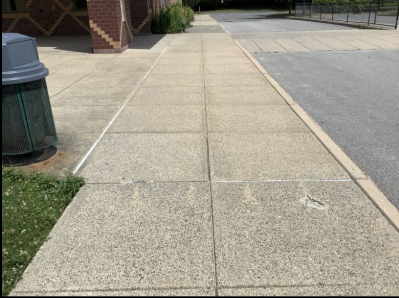
Route not maintained in operable working condition	-	Repair surface.	1	-	-
10	Sidewalk New Boston Road	Ext.	-	Exterior Access Route	Exterior

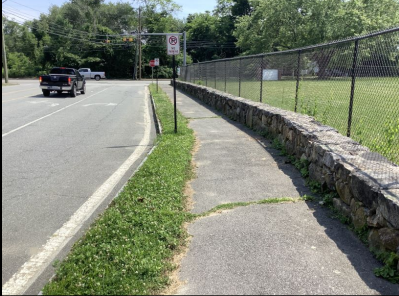
Route not maintained in operable working condition	-	Ensure the accessible route is maintained in operable working condition.	1	-	-

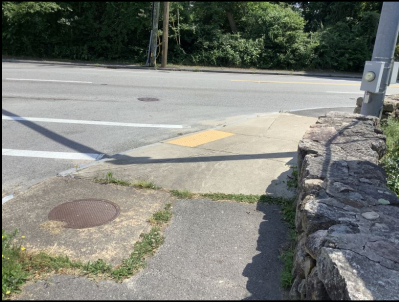
Route not maintained in operable working condition	-	Ensure the accessible route is maintained in operable working condition.	1	-	-
12	Memorial Outside of South Library Egress Door	Ext.	-	Exterior Access Route	Exterior

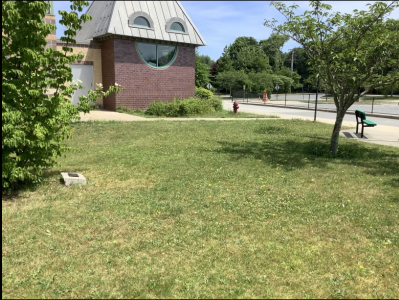
Accessible route not provided	-	Ensure an accessible route is provided to the memorial.	1	-	-
Curb Ramp												
13	Path to Basketball Court	Ext.	-	Curb Ramp	N/A

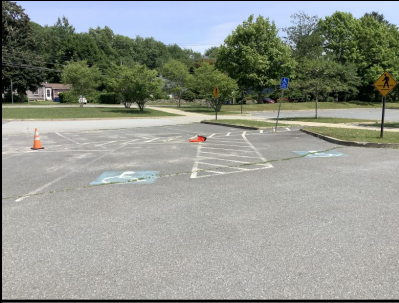
Sign with the International Symbol of Acc. not provided	-	Provide a sign with the International Symbol of Accessibility (ISA) with the bottom of the sign 60" min. above the ground and the top 96" max. above the ground.	1	500	\$500
											500	
17	Single Accessible Space in East Parking Lot	Ext.	-	Off-Street Parking Lot or Garage	Visitor

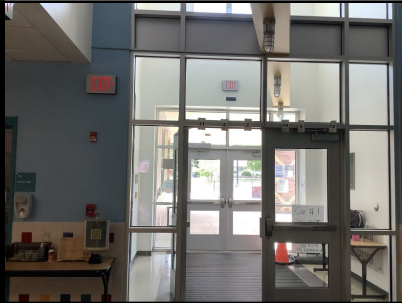
Tactile exit sign not provided Illuminated ISA symbol not provided (MAAB)	- -	Ensure that a tactile exit sign with raised characters and braille is provided at the exit door. Mount the sign between 48" - 60" above the finished floor located on the latch side of the door. Provide an illuminated sign with the International Symbol of Accessibility (ISA). (Cost is for one tactile exit sign and one illuminated sign with the International Symbol of Accessibility (ISA)).	1	250 200	\$450
											450	
23	Story Area, All Accessible Direct Egress Doors	1	110 C	Means of Egress	N/A

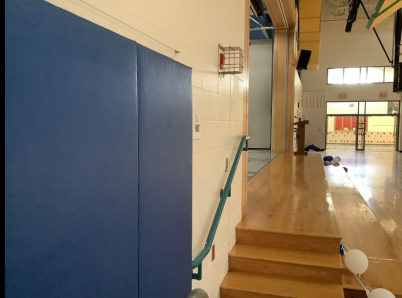
Obstructed by protruding objects	6"	Recommend providing a fire alarm guard that is no deeper than 4".	1	\$500	\$500

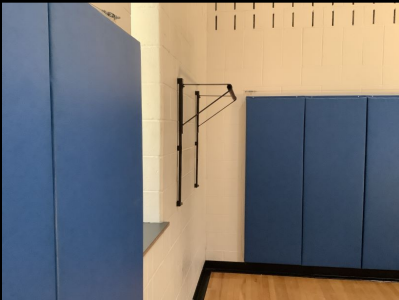
Obstructed by protruding objects	14"	Provide a cane-detectable barrier underneath the projecting object. Barriers must have leading edges no higher than 27" so that they are within cane sweep. Barriers can include fixed planters, benches, and guardrails. Applies to the other identical protruding object in the gym.	2	398	\$796
28	Stairway on East/West Corridor from Level 1 to LL	1	-	Interior Access Route	N/A

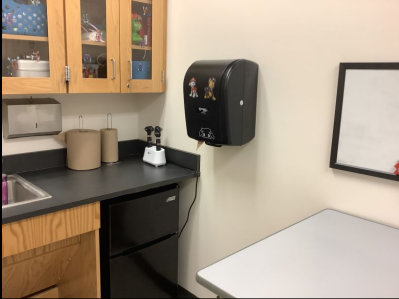
Obstructed by protruding objects	9"	Recommend relocating the paper towel dispenser over the counter so that it does not act as a protruding object.	1	500	\$500

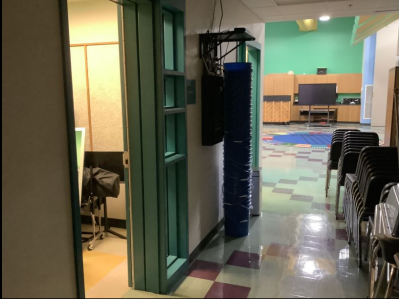
Obstructed by protruding objects	5", 79.5"	Provide a cane-detectable barrier underneath the projecting object with wires. Barriers must have leading edges no higher than 27" so that they are within cane sweep. Barriers can include fixed planters, benches, and guardrails.	1	398	\$398
31	Grade 3	2	235	Interior Access Route	N/A

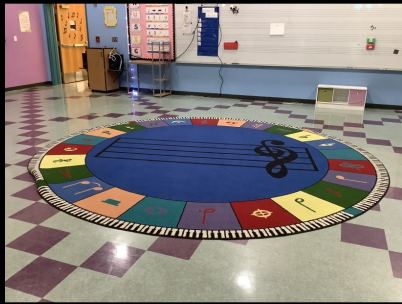
Surface not stable, firm, and slip-resistant	-	Secure the mat.	1	Labor	Labor
33	Speech Room	LL	121	Interior Access Route	N/A

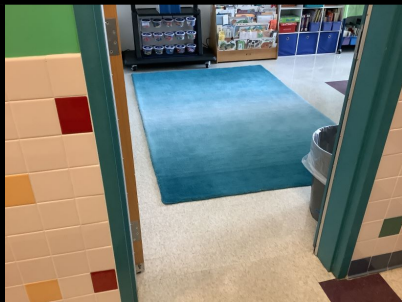
Surface not stable, firm, and slip-resistant	-	Secure the mat.	1	Labor	Labor
Doors, Doorways, & Gates												
34	Nurse's Office Single-User Toilet Room	1	-	Doors, Doorways, & Gates	Toilet Room

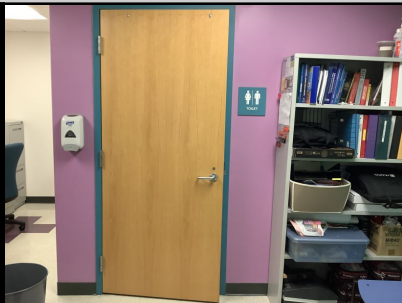
Maneuvering clearance(s) not provided	15.25"	Relocate the shelves to provide 18" of clear floor space next to the latch side of the door.	1	Labor	Labor
35	Music/Platform Common Area	1	103	Doors, Doorways, & Gates	Circulation

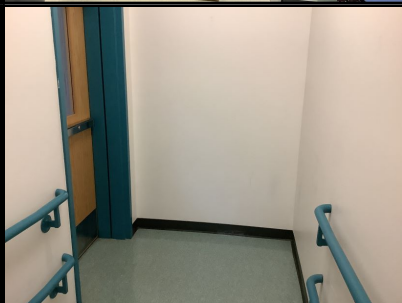
Maneuvering clearance not provided at recess > 6"	11"	Install an automatic door opener.	1	6000	\$6000
											6000	
36	Reception	1	100	Doors, Doorways, & Gates	Office

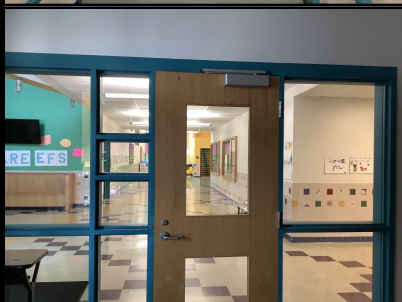
Door requires > 5 lbs. of force to open	14 lbs	Adjust closers so doors do not require more than 5 pounds of force to open. Applies to all interior doors in this condition.	1	Labor	Labor

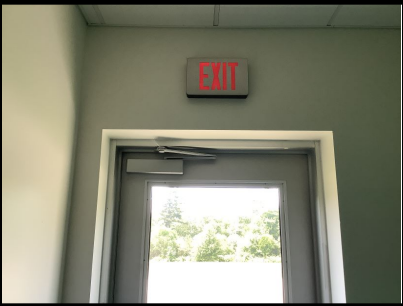
Exterior door requires > 15 lbs. of force to open	25 lbs.	Adjust closers so doors do not require more than 15 pounds of force to open. Applies to all exterior doors in this condition.	1	Labor	Labor
Ramps												
38	Ramp Leading to Stage/Music Room	1	-	Ramps	Interior

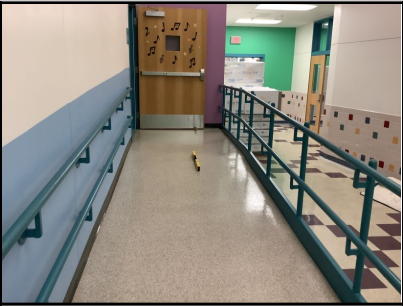
Running slope >1:12 (8.33%)	9.4%	Further study will be needed to determine whether it is technically feasible to bring the ramp into full compliance with the ADA Standards.	1	-	-
39	Ramp Leading to Stage/Music Room	1	-	Ramps	Interior

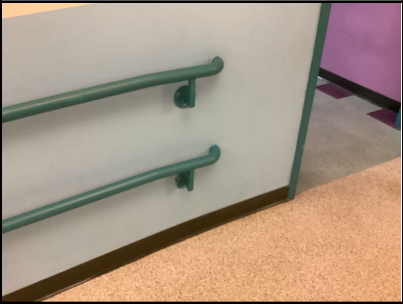
Handrails do not extend 12" past top & bottom	6"	Alter handrails to extend horizontally above the landing for 12" min. beyond the top and bottom of ramp runs.	2	-	-
40	Ramp From Stage to Gymnasium	1	103	Ramps	Interior

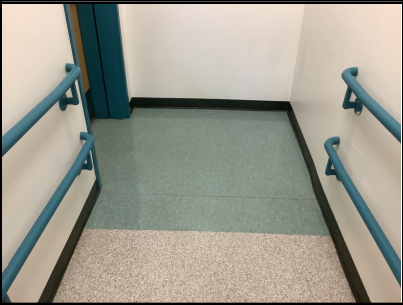
Handrails do not extend 12" past top & bottom	9"	Alter handrails on the right side of this image to extend horizontally above the landing for 12" min. beyond the top and bottom of ramp runs. Applies to the handrail extensions at the top of the ramp.	2	-	-

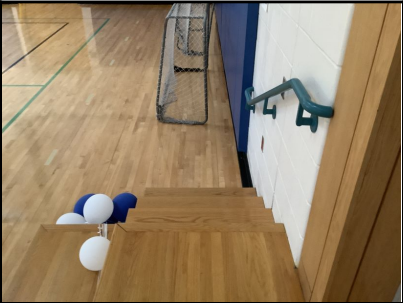
Handrail not provided on both sides	-	Provide a handrail on the open side.	1	-	-

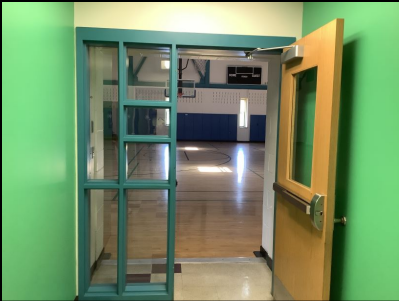
Signage is not provided		Locate compliant designation signage for the gymnasium with raised characters and braille alongside the door on the latch side.	1	250	\$250
											250	
43	Stairwell 2	2	-	Signage	Egress

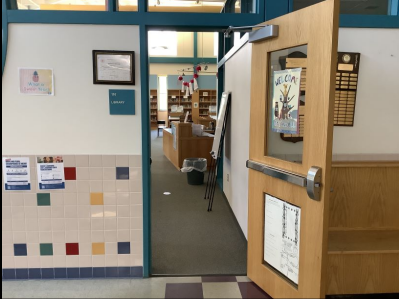
Raised characters < 48" or > 60" above ground Braille not provided on sign	62" -	Mount the sign so that the baseline of the lowest tactile character is 48" min. above finished floor and the baseline of the highest tactile character is 60" max. above the finished floor. Provide braille on the sign. Applies to all designation signs in this condition.	1	250	\$250

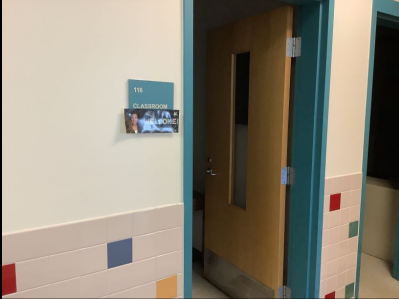
Braille not provided on sign	-	Ensure that braille is not blocked or covered up on signs. Applies to all rooms in this condition (Includes: , Special Education Extension. Room, Reading Room, Grade 1 Classroom 139).	4	Labor	Labor

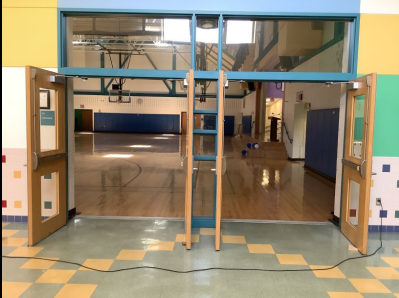
Location of tactile sign not compliant		Locate compliant designation signage to the gymnasium on the right side of the rightmost door.	1	Labor	Labor
48	Stairwell 2	1	-	Signage	Designation

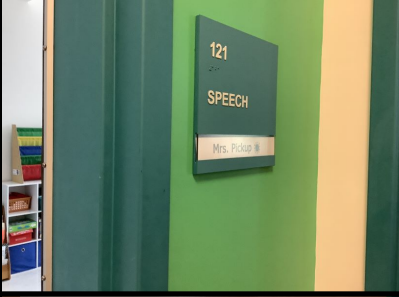
Non-glare finish and contrast not provided on sign	-	Install a sign with a non-glare finish. Applies to all room designation signs in this condition.	1	250	\$250
											250	
51	Grade 1	LL	139	Signage	Informational

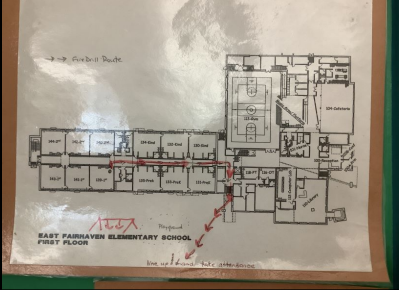
Non-glare finish and contrast not provided on sign	-	Remove the lamination to ensure there is no glare over the sign. Applies to all egress maps in this condition.	1	Labor	Labor

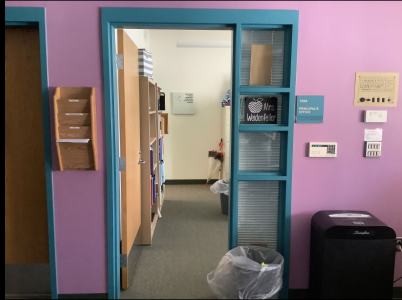
Signage lacks 18" by 18" clear floor space	-	Relocate the trash can to provide a clear floor space of 18" min. by 18" min. at the designation sign.	1	Labor	Labor
53	Kindergarten	LL	130	Signage	Designation

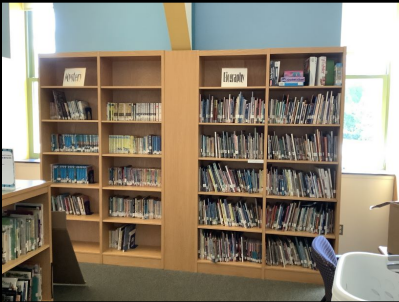
Reach < 15" or > 48"(forward/side approach)	60.5"	Ensure that staff is available to assist visitors who need assistance.	1	Labor	Labor
58	Cafeteria	1	124	Operable Parts / Reach Range	Food Service Shelf

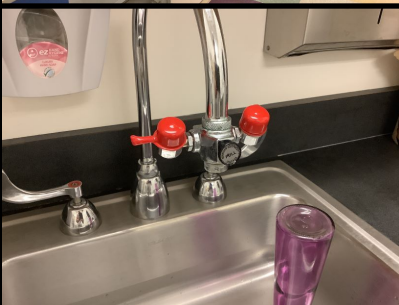
Not compliant		Provide hardware that can be operable with one hand and not require tight grasping, pinching, or twisting of the wrist.	1	-	-
Children's Reach Ranges												
60	Preschool	LL	131	Children's Reach Ranges	Coat Hooks

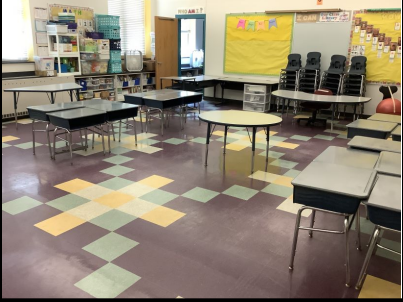
At least one or 5% accessible tables not provided	-	Ensure that at least one work surface is accessible. Applies to all classrooms where at least one or 5% of accessible work surfaces are not provided.	1	700	\$700
											700	
63	Library	1	110	Dining or Work Surfaces	Work Surface

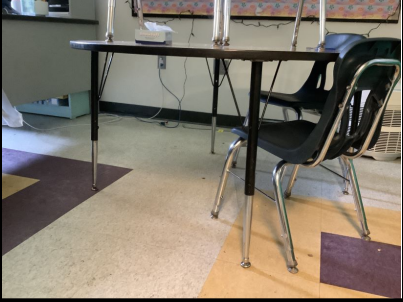
Knee or toe clearance not provided	21"	Provide at least one work surface with 30" min. wide knee and toe clearance.	1	700	\$700

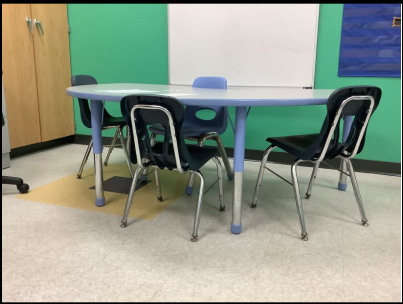
Knee or toe clearance not provided	26" wide	Provide at least one work surface with 30" min. wide knee and toe clearance.	1	700	\$700
											700	
68	Computer Room	1	112	Dining or Work Surfaces	Work Surface

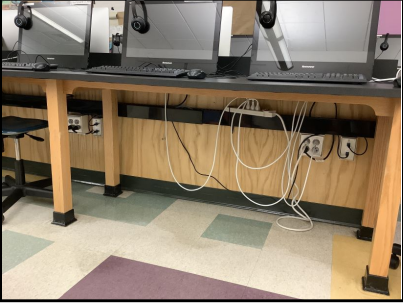
Knee clearance less than 19" deep	-	Ensure the cords do not project into at least one work surface so that the knee clearance is 19" deep min.	1	Labor	Labor
Picnic Tables												
69	Picnic Table on South Side of Library	Ext.	-	Picnic Tables	N/A

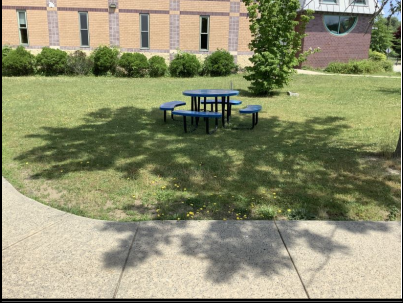
At least 5% accessible spaces not provided Picnic table not on an accessible route	- -	Ensure that at least 5% (minimum one) of picnic tables are accessible. Ensure that the accessible picnic table is connected to an accessible route. (Cost estimate is for an accessible picnic table.)	1	1400 -	\$1400

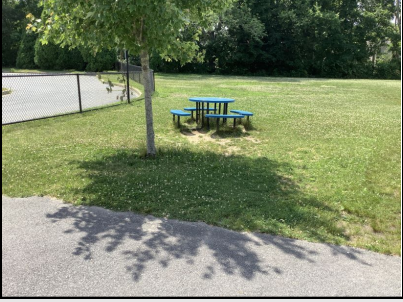
At least 5% accessible spaces not provided Picnic table not on an accessible route	- -	Ensure that at least 5% (minimum one) of picnic tables are accessible. Ensure that the accessible picnic table is connected to an accessible route. (Cost estimate is for an accessible picnic table.)	1	1400	\$1400
											1400	
Toilet & Bathing Rooms												
Lavatory												
71	Nurse's Office Single-User Toilet Room	1	-	Lavatory	N/A

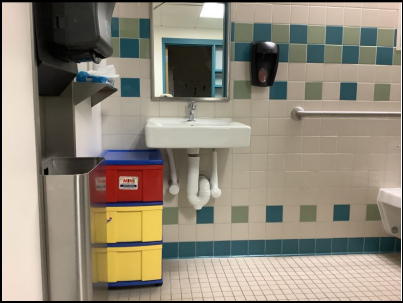
Toe or knee clearances not provided	-	Move storage cabinets to provide knee and toe clearance positioned for a forward approach.	1	Labor	Labor

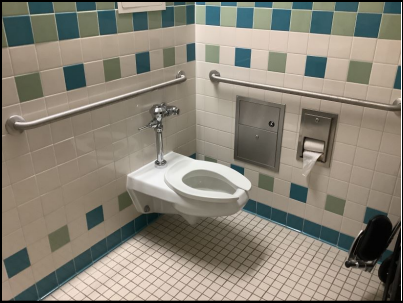
Side grab bar < 54" from back wall	48.5"	Relocate the side wall grab bar to be located 12" exactly from the rear wall.	1	800	\$800
											800	
73	Nurse's Office Single-User Toilet Room	1	-	Single-User Toilet	N/A

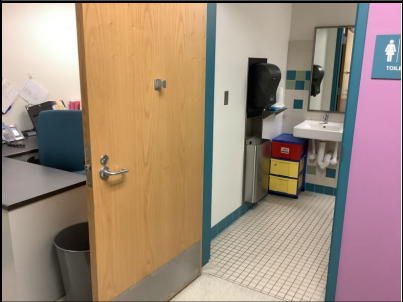
Hook located > 54" high	55.25"	Locate the coat hook no higher than 48" above the finished floor.	1	75	\$75
											75	
Toilet Compartment												
75	Boys' and Girls' Multi-User Toilet Room Next to Gym	1	-	Toilet Compartment	Accessible Compartment

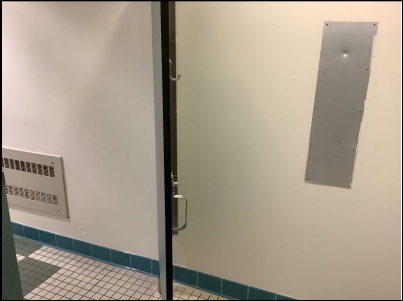
Door has noncompliant hardware Door has malfunctioning self-closing hinge	- -	Provide hardware that can be operable with one hand and not require tight grasping, pinching, or twisting of the wrist. Repair hinge.	2	70 Labor	\$140

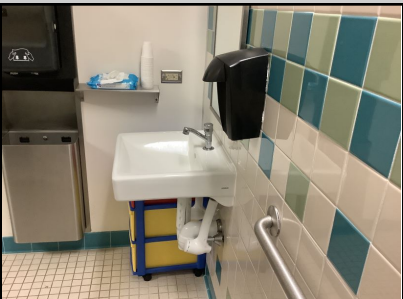
Dispenser acts as a protruding object	7"	Relocate the soap dispenser out of the circulation path.	1	500	\$500
											500

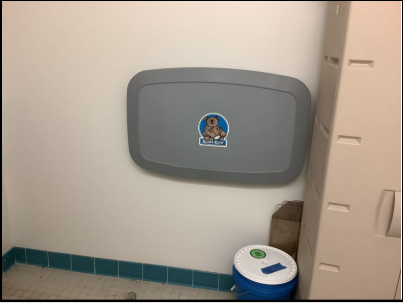
30" x 48" clear floor space not provided	-	Move objects underneath baby changing table to provide a 30" min. by 48" min. clear floor space positioned for a forward approach.	1	Labor	Labor
Toilet Rooms for Children												
Single-User Toilet (Children)												
79	Toilet Room Within Special Education Classroom	LL	117	Single-User Toilet (Children)	All Gender

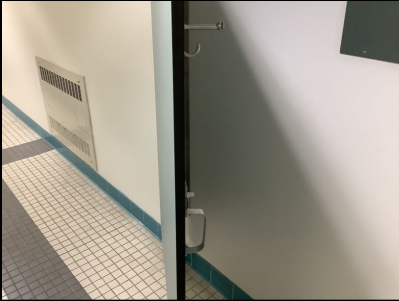
Door with malfunctioning self-closing hinge Door pull not provided Coat hook higher than 36"	- - 51.5"	Repair self-closing hinge. Provide a door pull on each side of the door between 34" to 48" above the finished floor that does not require tight grasping, pinching or twisting of the wrist. Lower hook so that it is no higher than 36" high for children.	4	Labor 140 75	\$860
84	Boys' and Girls' Multi-User Toilet Rooms	LL	-	Toilet Compartment (Children)	Accessible Compartment

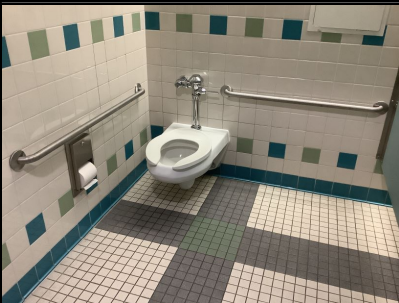
Toilet seat < 12" or > 15" high (Ages 5 - 8)	16.5"	Install a toilet with a seat between 12"- 15" high above the finished floor.	2	2816	\$5632

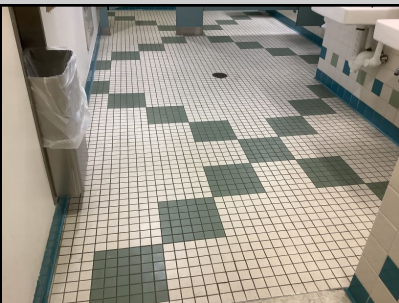
Element not maintained in operable condition	-	Ensure that floor is not slippery.	2	Labor	Labor
Additional Access

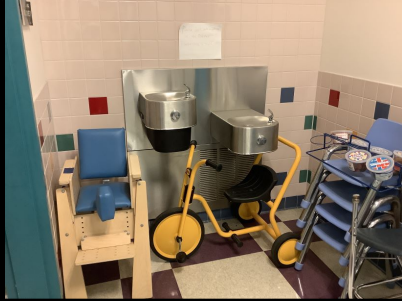
Clear floor space not provided	-	Remove objects to provide a 30" min. by 48" min. clear floor space positioned for a forward approach.	1	Labor	Labor
Sink												
88	Music/Stage Platform Common Area	1	103	Sink	N/A

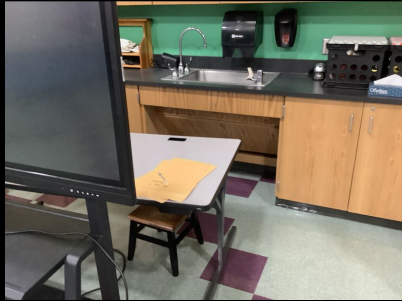
Clear floor space not provided at sink	-	Move objects to provide a 30" by 48" clear floor space positioned for a forward approach.	1	Labor	Labor
89	Innovation	2	230	Sink	N/A

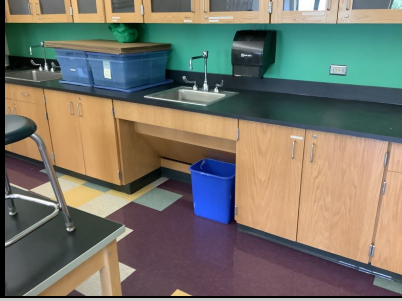
Clear floor space not provided at sink	-	Move trash can underneath sink to provide a 30" by 48" clear floor space positioned for a forward approach.	1	Labor	Labor
Sinks for Children's Use												
90	Preschool	LL	131	Sinks for Children's Use	N/A

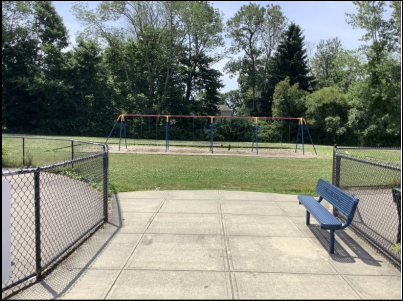
Accessible route not provided to playground Accessible route not provided around playground Accessible route not provided to play components	- - -	Install an accessible route to and around the playground. Provide an accessible route around the play area. Provide a compliant impact-attenuating surface to and around the play components.	1	-	-
93	Play Components on West Side of Field	Ext.	-	Play Areas

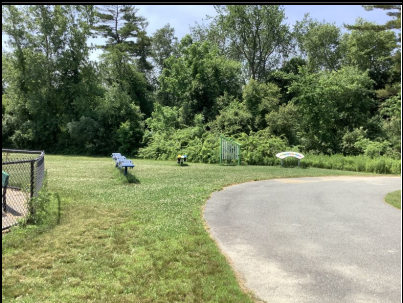
Accessible route not provided to playground Accessible route not provided around playground Accessible route not provided to play components	- - -	Install an accessible route to and around the playground. Provide an accessible route around the play area. Provide a compliant impact-attenuating surface to and around the play components.	1	-	-

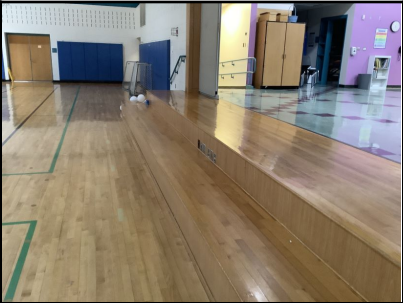
Recommend providing a solid and continuous contrasting stripe applied to the edge of the stage for low vision users to see that there is a change in level.	1	-	-

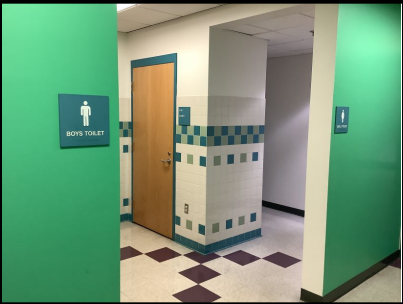
Recommend placing additional designation signage for the boys' and girls' multi-user toilet rooms on the tiled walls.	2	-	-
97	Gymnasium/ Stage	1	-

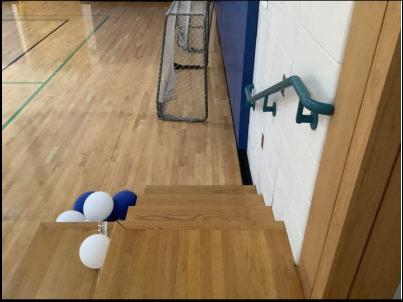
Recommend providing a solid and continuous stripe applied to the horizontal leading edge of each interior and exterior stair tread so that each tread is readily apparent when viewed in descent at each stair in the building.	1	-	-
98	Exam Room Within Nurse's Office	1	101 B

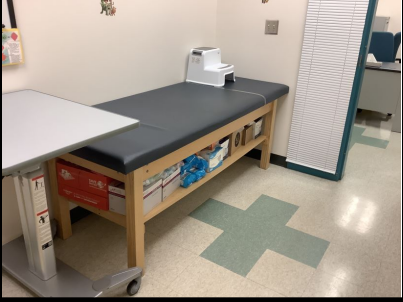
Recommend height adjustable exam table. Applies to rest area (Room 101 C).	2	-	-
99	Cafeteria	1	124

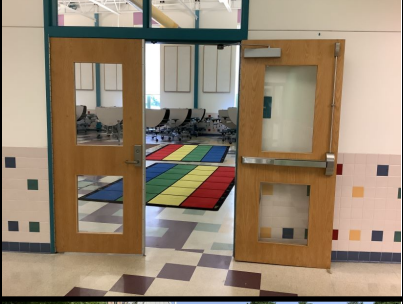
-	Recommend providing an additional tactile designation sign alongside the right door for cases when the right door is propped open, as was seen during the survey.	1	-	-
100	Between Passenger Loading Zone and Path to Basketball Court	Ext.	-

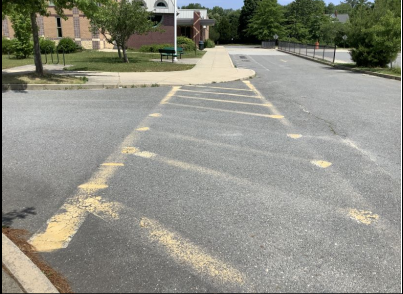
Recommend repainting striping on crosswalk.	1	-	-

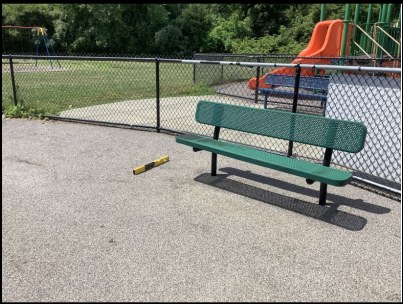
Recommend providing a clear floor space alongside one bench in each area where benches are provided that does not exceed a slope of 2.00% surface at least one bench, positioned to allow a person in a wheeled mobility device and a person sitting on the bench to have their shoulders aligned.	1	-	-
102	Two Accessible Spaces in East Parking Lot	Ext.	-

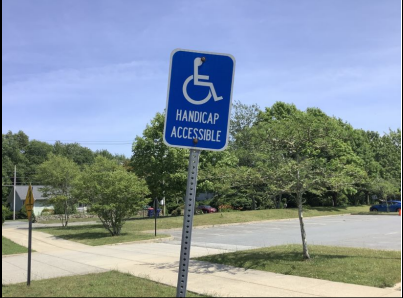
Recommend using term "Accessible Parking" instead of "Handicapped Parking".	1	-	-
103	Playgrounds and Sport Areas	Ext.	-

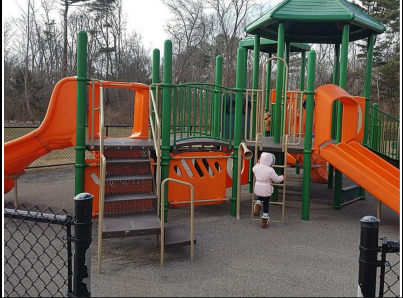
Based on a comment from the Commission on Disability, recommend providing adaptive play and sport equipment.	1	-	-
104	Picnic Table on South Side of Library and Next to Playground	Ext.	-

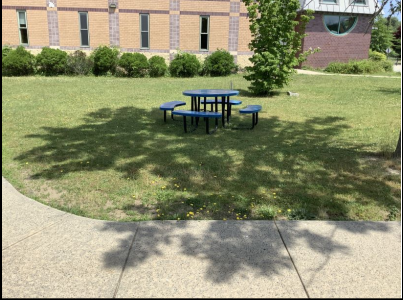
Recommend providing a stable, firm and slip-resistant surface that is 48" clear on all sides of the accessible picnic table in each location.	1	-	-

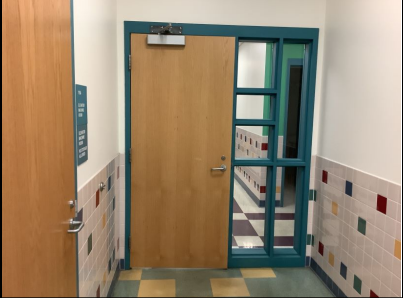
Recommend providing a directional sign to the programs within this corridor.	1	-	-
