# Elizabeth Hastings Middle School

## Town of Fairhaven ADA Transition Plan

December 2024

Institute for Human Centered Design

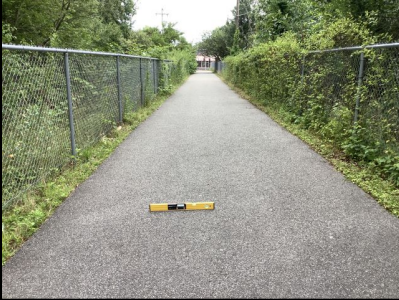
Cross slope > 1:50 (2.00%)	4.2%	Reduce cross slope to be no steeper than 1:50 (2.00%).	1	-	-
2	Exterior Route to South Egress Door - 6th Grade Wing	Ext.	-	Exterior Access Route	Walkway

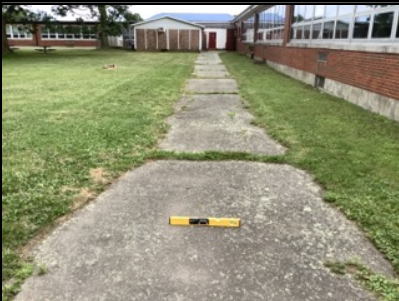
Cross slope > 1:50 (2.00%) Route not maintained in operable working condition	2.9% -	Reduce cross slope to be no steeper than 1:50 (2.00%). Ensure the accessible route is maintained in operable working condition.	1	-	-
3	Route From North Parallel Parking Space With the ISA to Main Entrance Outside Bus Drop Off	Ext.	-	Exterior Access Route	Walkway

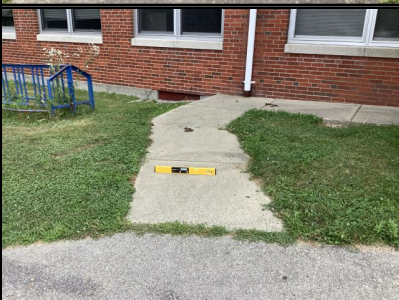
Cross slope > 1:50 (2.00%) Route not maintained in operable working condition	3% -	Reduce cross slope to be no steeper than 1:50 (2.00%). Ensure the accessible route is maintained in operable working condition.	1	-	-

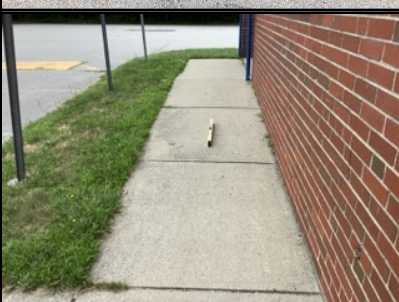
Running slope > 1:20 (5.00%)	6.1%	Reduce running slope to be no steeper than 1:20 (5.00%).	1	-	-
5	Route From North Parallel Parking Space With the ISA to Main Entrance Outside Bus Drop Off	Ext.	-	Exterior Access Route	Walkway

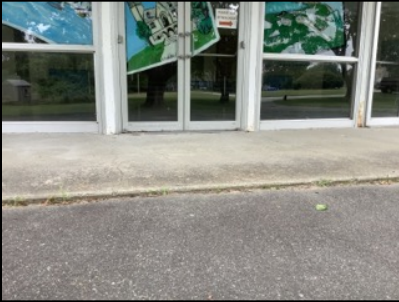
Level changes > 1/4"	2"	Alter change in level to be 1/4" high max.	1	-	-	
7	Exterior Ramp Next to Auditorium	Ext.	-	Exterior Access Route	Walkway

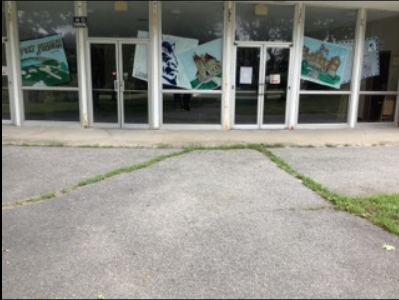
Route not maintained in operable working condition	-	Ensure the accessible route is maintained in operable working condition.	1	-	-

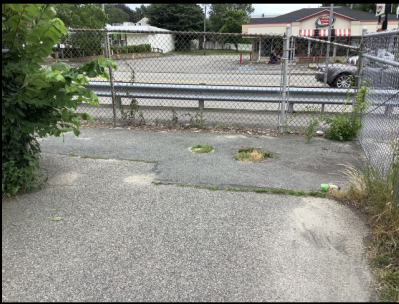
Route not maintained in operable working condition	-	Ensure the accessible route is maintained in operable working condition.	1	-	-
12	Pathway From Route 6 Sidewalk to South Wing Entrance	Ext.	-	Exterior Access Route	Walkway

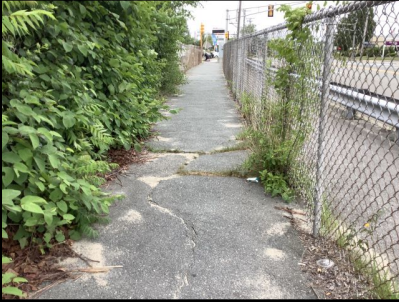
Route not maintained in operable working condition	-	Ensure the accessible route is maintained in operable working condition.	1	-	-
13	Exterior Ramp Next to Auditorium	Ext.	-	Exterior Access Route	Walkway

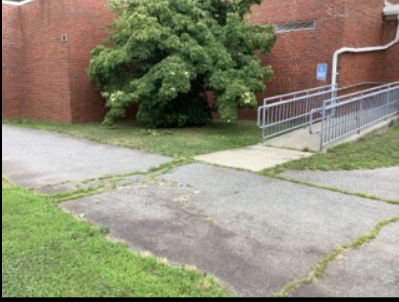
Does not prevent accumulation of water Route not maintained in operable working condition	- -	Repair surface. Ensure the accessible route is maintained in operable working condition.	1	-	-
14	Outdoor Garden	Ext.	-	Exterior Access Route	Exterior

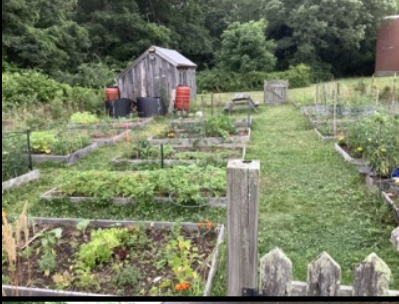
Accessible route not provided	-	Ensure an accessible route is provided to the garden.	1	-	-

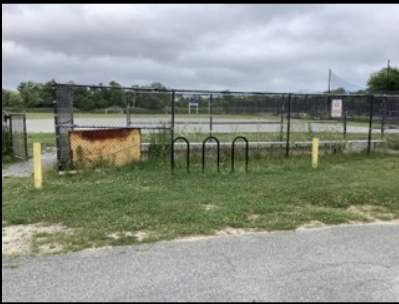
Accessible route not provided	-	Ensure an accessible route is provided to the bike rack.	1	-	-
17	Bike Racks by Main Entrance Outside Bus Drop Off	Ext.	-	Exterior Access Route	Exterior

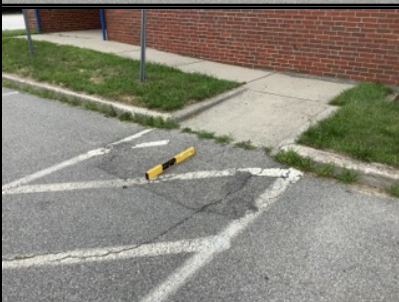
Running or cross slope at space > 1:50 (2.00%) Access aisle not maintained in operable working condition.	7%	Reduce running or cross slope to be no steeper than 1:50 (2.00%). Repair openings in the asphalt where vegetation is growing from.	1	-	-

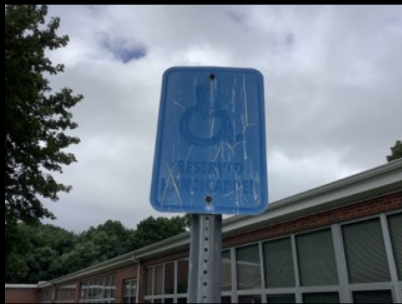
Sign with the International Symbol of Acc. not maintained	-	Provide a sign with the International Symbol of Accessibility (ISA) with the bottom of the sign 60" min. above the ground and the top 96" max. above the ground.	1	500	\$500
22	Accessible Parking Next to Main Entrance Outside Bus Drop Off	Ext.	-	Off-Street Parking Lot or Garage	Visitor

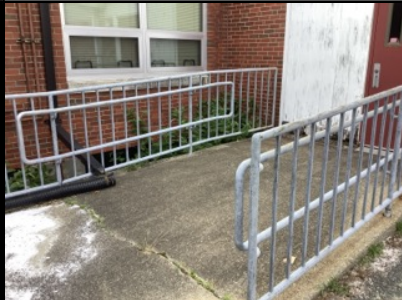
Handrails do not extend 12" past top & bottom Not maintained in operable working condition	- -	Alter handrails to extend horizontally above the landing for 12" min. beyond the top ramp runs, at the handrail to the right of this photo. Ensure the ramp is maintained in operable working condition.	1	-	-

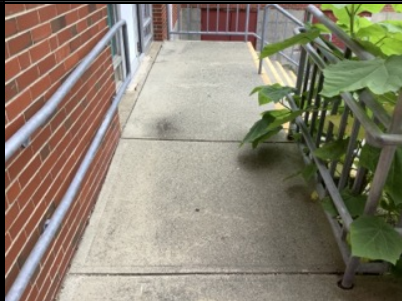
Not maintained in operable working condition	-	Ensure the leaves that protrude into the ramp from the handrails are trimmed.	1	-	-
Exterior Stair												
25	North Egress Door Next to Staff Room 28	Ext.	-	Exterior Stair	N/A

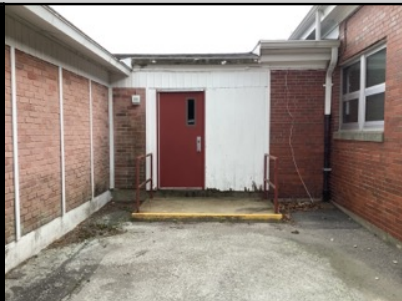
Bottom handrail extends < 12" + one tread	-	Bottom: Ensure that the sloped bottom extension extends one tread depth min. beyond last riser nosing in same direction as stair flight.	2	-	-

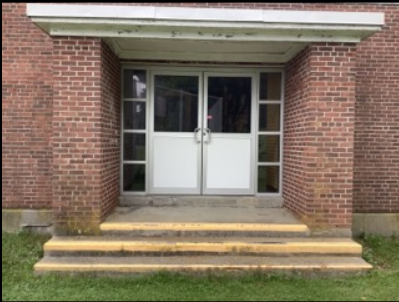
Handrail not provided on both sides	-	Provide a handrail on each side.  Applies to all exterior stairs in this condition.	1	-	-
27	West Egress Door on Auditorium Stage	Ext.	-	Exterior Stair	N/A

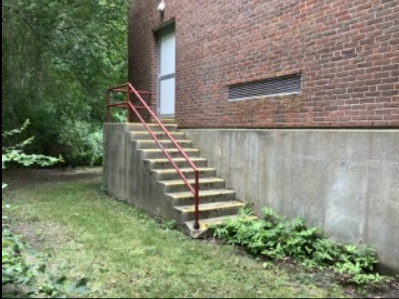
Handrail is not continuous where required Not maintained in operable working condition	-	Provide continuous handrails. Ensure stairs are maintained in operable working condition.	1	-	-
28	North/West Egress Door - Auditorium	Ext.	-	Exterior Stair	N/A

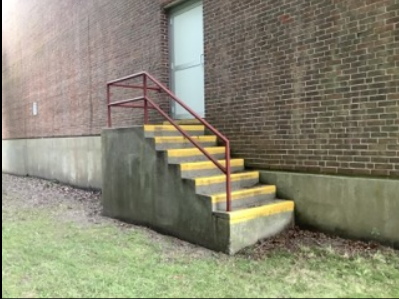
Handrail not provided on both sides Tread widths or riser heights are not uniform	34"	Provide a handrail on each side. Further study will be needed to determine whether it is technically feasible to bring the stair risers into full compliance with the ADA Standards, however stairs may be hazardous for users.	1	-	-

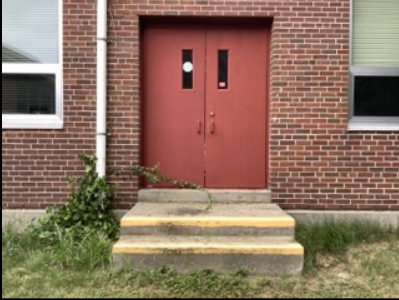
Handrail not provided on both sides Tread widths or riser heights are not uniform	- -	Provide a handrail on each side. Further study will be needed to determine whether it is technically feasible to bring the stair risers into full compliance with the ADA Standards, however stairs may be hazardous for users.	1	-	-
30	S.T.E.M. Classroom/ South Egress Door	Ext.	-	Exterior Stair	N/A

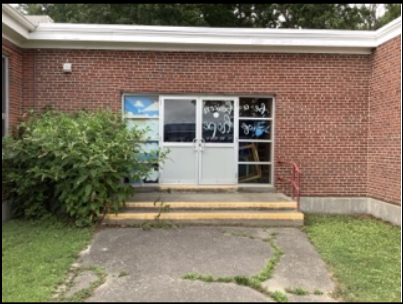
Bottom handrail extends < 12" + one tread Not maintained in operable working condition Tread widths or riser heights are not uniform	9.5" - -	Bottom: Ensure that the sloped bottom extension extends one tread depth min. beyond last riser nosing in same direction as stair flight. Trim bush that protrudes into stair. Further study will be needed to determine whether it is technically feasible to bring the stair risers into full compliance with the ADA Standards, however stairs may be hazardous for users.	1	-	-
Access to Goods and Services												
Means of Egress												
32	Main Entrance Outside Bus Drop Off, South Wing Entrance - Outside Gym	1	-	Means of Egress	N/A

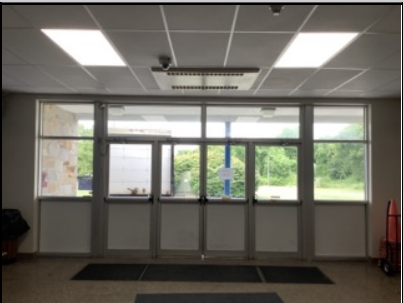
Tactile exit sign not provided Illuminated ISA symbol not provided (MAAB)	- -	Ensure that a tactile exit sign with raised characters and braille is provided at the exit door. Mount the sign between 48" - 60" above the finished floor located next to the right door. When the illuminated exit sign is repaired or replaced, provide an illuminated sign with the International Symbol of Accessibility (ISA).	2	250	\$500

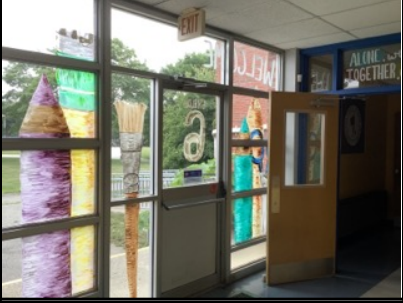
Tactile exit sign not provided Illuminated ISA symbol not provided (MAAB)	- -	Ensure that a tactile exit sign with raised characters and braille is provided at the exit door. Mount the sign between 48" - 60" above the finished floor located on the latch side of the door. When the illuminated exit sign is repaired or replaced, provide an illuminated sign with the International Symbol of Accessibility (ISA).	1	250	\$250
											250	
34	Auditorium Entrance	1	-	Means of Egress	N/A

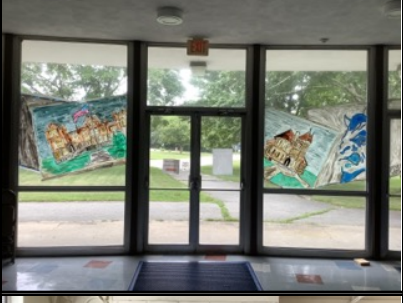
Tactile exit sign not provided Illuminated ISA symbol not provided (MAAB)	- -	Ensure that a tactile exit sign with raised characters and braille is provided at the exit door. Mount the sign between 48" - 60" above the finished floor located on the right side of the right door. When the illuminated exit sign is repaired or replaced, provide an illuminated sign with the International Symbol of Accessibility (ISA).	3	250	\$750

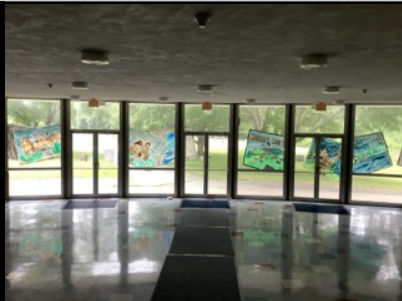
<b>Note:</b> If programs are held in this space during events at the auditorium, including sales of tickets or other goods, an accessible platform lift between the exterior entrance/exit floor level and the auditorium entrance floor level must be provided. If programs similar to these are not held in this area, IHCD recommends providing a platform lift as best practice.	1	-	-
37	Girls' Locker Room	1	-	Interior Access Route	N/A

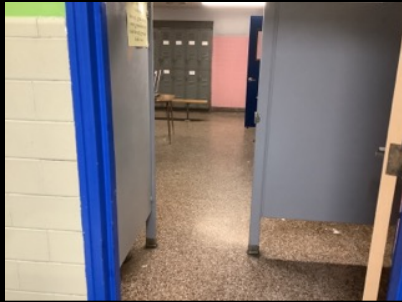
Route < 36" wide	28"	Remove or relocate the privacy partition to ensure that a clear width of 36" min. is maintained at the accessible route.	1	Labor	Labor
38	Main Entrance Outside Bus Drop Off	1	-	Interior Access Route	N/A

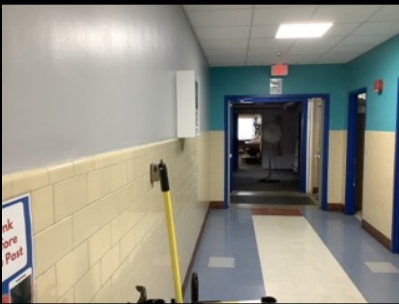
Obstructed by protruding objects	7"	Provide a cane-detectable barrier underneath the defibrillator. Barriers must have leading edges no higher than 27" so that they are within cane sweep. Barriers can include fixed planters, benches, and guardrails.	1	398	\$398
											398	
42	South Egress Door by Art, S.T.E.M. Classrooms	1	-	Interior Access Route	N/A

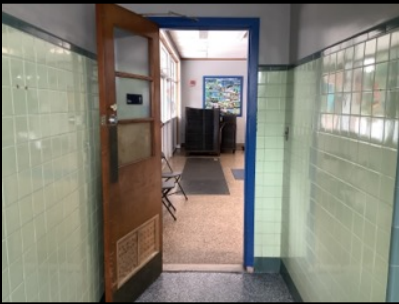
Clear width at door < 32" Maneuvering clearance(s) not provided	29" 12"	Widen the door so that there is 32" min. clear width. Provide an automatic door opener. Another option could be to provide an accessible single-user toilet room in this area. Cost estimate is for widening the door and providing an automatic door opener.	2	4376 6000	\$20752
											20752	
47	Art Classroom	1	5B	Doors, Doorways, & Gates	Classroom

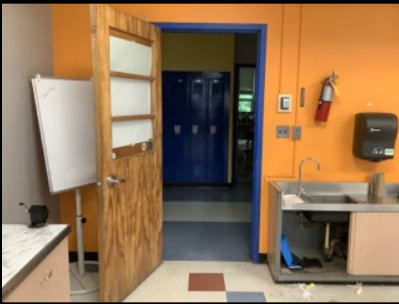
Maneuvering clearance(s) not provided	5"	Provide an automatic door opener.	1	6000	\$6000
											6000	
52	Girls' Locker Room	1	-	Doors, Doorways, & Gates	Circulation

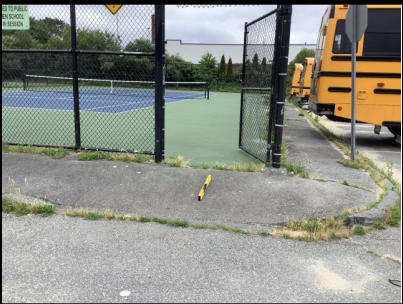
Maneuvering clearance at door > 1:50 (2.00%) Maneuvering clearance route not maintained in operable working condition.	15.5%	Alter so that the slope in all directions is no greater than 1:50 (2.00%). Repair openings in the asphalt where vegetation is growing from.	1	-	-
57	Gymnasium Entrance Door - Left		-	Doors, Doorways, & Gates	Assembly Space

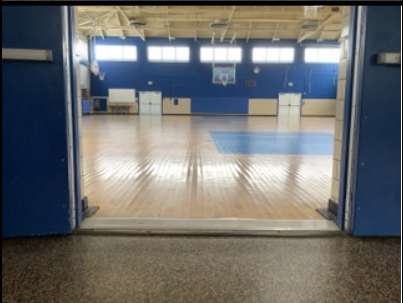
Threshold not beveled	-	Bevel the threshold.	1	195	\$195
											195	
58	Boys' Multi-User Toilet Room - 8th Grade Wing, Boys' and Girls' Multi-User Toilet Rooms Outside Gym	1	-	Doors, Doorways, & Gates	Toilet Room

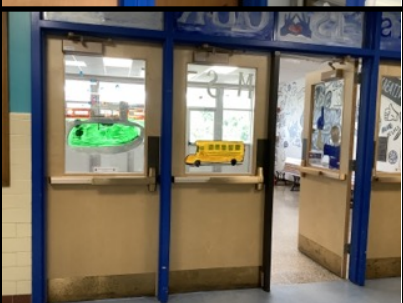
Door requires > 5 lbs. of force to open	10 lbs	Adjust closers so doors do not require more than 5 pounds of force to open.  Applies to all interior doors in this building in this condition.	1	Labor	Labor

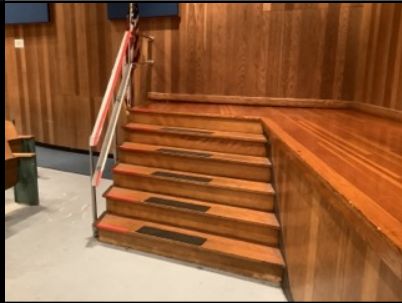
Handrail not provided on both sides Handrails do not extend 12" from stairs at top Bottom handrail extends < 12" and one tread Handrails lack a compliant cross section Handrails do not return properly	4"	Provide handrail on one side. Ensure handrails extend horizontally above the landing for 12" min. beginning above the first riser. Ensure the sloped bottom extension extends one tread depth min. beyond the last riser in the same direction as the stair flight. Provide handrails with 1 1/4" - 2" circular cross sections. Ensure handrails return to wall, guard, or landing or are continuous to a handrail of a adjacent stair flight.	2	-	-
62	Auditorium Entrance	1	-	Stairways	Interior

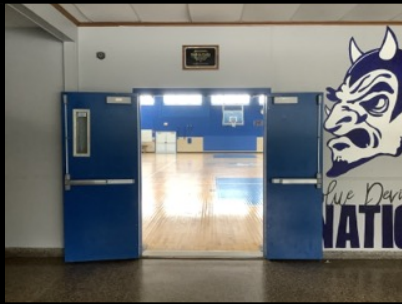
Signage is not provided Location of tactile sign not compliant	- -	Locate compliant signage with raised characters and braille on the right side of the right-hand door.	1	250	\$250
											250	
67	Assistant Vice Principal's Office	1	-	Signage	Designation

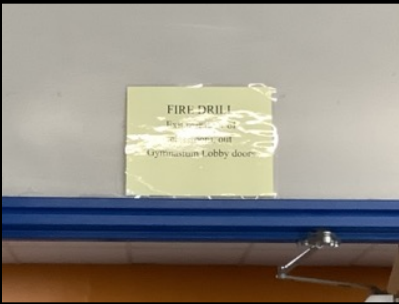
Non-glare finish and contrast not provided on sign	-	Install a sign with a non-glare finish with characters that have a high contrast to the background.	1	250	\$250
											250	
72	Media Classroom	1	12	Signage	Designation

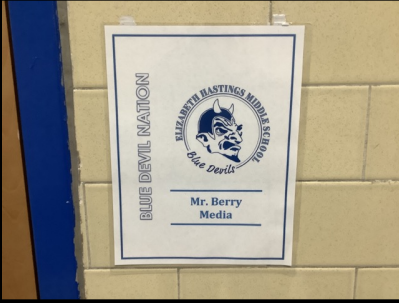
Raised characters not provided on sign Braille not provided on sign Non-glare finish and contrast not provided on sign	- - -	Provide text with raised characters duplicated in braille on the sign, and with a non-glare finish with characters that have a high contrast to the background. Provide a sign with compliant characters. Applies to all room designation signs in this condition. Cost estimate is for one sign.	1	250	\$250
											250	
73	Door Leading to Gymnasium/ South Wing Entrance From Corridor	1	-	Signage	Informational

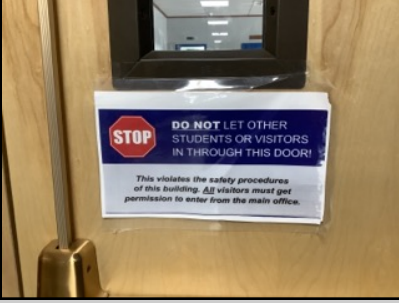
Non-glare finish and contrast not provided on sign Character style not compliant	- -	Install a sign with a non-glare finish with characters that have a high contrast to the background, and with compliant characters. Characters should not be in italic.	1	250	\$250

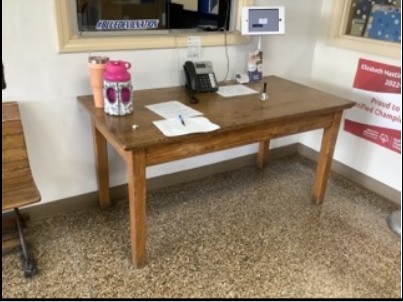
Knee or toe clearance not provided	24.5"	Provide at least one dining or work surface with 27" min. high knee and toe clearance.	1	700	700
Assembly Area												
77	Auditorium	1	-	Assembly Area	N/A

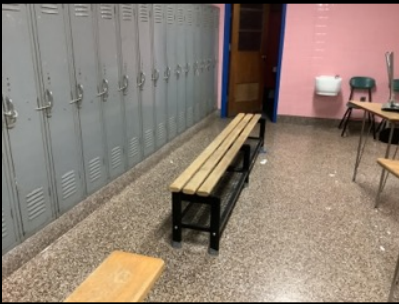
Back support not provided at bench Bench < 24" deep Bench lacks 12" clear underneath	- 13.5" -	Provide at least one bench with back support or that is affixed to a wall with room on the side to transfer. Provide a bench that is 24" deep. Provide a bench that has 12" clear underneath.	1	260	\$260
											260	
82	Corridor Lockers	1	-	Locker Room	Student

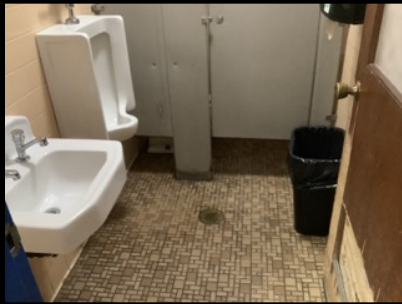
Accessible plumbing fixtures or stalls not provided	-	Add an accessible single-user toilet room.	2	31985	\$63970
											<b>63970</b>	
87	Girls' and Boys' Multi-User Toilet Rooms - 6th Grade Wing	1	-	Overall Access	Toilet Room

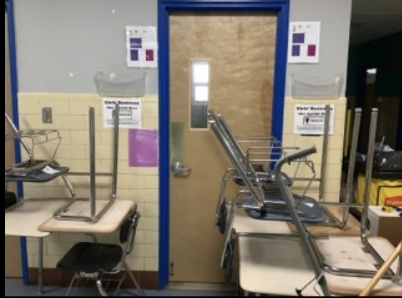
Accessible plumbing fixtures or stalls not provided	-	Provide one accessible wheelchair compartment.  Notes: IHCD could not survey inside both of these toilet rooms due to the locked doors, but they observed there were no accessible plumbing fixtures or stalls provided.	2	8037	\$16074

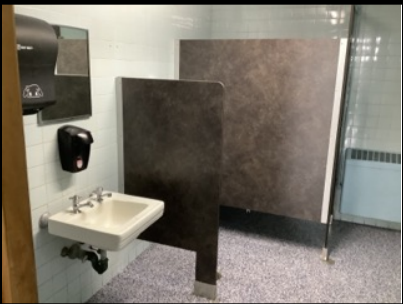
Accessible plumbing fixtures or stalls not provided	-	Provide one accessible wheelchair compartment.	2	8037	\$16074
Lavatory												
92	Men's and Women's Multi-User Toilet Rooms Next to Auditorium	1	-	Lavatory

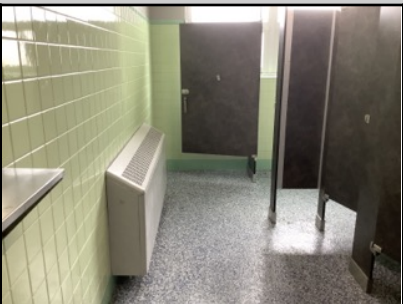
Door has inadequate maneuvering clearance Door has malfunctioning self-closing hinge	39" -	Redo the toilet compartment to bring it to full compliance with ADA and MAAB standards.	1	8037	\$8037
95	Boys' Multi-User Toilet Room - 8th Grade Wing	1	-	Toilet Compartment	Accessible Compartment

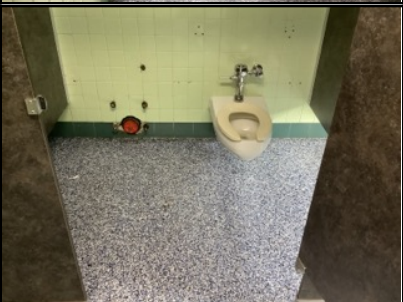
Grab bars not provided Clearance at toilet < 60" clear width Centerline < or > 18" (MAAB)	- 70" 21.5"	Provide one grab bar on the side wall of the water closet and one on the rear wall. Provide a wheelchair accessible compartment that is 60" wide min. Relocate toilet so the centerline is 18" from the side wall.	1	1500 3676 8037 75	\$13288

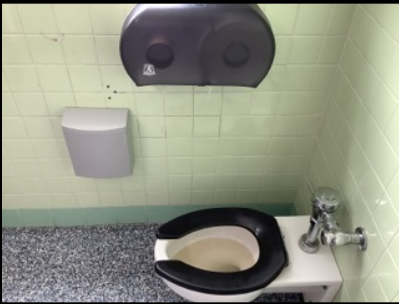
Noncompliant toilet paper dispenser	-	When new grab bars are installed, ensure dispensers and other devices are not mounted above grab bars. Relocate toilet paper dispenser so that it is between 14"- 19" above the finished floor and between 7"- 9" in front of the toilet.	1	500	\$500
											500	
97	Boys' Multi-User Toilet Room - 8th Grade Wing	1	-	Toilet Compartment	Accessible Compartment

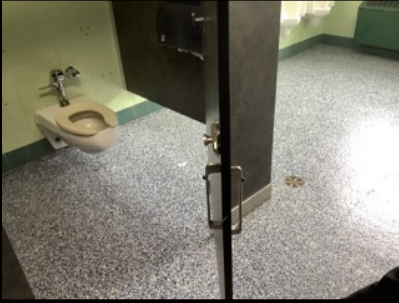
Door has inadequate maneuvering clearance Clearance at toilet < 72" clear depth (MAAB) Coat hook > 48" (2010 ADA)	- 59.5" 38"	Reverse swing at door and replace keeper. Provide a wheelchair accessible compartment that is 60" wide and 72" deep. Locate the coat hook no higher than 48" above the finished floor.	1	- 8037 75	\$8112

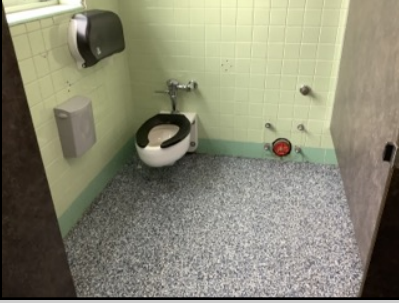
Grab bars not provided Flush control not on open side Centerline < or > 18" (MAAB)	- - 14"	Provide one grab bar on the side wall of the water closet and one on the rear wall. Provide the flush control on the open side of the toilet (transfer side). Relocate toilet so the centerline is 18" from the side wall.	1	1500 - 3676	\$5176
											5176	
Urinal												
99	Boys' Multi-User Toilet Room - 8th Grade Wing	1	-	Urinal	N/A

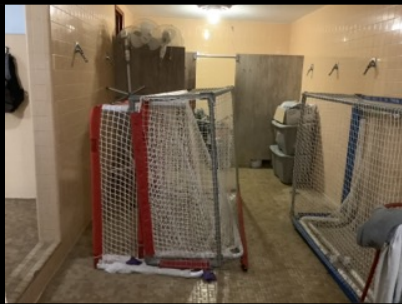
Accessible shower not provided	-	If the showers are used by students, provide at least one accessible shower and remove items that are in storage.	1	3606	\$3606
											3606	
102	Girls' Locker Room	1	-	Shower Compartment	N/A

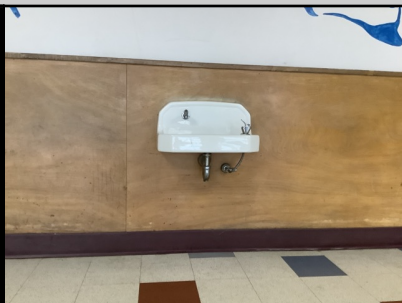
Inadequate water flow	-	Ensure the water fountain is in operable working condition when school resumes session.	1	Labor	Labor
105	Corridor/ Outside Cafeteria	1	-	Drinking Fountains	Low

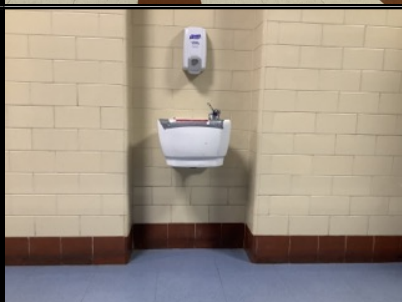
No drinking fountain provided for standing users	-	Relocate the drinking fountain so that it can be used by standing-users. Locate the spout between 38" and 43" high above the finished floor. <b>Note:</b> The drinking fountains provided in the school do not comply with ADA 211.3.	1	2028	\$2028
											2028

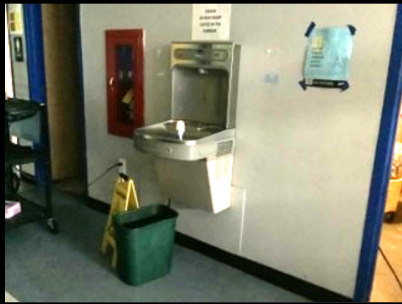
Inadequate water flow Standing height fountain does not have cane protection	- 16.5"	Ensure the water fountain is in operable working condition when school resumes session. Provide a cane-detectable barrier skirt under the high unit.	1	- 890	\$890
											890	
107	Between Boys'/Girls' - 8th Grade Wing	1	-	Drinking Fountains	Low

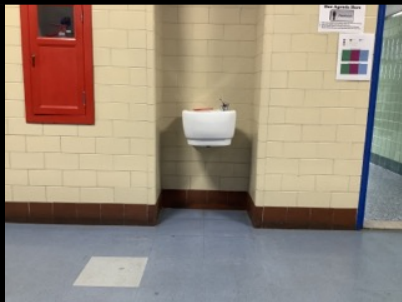
Inadequate water flow Knee or toe clearance not provided	- 21.5"	Ensure the water fountain is in operable working condition when school resumes session. Relocate the drinking fountain to provide knee and toe clearance at 27" min. high above the finished floor.	1	Labor 2028	\$2028
											2028	
108	Girls' Locker Room	1	-	Drinking Fountains	Low

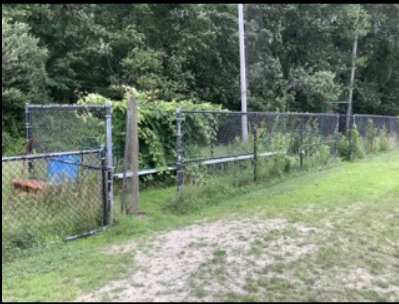
Accessible spaces not provided at team seating Field not maintained in operable working condition	- -	Provide a 36" x 48" clear floor space at team seating. Ensure that the baseball field is maintained in operable working condition.  Applies to the third base team seating area at the south baseball field.	3	-	-
122	South Softball Field - First Base and Third Base Team Seating Area	Ext.	-	Field	Softball

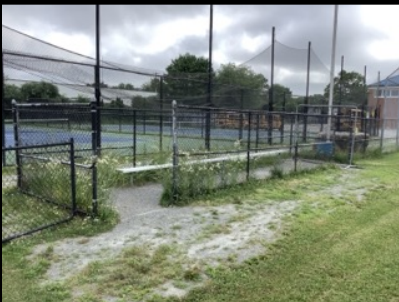
Field not maintained in operable working condition No accessible route to all areas of sport activity	- -	Ensure softball field is maintained in operable working condition. Install an accessible route to the boundary of sport activity at the softball field, and to both areas of team seating.	2	-	-

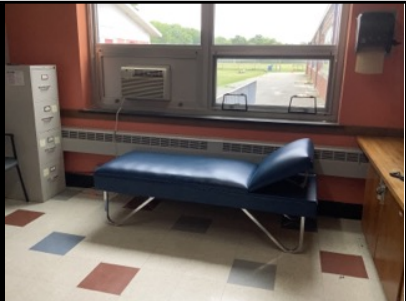
Recommend providing a height adjustable bed.	1	-	-
129	Auditorium Stage	1	-	Furniture	N/A

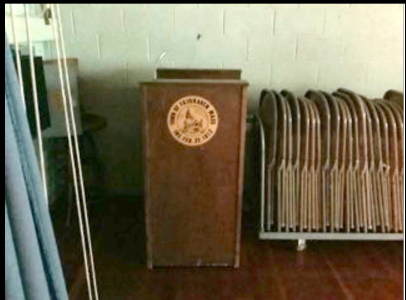
Recommend providing an adjustable height podium with knee and toe clearance.	1	-	-
