Emergency Management

Town of Fairhaven ADA Transition Plan

November 2024

Institute for Human Centered Design

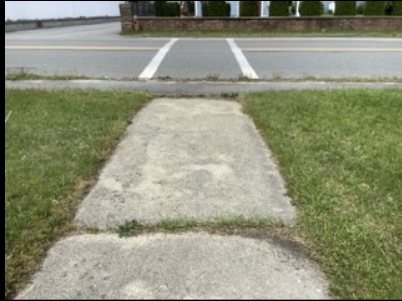
Surface is not stable, firm, and slip-resistant	-	Repair surface.	1	-	-
Off-Street Parking Lot or Garage												
2	Parking	Ext.		Off-Street Parking Lot or Garage	Visitor

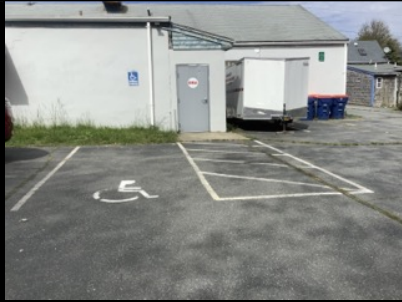
Total # of parking Total # of designated van accessible spaces Van space < 132" or <96" wide Access aisle < 96" wide at van space Sign does not have the designation "Van Accessible"	11 1 95" 83" -	Provide a van accessible space that is at least 96" wide. Provide a marked access aisle that is at least 96" wide. Add the designation "Van Accessible" to the sign located at the van accessible space. (Cost estimate is for the sign.)	1	500	\$500
3	Parking	Ext.		Off-Street Parking Lot or Garage	Visitor

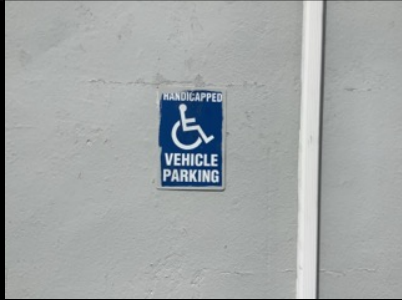
Sign is not maintained in operable working condition	-	Provide a new sign with the International Symbol of Accessibility. As best practice, recommend providing a sign that states "Accessible Parking", rather than "Handicapped Parking".	1	500	\$500

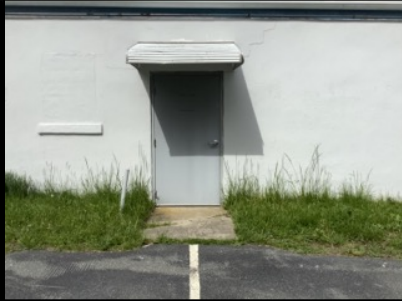
Entrance												
4	Inaccessible South Entrance	Ext.		Entrance	Other

Directional sign to accessible entrance not provided	-	Provide a directional sign indicating the location of the nearest accessible entrance.	1	450	\$450

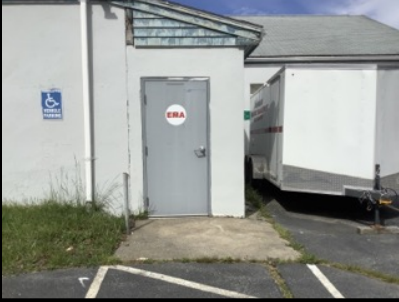
International Symbol of Accessibility not provided	-	Provide a sign with the International Symbol of Accessibility (ISA).	1	450	\$450
											450	
6	Front Door Used as an Exit	1		Entrance	Other

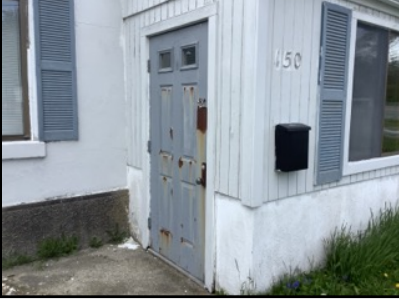
Hardware not compliant	-	Provide hardware that can be operable with one hand and not require tight grasping, pinching, or twisting of the wrist.	1	750	\$750
											750	
Access to Goods and Services												
Means of Egress												
7	Southeast Side Egress	1		Means of Egress	N/A

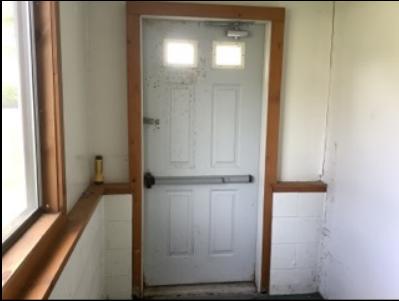
Tactile exit sign not provided Illuminated ISA symbol not provided (MAAB)	- -	Ensure that a tactile exit sign with raised characters and braille is provided at the exit door. Mount the sign between 48"- 60" above the finished floor located on the latch side of the door. After the walkway is maintained, when the illuminated exit sign is repaired or replaced, provide an illuminated sign with the International Symbol of Accessibility (ISA).	1	250	\$250

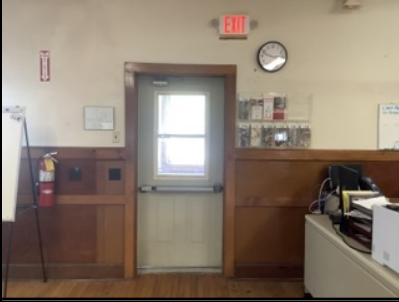
250	
8	In Meeting Space	1		Means of Egress	N/A

Tactile exit sign not provided Illuminated ISA symbol not provided (MAAB)	- -	Ensure that a tactile exit sign with raised characters and braille is provided at the exit door. Mount the sign between 48"- 60" above the finished floor located on the latch side of the door. When the illuminated exit sign is repaired or replaced, provide an illuminated sign with the International Symbol of Accessibility (ISA).	1	250	\$250
											250	
9	Largely Accessible Egress	1		Means of Egress	N/A

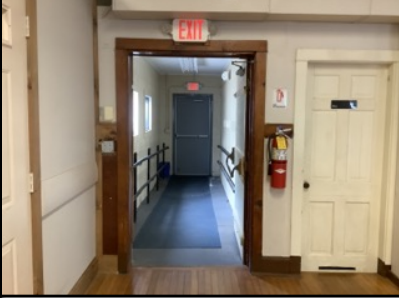
Tactile exit sign not provided Illuminated ISA symbol not provided (MAAB)	- -	Ensure that a tactile exit sign with raised characters and braille is provided at the exit door. Mount the sign between 48"- 60" above the finished floor located on the right side of the door. When the illuminated exit sign is repaired or replaced, provide an illuminated sign with the International Symbol of Accessibility (ISA).	1	250	\$250

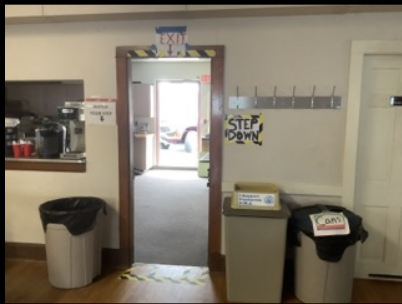
Tactile exit sign not provided Directional sign to accessible emergency exit not provided	- -	Ensure that a tactile exit sign with raised characters and braille is provided at the exit door. Mount the sign between 48" - 60" above the finished floor located on the latch side of the door. Provide a directional sign indicating the location of the nearest accessible emergency exit.	1	250 250	\$500
											500	
11	Kitchen	1		Means of Egress	N/A

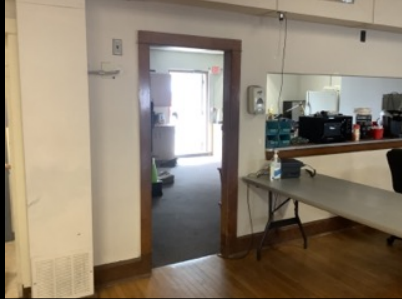
Tactile exit sign not provided Directional sign to accessible emergency exit not provided	- -	Ensure that a tactile exit sign with raised characters and braille is provided at the exit door. Mount the sign between 48" - 60" above the finished floor located on the latch side of the door. Provide a directional sign indicating the location of the nearest accessible emergency exit.	1	250 250	\$500

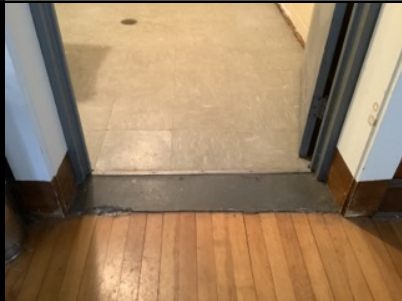
Surface not stable, firm, and slip-resistant	-	Repair surface.	1	-	-
Doors, Doorways, & Gates												
13	Largely Accessible Single-User Toilet Room	1		Doors, Doorways, & Gates	Toilet Room

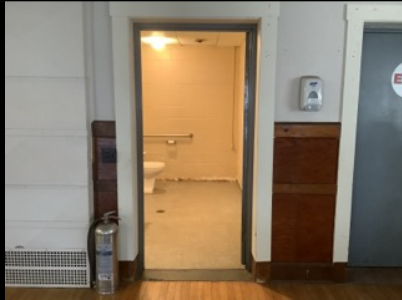
Maneuvering clearance not provided at recess > 6"	9"	Install an automatic door opener.	1	6000	\$6000
											6000	
14	Largely Accessible Egress	1		Doors, Doorways, & Gates	Other

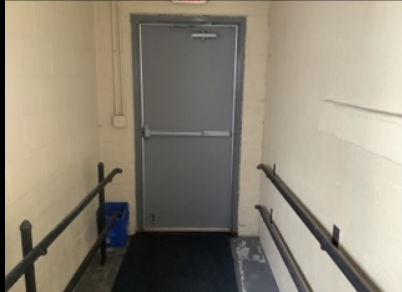
Mat not securely attached	-	Secure the mat.	1	Labor	Labor

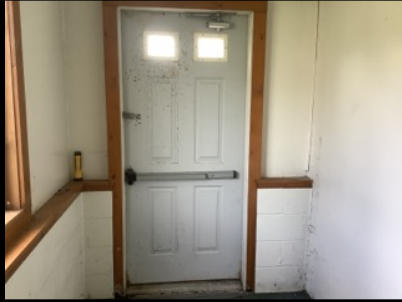
Maneuvering clearance(s) not provided Threshold > 1/2" high Closing speed not compliant	- 1.5" -	Provide an automatic door opener. Alter the threshold to be 1/2" high max. Adjust door closer so that from an open position of 90 degrees, the time required to move the door to an open position of 12 degrees from the latch is 5 seconds min.	1	6000 1000 Labor	\$7000
											7000	
16	Egress	1		Doors, Doorways, & Gates	Other

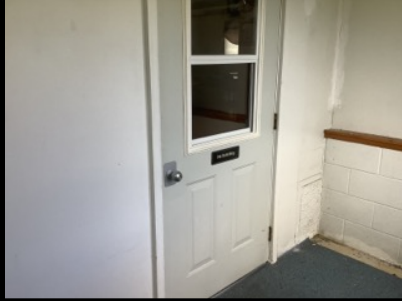
Hardware not compliant Door requires > 5 lbs. of force to open	- 10 lbs	Provide hardware that can be operable with one hand and not require tight grasping, pinching, or twisting of the wrist. Adjust closers so doors do not require more than 5 pounds of force to open.	1	750 Labor	\$750
											750

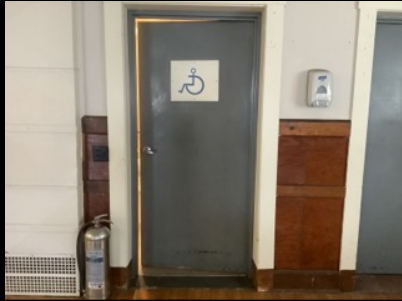
Signage is not provided	-	Locate compliant signage with raised characters and braille alongside the door on the latch side.	1	250	\$250
											250	
18	Men's Multi-User Toilet Room	1		Signage	Designation

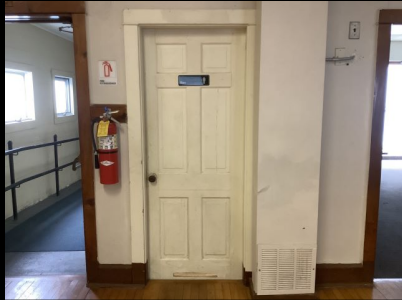
Raised characters not provided on sign Braille not provided on sign Location of tactile sign not compliant Non-glare finish and contrast not provided on sign Directional sign to access. toilet not provided	- - - - -	Provide text with raised characters duplicated in braille on the sign. Locate sign alongside the door on the latch side. Install a sign with a non-glare finish with characters that have a high contrast to the background. Install a sign indicating the location of the nearest accessible toilet room.	1	250 250	\$500
											500	
19	Egress Plan	1		Signage	Informational

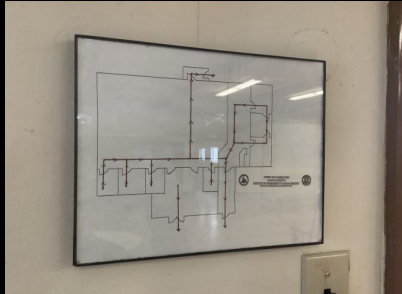
Non-glare finish and contrast not provided on sign	-	Install a sign with a non-glare finish with characters that have a high contrast to the background.	1	Labor	Labor

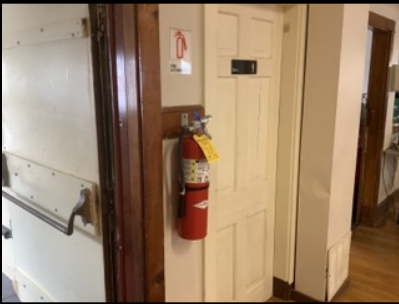
Non-glare finish and contrast not provided on sign	-	Install a sign with a non-glare finish with characters that have a high contrast to the background.	1	250	\$250	
											250		
21	Women's Single-User Toilet Room	1		Signage	Designation

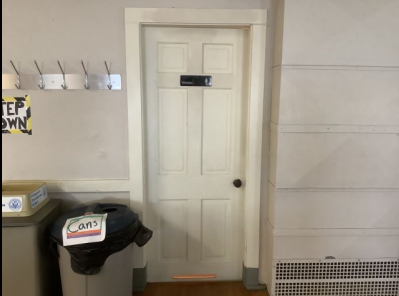
Raised characters not provided on sign Braille not provided on sign Location of tactile sign not compliant Directional sign to access. toilet not provided	- - - -	Provide text with raised characters duplicated in braille on the sign. Locate sign alongside the door on the latch side. Install a sign indicating the location of the nearest accessible toilet room.	1	250 250	\$500	
											500		
. Operable Parts / Reach Range													
22	In Meeting Space	1		Operable Parts / Reach Range	Other

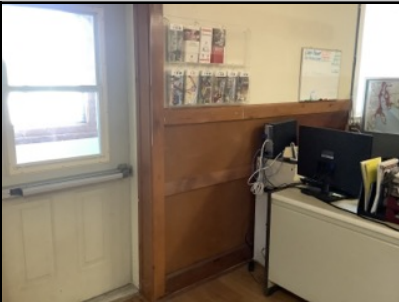
Reach < 15" or > 48"(forward/side approach)	65"	Relocate pamphlets to be between 15"- 48" above the finished floor or ensure that staff is available to assist visitors who need assistance.	1	Labor	Labor

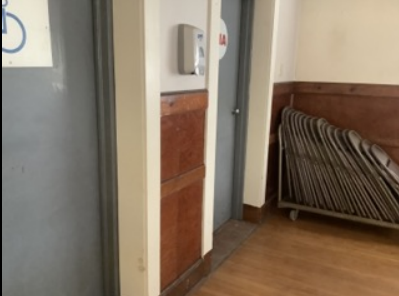
23	Meeting Hall	1		Operable Parts / Reach Range	Other

Reach < 15" or > 48"(forward/side approach)	56"	Relocate hand sanitizer dispensers so that controls are between 15"- 48" above the finished floor.	2	500	\$1000	
											1000		
24	Near Women's Toilet Room	1		Operable Parts / Reach Range	Clothes Rod/Hooks

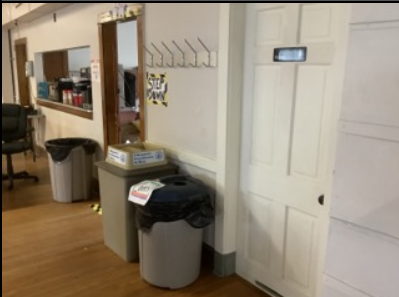
Clear floor space is not provided Reach < 15" or > 48"(forward/side approach)	- 58"	Provide a coat hook no higher than 48" in an accessible location with clear floor space.	1	75	\$75	
											75		
Toilet & Bathing Rooms

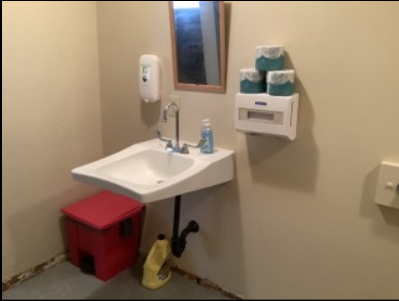
Plumbing underneath is exposed Mirror above lavatory w/reflective surface > 40"	- 54"	Insulate or otherwise configure pipes to prevent contact at lavatory. Lower mirror so that the bottom surface is at 40" max. above the finished floor.	1	120 500	\$620
												620
Single-User Toilet												
26	Largely Accessible Single-User Toilet Room	1		Single-User Toilet	N/A

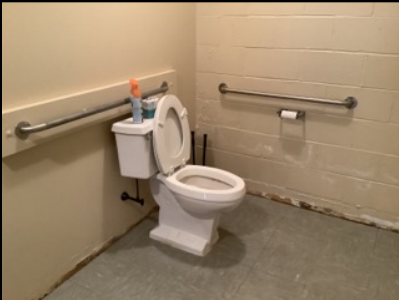
Centerline < or > 18" (MAAB) Side grab bar < 54" from back wall	30" 46"	Relocate toilet so that the centerline is 18" from the side wall. Provide a side wall grab bar that is 42" long min. located 12" max. from the rear wall.	1	3676 800	\$4476
												4476
Best Practice												
27	Near Front of Building	Ext.

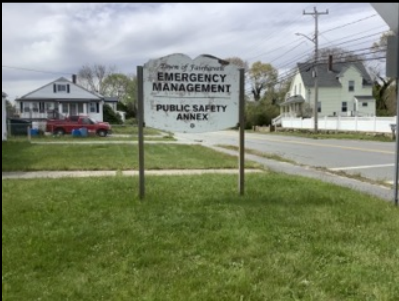
Recommend replacing sign in front of the building.	1	-	-

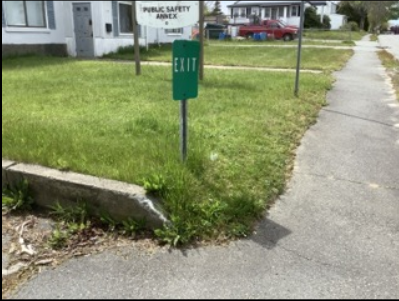
28	Parking Lot Exit	Ext.

Recommend raising the height of the parking lot exit sign so that is it more visible to a person driving from the road.	1	-	-

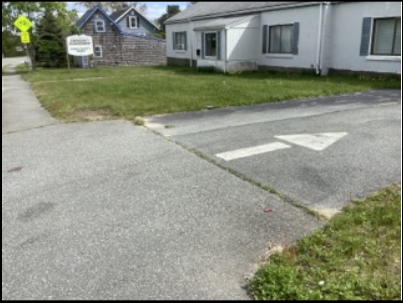
Recommend providing a sign that says "Enter" at this point.	1	-	-
