# Fairhaven High School

## Town of Fairhaven ADA Transition Plan

January 2025

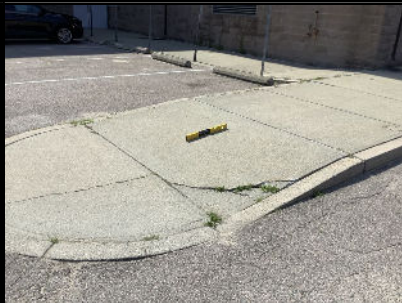
Route not maintained in operable working condition	-	Repair the cracks where grass is growing to ensure the accessible route is maintained in operable working condition.	1	-	-
2	Next to Staff Parking on East Side of Parking/Next to Football Field	Ext.	-	Exterior Access Route	Curb Ramp

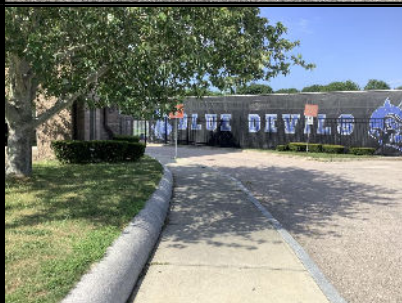
Route not maintained in operable working condition	-	Ensure the accessible route is maintained in operable working condition. Repair cracks in curb ramp.	1	-	-
3	Walkway on Southeast Corner of Building	Ext.	-	Exterior Access Route	Sidewalk

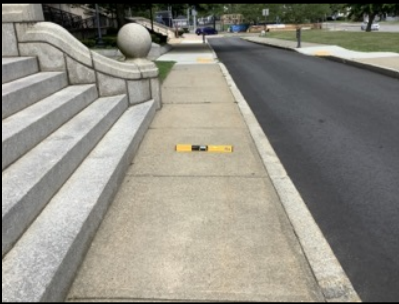
Cross slope > 1:50 (2.00%)	4.9%	Reduce cross slope to be no steeper than 1:50 (2.00%).	1	-	-	
7	Main Building, Sidewalk for Bus Drop Off/ In Front of Main Building	Ext.	-	Exterior Access Route	Sidewalk

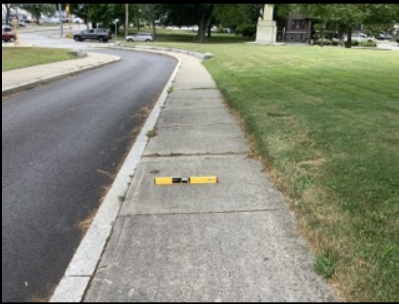
Cross slope > 1:50 (2.00%)	4.2%	Reduce cross slope to be no steeper than 1:50 (2.00%).	1	-	-
12	Main Building, West Exterior Egress Stair	Ext.	-	Exterior Access Route	Walkway

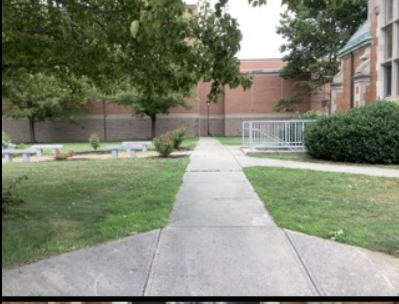
Obstructed by protruding objects	66"	Trim low hanging branches in trees to a height of 80" min. above the ground.	1	-	-
15	Main Building, North Egress Door From Library	Ext.	-	Exterior Access Route	Walkway

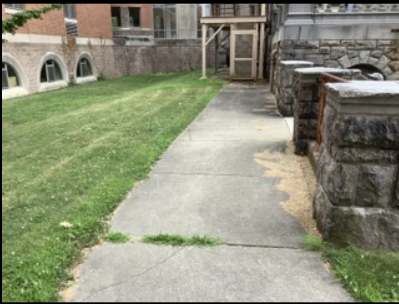
Surface openings > 1/2"	1"	Repair cracks in the concrete to ensure that the surface opening is no greater than 1/2" max.	1	-	-	
17	Memorial Walkway to North Library Egress Door	Ext.	-	Exterior Access Route	Walkway

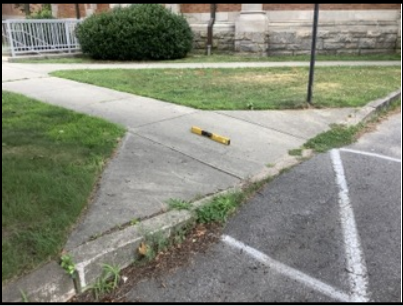
Running slope is > 1:12 (8.33%) Curb ramp flares > 1:10 (10%)	10.1% 12%	Reduce running slope to be no steeper than 1:12 (8.33%). Reduce slope at curb ramp flares to be no steeper than 1:10 (10%).	1	-	-
Off-Street Parking Lot or Garage												
27	Accessible Parking by North Entrance/ Adjacent to Larch Avenue	Ext.	-	Off-Street Parking Lot or Garage	Visitor

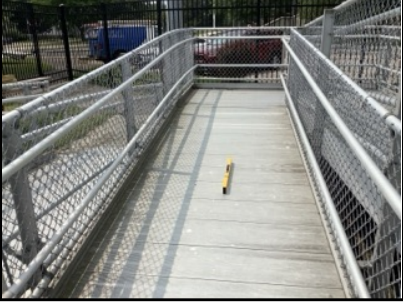
Running slope > 1:12 (8.33%)	9.8%	Reduce running slope to be no steeper than 1:12 (8.33%).	1	-	-
Exterior Stair												
32	Main Building, South Egress Door Next to Ramp	Ext.	-	Exterior Stair	N/A

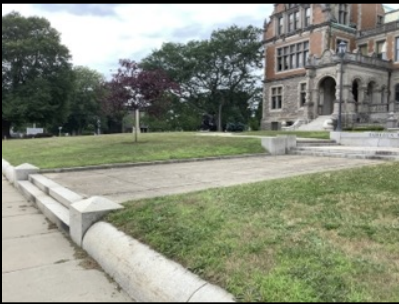
Handrail not provided on both sides Surface not stable, firm, and slip-resistant		Provide a handrail on each side. Surface must be sanded down as it is slippery.	1	-	-	
37	Main Building, West Egress/ Between Office 015M and TV Studio 004M	Ext.	-	Exterior Stair	N/A

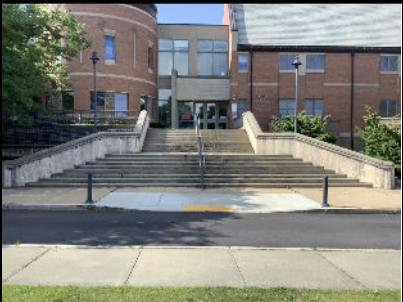
Directional sign to accessible entrance not provided	-	Provide a directional sign indicating the location of the nearest accessible entrance.	1	450	\$450
											450	
42	New Building Main Entrance (South Side), New Building, Secondary Entrance (North Side)	Ext.	-	Entrance	Main Entrance

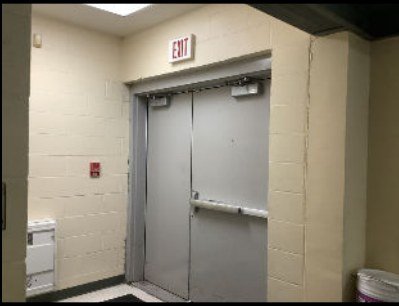
Tactile exit sign not provided Illuminated ISA symbol not provided (MAAB)	- -	Ensure that a tactile exit sign with raised characters and braille is provided at the exit door. Mount the sign between 48" - 60" above the finished floor located on the latch side of the door. When the illuminated exit sign is repaired or replaced, provide an illuminated sign with the International Symbol of Accessibility (ISA).	1	250	\$250
											250	
47	New Building, East Egress Door From Stairwell on North/East Corner of Building	B	-	Means of Egress	N/A

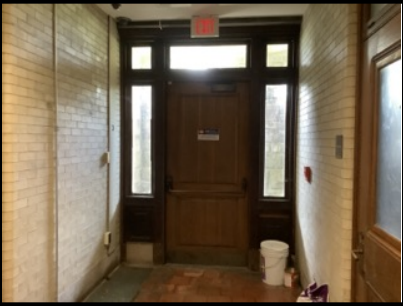
Tactile exit sign not provided Directional sign to accessible emergency exit not provided		Ensure that a tactile exit sign with raised characters and braille is provided at the exit door. Mount the sign between 48" - 60" above the finished floor located on the latch side of the door. Provide a directional sign indicating the location of the nearest accessible emergency exit.	1	250 250	\$500
52	Main Building, South Egress Doors 6 (By Room 104M) and South Egress Doors by Room 109M	1	-	Means of Egress	N/A

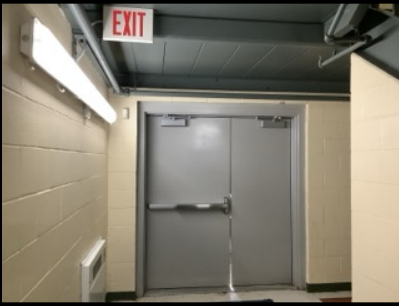
Tactile exit sign not provided Illuminated ISA symbol not provided (MAAB)		Ensure that a tactile exit sign with raised characters and braille is provided at the exit door. Mount the sign between 48" - 60" above the finished floor located on the latch side of the door. When the illuminated exit sign is repaired or replaced, provide an illuminated sign with the International Symbol of Accessibility (ISA).	1	250 Labor	\$250
57	New Building, Egress Door From Staircase on South Side of Auditorium	B	011	Means of Egress	N/A		Tactile exit sign not provided Directional sign to accessible emergency exit not provided		Ensure that a tactile exit sign with raised characters and braille is provided at the exit door. Mount the sign between 48" - 60" above the finished floor located on the latch side of the door. Provide a directional sign indicating the location of the nearest accessible emergency exit.	1	250 250	\$500

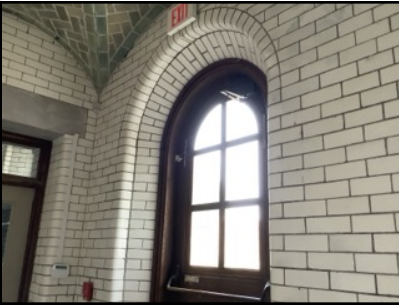
Tactile exit sign not provided Directional sign to accessible emergency exit not provided	- -	Ensure that a tactile exit sign with raised characters and braille is provided at the exit door. Mount the sign between 48" - 60" above the finished floor located on the latch side of the door. Provide a directional sign indicating the location of the nearest accessible emergency exit.	1	250 250	\$500
59	Main Building, Library - North Egress	B	031M	Means of Egress	N/A

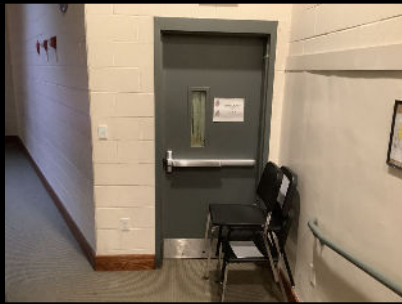
Accessible route not provided	-	Relocate the chairs to provide an accessible route to the door.	1	-	-	
67	New Building, Ramp by North Entrance/ Near Auditorium	Ground Level	-	Interior Access Route	N/A

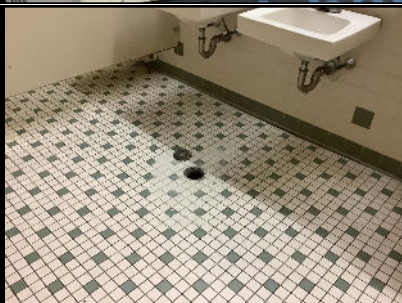
Surface openings > 1/2"	-	Replace or reposition so that openings are 1/2" max. and the long opening dimension is perpendicular to the dominant direction of travel. (Provide a drain cover.)	1	Labor	Labor	
69	New Building, Men's Multi-User - Level 2 Corridor	2	-	Interior Access Route	N/A

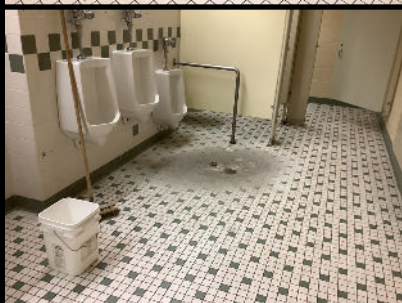
Surface not stable, firm, and slip-resistant		Repair surface. At the time of surveying, water was coming up from the drain.	1	Labor	Labor

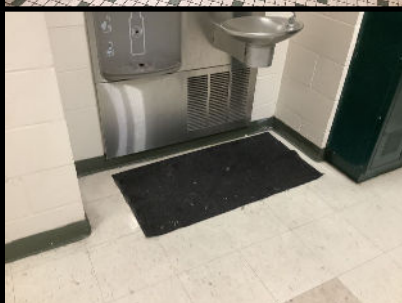
Surface not stable, firm, and slip-resistant		Secure the mat.	1	Labor	Labor

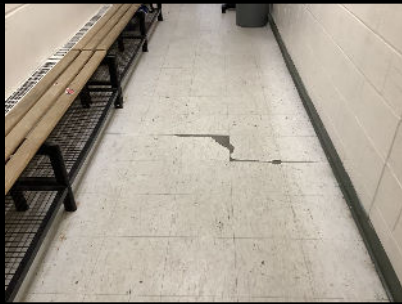
Route not maintained in operable working condition	-	Ensure the accessible route is maintained in operable working condition.	1	Labor	Labor
72	Main Building, Special Education Classroom	B	001M	Interior Access Route	N/A

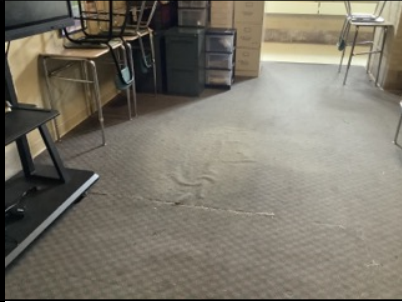
Surface not stable, firm, and slip-resistant		Repair surface, as part of the carpet is not secured.	1	Labor	Labor
73	Main Building, West Stairwell of Main Building	B	-	Interior Access Route	N/A

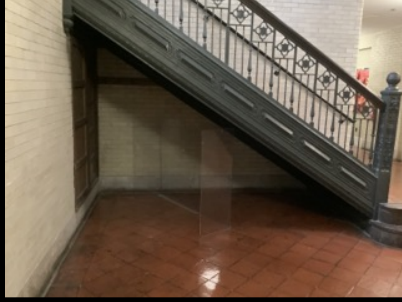
Vertical clearance < 80" above finished floor	72"	Provide a cane-detectable barrier underneath stair.	1	1248	\$1248
											1248	
74	Main Building, North Egress to Picnic Tables	B	006M	Interior Access Route	N/A

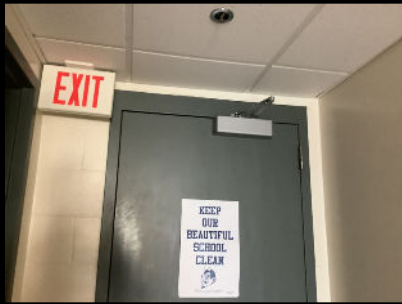
Door requires > 5 lbs. of force to open	13 lbs	Adjust closers so doors do not require more than 5 pounds of force to open.  Applies to all doors in the New Building in this condition.	1	Labor	Labor
77	New Building, Health Suite	1	103	Doors, Doorways, & Gates	Office

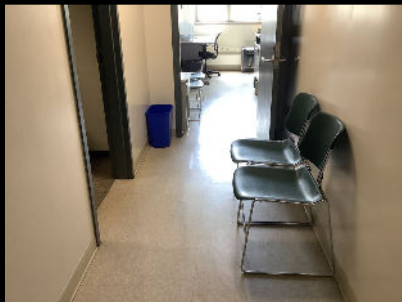
Maneuvering clearance(s) not provided	33"	Relocate the chairs to provide 48" of clear floor space in front of the doors.	1	Labor	Labor
78	New Building, Conference in Health Suite	1	103	Doors, Doorways, & Gates	Office

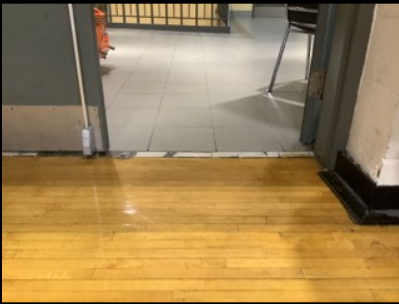
Threshold not maintained in operable working condition		Repair the threshold. Ensure threshold is in operable working condition and 1/2" high max. beveled.	1	1000	\$1000
											1000	
87	New Building, Entry to Main Building From Ramp	B	-	Doors, Doorways, & Gates	Circulation

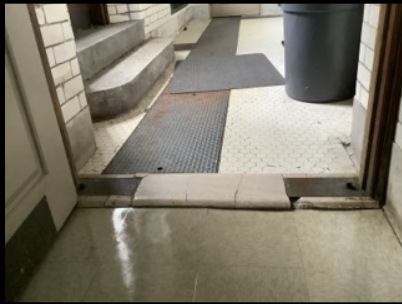
Threshold not maintained in operable working condition		Replace the threshold with a threshold that is 1/2" high max. beveled.	1	1000	\$1000
											1000	
102	New Building, Both Entrances To Mabel Hoyle Knipe Auditorium	2	-	Doors, Doorways, & Gates	Assembly Space

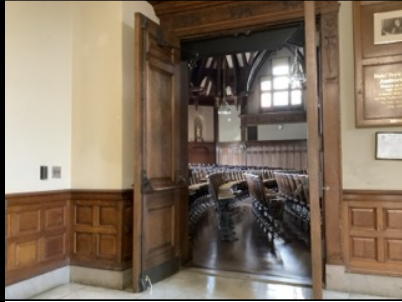
Threshold not beveled Threshold > 1/2" high	- 1"	Bevel the threshold. Alter the threshold to be 1/2" high max.	1	1000	\$1000
											1000	
103	New Building, Men's Multi-User Toilet Room	2	-	Doors, Doorways, & Gates	Toilet Room

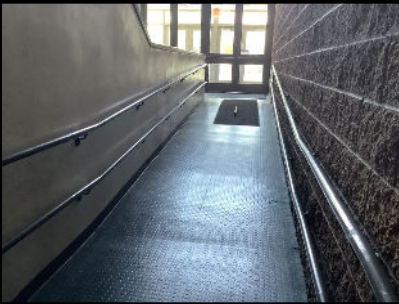
Running slope >1:12 (8.33%)	9.3%	Further study will be needed to determine whether it is technically feasible to bring the ramp into full compliance with the ADA Standards.	1	-	-
107	New Building, Ramp by North Entrance/ Near Auditorium	B	-	Ramps	Interior

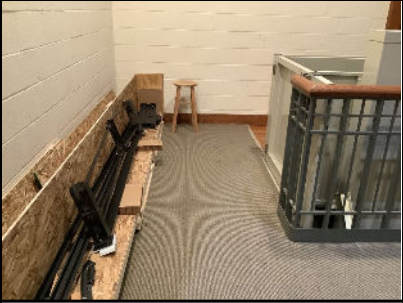
Ensure that additional stored items do not interfere with the accessible route to the lift.	1	Labor	Labor
117	New Building, Auditorium	B	011	Platform Lift	N/A

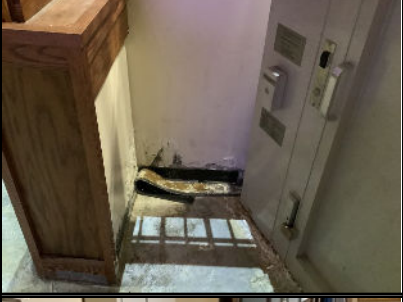
Door lacks maneuvering clearance	28.5"	When lift is replaced with a compliant lift, ensure the required maneuvering clearance is provided at the lift door.	1	Labor	Labor

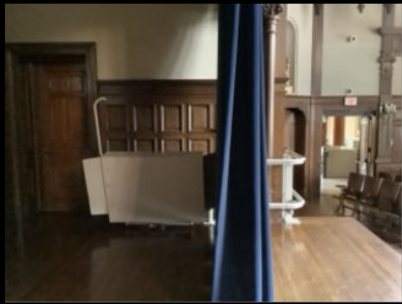
Not maintained in operable working condition	-	Ensure that the lift is maintained in operating working condition.	1	Labor	Labor
Elevator												
122	New Building, Elevator	1	-	Elevator	Interior

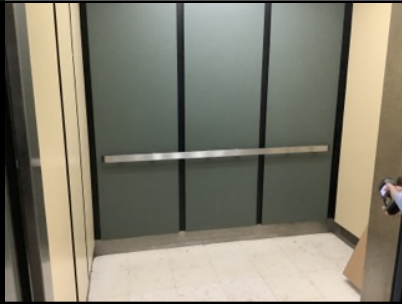
Elevator is not independently operable		Ensure the elevator is independently operable.	1	Labor	Labor
123	New Building, Elevator	1	-	Elevator	Interior

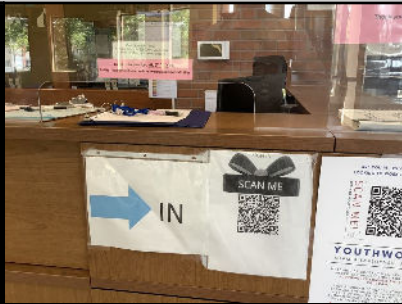
Non-glare finish and contrast not provided on sign		Remove the laminate covering over all informational signage to prevent glare.  Applies to all informational signage in this condition.	1	Labor	Labor

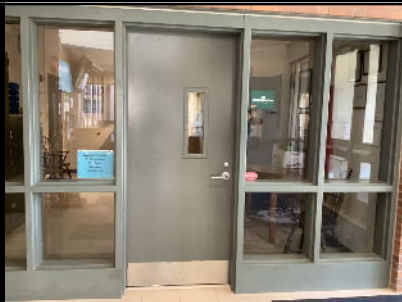
Raised characters < 48" or > 60" above ground	61.25"	Mount the sign so that the baseline of the lowest tactile character is 48" min. above finished floor and the baseline of the highest tactile character is 60" max. above the finished floor.  Applies to all designation signage in this condition.	1	Labor	Labor

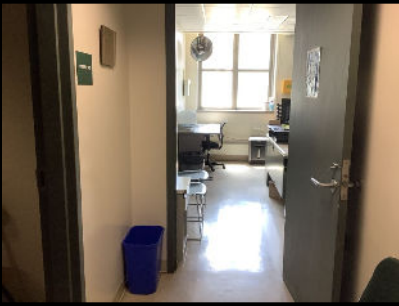
Signage is not provided Location of tactile sign not compliant		Locate compliant signage with raised characters and braille alongside the nearest adjacent wall to the latch side of the door.	1	250	\$250
											250	
127	New Building, Exam Room in Health Suite	1	103	Signage	Designation

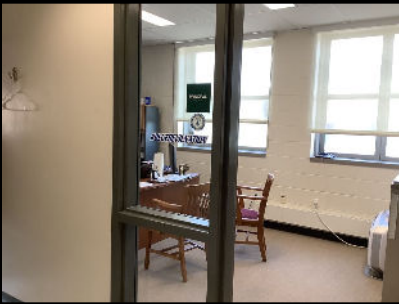
Raised characters < 48" or > 60" above ground	61.75"	Mount the sign so that the baseline of the lowest tactile character is 48" min. above finished floor and the baseline of the highest tactile character is 60" max. above the finished floor.  Applies to all designation signage in this condition.	1	Labor	Labor
132	New Building, Conference Room Connected to Principal Office	1	-	Signage	Designation

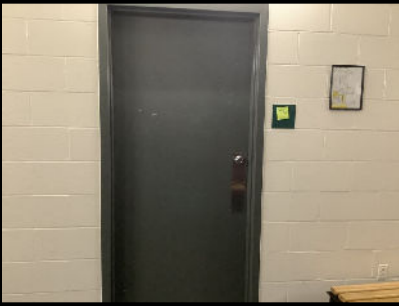
Not in operable working condition	-	Remove paper blocking raised characters/braille. Update accessible sign if necessary.	1	Labor	Labor
147	New Building, Staff Office in Women's Locker Room	B	008	Signage	Designation

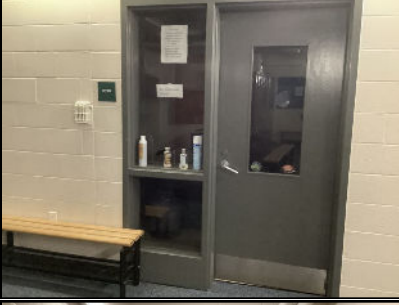
Signage lacks 18" by 18" clear floor space	-	Relocate the bench to provide a clear floor space of 18" min. by 18" min. at the sign (Recommend locating sign on the glass at a compliant height closer to the latch side of the door.)	1	Labor	Labor
148	New Building, Exit Door Near Room 010 in Women's Locker Room	B	008	Signage	Egress

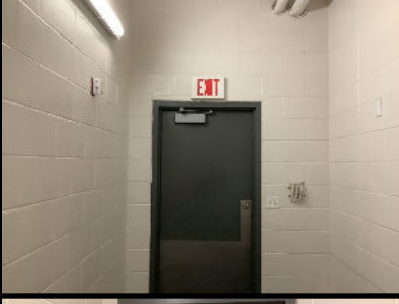
Sign not maintained in operable working condition.		Replace sign with sign with all characters.	1	-	-
149	New Building, Door to Training Room in Men's Locker Room	B	009	Signage	Designation

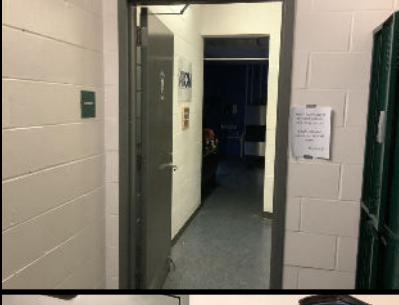
Location of tactile sign not compliant		Locate sign alongside the door on the latch side.	1	Labor	Labor

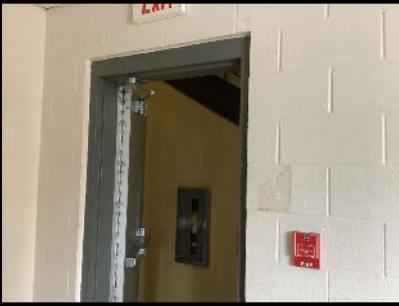
Signage is not provided	-	Locate compliant stairway signage with raised characters and braille alongside the door on the latch side.	1	250	\$250
											250	
152	New Building, Entrance to Stairwell on South Side of Gymnasium	1	-	Signage	Designation

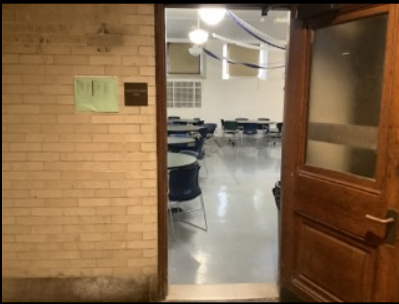
Designation sign is incorrect		If necessary to accurately identify this room, provide a sign with the correct room designation. The text on this sign reads "Teacher Dining," when this is also used by seniors.	1	250	\$250
											250	
157	Main Building, Library	B	030M	Signage	Designation

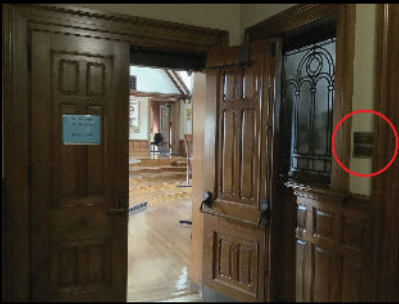
Location of tactile sign not compliant	-	Locate the sign to the right of the right-hand door.	1	Labor	Labor
162	Main Building, TV Studio - Computer Lab	B	004M	Signage	Designation

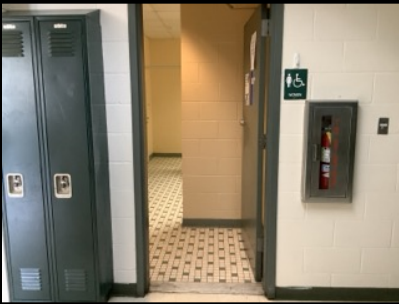
Location of tactile sign not compliant Signage lacks 18" by 18" clear floor space	- 9"	Remove the locker closest to the latch side of the door to provide 18" of clear floor space at the sign, as well as 12" of push-side maneuvering clearance at the door. Locate sign alongside the door on the latch side.	1	500 Labor	\$500
Service Counter												
167	New Building, South Main Entrance	1	-	Service Counter	N/A

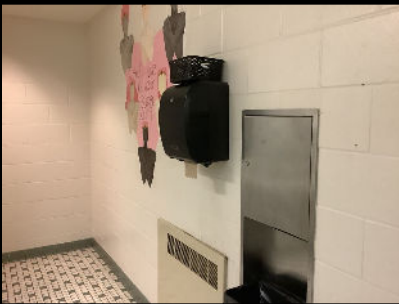
Reach < 15" or > 48"(forward/side approach)	70.5"	Relocate the container with tampons on top of the paper towel dispenser between 15"- 48" above the finished floor.	1	Labor	Labor
172	New Building, Defibrillator Across From Gymnasium	1	-	Operable Parts / Reach Range	Defibrillator

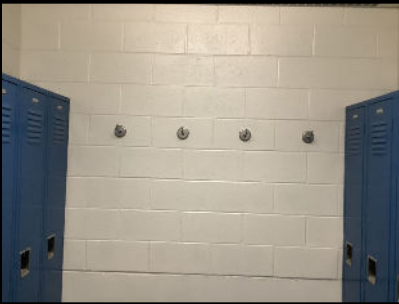
Reach < 15" or > 48"(forward/side approach)	69"	Provide one additional coat hook, located between 15"- 48" above the finished floor.	1	75	\$75
											75	
177	Main Building, Senior Cafeteria	B	009M	Operable Parts / Reach Range	Microwave

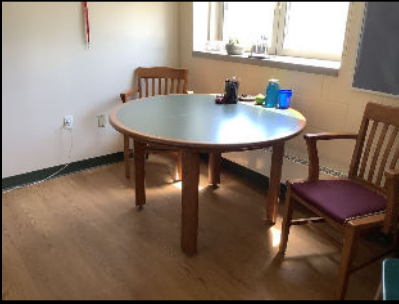
Knee or toe clearance not provided	24"	Provide at least one work surface with 30" min. wide knee and toe clearance.	1	700	\$700
											700	
182	New Building, Guidance Suite	1	102	Dining or Work Surfaces	Work Surface

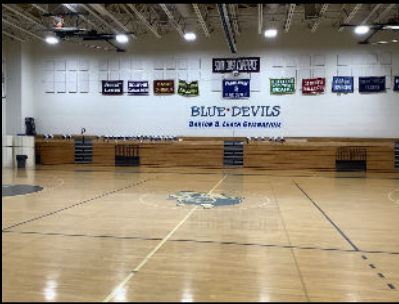
Assistive listening devices not provided	-	If audible communication is integral to the use of the space, provide an assistive listening system. <b>Note:</b> Assistive listening system receiver count was not confirmed. Ensure that assistive listening devices are provided based on the 2010 ADA Standards, Table 219.3.	1	Labor	Labor
187	New Building, Auditorium	B	011	Assembly Area	N/A

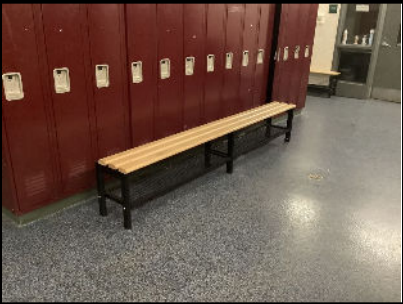
Back support not provided at bench Bench < 24" deep Bench lacks 12" clear underneath	10.5" - -	Provide at least one bench with back support or that is affixed to a wall with room on the side to transfer, is 24" deep, and that has 12" clear underneath.  Applies to all locker rooms with benches in this condition. Unit cost is provided for one instance of this repetitive item.	1	200	\$200
											200	
197	New Building, All Lockers on All Floors	B	-	Locker Room	School Lockers

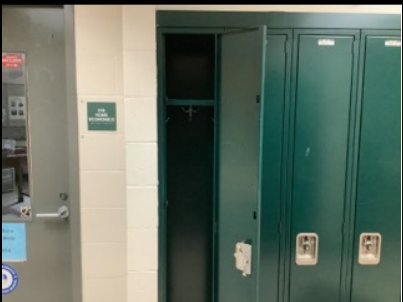
5% of lockers are not accessible Storage > 48" high Hook > 48" high	- 63" 60"	Ensure at least one or 5% of all lockers are accessible. When additional accessible lockers are provided, ensure all storage and coat hooks within these lockers are located no higher than 48 inches above the floor. Applies to all floors where at least one or 5% of all lockers are not accessible.  Unit cost is provided for one instance of this repetitive item.	1	660	\$660

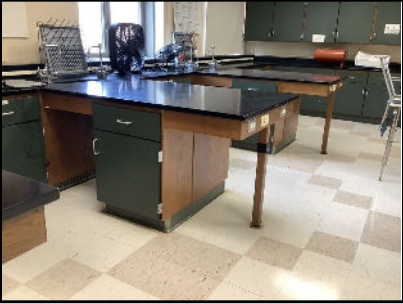
At least one (or 5%) acc. work surface not provided	36.75"	Alter so that 5% of work surfaces (at least one) are 28"- 34" above the finished floor with knee and toe clearance positioned for a forward approach.	1	1144	\$1144
Picnic Tables												
202	Main Building, Picnic Area Behind Classroom 006M	Ext.	-	Picnic Tables	N/A

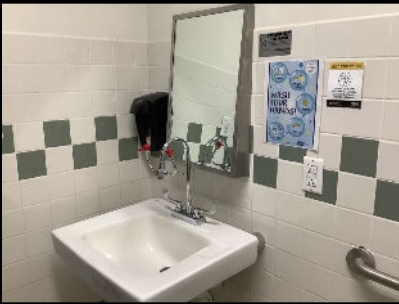
Mirror above lavatory w/reflective surface not compliant.	-	Flip the mirror so that it is angled downwards.	1	500	\$500
											500	
206	New Building, Men's and Women's Multi-User Toilet Rooms Across From Main Office	1	-	Lavatory	N/A

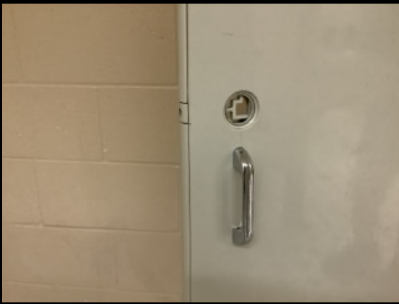
Door has noncompliant hardware Door has malfunctioning self-closing hinge	- -	Provide hardware at the lock that can be operable with one hand and not require tight grasping, pinching, or twisting of the wrist. Repair hinge.	1	70 Labor	\$70	
216	New Building, Multi-User Toilet Room in Women's Locker Room	B	008	Toilet Compartment	Accessible Compartment

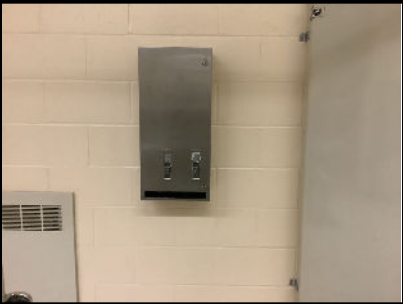
Noncompliant operable part	- -	Provide a dispenser that can be operable with one hand and not require tight grasping, pinching, or twisting of the wrist.  Applies to girls' multi-user toilet room east in Main Building.	3	1000	\$3000
Shower Compartment												
226	New Building, Shower Room in Women's Locker Room	B	008	Shower Compartment	Transfer Type
