# LeRoy Wood Elementary School

## Town of Fairhaven ADA Transition Plan

October 2024

Institute for Human Centered Design

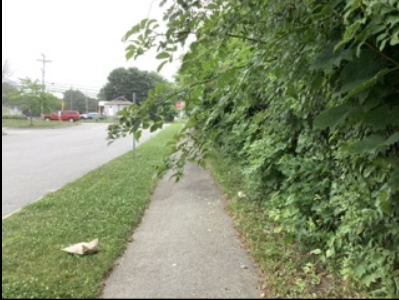
Obstructed by protruding objects	55"	Trim low hanging branches in trees.	1	Labor	Labor
2	Accessible Parking by Main Drop Off Entrance (South/East Spaces)	Ext.	-	Exterior Access Route	Sidewalk

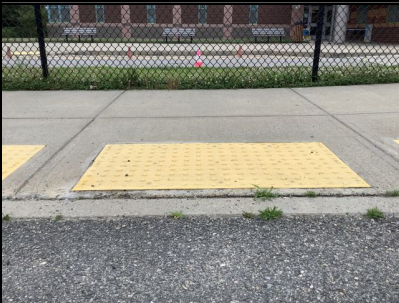
Level changes > 1/4"	0.75"	Alter change in level to be 1/4" high max.	1	-	-
3	Sidewalk In Front of Main Entrance (Near East Corner of Building)	Ext.	-	Exterior Access Route	Sidewalk

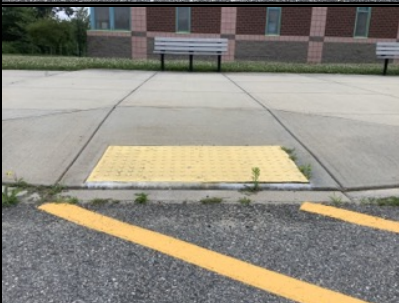
Level changes > 1/4"	1"	Alter change in level to be 1/4" high max.	1	-	-
4	Path Leading to Sconicut Neck Road on South/East Side of Site	Ext.	-	Exterior Access Route	Sidewalk

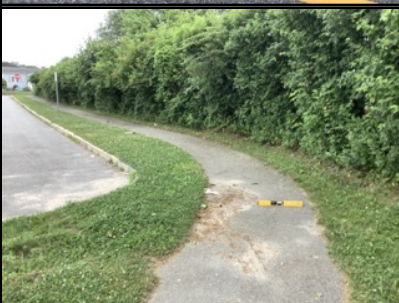
Cross slope > 1:50 (2.00%) Does not prevent accumulation of water	3% -	Reduce cross slope to be no steeper than 1:50 (2.00%). Repair surface.	1	-	-

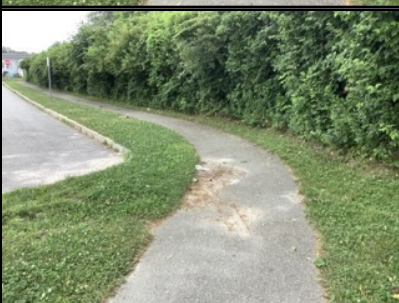
Does not prevent accumulation of water Route not maintained in operable working condition	- -	Repair surface. Ensure the accessible route is maintained in operable working condition.	1	-	-

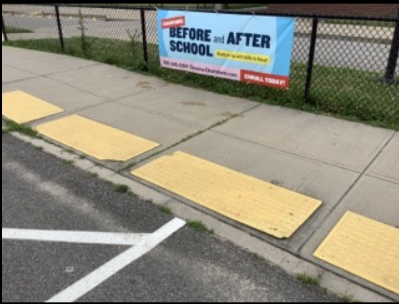
Route not maintained in operable working condition		Ensure the accessible route is maintained in operable working condition.	1	-	-
7	Sidewalk from North/East Parking Lot to Bus Drop Off Entrance	Ext.	-	Exterior Access Route	Sidewalk

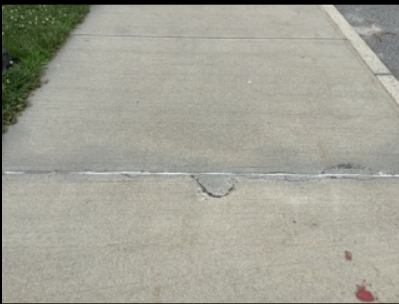
Route not maintained in operable working condition	-	Ensure the accessible route is maintained in operable working condition.	1	-	-
8	Outdoor Garden	Ext.	-	Exterior Access Route	Walkway

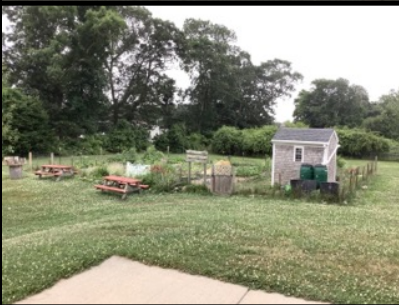
Accessible route not provided		Ensure an accessible route is provided to the garden.	1	-	-
9	Bike Racks Across From Playground on North Corner of Building	Ext.	-	Exterior Access Route	Exterior

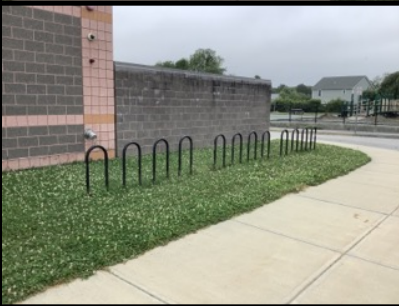
Accessible route not provided		Ensure an accessible route is provided to the bike racks.	1	-	-

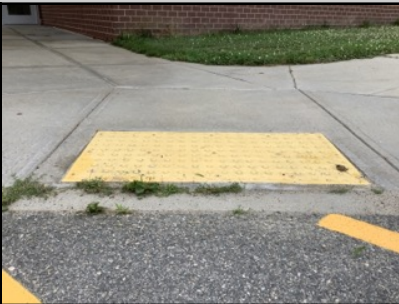
Transition from curb ramp to street not flush	.5"	Maintain the curb ramp to ensure transition from curb ramp to street is flush or free of changes in level.	1	-	-

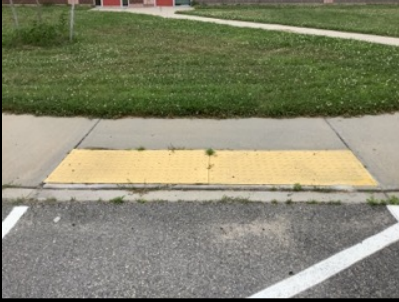
Transition from curb ramp to street not flush	1.5"	Ensure transition from curb ramp to street is flush or free of changes in level.	1	-	-
12	Accessible Parking by Bus Drop Off Entrance	Ext.	-	Curb Ramp	Parallel

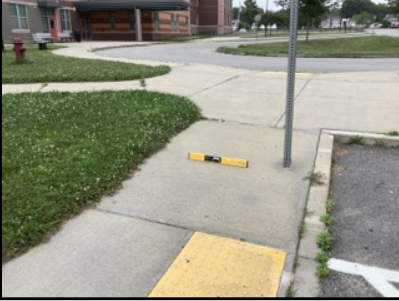
Cross slope > 1:50 (2.00%) (MAAB)	2.7%	Reduce cross slope at curb ramp to be no steeper than 1:50 (2.00%).	1	-	-
Off-Street Parking Lot or Garage												
13	Accessible Parking by Main Drop Off Entrance (South/East Spaces)	Ext.	-	Off-Street Parking Lot or Garage	Visitor

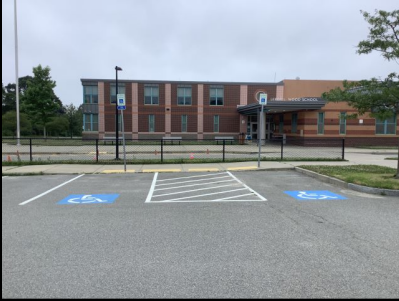
Sign top > 96" above finished grade	120"	Locate signs with the tops of the sign 96" above the ground.	2	Labor	Labor
14	Accessible Parking by Main Drop Off Entrance (North/West Spaces)	Ext.	-	Off-Street Parking Lot or Garage	Visitor

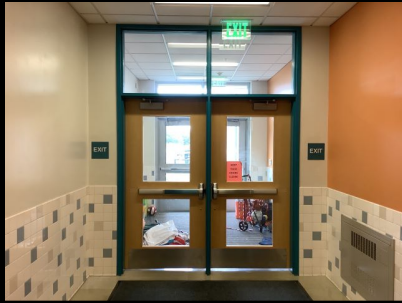
Illuminated ISA symbol not provided (MAAB)		Provide an illuminated sign with the International Symbol of Accessibility (ISA).	1	200	\$200
											200	
Interior Access Route												
17	Library	1	-	Interior Access Route	N/A

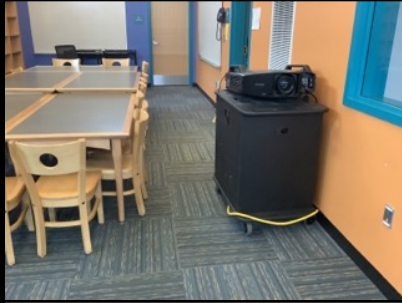
Route < 36" wide	22"	Move the projector table to ensure that a clear width of 36" min. is maintained at the accessible route.	1	Labor	Labor
18	Next to Main Office/Across from Nurse's Office	1	-	Interior Access Route	N/A

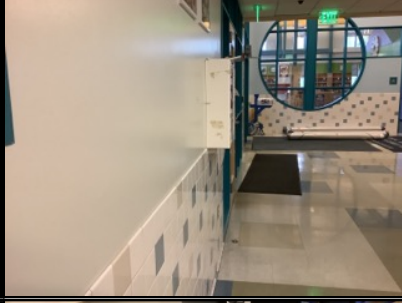
Obstructed by protruding objects	6.5"	Provide a cane-detectable barrier underneath the defibrillator. Barriers must have leading edges no higher than 27" so that they are within cane sweep. Barriers can include fixed planters, benches, and guardrails.	1	398	\$398

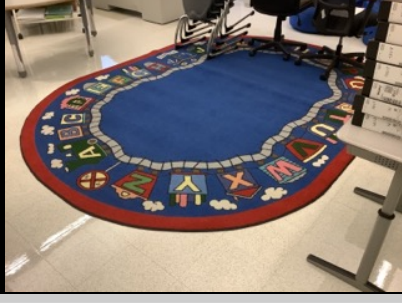
Surface not stable, firm, and slip-resistant		Secure the mat.	1	Labor	Labor
Doors, Doorways, & Gates												
20	Pre-K Classroom	1	131	Doors, Doorways, & Gates	Classroom

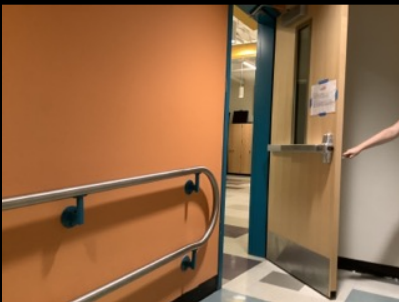
Maneuvering clearance(s) not provided	15"	Provide an automatic door opener.	1	6000	\$6000
											6000	
22	Single-User Special Education Corridor	1		Doors, Doorways, & Gates	Toilet Room

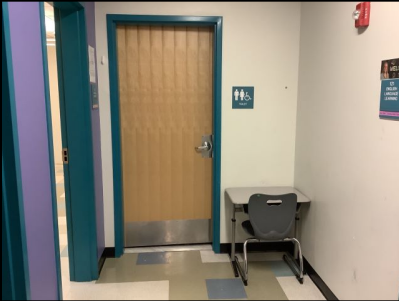
Maneuvering clearance(s) not provided	-	Relocate the desk to provide 12" of push side maneuvering clearance.	1	Labor	Labor
23	Reading Classroom	1	118	Doors, Doorways, & Gates	Classroom

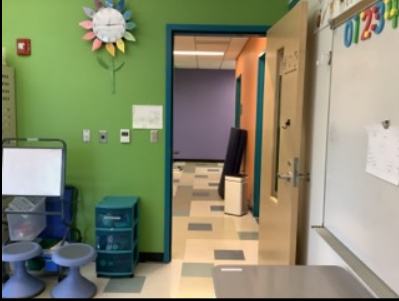
Maneuvering clearance(s) not provided	11.5"	Relocate the cabinet to provide 18" of pull side maneuvering clearance.	1	Labor	Labor
24	Kindergarten Classroom	1	130	Doors, Doorways, & Gates	Classroom

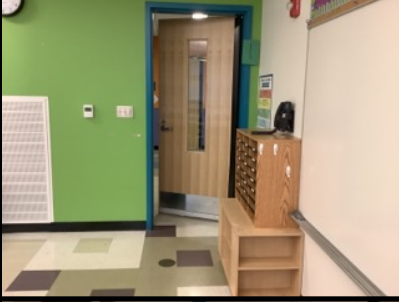
Maneuvering clearance(s) not provided	-	Relocate shelves to provide 48" clear floor space at the door.	1	Labor	Labor

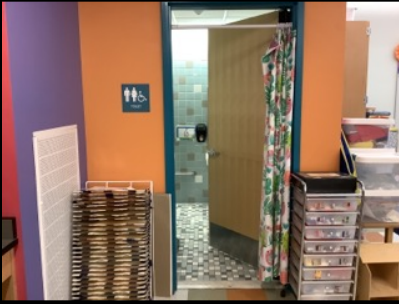
Maneuvering clearance(s) not provided	4"	Relocate the object underneath the designation sign to provide 12" of push side maneuvering clearance as well as 18" by 18" clear at the sign.	1	Labor	Labor
27	Single-User Toilet Room in Pre-K Classroom	1	131	Doors, Doorways, & Gates	Toilet Room

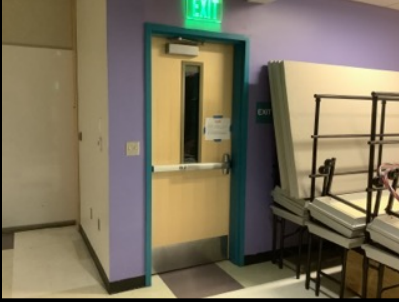
Maneuvering clearance not provided at recess > 6"	11.5"	Install an automatic door opener or rebuild the doors so that the doors are not recessed greater than 6" deep on the push or the pull side.  (Cost estimate is for an automatic door opener.)	1	6000	\$6000
											6000	
30	Ensemble Room, Practice Room 105 C	1	105 C	Doors, Doorways, & Gates	Classroom

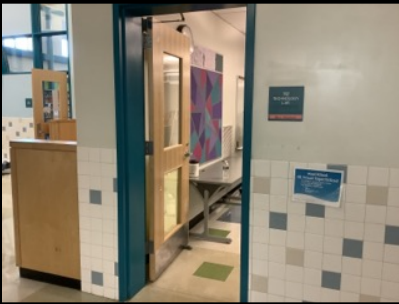
Maneuvering clearance not provided at recess > 6"	11"	Install an automatic door opener or rebuild the doors so that the doors are not recessed greater than 6" deep on the push or the pull side.  (Cost estimate is for an automatic door opener.)	1	6000	6000
32	Main Entrance	1	-	Doors, Doorways, & Gates	Vestibule

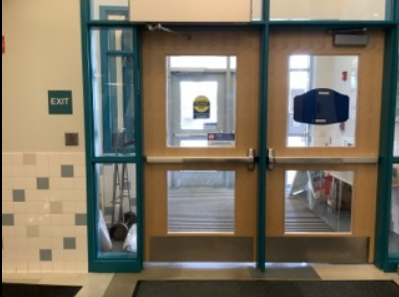
Door requires > 5 lbs. of force to open	15 lbs	Adjust closers so doors do not require more than 5 pounds of force to open.  Applies to all interior doors with a closer in this condition.	1	Labor	Labor
33	Main Entrance Vestibule	1	-	Doors, Doorways, & Gates	Vestibule

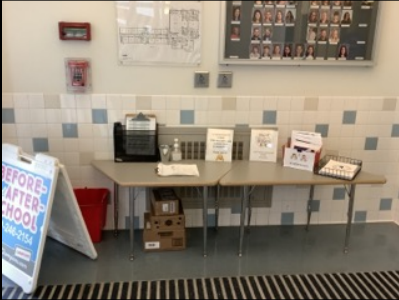
Automatic door opener > 48" above the floor surface Clear floor space at opener not provided	52" -	Lower automatic door opener to 48" max. above ground. Relocate table to provide a 30" x 48" clear floor space at automatic door opener.	1	800 Labor	\$800

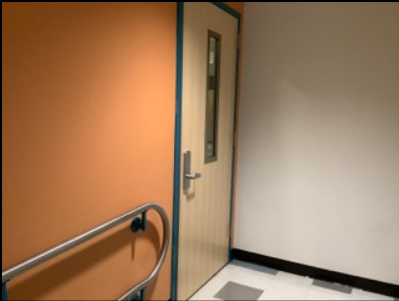
Signage is not provided		Locate compliant signage with raised characters and braille alongside the door on the latch side.	1	250	\$250
											250	
37	Multilingual Learners Classroom	1	119	Signage	Designation

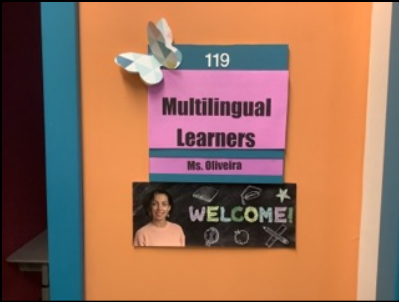
Raised characters not provided on sign Braille not provided on sign Character style not compliant		Signage currently placed on this designation sign should be relocated in order for the raised characters and braille to not be obstructed. Applies to all other designation signs in this condition.	1	Labor	Labor
38	Library Entrance	1		Signage	Designation

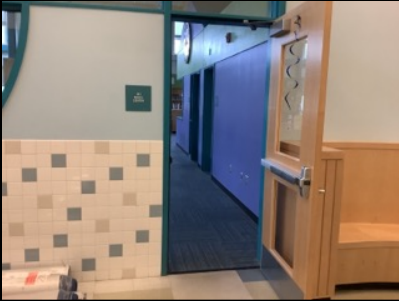
Raised characters < 48" or > 60" above ground	61"	Mount the sign so that the baseline of the lowest tactile character is 48" min. above finished floor and the baseline of the highest tactile character is 60" max. above the finished floor.  Applies to all designation signage in this condition.	1	Labor	Labor

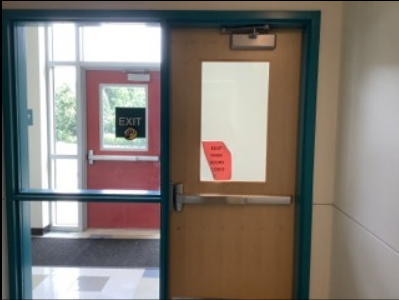
Braille not provided on sign	-	Relocate small sign on the tactile exit sign that obstructs the braille.	1	Labor	Labor
40	Ramp Leading From Cafeteria to Music/ Platform	1		Signage	Designation

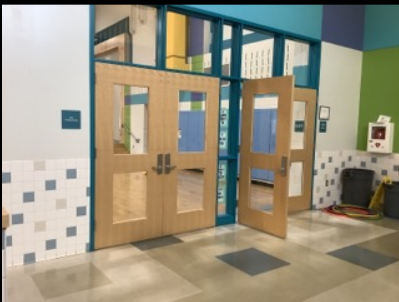
Location of tactile sign not compliant		Locate the designation sign to the gymnasium the right of the right-hand door. The sign that is located on the right currently is an occupancy sign.	1	Labor	Labor
42	Main Entrance	1		Signage	Egress

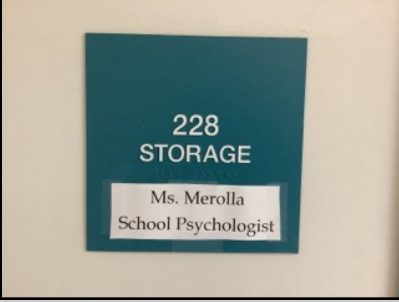
Designation sign is incorrect		Provide a sign with the correct room designation. This is the School Psychologist Classroom, not a storage room.	1	250	\$250

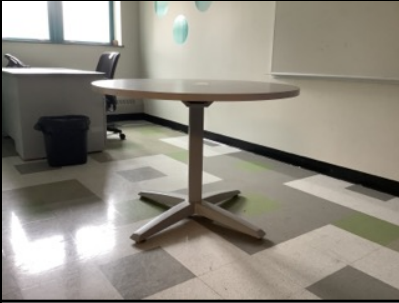
Knee or toe clearance not provided	22"	Provide at least one work surface with 30" min. wide knee and toe clearance.	1	700	\$700
											700	
47	Speech Classroom	1	117	Dining or Work Surfaces	Work Surface

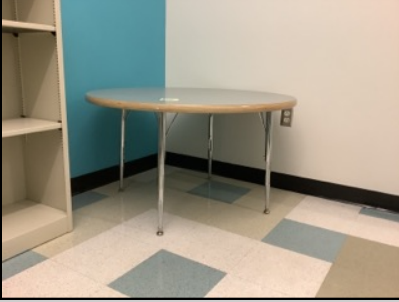
Knee or toe clearance not provided	16.5"	Provide at least one work surface with 30" min. wide knee and toe clearance.	1	700	\$700
											700	
Picnic Tables												
48	Outside South/West Side of Gymnasium	Ext.	-	Picnic Tables	N/A

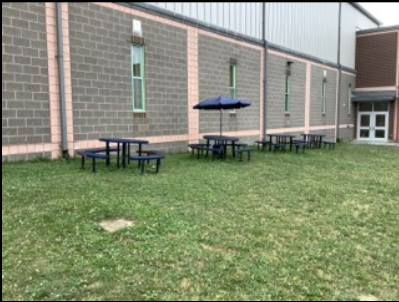
At least 5% accessible spaces not provided Picnic table not on an accessible route		Ensure that at least 5% (minimum one) of picnic tables are accessible with knee and toe clearance. Ensure that the accessible picnic table is connected to an accessible route. (Cost estimate is for an accessible picnic table.)	1	1400 -	\$1400

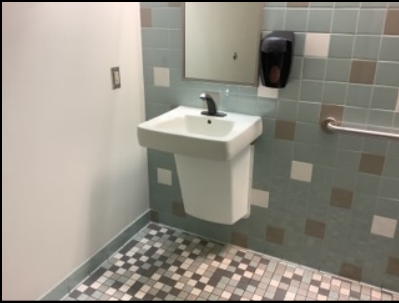
Lavatory rim or counter > 34" high Mirror above lavatory w/reflective surface > 40"	36" 43"	Provide at least one lavatory with the rim no higher than 34" max. above the finished floor. Lower mirror so that the bottom surface is at 40" max. above the finished floor.	3	4022 500	\$13566
											13566	
51	Single-User Toilet Room Next to Teacher Lunch Room	1		Lavatory	N/A

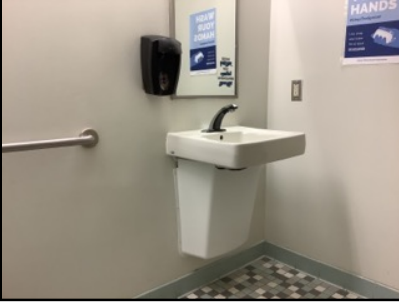
Mirror above lavatory w/reflective surface > 40"	43"	Lower mirror so that the bottom surface is at 40" max. above the finished floor.	1	500	\$500
											500	
Single-User Toilet												
52	Single-User Toilet Room Next to Teacher Lunch Room	1		Single-User Toilet	N/A

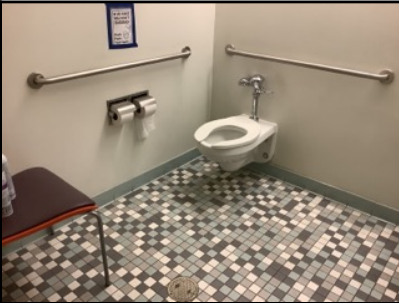
Clearance at toilet < 72" clear depth (MAAB)	-	Relocate the chair across from the toilet.	1	Labor	Labor

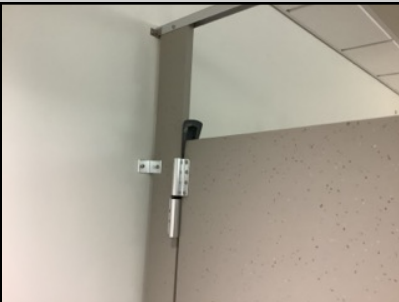
Remove the door closer that is placed in the hinge.	1	Labor	Labor
54	Men's Multi-User Toilet Room Next to Gymnasium	1		Toilet Compartment	Accessible Compartment

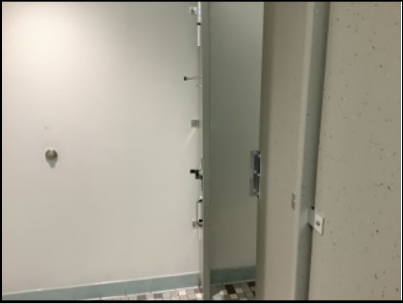
Door has malfunctioning self-closing hinge Coat hook > 48" (2010 ADA)	- 54"	Repair hinge, and remove the door closer that is placed in the hinge. Locate the coat hook no higher than 48" above the finished floor.	1	Labor 75	\$75
Dispersers											75	
56	Women's Multi-User Toilet Room Next to Gymnasium	1		Dispersers	Soap Dispenser

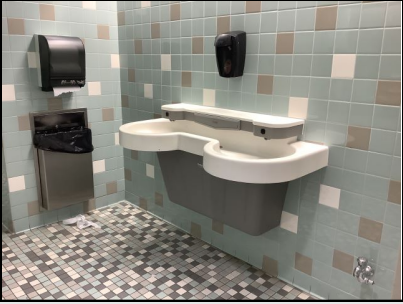
Controls > 48" high	54"	Relocate the soap dispenser so the operable part is 48" max. above the finished floor.	1	500	\$500
Toilet Rooms for Children											500	
Single-User Toilet (Children)												
57	Single-User Toilet Room in Pre-K Classroom	1	131	Single-User Toilet (Children)	All Gender

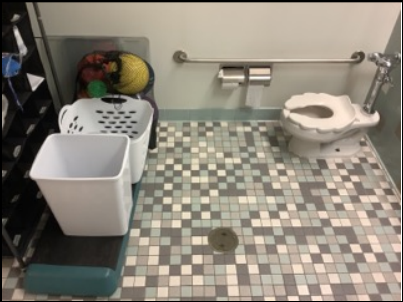
Clearance at toilet < 72" clear deep	-	Relocate the baskets and step platform underneath to provide 72" clearance at the toilet.	1	Labor	Labor

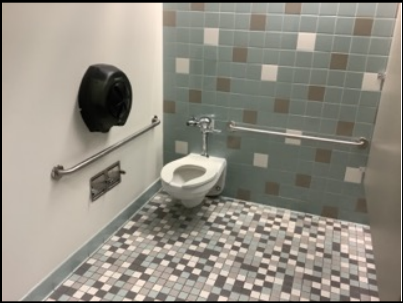
Noncompliant toilet paper dispenser	-	Relocate toilet paper dispenser so that it is between 14"- 19" above the finished floor and between 7"- 9" in front of the toilet. Ensure dispensers and other devices are not mounted above grab bars.	2	500	\$1000
											1000

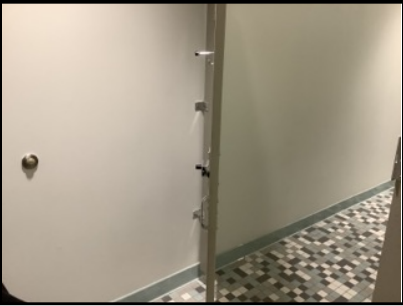
Door pull not provided Coat hook higher than 36"	54"	Provide a door pull on each side of the door between 34" to 48" above the finished floor that does not require tight grasping, pinching or twisting of the wrist. Lower hook so that it is no higher than 36" high for children.	4	70 75	\$580
Lavatory (Children)												
60	Single-User Toilet Room in Pre-K Classroom	1	131	Lavatory (Children)	N/A

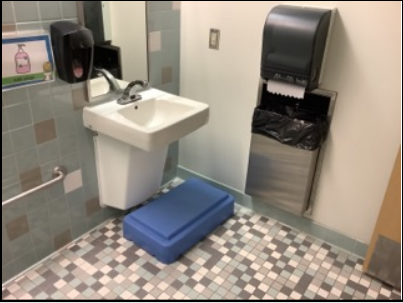
Toe or knee clearances not provided	-	Ensure that the step platform is relocated when a student in a wheeled mobility device is to use this lavatory to provide knee and toe clearance.  Applies to all lavatories with step platforms.	1	Labor	Labor

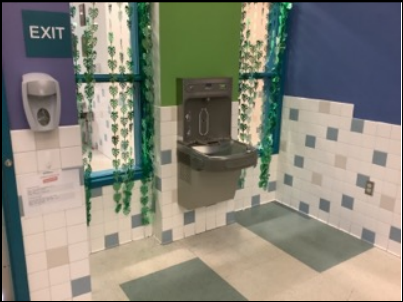
Inadequate water flow No drinking fountain provided for standing users in Cafeteria	- -	Repair drinking fountain to provide adequate water flow. Provide an additional drinking fountain for standing users.	1	Labor 4028	\$4028
Sink												
62	Music/Platform	1	104	Sink	N/A

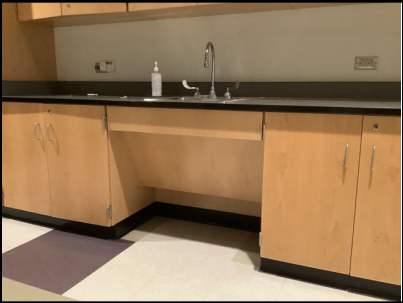
Toe and knee clearances not provided	6"	Ensure there is a 8" min. deep clearance at the top of the knee and toe clearance positioned for a forward approach.  Applies to all sinks in this condition.	1	800	\$800
Play and Sport Areas

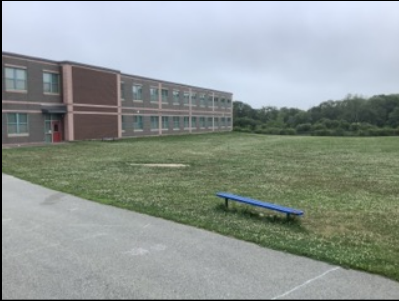
Accessible spaces not provided at team seating Field not connected to an accessible route No accessible route to all areas of sport activity		Provide a 36" x 48" clear floor space at team seating. Provide an accessible route to the boundary of sport activity.  Install an accessible route between all areas of sport activity.	1	-	-
Best Practice												
64	Route From Parking to Main Entrance	1

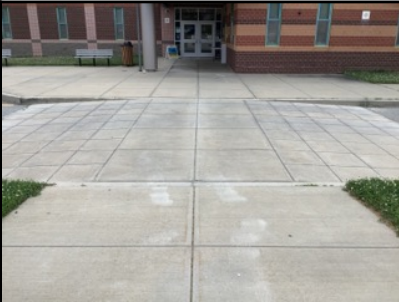
Recommend providing detectable warnings on each side of the crosswalk and ladder style striping at the crosswalk.	1	-	-
65	Sidewalk In Front of Main Entrance (South/East of Door)	1

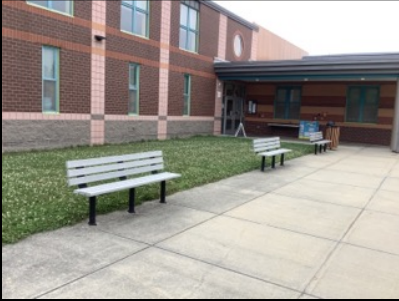
Recommend providing armrests on one of these benches.	1	-	-
66	East Corner of Building Leading to Path to Sconicut Neck Road	1

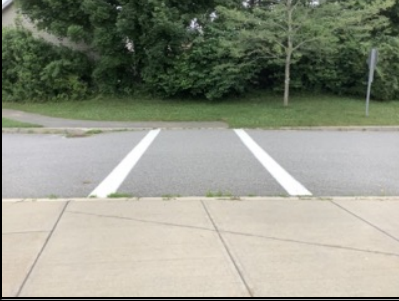
Recommend detectable warnings on each side of the crosswalk and ladder-style striping on the crosswalk.	1	-	-

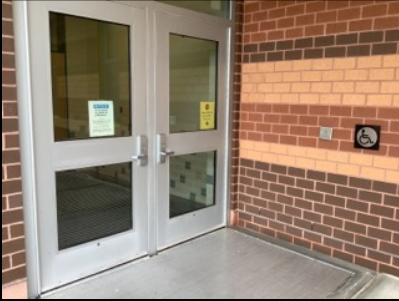
Recommend relocating the sign with the International Symbol of Accessibility onto the door on the right side.	1	-	-

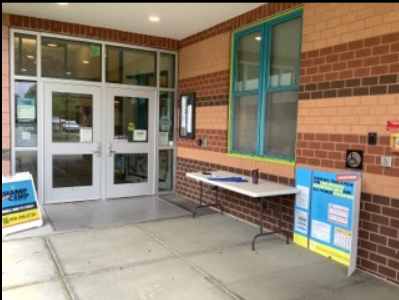
Recommend relocating the sign with the International Symbol of Accessibility onto the door on the right side.	1	-	-
69	Next to Main Office/Across From Nurse's Office	1

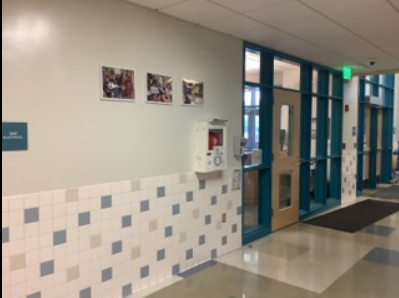
Recommend providing blade signage over all defibrillators and fire extinguishers in the school to indicate their location. Blade signage should be placed no lower than 80" high above the floor.	1	-	-
70	Exam Room in Nurse's Office	1	-

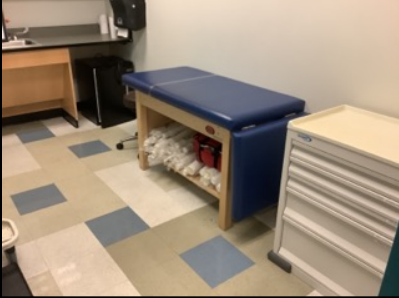
Recommend providing a height adjustable exam table.	1	-	-
71	Single-User Toilet Room Next to Teacher Lunch Room	1

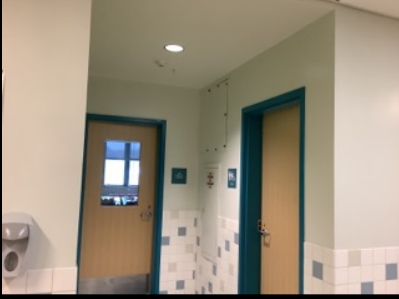
Recommend providing more illumination by the entrance door to the single-user toilet room.	1	-	-
72	Cafeteria	1	-

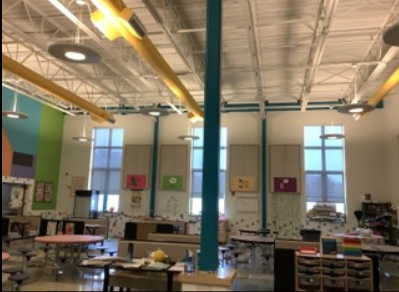
Recommend providing additional acoustic paneling in the cafeteria.  Note: This concern was brought up to the IHCD team by a staff member.	1	-	-

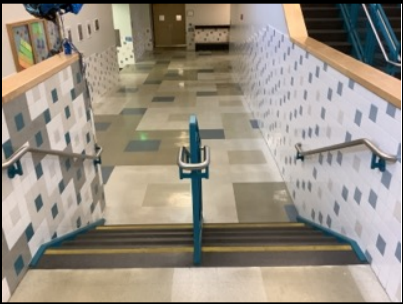
Recommend providing a solid and continuous stripe applied to the horizontal leading edge of each interior stair tread so that each tread is readily apparent when viewed in descent at each stair in the building.	1	-	-
74	Ramp Leading From Music/ Platform to Gymnasium	1

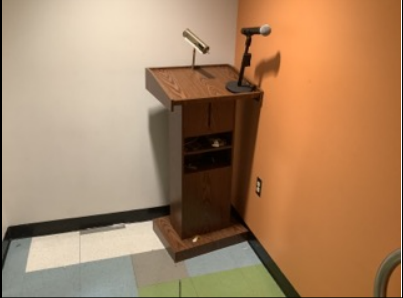
Recommend providing a height adjustable podium with knee and toe clearance.	1	-	-
75	Gymnasium/ Door to Ramp	1

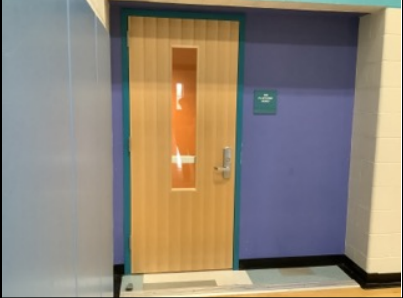
Recommend providing a sign with the International Sign of Accessibility (ISA) at this door to indicate this as an accessible route to the stage.	1	-	-
76	Gymnasium North/West Egress Doors	1			326

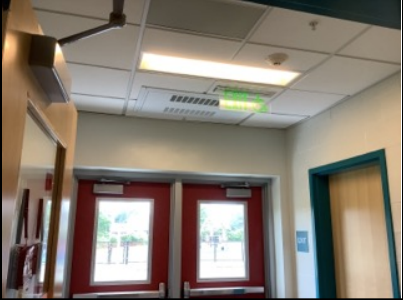
-	Recommend renovating lighting in this area to improve the readability of the illuminated egress sign.	1	-	-

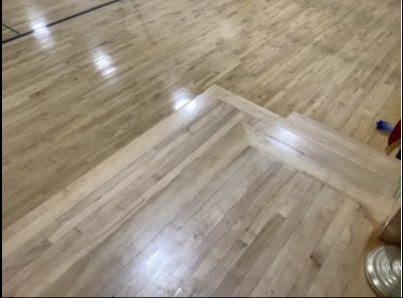
Recommend providing a solid and continuous stripe applied to the horizontal leading edge of each interior stair tread so that each tread is readily apparent when viewed in descent at each stair in the building.	1	-	-

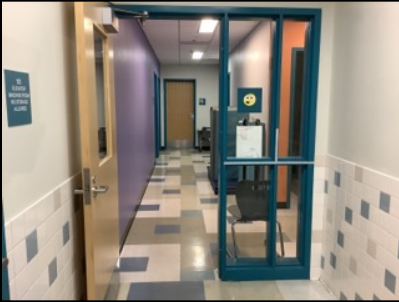
Recommend providing a designation sign at the entrance door to the Special Education Corridor.	1	-	-
79	North/West Egress Door Across From Bus Drop Off Entrance	1	-

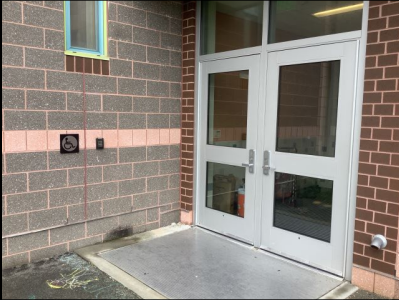
Recommend relocating the sign onto the door on the right side.	1	-	-
80	Men's/ Women's Multi-User Toilet Rooms Next to Gymnasium	1

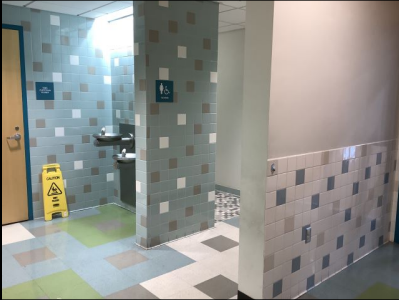
Recommend providing blade signage at all men's and women's multi-user toilet rooms where the tactile designation signage is not visible from the corridor. Ensure that blade signage is not located any lower than 80" high.	2	-	-
81	Music/ Platform	1	104

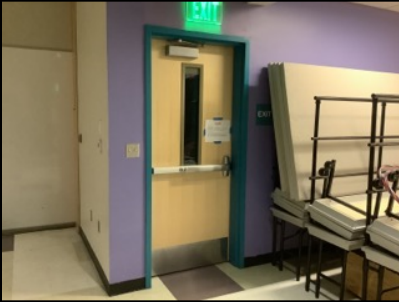
Recommend informational sign leading to the gymnasium.	1	-	-
82	Playground	Ext.	-

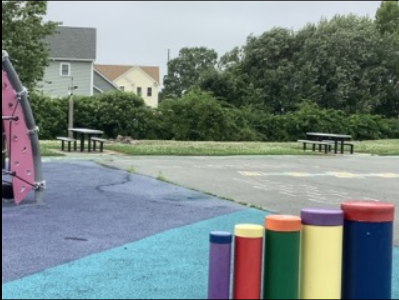
The playground was under construction and unable to be surveyed. Based on a comment from the Commission on Disability, recommend providing adaptive play and sport equipment.	1	-	-

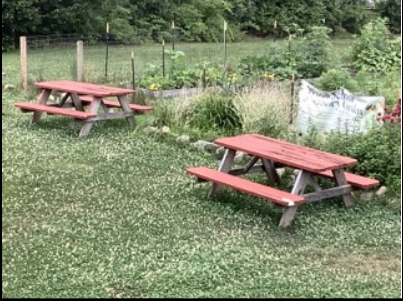
Recommend providing a stable, firm and slip-resistant surface that is 48" clear on all sides of accessible picnic tables.	1	-	-
