Livesay Park

Town of Fairhaven ADA Transition Plan

August 2024

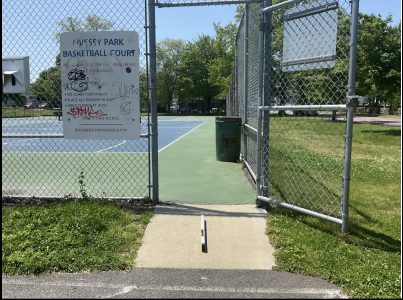
ID	Location	Floor	Room	Element	Type	Photo	Issues	Current Measure	Recommendations	Quantity	Price	Cost Estimation
Approach and Entrance												
Exterior Access Route												
1	Basketball Court	Ext.		Exterior Access Route	Exterior

Running slope > 1:20 (5.00%)	15%	Reduce running slope to be no steeper than 1:20 (5.00%).	1	-	-
2	East Softball Field - First Base Side	Ext.		Exterior Access Route	Exterior

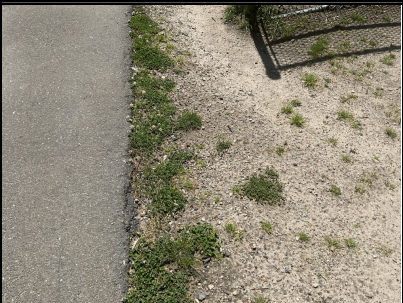
Level changes > 1/4"	1.5"	Alter change in level to be 1/4" high max.	1	-	-
3	Parker Street by Football Field	Ext.		Exterior Access Route	Curb Ramp

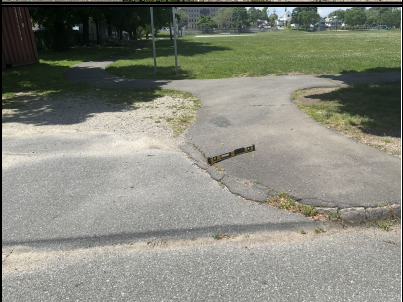
Route not maintained in operable working condition	-	Ensure the accessible route is maintained in operable working condition.	1	-	-
4	Skate Park	Ext.		Exterior Access Route	Exterior

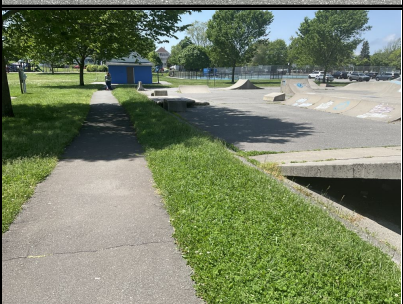
Accessible route not provided	-	Ensure an accessible route is provided from the walkway to the skate park.	1	-	-
Off-Street Parking Lot or Garage

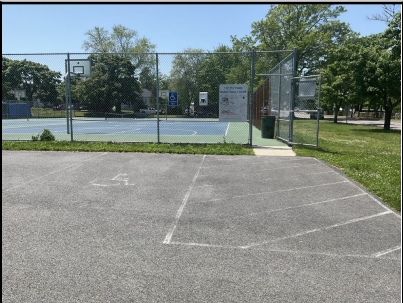
5	Northwest Parking Lot	Ext.		Off-Street Parking Lot or Garage	N/A

Access aisle not compliant	-	Restripe to provide a marked access aisle that is at least 60" wide.	1	-	-

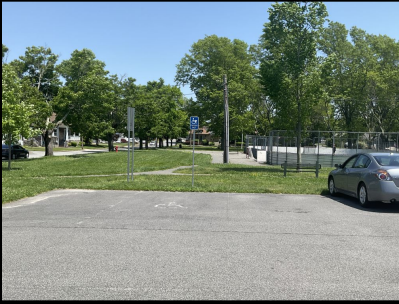
ID	Location	Floor	Room	Element	Type	Photo	Issues	Current Measure	Recommendations	Quantity	Price	Cost Estimation
6	Northwest Parking Lot	Ext.		Off-Street Parking Lot or Garage	N/A

Access aisle not compliant Sign does not have the designation "Van Accessible"	-	Restripe to provide a marked access aisle that is at least 96" wide at the van accessible space Add the designation "Van Accessible" to the sign located at the van accessible space.	1	500	\$500
											500	
7	West Parking Lot	Ext.		Off-Street Parking Lot or Garage	N/A

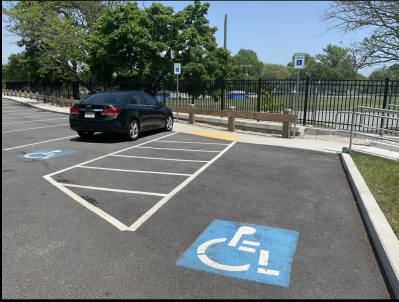
Accessibility issue includes lack of an identification sign with the International Symbol of Accessibility (ISA) and the designation “Van Accessible” at the van accessible parking space in the west parking lot.

Total # of parking Total # of designated car accessible parking spaces Total # of designated van accessible spaces Sign does not have the designation "Van Accessible"	28 1 1 -	Add the designation "Van Accessible" to the sign located at the van accessible space.	1	500	\$500
											500	
Access to Goods and Services												
Doors, Doorways, & Gates

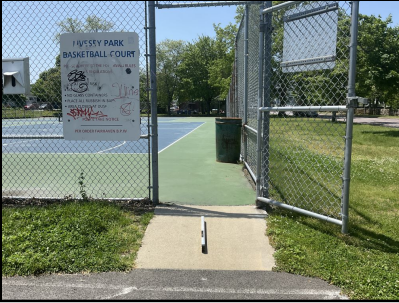
8	Basketball Court	Ext.		Doors, Doorways, & Gates	N/A

Maneuvering clearance at door > 1:50 (2.00%)	14.2%	Alter so that the slope in all directions is no greater than 1:50 (2.00%) or provide an automatic door opener.	1	-	-
Signage												
9	Men's Single-User Toilet Room	1		Signage	Designation

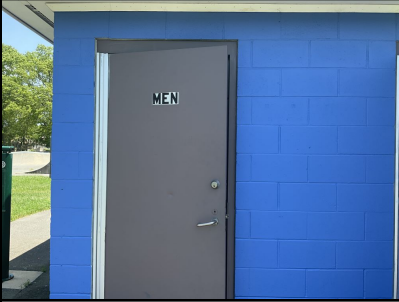
Accessibility issues include lack of tactile designation signage at the men’s and women’s single-user toilet rooms.

Tactile signage is not provided	-	Locate compliant signage with raised characters and braille alongside the door on the latch side. Recommendation also applies to the women's single-user toilet room.	2	450	\$900
											900

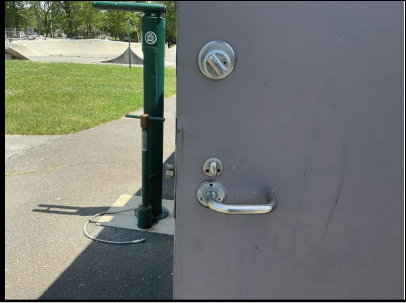
ID	Location	Floor	Room	Element	Type	Photo	Issues	Current Measure	Recommendations	Quantity	Price	Cost Estimation
Operable Parts / Reach Range												
10	Men's Single-User Toilet Room	1		Operable Parts / Reach Range	N/A

Not compliant	-	Provide hardware that can be operable with one hand and not require tight grasping, pinching, or twisting of the wrist. Recommendation also applies to women's single-user toilet room.	2	750	\$1500
											1500	
Picnic Tables												
11	Picnic Table	Ext.		Picnic Tables	N/A

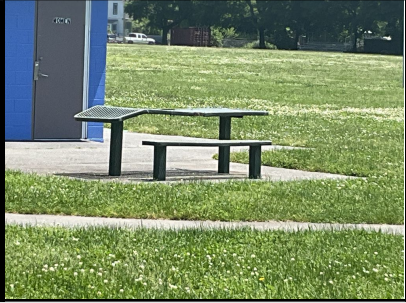
- Lack of an accessible picnic table.

Picnic table not maintained in operable working condition	-	Ensure the picnic table is maintained in operable working condition. Recommend replacing with an accessible picnic table.	1	1400	\$1400
											1400	
Toilet & Bathing Rooms												
Lavatory												
12	Men's Single-User Toilet Room	1		Lavatory	N/A

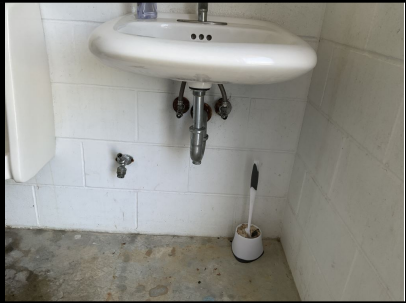
Plumbing underneath is exposed	-	Insulate or otherwise configure pipes to prevent contact for at least one lavatory. Recommendation also applies to women's single-user toilet room.	2	150	\$300

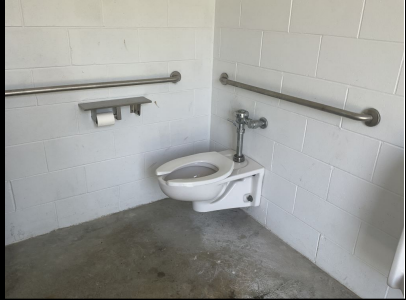
300	
Single-User Toilet												
13	Men's Single-User Toilet Room	1		Single-User Toilet	N/A

Flush control not on open side	-	Relocate the flush control to the open side.	1	486	\$486
											486

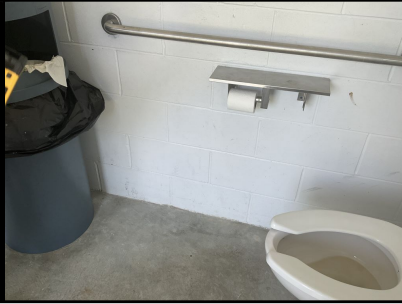
ID	Location	Floor	Room	Element	Type	Photo	Issues	Current Measure	Recommendations	Quantity	Price	Cost Estimation
14	Men's Single-User Toilet Room	1		Single-User Toilet	N/A

< 42" clear deep in front of toilet (MAAB)	34"	Relocate the trash can to maintain a 42" clear deep min. in front of the toilet bowl. Recommendation also applies to women's single-user toilet room.	2	Labor	Labor
Dispensers												
15	Women's Single-User Toilet Room	1		Dispensers	Paper Towel Dispenser

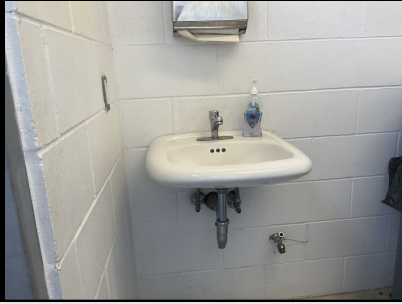
Controls > 48" high	51"	Relocate the paper towel dispenser so the operable part is 48" max. above the finished floor. Recommendation also applies to men's single-user toilet room.	2	500	\$1000
												1000
Play and Sport Areas												
Play Areas												
16	Play Structure (5-12 yrs.)	Ext.		Play Areas	N/A

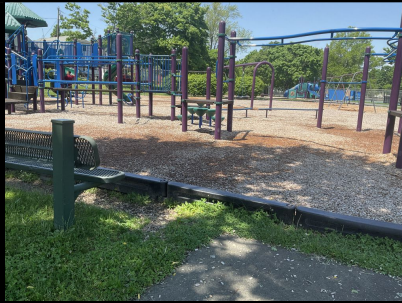
There is a lack of an accessible route to and around each playground and lack of a compliant impact-attenuating surface to the play components.

Accessible route not provided to playground Accessible route not provided around playground Accessible route not provided to play components	6.5" - -	Install an accessible route to and around the playground. Provide an accessible route around the play area. Provide a compliant impact-attenuating surface to and around the play components.	1	-	-

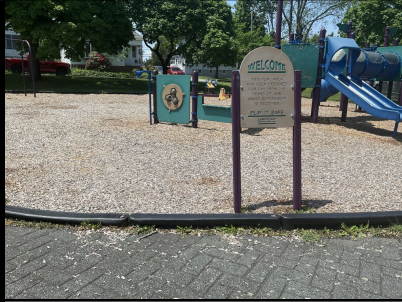
17	Play Structure (2-5 yrs.)	Ext.		Play Areas	N/A

Accessible route not provided to playground Accessible route not provided around playground Accessible route not provided to play components	5" - -	Install an accessible route to and around the playground. Provide an accessible route around the play area. Provide a compliant impact-attenuating surface to and around the play components.	1	-	-

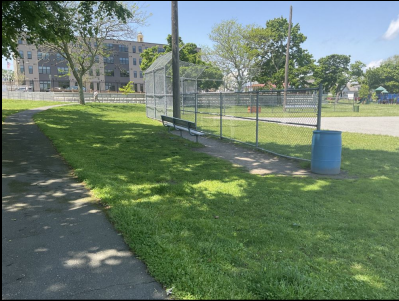
ID	Location	Floor	Room	Element	Type	Photo	Issues	Current Measure	Recommendations	Quantity	Price	Cost Estimation
Field												
18	West Softball Field - Third Base	Ext.		Field

Accessible spaces not provided at team seating		Provide a 36" x 48" clear floor space at team seating. Recommendation also applies to the first base side of the west softball field.	1	-	-
19	East Softball Field - Third Base Side	Ext.		Field	Softball

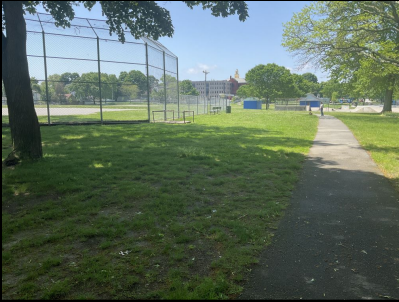
Accessible spaces not provided at team seating Accessible spaces not provided at sidelines seating Field not connected to an accessible route	<ul style="list-style-type: none">---	Provide a 36" x 48" clear floor space at team seating. Provide a 36" x 60" clear floor space at sidelines seating. Provide an accessible route to the field. Recommendation also applies to the east softball field on the first base side.	1	-	-
20	Football Field	Ext.		Field	Football

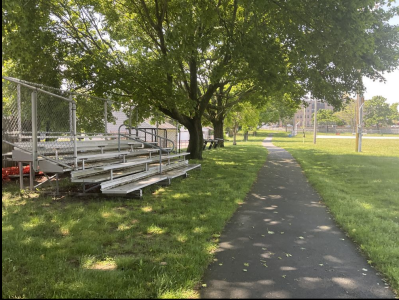
Accessible spaces not provided at sidelines seating	-	Provide a 36" x 60" clear floor space at sidelines seating.	1	-	-

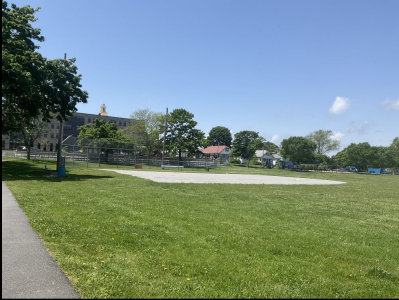
21	West Softball Field	Ext.		Field	Softball

Field not connected to an accessible route		Provide an accessible route to the field.	1	-	-
Court												
22	Pickleball/ Tennis Court	Ext.		Court	Other

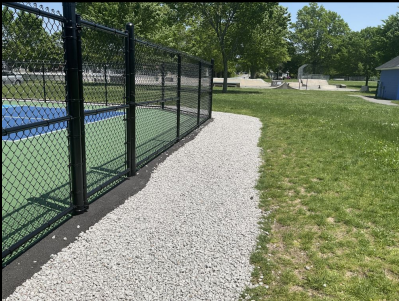
No accessible route between all areas of sport activity	-	Install an accessible route between all areas of sport activity.	1	-	-
Best Practice

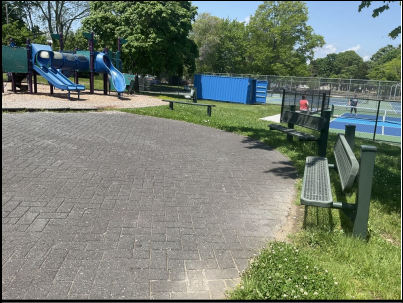
ID	Location	Floor	Room	Element	Type	Photo	Issues	Current Measure	Recommendations	Quantity	Price	Cost Estimation
23	Play Structure (5-12 yrs.)	Ext.			N/A

Recommend providing a 36" min. by 48" min. stable, firm and slip-resistant surface adjacent to at least one of the existing benches.	1	-	-
24	Northwest Parking Lot	Ext.			N/A

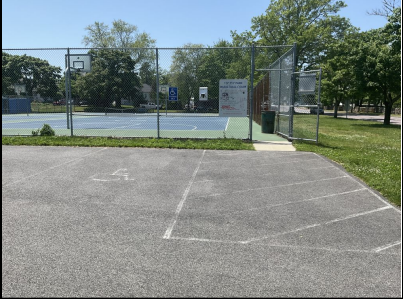
Recommend locating this sign with the bottom of the sign 60" above the ground.	1	-	-
