Macomber and Pimental Field

Town of Fairhaven ADA Transition Plan

November 2024

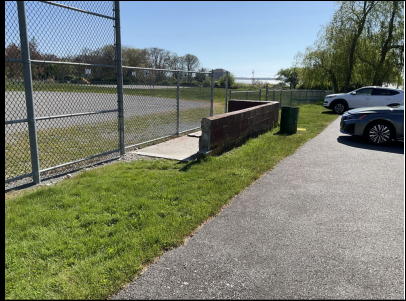
ID	Location	Floor	Room	Element	Type	Photo	Issues	Current Measure	Recommendations	Quantity	Price	Cost Estimation
Approach and Entrance												
Off-Street Parking Lot or Garage												
1	Parking Lot by Softball Field	Ext.		Off-Street Parking Lot or Garage	Visitor

Total # of designated van accessible spaces Van space < 132" or <96" wide Access aisle < 96" wide at van space Sign with the International Symbol of Acc. not provided Sign does not have the designation "Van Accessible"	0 - - - -	Provide one van accessible space that is at least 96" wide. Provide a marked access aisle that is at least 96" wide. Provide a sign with the International Symbol of Accessibility (ISA) with the bottom of the sign 60" min. above the ground and the top 96" max. above the ground. Add the designation "Van Accessible" to the sign located at the van accessible space. (Cost for signage.)	1	500	\$500
Access to Goods and Services

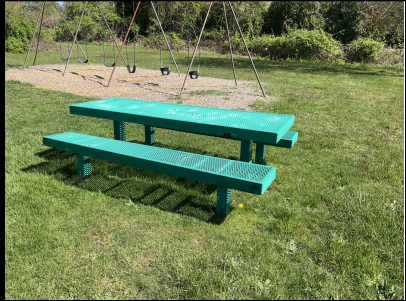
Picnic Tables												
2	Picnic Table by Play Components on Southwest Side of Field	Ext.		Picnic Tables	N/A

Toe or knee clearance at tables not provided Picnic table not on an accessible route	-	Provide at least 1 picnic table (or ensure that 5% of picnic tables) have toe and knee clearance. When an accessible picnic table is provided, ensure that the picnic table is connected to an accessible route. (Cost estimate is for an accessible picnic table.)	1	1400	\$1400
Exterior Benches												
3	Softball Field - Bench on First Base Line by Outfield	Ext.		Exterior Benches	N/A

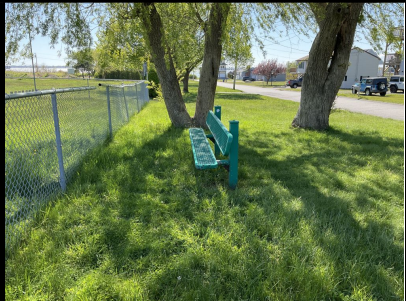
No accessible route to one bench in area	-	Provide an accessible route to one bench in this area.	1	-	-
4	Bench by Play Components on Southwest Side of Field	Ext.		Exterior Benches	N/A

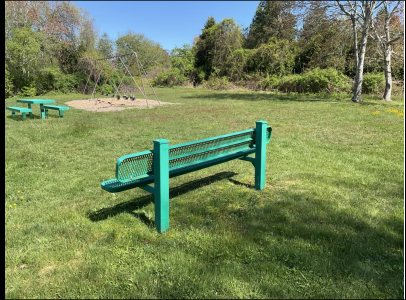
No accessible route to one bench in area	-	Provide an accessible route to one bench in this area.	1	-	-

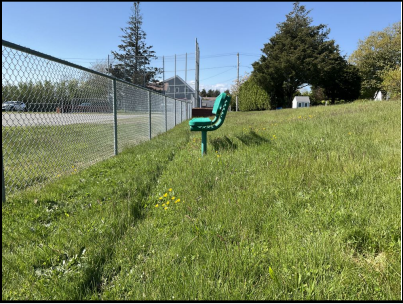
ID	Location	Floor	Room	Element	Type	Photo	Issues	Current Measure	Recommendations	Quantity	Price	Cost Estimation
5	Softball Field - Bench on Third Base Line	Ext.		Exterior Benches	N/A

No accessible route to one bench in area	-	Provide an accessible route to one bench in this area.	1	-	-
Play and Sport Areas												
Play Areas												
6	Play Components on Southwest Side of Field	Ext.		Play Areas	N/A

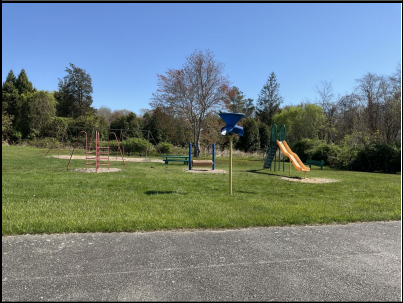
Accessible route not provided to playground Accessible route not provided around playground Accessible route not provided to play components	-	Install an accessible route to and around the playground. Provide an accessible route around the play area. Provide a compliant impact-attenuating surface to and around the play components.	1	-	-
7	Play Components on Southwest Side of Field	Ext.		Play Areas	N/A

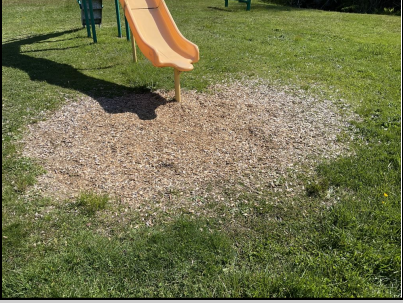
Surface not stable, firm, and slip-resistant	-	Repair surface and ensure that surface is firm, stable and slip-resistant (to areas around play components). Note: The Massachusetts Architectural Access Board (MAAB) does not consider engineered wood fiber (EWF) to comply with its regulation requiring an accessible route to each play component and around the playground.	1	-	-

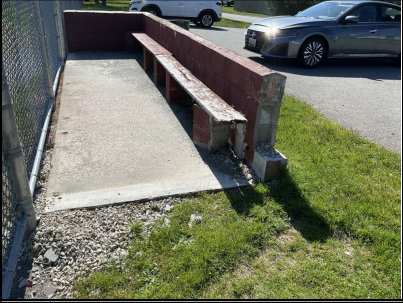
Field												
8	First Base Dugout	Ext.		Field	Softball

Route not maintained in operable working condition	-	When an accessible route is provided, ensure the accessible route is maintained in operable working condition, and free of level changes and loose gravel.	1	-	-
9	First Base Dugout	Ext.		Field	Softball

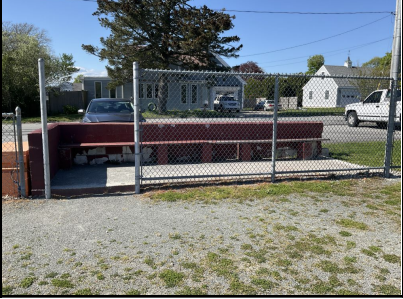
Accessible spaces not provided at team seating	-	Provide a 36" x 48" clear floor space at team seating alongside the bench.	1	-	-

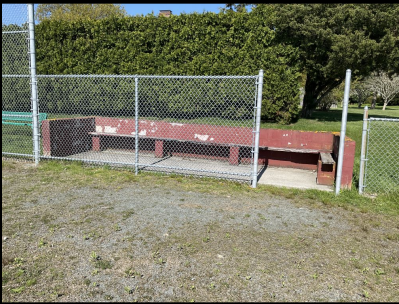
ID	Location	Floor	Room	Element	Type	Photo	Issues	Current Measure	Recommendations	Quantity	Price	Cost Estimation
10	Third Base Dugout	Ext.		Field	Softball

Accessible spaces not provided at team seating No accessible route to all areas of sport activity Accessible entrance to dugout not provided	- - -	Provide a 36" x 48" clear floor space at team seating alongside the bench. Install an accessible route to the third base dugout. Provide a compliant accessible entrance to the dugout.	1	-	-
11	Softball Field - Bleacher Seating on First Base Line	Ext.		Field	Softball

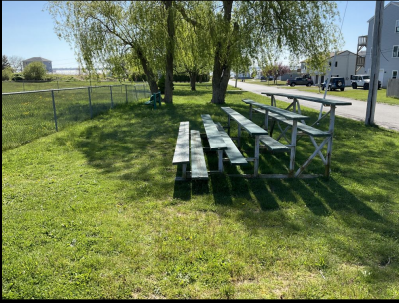
Accessible spaces not provided at sidelines seating Accessible route not provided	-	Provide a 36" x 60" clear floor space at sidelines seating. When compliant clear floor space is provided, ensure an accessible route is provided to the area of clear floor space.	1	-	-
12	Field Entrance on Third Base Line	Ext.		Field	Softball

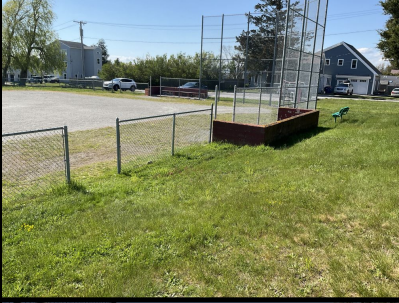
Field not connected to an accessible route	-	Provide an accessible route to the field.	1	-	-

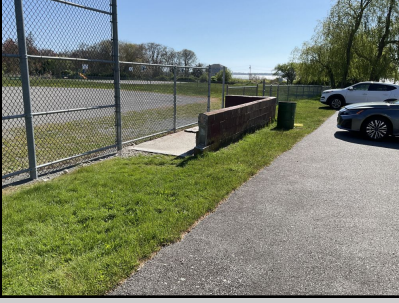
13	First Base Dugout	Ext.		Field	Softball

No accessible route to all areas of sport activity	-	Install an accessible route to the first base dugout, and to the field entrance on the first base line.	1	-	-
Court												
14	Basketball Courts on Southwest Side of Field	Ext.		Court	Basketball

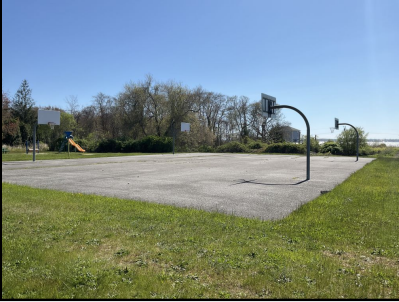
Court is not connected to an accessible route	-	Provide an accessible route to the court.	1	-	-
Best Practice

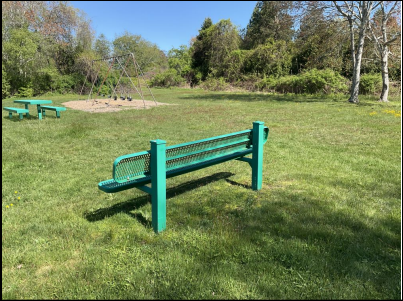
ID	Location	Floor	Room	Element	Type	Photo	Issues	Current Measure	Recommendations	Quantity	Price	Cost Estimation
15	Bench by Play Components on Southwest Side of Field	Ext.

-	Recommend providing a 36" min. by 48" min. stable, firm and slip-resistant surface adjacent to at least one bench in each area where benches are provided positioned to allow a person in a wheeled mobility device and a person sitting on the bench to have their shoulders aligned.	1	-	-
16	Picnic Table by Play Components on Southwest Side of Field	Ext.

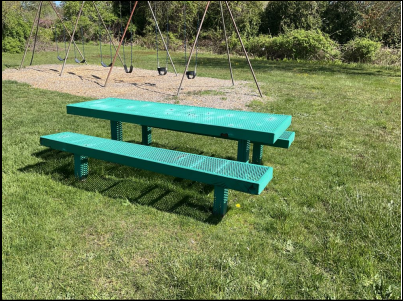
Recommend providing a stable, firm and slip-resistant surface that is 48" clear on all sides of all provided accessible picnic tables.	1	-	-
