Police and Fire Station

Town of Fairhaven ADA Transition Plan

November 2024

Institute for Human Centered Design

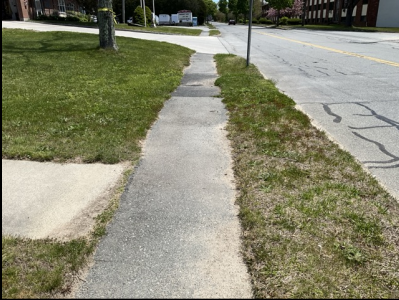
ID	Location	Floor	Room	Element	Type	Photo	Issues	Current Measure	Recommendations	Quantity	Price	Cost Estimation
Approach and Entrance												
Exterior Access Route												
1	Washington Street	Ext.		Exterior Access Route	Sidewalk

Exterior route < 48" wide	38"	Ensure that a clear width of 48" min. is maintained at the accessible route.	1	-	-
2	Fire Department Ramp			Exterior Access Route	Exterior

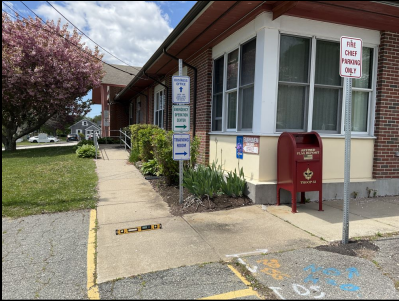
Cross slope > 1:50 (2.00%)	6.8%	Reduce cross slope to be no steeper than 1:50 (2.00%).	1	-	-
3	Washington Street	Ext.		Exterior Access Route	Sidewalk

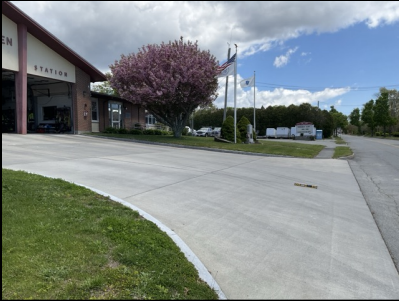
Cross slope > 1:50 (2.00%)	11.2%	Reduce cross slope to be no steeper than 1:50 (2.00%).	1	-	-
4	West Side Police Department Parking	Ext.		Exterior Access Route	Exterior

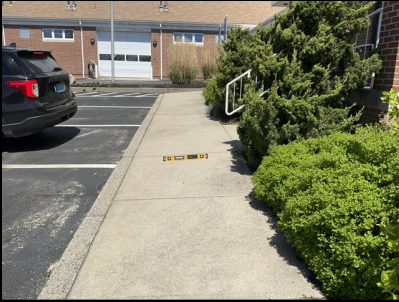
Cross slope > 1:50 (2.00%) Running slope > 1:20 (5.00%)	7.4% 6.6%	Reduce cross slope to be no steeper than 1:50 (2.00%). Reduce running slope to be no steeper than 1:20 (5.00%).	1	-	-

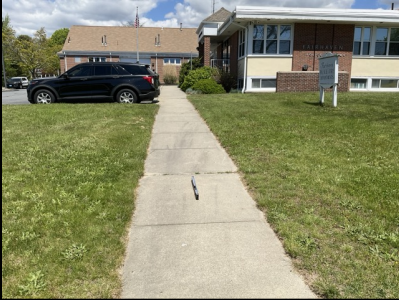
5	Path to Fire Department	Ext.		Exterior Access Route	Exterior

Running slope > 1:20 (5.00%)	7.4%	Reduce running slope to be no steeper than 1:20 (5.00%).	1	-	-

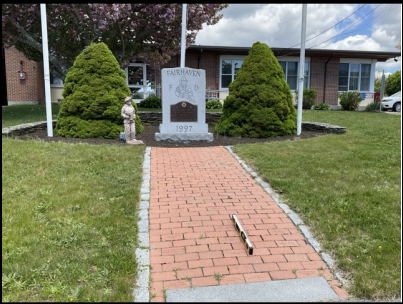
ID	Location	Floor	Room	Element	Type	Photo	Issues	Current Measure	Recommendations	Quantity	Price	Cost Estimation
6	To Memorial	Ext.		Exterior Access Route	Exterior

Running slope > 1:20 (5.00%)	19.9%	Reduce running slope to be no steeper than 1:20 (5.00%).	1	-	-
7	Fire Department Accessible Entrance	Ext.		Exterior Access Route	Exterior

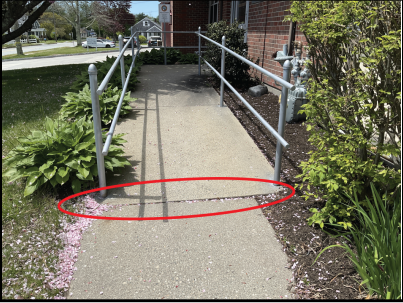
Level changes > 1/4"	0.75"	Alter change in level to be 1/4" high max.	1	-	-
Off-Street Parking Lot or Garage												
8	West Side Police Department Parking	Ext.		Off-Street Parking Lot or Garage	N/A

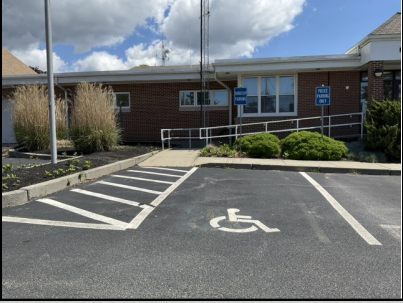
Access aisle not compliant Sign with the International Symbol of Acc. not provided Sign does not have the designation "Van Accessible"	4.6% - -	Level out the access aisle so that slopes do not exceed 2% in all directions. Provide a sign with the International Symbol of Accessibility (ISA) with the bottom of the sign 60" min. above the ground and the top 96" max. above the ground. Add the designation "Van Accessible" to the sign located at the van accessible space. (Cost estimate is for two signs.)	1	- 500 500 1000	\$1000

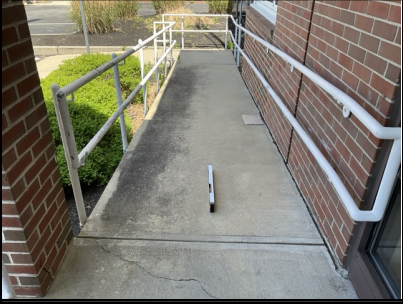
Exterior Ramp												
9	Police Department Main Entrance	Ext.		Exterior Ramp	N/A

Running slope > 1:12 (8.33%) Edge protection < 4" high	8.6% -	Reduce running slope to be no steeper than 1:12 (8.33%). Provide edge protection that prevents the passage of a 4" diameter sphere, where any portion of the sphere is within 4" of the finished floor or ground surface.	1	-	-
10	Fire Department Accessible Entrance	Ext.		Exterior Ramp	N/A

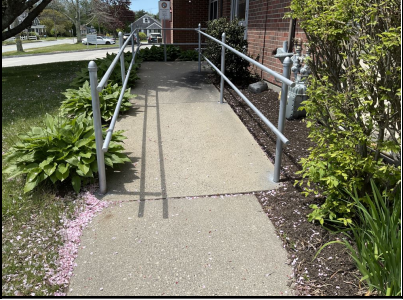
Edge protection < 4" high Handrails do not return properly	- -	Provide edge protection that prevents the passage of a 4" diameter sphere, where any portion of the sphere is within 4" of the finished floor or ground surface. Ensure that handrail extensions return to a wall, guard, or the landing surface, or shall be continuous to the handrail of an adjacent ramp run.	1	-	-

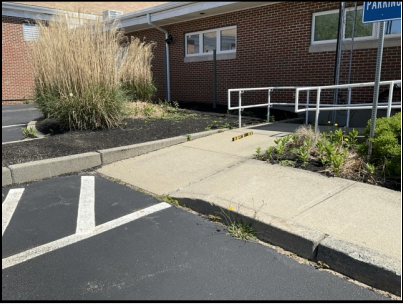
ID	Location	Floor	Room	Element	Type	Photo	Issues	Current Measure	Recommendations	Quantity	Price	Cost Estimation
11	Police Department Main Entrance	Ext.		Exterior Ramp	N/A

Landing has a slope > 1:50 in either direction Handrails are not provided	8.9% -	A landing must be provided at the base of the ramp. Rebuild the ramp to ensure that the slope of the landing does not exceed 1:50 (2.00%). Provide handrails with 1-1/4" to 1-1/2" circular cross sections along all portions of the ramp.	1	-	-
Access to Goods and Services												
Means of Egress												
12	Police Department Main Entrance	1		Means of Egress	N/A

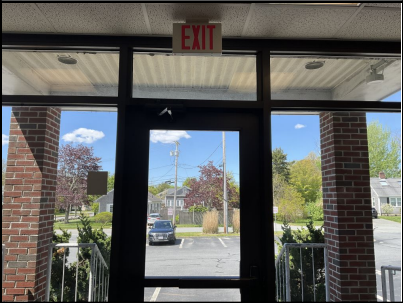
Tactile exit sign not provided Illuminated ISA symbol not provided (MAAB)	-	Ensure that a tactile exit sign with raised characters and braille is provided at the exit door. Mount the sign between 48" - 60" above the finished floor located on the latch side of the door. When the illuminated exit sign is repaired or replaced, provide an illuminated sign with the International Symbol of Accessibility (ISA). Recommendation applies to all accessible exit doors in the police and fire station.	1	250	\$250

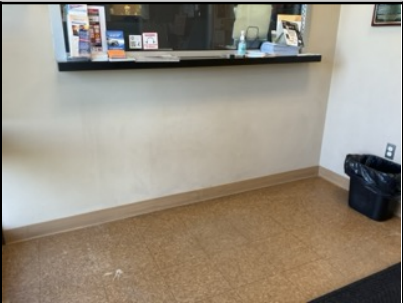
Interior Access Route												
13	Main Police Entrance	1		Interior Access Route	N/A

Obstructed by protruding objects	6.5"	Provide a cane-detectable barrier underneath the open end of the service counter.	1	398	\$398
14	Fire Department Service Counter	1		Interior Access Route	N/A

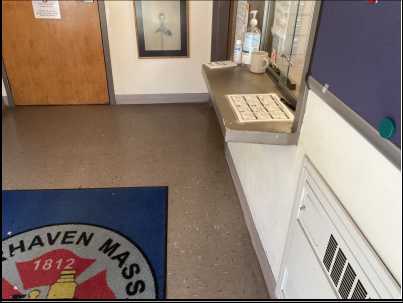
Obstructed by protruding objects	9.5"	Provide a cane-detectable barrier underneath each side of the service counter. Recommendation applies to both service counters within the fire department.	2	398	\$796
15	Police Station Fingerprinting Station	1		Interior Access Route	N/A

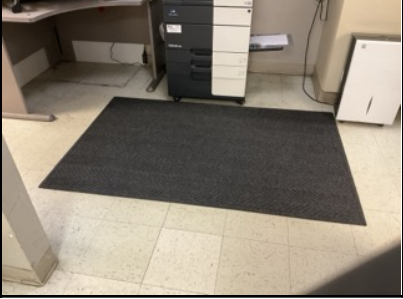
Surface not stable, firm, and slip-resistant	-	Secure mat to floor. Recommendation applies to all mats.	1	Labor	Labor

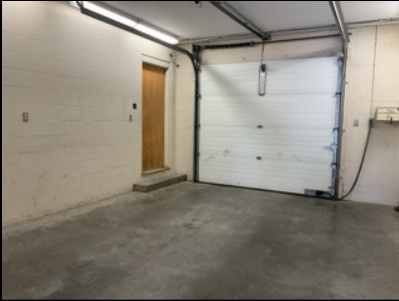
ID	Location	Floor	Room	Element	Type	Photo	Issues	Current Measure	Recommendations	Quantity	Price	Cost Estimation
Doors, Doorways, & Gates												
16	Police Station Route to Holding Cell			Doors, Doorways, & Gates	Circulation

Ensure the accessible route to the holding cell is used when needed.	1	Labor	Labor
17	Police Station Single-User Toilet Room in Meeting Room	1		Doors, Doorways, & Gates	N/A

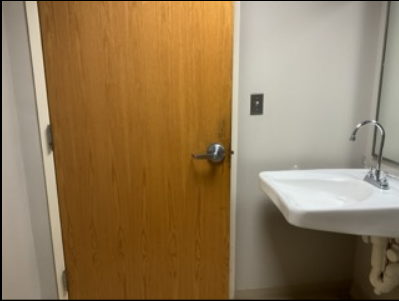
Maneuvering clearance(s) not provided	-	Provide an automatic door opener.	1	6000	\$6000
											6000	
18	Fire Department Meeting Room	1		Doors, Doorways, & Gates	Meeting Room

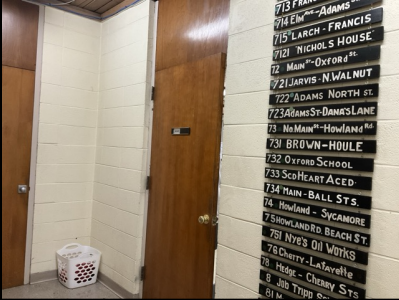
Hardware not compliant		Provide hardware that can be operable with one hand and not require tight grasping, pinching, or twisting of the wrist.	1	750	\$750
											750	
19	Main Police Entrance	1		Doors, Doorways, & Gates	N/A

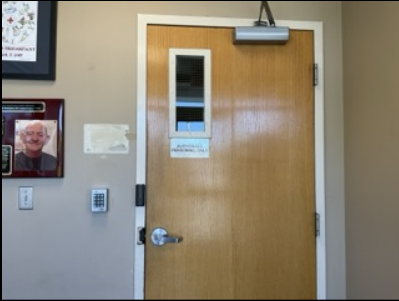
Door requires > 5 lbs. of force to open	9 lbs.	Adjust closers so doors do not require more than 5 pounds of force to open. Recommendation applies to all interior doors with excessive door opening force at the police and fire station. Ensure that door opening pressure is monitored and kept in compliance at all doors by maintenance staff every 6 months.	1	Labor	Labor

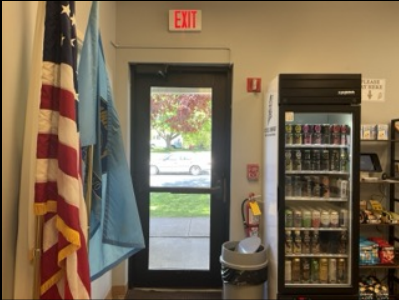
20	Police Station Classroom/ Meeting Room Entrance/ Egress	1		Doors, Doorways, & Gates	N/A

Exterior door requires > 15 lbs. of force to open	16 lbs	Adjust closers so doors do not require more than 15 pounds of force to open.	1	Labor	Labor

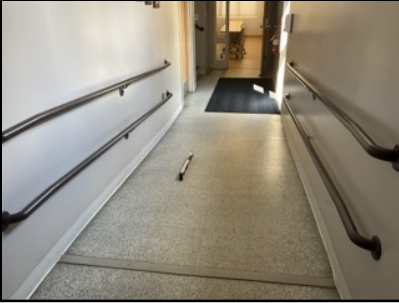
ID	Location	Floor	Room	Element	Type	Photo	Issues	Current Measure	Recommendations	Quantity	Price	Cost Estimation
Ramps												
21	Police Station Path to Accessible Route to Holding Cell	1		Ramps	Interior

Running slope >1:12 (8.33%) Handrails do not extend 12" past top & bottom	8.9% -	Further study will be needed to determine whether it is technically feasible to bring the ramp into full compliance with the ADA Standards. Alter handrails to extend horizontally from the landing for 12" min. beyond the bottom of ramp runs.	2	-	-
Signage												
22	Police Station Captain's Office	1		Signage	Designation

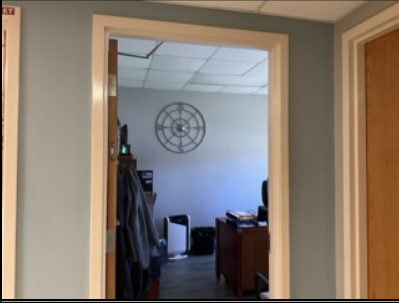
Tactile signage is not provided	-	Locate compliant signage with raised characters and braille alongside the door on the latch side.	1	250	\$250
											250	
23	Police Station Holding Cell Toilet Room	1		Signage	Designation

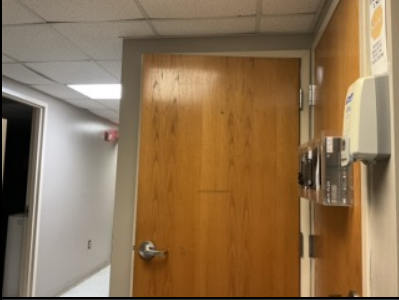
Signage is not provided	-	Locate compliant signage with raised characters and braille alongside the door on the latch side.	1	250	\$250

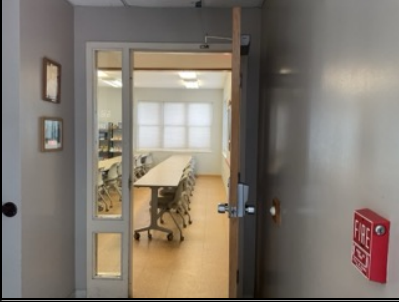
250	
24	Police Station Classroom/ Meeting Room	1		Signage	Designation

Signage is not provided	-	Locate compliant signage with raised characters and braille alongside the door on the latch side.	1	250	\$250
											250	
25	Fire Department Single-User Toilet Room	1		Signage	Designation

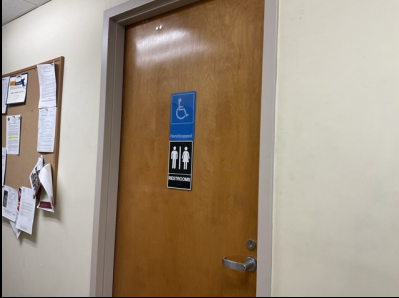
Location of tactile sign not compliant	-	Locate sign alongside the door on the latch side.	1	Labor	Labor

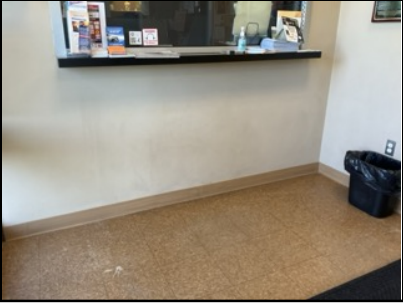
ID	Location	Floor	Room	Element	Type	Photo	Issues	Current Measure	Recommendations	Quantity	Price	Cost Estimation
Service Counter												
26	Main Police Entrance	1		Service Counter	N/A

Counter > 36" high	44"	Provide a counter that is 36" max. above the ground or finished floor.	1	1144	\$1144
Operable Parts / Reach Range												
27	Main Police Entrance	1		Operable Parts / Reach Range	Pamphlets

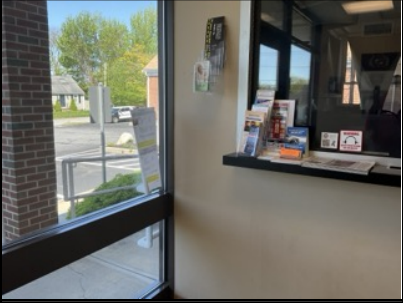
Reach < 15" or > 48"(forward/side approach)	62"	Relocate brochures to be between 15"- 48" above the finished floor.	1	Labor	Labor
28	Police Station Classroom/ Meeting Room	1		Operable Parts / Reach Range	Emergency Telephone

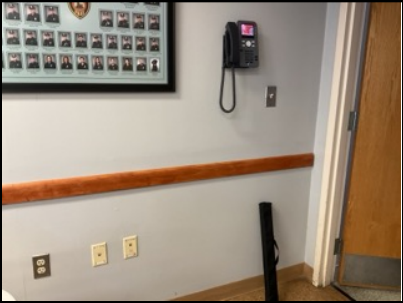
Reach < 15" or > 48"(forward/side approach)	61"	Relocate emergency phone so that controls are between 15"- 48" above the finished floor.	1	500	\$500
29	Police Station Classroom/ Meeting Room	1		Operable Parts / Reach Range	N/A

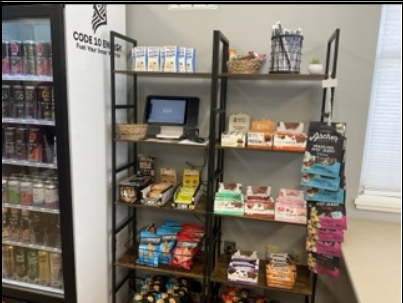
Reach < 15" or > 48"(forward/side approach)	54.5"	Relocate payment screen to be between 15"- 48" above the finished floor.	1	Labor	Labor

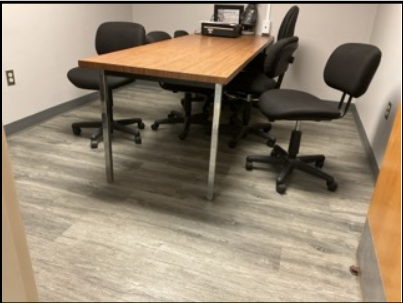
Dining or Work Surfaces												
30	Police Station Interview Room	1		Dining or Work Surfaces	Work Surface

Knee or toe clearance not provided	25.25"	Provide at least one work surface with 27" min. high knee and toe clearance.	1	1100	\$1100

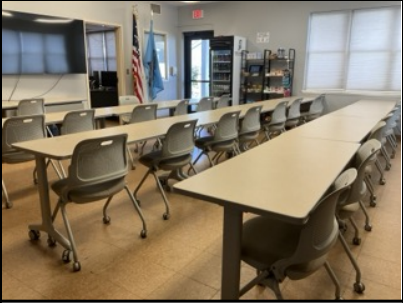
ID	Location	Floor	Room	Element	Type	Photo	Issues	Current Measure	Recommendations	Quantity	Price	Cost Estimation
Assembly Area												
31	Police Station Classroom/ Meeting Room	1		Assembly Area	N/A

Assistive listening devices not provided	-	If audible communication is integral to the use of the space, provide an assistive listening system. Cost estimation is for an assistive listening system for a seating capacity of 50 people.	1	1578	\$1578
											1578	
32	Fire Department Meeting Room	1		Assembly Area	N/A

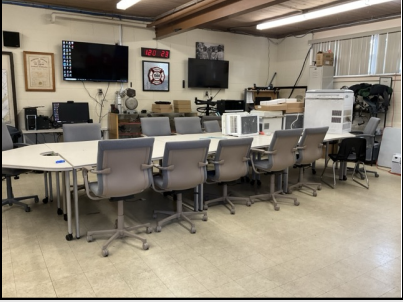
Assistive listening devices not provided	-	If audible communication is integral to the use of the space, provide an assistive listening system. Cost estimation is for an assistive listening system for a seating capacity of 50 people.	1	1578	\$1578
											1578	
Toilet & Bathing Rooms												
Overall Access												
33	Police Station Holding Cell Toilet Room	1		Overall Access	N/A

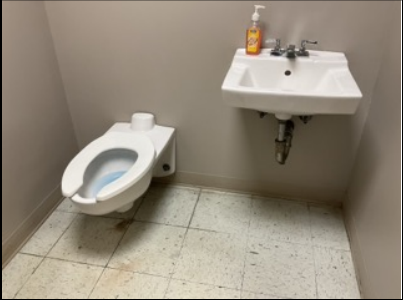
Turning space not provided Accessible plumbing fixtures or stalls not provided	- -	Provide an accessible single-user toilet room for detainees.	1	31985	\$31985

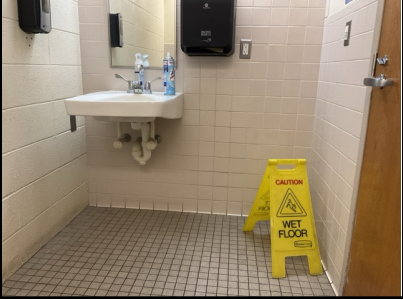
31985	
Lavatory												
34	Fire Department Single-User Toilet Room	1		Lavatory	N/A

Toe or knee clearances not provided	25"	Provide at least one lavatory with knee and toe clearance positioned for a forward approach.	1	2192	\$2192
											2192

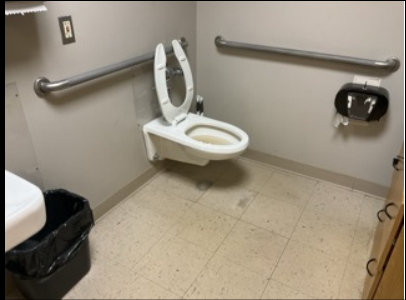
ID	Location	Floor	Room	Element	Type	Photo	Issues	Current Measure	Recommendations	Quantity	Price	Cost Estimation
Single-User Toilet												
35	Police Station Single-User Toilet Room in Meeting Room	1		Single-User Toilet	N/A

Side grab bar < 54" from back wall	49.5"	Provide a side wall grab bar that is 42" long min. located 12" max. from the rear wall.	1	500	\$500
											500	
Best Practice												
36	Police Department Main Entrance	Ext.

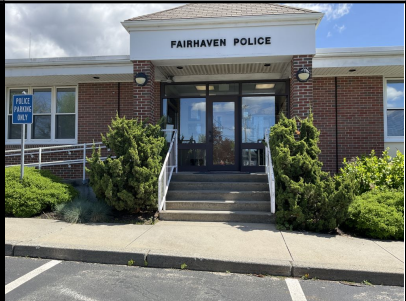
Recommend providing visual contrast on the stair treads.	1	-	-
