# Southeastern Massachusetts Education Collaborative

## Town of Fairhaven ADA Transition Plan

December 2024

Institute for Human Centered Design

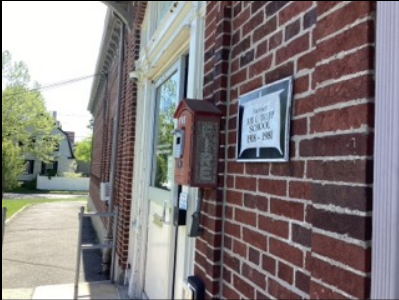
ID	Location	Floor	Room	Element	Type	Photo	Issues	Current Measure	Recommendations	Quantity	Price	Cost Estimation
Approach and Entrance												
Exterior Access Route												
1	Alarm Box by South Main Entrance/ Egress	Ext.		Exterior Access Route	Walkway

Obstructed by protruding objects	6"	Provide a cane-detectable barrier underneath the alarm box. Barriers must have leading edges no higher than 27" so that they are within cane sweep. Barriers can include fixed planters, benches, and guardrails.	1	398	\$398
											398	
2	South Main Entrance/ Egress	Ext.		Exterior Access Route	Walkway

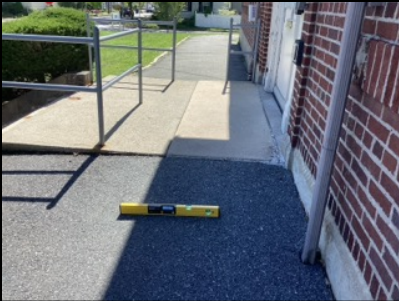
Cross slope > 1:50 (2.00%)	3.3%	Reduce cross slope to be no steeper than 1:50 (2.00%).	1	-	-
3	South Main Entrance/ Egress	Ext.		Exterior Access Route	Walkway

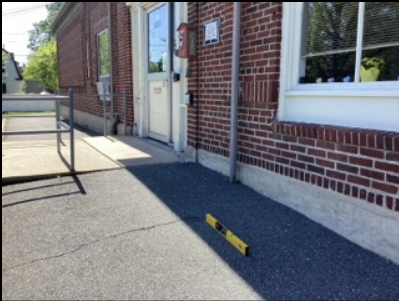
Running slope > 1:20 (5.00%)	7.3%	Reduce running slope to be no steeper than 1:20 (5.00%).	1	-	-
4	North Entrance/ Egress	Ext.		Exterior Access Route	Walkway

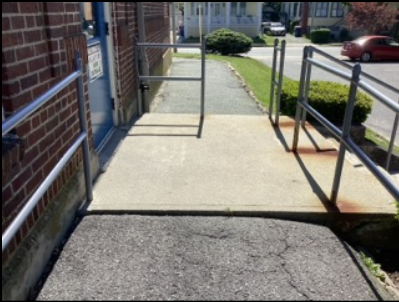
Level changes > 1/4"	2"	Alter change in level to be 1/4" high max.	1	-	-

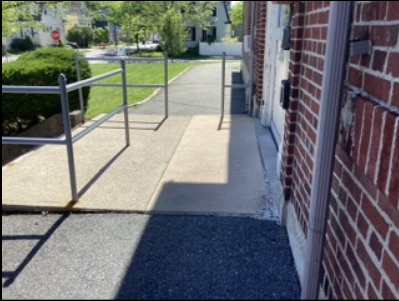
5	South Main Entrance/ Egress	Ext.		Exterior Access Route	Walkway

Level changes > 1/4" Route not maintained in operable working condition	1" -	Alter change in level to be 1/4" high max. Resurface cracked openings in the concrete to ensure the accessible route is maintained in operable working condition.	1	-	-

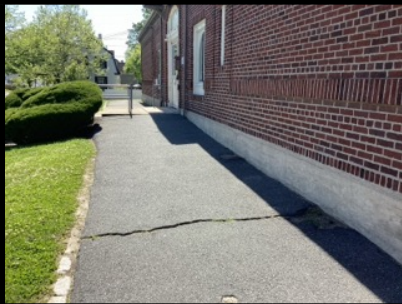
ID	Location	Floor	Room	Element	Type	Photo	Issues	Current Measure	Recommendations	Quantity	Price	Cost Estimation
6	Route to South Main Entrance/ Egress	Ext.		Exterior Access Route	Walkway

Surface openings > 1/2" Route not maintained in operable working condition	2"	Repair cracked openings in the asphalt to ensure that the surface opening is no greater than 1/2" max. and that the accessible route is maintained in operable working condition.	2	-	-
Off-Street Parking Lot or Garage												
7	Accessible Van Parking Space	Ext.		Off-Street Parking Lot or Garage	Visitor

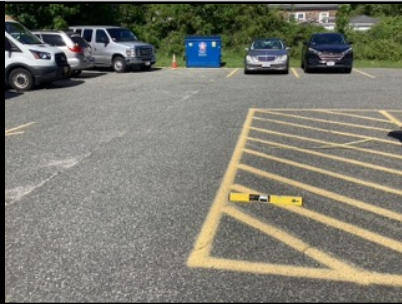
Total # of designated car accessible parking spaces Running or cross slope at space > 1:50 (2.00%) Sign with the International Symbol of Acc. not provided Sign does not have the designation "Van Accessible"	0 2.7% - -	Provide 2 accessible car parking spaces with a marked access aisle and sign. Reduce slope to (2.00%) max. in all directions at the accessible parking spaces and access aisles. Provide a sign with the International Symbol of Accessibility (ISA). Include the designation "Van Accessible" at the van accessible parking space. (Cost is \$1,000 for two ISA signs and \$500 for a "Van Accessible" sign.)	1	1000 - 500  <b>1500</b>	\$1500

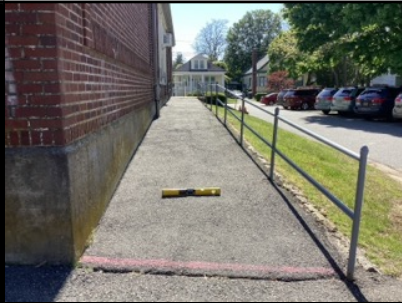
Exterior Ramp												
8	Route to North Entrance/ Egress	Ext.		Exterior Ramp	N/A

Cross slope of ramp > 1:50 (2.00%) Handrails do not extend 12" past top & bottom Edge protection < 4" high Handrails not provided on both sides	3.6% - - -	Reduce cross slope to be no steeper than 1:50 (2.00%). Alter handrails to extend horizontally above the landing for 12" min. beyond the top and bottom of ramp runs. Provide edge protection on the open side that prevents the passage of a 4" diameter sphere, where any portion of the sphere is within 4" of the finished floor or ground surface. Ensure compliant handrails are provided on both sides.	1	-	-
Exterior Stair												
9	Stairs To North Entrance/ Egress	Ext.		Exterior Stair	N/A

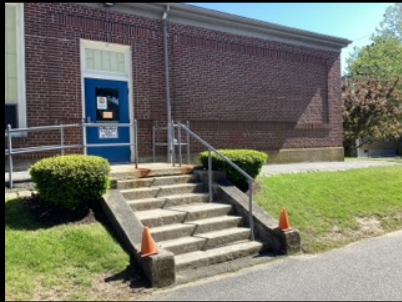
Handrails do not extend 12" from stair at top Handrail not provided on both sides Tread widths or riser heights are not uniform	-	Top: Ensure handrails extend horizontally above the landing for 12" min. beginning above the first riser nosing. Provide a handrail on each side. Further study will be needed to determine whether it is technically feasible to bring the stair risers into full compliance with the ADA Standards, however stairs may be hazardous for users.	1	-	-

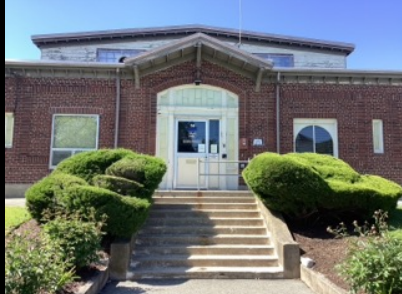
10	South Main Entrance/ Egress	Ext.		Exterior Stair	N/A

Handrail not provided on both sides	-	Provide a handrail on each side.	1	-	-

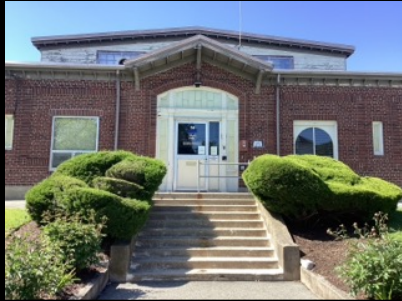
ID	Location	Floor	Room	Element	Type	Photo	Issues	Current Measure	Recommendations	Quantity	Price	Cost Estimation
Entrance												
11	South Main Entrance/ Egress and North Secondary Entrance/ Egress	Ext.		Entrance	Main Entrance

International Symbol of Accessibility not provided	-	Provide a sign with the International Symbol of Accessibility (ISA).	2	450	\$900
											900	
Access to Goods and Services												
Means of Egress												
12	South Main Entrance/ Egress and North Secondary Entrance/ Egress	1		Means of Egress	N/A

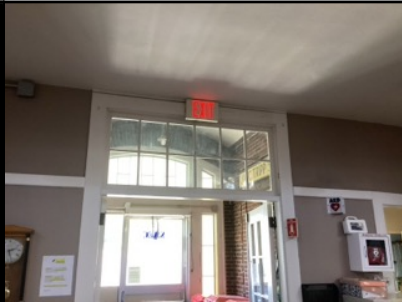
Tactile exit sign not provided Illuminated ISA symbol not provided (MAAB)	- -	Ensure that a tactile exit sign with raised characters and braille is provided at the exit door. Mount the sign between 48"- 60" above the finished floor located on the right side of the right handed door. When the illuminated exit sign is repaired or replaced, provide an illuminated sign with the International Symbol of Accessibility (ISA).	2	250 Labor	\$500

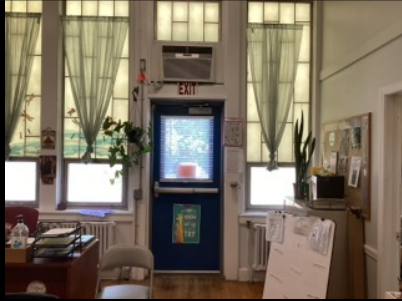
500	
13	Classroom 1	1		Means of Egress	N/A

Tactile exit sign not provided Directional sign to accessible emergency exit not provided		Ensure that a tactile exit sign with raised characters and braille is provided at the exit door. Mount the sign between 48"- 60" above the finished floor located on the latch side of the door. Provide a directional sign indicating the location of the nearest accessible emergency exit.	1	250 250	\$500
											500	
14	Kitchen/West Egress	1		Means of Egress	N/A

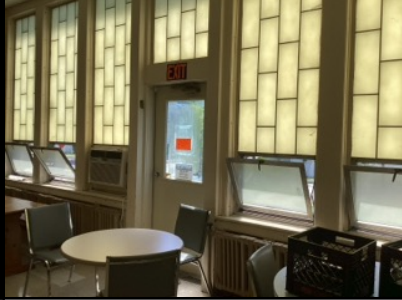
Tactile exit sign not provided Directional sign to accessible emergency exit not provided	- -	Ensure that a tactile exit sign with raised characters and braille is provided at the exit door. Mount the sign between 48"- 60" above the finished floor located on the latch side of the door. Provide a directional sign indicating the location of the nearest accessible emergency exit.	1	250 250	\$500

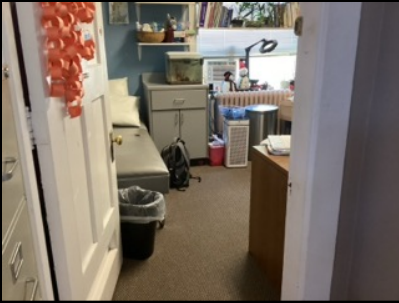
ID	Location	Floor	Room	Element	Type	Photo	Issues	Current Measure	Recommendations	Quantity	Price	Cost Estimation
Interior Access Route												
15	Nurse's Office	1		Interior Access Route	N/A

Route < 36" wide	24"	Relocate furniture to ensure that a clear width of 36" min. is maintained at the accessible route from the entrance door.	1	Labor	Labor
16	Classroom 2	1		Interior Access Route	N/A

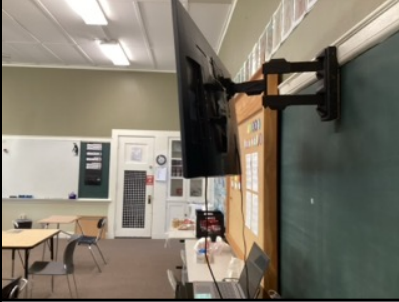
Obstructed by protruding objects	61"	Ensure the television is retracted to be as close to the wall as possible. If the television still protrudes more than 4" from the wall when fully retracted, provide a cane-detectable barrier 27" max. above the finished floor underneath the television.	1	398	\$398
17	Men's Multi-User Toilet Room	1		Interior Access Route	N/A

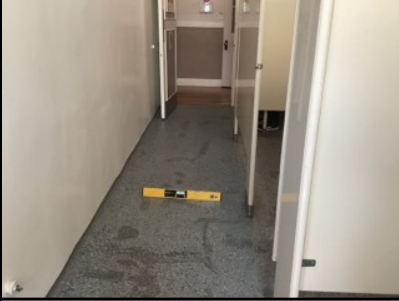
Cross slope > 1:50 (2.00%)	4.1%	Further study will be needed to determine whether it is technically feasible to bring the route into full compliance with the ADA Standards.	1	-	-

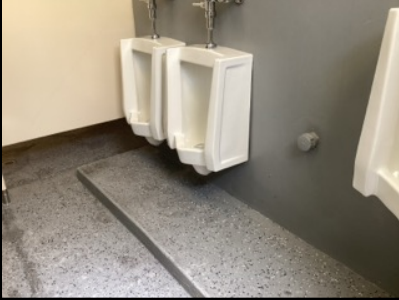
18	Men's Multi-User Toilet Room	1		Interior Access Route	N/A

Level changes > 1/4" Accessible route not provided	4" -	Alter change in level to be 1/4" high max. Provide an accessible route. Provide a level compliant accessible route to at least one urinal. When finished, ensure at least one urinal has a bottom opening no higher than 17" above the finished floor.	1	-	-
Doors, Doorways, & Gates												
19	Nurse's Office	1		Doors, Doorways, & Gates	Office

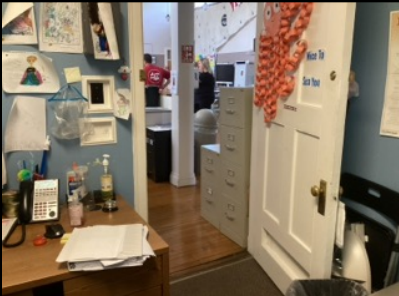
Maneuvering clearance(s) not provided	8"	Relocate the desk to maintain 18" min. pull side maneuvering clearance on the latch side of the door.	1	Labor	Labor

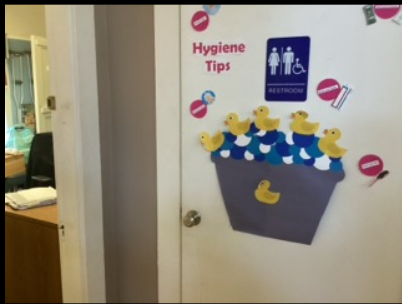
ID	Location	Floor	Room	Element	Type	Photo	Issues	Current Measure	Recommendations	Quantity	Price	Cost Estimation
20	All-Gender, Single-User Toilet Room/ Shower in Nurse's Office	1		Doors, Doorways, & Gates	Toilet Room

Maneuvering clearance(s) not provided Hardware not compliant	16" -	If this toilet room is used by students or other members of the public provide an automatic door opener. Provide hardware that can be operable with one hand and not require tight grasping, pinching, or twisting of the wrist.	1	6000 750	\$6750
											<b>6750</b>	
21	Kitchen/West Egress	1		Doors, Doorways, & Gates	Circulation

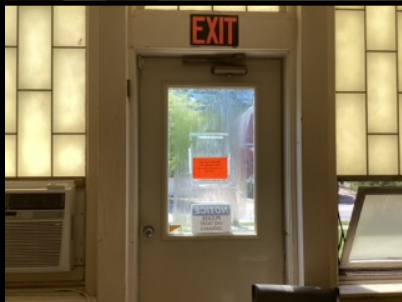
Hardware not compliant	-	Provide hardware that can be operable with one hand and not require tight grasping, pinching, or twisting of the wrist.	1	750	\$750
											<b>750</b>	
22	Social Worker's Office	1		Doors, Doorways, & Gates	Office

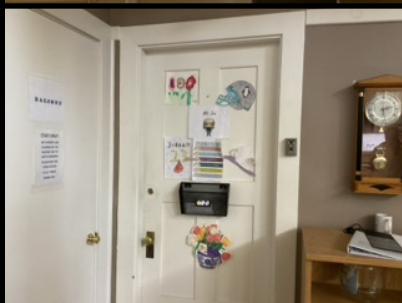
Hardware not compliant	-	Provide hardware that can be operable with one hand and not require tight grasping, pinching, or twisting of the wrist.	1	750	\$750

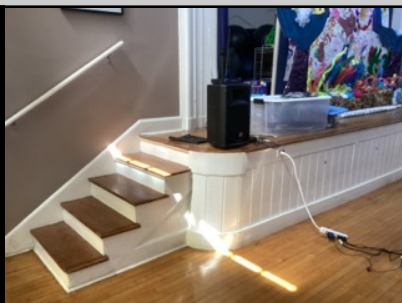
Handrail not provided on both sides Handrails do not extend 12" from stairs at top	- -	Provide handrail on one side. Top: Ensure handrails extend horizontally above the landing for 12" min. beginning above the first riser nosing.	1	-	-
<b>Signage</b>												
24	Social Worker's Office	1		Signage	Designation

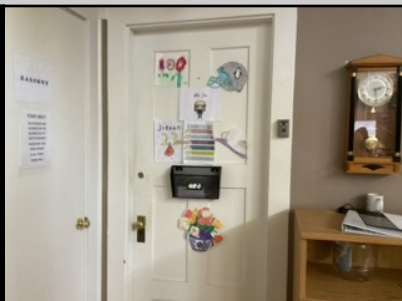
Signage is not provided		Locate compliant signage with raised characters and braille alongside the door on the latch side. Ensure there is 18" x 18" min. clear floor space at the accessible sign.	1	250	\$250
											<b>250</b>

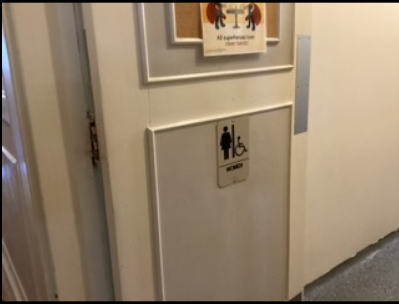
ID	Location	Floor	Room	Element	Type	Photo	Issues	Current Measure	Recommendations	Quantity	Price	Cost Estimation
25	Men's and Women's Multi-User Toilet Rooms	1		Signage	Designation

Raised characters < 48" or > 60" above ground	-	Mount the sign so that the baseline of the lowest tactile character is 48" min. above finished floor and the baseline of the highest tactile character is 60" max. above the finished floor.	2	Labor	Labor
26	All-Gender, Single-User Toilet Room/ Shower in Nurse's Office	1		Signage	Designation

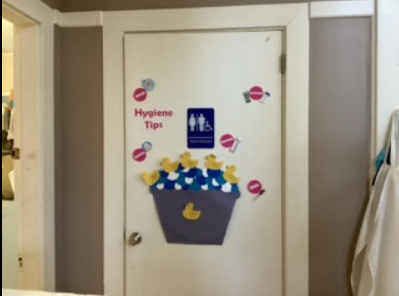
Location of tactile sign not compliant	-	Locate sign alongside the door on the latch side. Where there is no wall space at the latch side of a single door, locate sign on the nearest adjacent wall.	1	Labor	Labor
Operable Parts / Reach Range												
27	Kitchen	1		Operable Parts / Reach Range	Paper Towel Dispensar

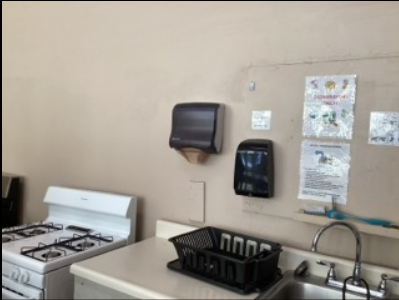
Side reach > 54"	58"	Relocate the paper towel dispenser so that controls are between 15" - 48" above the finished floor.	1	500	\$500

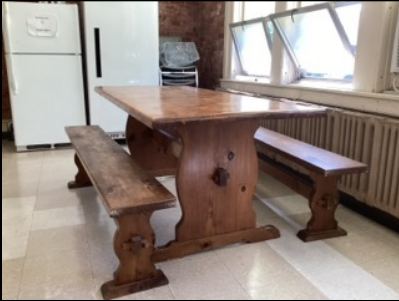
Dining or Work Surfaces												
28	Kitchen	1		Dining or Work Surfaces	Dining Surface

Knee clearance less than 19" deep	13"	Provide at least one dining surface with knee clearance that is 19" deep min.	1	1100	\$1100
Assembly Area												
29	Main Assembly Hall - Stage	1		Assembly Area	N/A

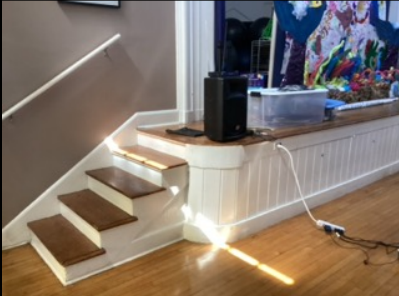
Accessible route to stage not provided	-	If this stage is used by students or other members of the public, provide an interior lift to the stage so that the stage is on an accessible route.	1	70000	\$70000

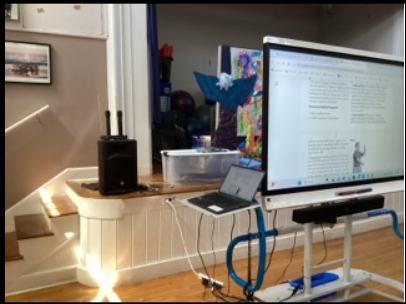
ID	Location	Floor	Room	Element	Type	Photo	Issues	Current Measure	Recommendations	Quantity	Price	Cost Estimation
30	Main Assembly Hall	1		Assembly Area	N/A

Assistive listening devices not provided	-	If audible communication is integral to the use of the space, provide an assistive listening system. (Cost is for an assistive listening device with a capacity of 50 or less.)	1	1578	\$1578
Picnic Tables												
31	Picnic Table by East Side of Parking Lot	Ext.		Picnic Tables	N/A

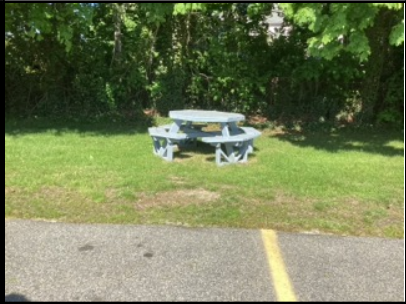
At least 5% accessible spaces not provided Picnic table not on an accessible route		Ensure that at least 5% (minimum one) of picnic tables are accessible. Ensure that the picnic table is connected to an accessible route.	1	1400	\$1400
Kitchens and Kitchenettes												
32	Kitchen	1		Kitchens and Kitchenettes	730

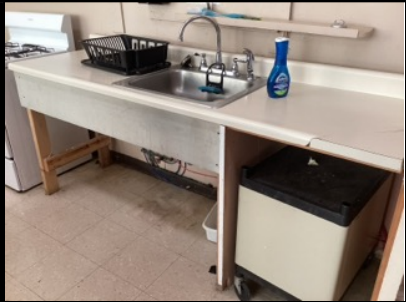
Knee/toe clearance not provided at sink Sink > 34" high	26" 36"	If this sink is used by students or other members of the public ensure there is a 27" min. knee clearance positioned for a forward approach. Relocate sink with the front of the rim or counter no higher than 34" above the finished floor. (Cost of \$400 is for a 8" deep drop-sink sink, and cost of \$3,094 is to lower the counter and sink).	1	400 3094	\$3494

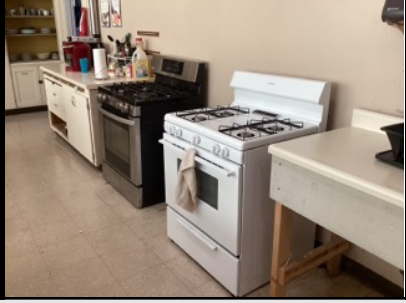
33	Kitchen	1		Kitchens and Kitchenettes	N/A

Knee/toe clearance not provided at cooktop Wall oven type not provided	- -	If the stove and oven are used by students or other members of the public, provide a cooktop with knee and toe clearance positioned for a forward approach, with controls that do not require reaching across burners. Ensure that a wall type oven is provided.	1	1000 1300	\$2300
Toilet & Bathing Rooms

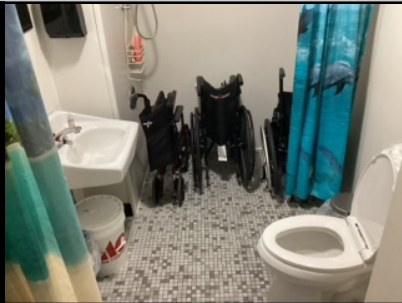
ID	Location	Floor	Room	Element	Type	Photo	Issues	Current Measure	Recommendations	Quantity	Price	Cost Estimation
Overall Access												
34	All-Gender, Single-User Toilet Room/ Shower in Nurse's Office	1		Overall Access	Toilet Room

Turning space not provided Accessible plumbing fixtures or stalls not provided	50" -	If students or other members of the public use this toilet room, provide an accessible all-gender single-user toilet room. The dimensions of the toilet room are 71" deep by 50" wide.	1	31985	\$31985
											31985	
Lavatory												
35	Men's and Women's Multi-User Toilet Rooms	1		Lavatory	N/A

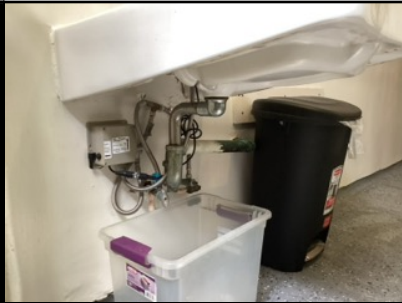
Clear floor space not provided at lavatory Plumbing underneath is exposed Mirror above lavatory w/reflective surface > 40"	- - 43"	Relocate the stored items underneath the lavatory to provide 30" min. by 48" min. clear floor space positioned for a forward approach. Insulate or otherwise configure pipes to prevent contact for at least one lavatory. Lower mirror so that the bottom surface is at 40" max. above the finished floor.	2	Labor 150 500	\$1300

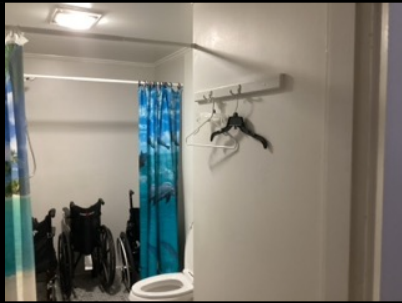
Hook located > 54" high	67"	Provide an additional coat hook no higher than 48" above the finished floor. <b>Note:</b> IHCD team was told that students and members of the public do not use the shower. If students or other members the public in fact do use this shower, ensure a compliant accessible shower is provided.	1	75	\$75
											75	
Toilet Compartment												
37	Men's and Women's Multi-User Toilet Rooms	1		Toilet Compartment	Accessible Compartment

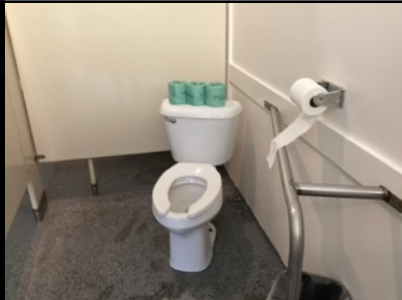
Rear grab bar not provided Noncompliant toilet paper dispenser Clearance at toilet < 60" clear width Centerline < or > 18" (MAAB) Side grab bar < 54" from back wall	- - 53" 22" 34"	Provide one grab bar on the rear wall. Relocate toilet paper so that it is 24" min. high, located under the grab bar, and between 7" and 9" from the front of the toilet. Provide a wheelchair accessible compartment that is 60" wide min. Relocate toilet so the centerline is 18" from the side wall. Provide a side wall grab bar that is 42" long min. located 12" max. from the rear wall.	2	- - 8037	\$16074

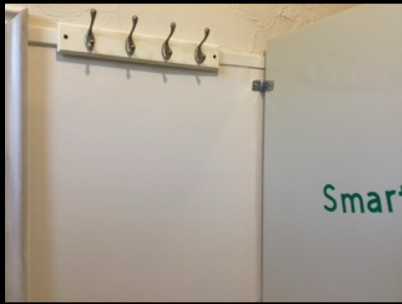
ID	Location	Floor	Room	Element	Type	Photo	Issues	Current Measure	Recommendations	Quantity	Price	Cost Estimation
38	Women's Multi-User Toilet Room	1		Toilet Compartment	Coat Hook

Coat hook > 48" (2010 ADA)	66"	Locate the coat hook no higher than 48" above the finished floor.	1	75	\$75
											75	
39	Men's and Women's Multi-User Toilet Rooms	1		Toilet Compartment	Accessible Compartment

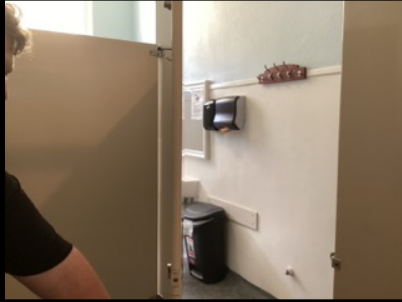
Door has noncompliant hardware Coat hook > 48" (2010 ADA) Door pull not provided	- 67" -	Provide a door lock that can be operable with one hand and not require tight grasping, pinching, or twisting of the wrist. Provide an additional coat hook no higher than 48" above the finished floor. Provide a door pull on each side of the door between 34" to 48" above the finished floor that does not require tight grasping, pinching or twisting of the wrist.	2	70 75 140	\$570
											570	
Best Practice

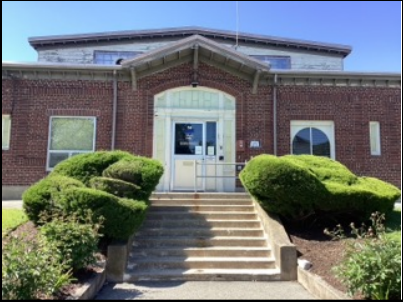
ID	Location	Floor	Room	Element	Type	Photo	Issues	Current Measure	Recommendations	Quantity	Price	Cost Estimation
Stairways												
42	South Main Entrance/ Egress	Ext.		Stairways

Recommend providing a solid and continuous stripe applied to the horizontal leading edge of each exterior stair tread so that each tread is readily apparent when viewed in descent at this exterior stair. Recommendation applies to all interior and exterior stairs that lack visual contrast on the stair nosings.	1	-	-
