# Fairhaven Town Hall

## Town of Fairhaven ADA Transition Plan

February 2025

Institute for Human Centered Design

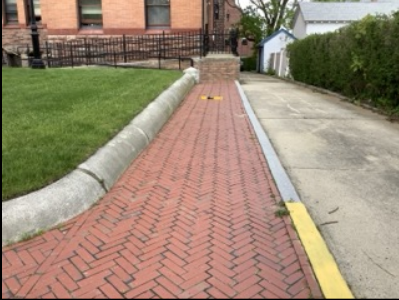
ID	Location	Floor	Room	Element	Type	Photo	Issues	Current Measure	Recommendations	Quantity	Price	Cost Estimation
Approach and Entrance												
Exterior Access Route												
1	Walkway From Walnut Street Towards Exterior Ramp	Ext.		Exterior Access Route	Walkway

Cross slope > 1:50 (2.00%)	3.7%	Reduce cross slope to be no steeper than 1:50 (2.00%).	1	-	-
2	Southwest Side - Near Office	Ext.		Exterior Access Route	Walkway

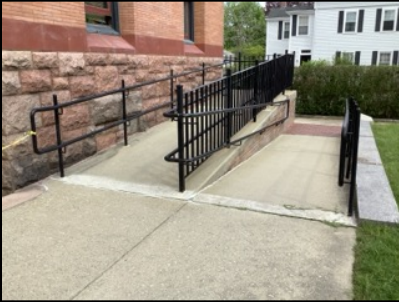
ID	Location	Floor	Room	Element	Type	Photo	Issues	Current Measure	Recommendations	Quantity	Price	Cost Estimation
6	Exterior Ramp Northeast Side	Ext.		Exterior Access Route

Level changes > 1/4"	0.5"	Alter change in level to be 1/4" high max. or 1/2" max. beveled.	1	-	-
7	Southeast Side	Ext.		Exterior Access Route	Walkway

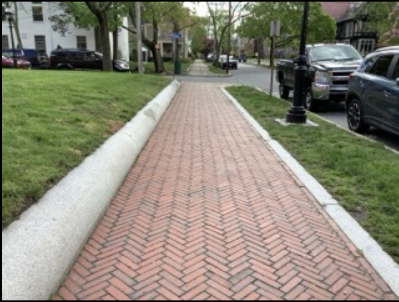
Surface is not stable, firm, and slip-resistant	-	Surface can be slippery in some conditions such as when there is snow, ice or rain. Recommend applying ice melt or other treatments that can reduce the slipperiness of the surface as needed. <b>Note:</b> Recommendation applies to all areas with a comparable surface.	1	-	-

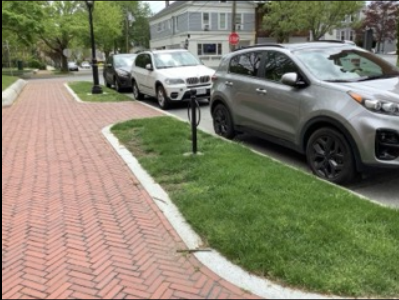
Accessible route not provided	-	Ensure an accessible route is provided to the bike rack, or relocate the bike rack to an accessible route.	1	-	-

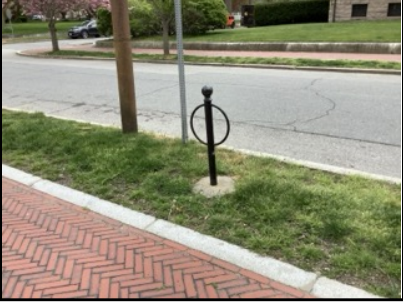
ID	Location	Floor	Room	Element	Type	Photo	Issues	Current Measure	Recommendations	Quantity	Price	Cost Estimation
11	South Side - Center Street	Ext.		Exterior Access Route

Accessible route not provided	-	Ensure an accessible route is provided to the bike rack, or relocate the bike rack to an accessible route.	1	-	-
Curb Ramp												
12	South Side - Intersection at Center Street and William Street	Ext.		Curb Ramp	Perpendicular

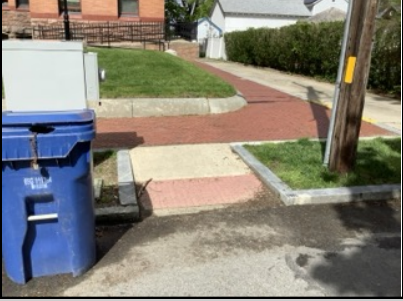
Does not prevent accumulation of water	-	Repair curb ramp to prevent accumulation of water.	1	-	-
Exterior Ramp												
14	Exterior Ramp Northeast Side	Ext.		Exterior Ramp	N/A

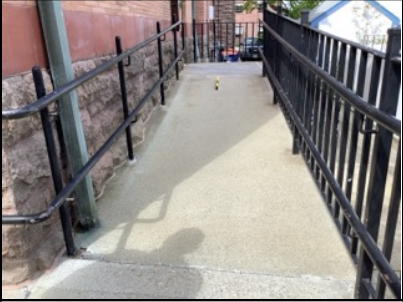
Running slope > 1:12 (8.33%) Handrails do not extend 12" past top & bottom Handrails do not return properly	8.9%, 11.3% 10.5" -	Reduce running slope to be no steeper than 1:12 (8.33%). Alter handrails to extend horizontally above the landing for 12" min. beyond the top and bottom of ramp runs. Ensure that handrail extensions return to a wall, guard, or the landing surface, or shall be continuous to the handrail of an adjacent ramp run.	1	-	-

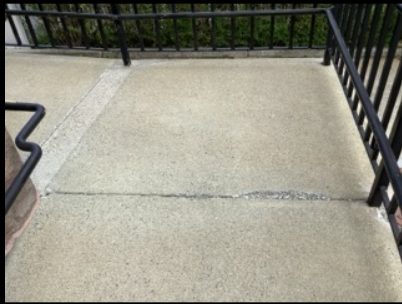
ID	Location	Floor	Room	Element	Type	Photo	Issues	Current Measure	Recommendations	Quantity	Price	Cost Estimation
16	Exterior Ramp Northeast Side	Ext.		Exterior Ramp	N/A

Surface openings > 1/2"	-	Ensure the surface opening is no greater than 1/2" max.	1	-	-
17	Exterior Ramp Northeast Side	Ext.		Exterior Ramp	N/A

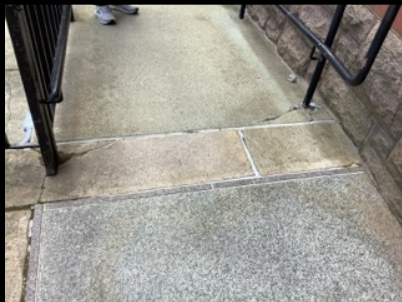
Surface is not stable, firm, and slip-resistant	-	Repair surface at top of ramp to ensure it is stable, firm, and slip-resistant.	1	-	-
18	Exterior Ramp Northeast Side	Ext.		Exterior Ramp	N/A

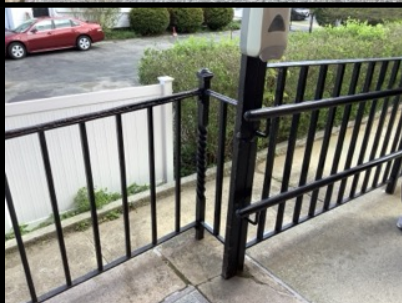
Handrails do not return properly	-	Ensure that handrail extensions return to a wall, guard, or the landing surface, or shall be continuous to the handrail of an adjacent ramp run.	1	-	-
Exterior Stair												
19	Main Entrance (South Side)	Ext.		Exterior Stair	N/A

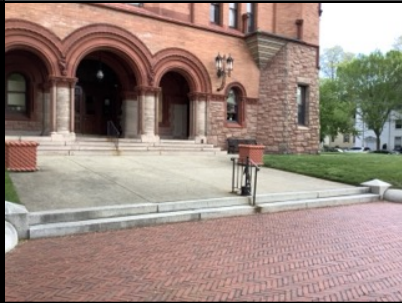
Handrail height < 34" or > 38" Handrails do not extend 12" from stair at top Bottom handrail extends < 12" + one tread Cross section of handrail is not compliant Handrail not provided on both sides Surface not stable, firm, and slip-resistant	32" - - - - -	Alter so the handrails are 34"- 38" high above the ground. Bottom: Ensure that the sloped bottom extension extends one tread depth min. beyond last riser nosing in same direction as stair flight. Provide handrails with 1 1/4" - 2" circular cross sections. Provide a handrail on each side. Repair the surface.	1	-	-

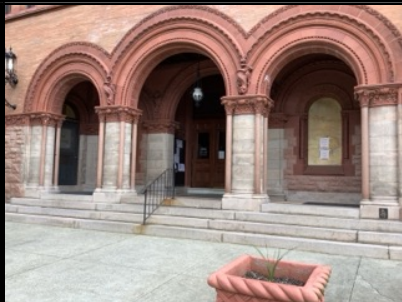
Handrail height < 34" or > 38" Handrails do not extend 12" from stair at top Bottom handrail extends < 12" + one tread Cross section of handrail is not compliant Handrail not provided on both sides	30" - - - -	Alter so the handrails are 34"- 38" high above the ground. Top: Ensure handrails extend horizontally above the landing for 12" min. beginning above the first riser nosing. Bottom: Ensure that the sloped bottom extension extends one tread depth min. beyond last riser nosing in same direction as stair flight. Provide handrails with 1 1/4" - 2" circular cross sections. Provide a handrail on each side.	1	-	-

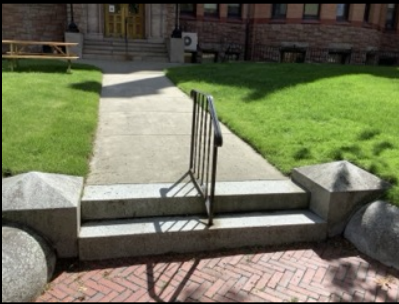
ID	Location	Floor	Room	Element	Type	Photo	Issues	Current Measure	Recommendations	Quantity	Price	Cost Estimation
21	Northwest - Near Elevator Entry	Ext.		Exterior Stair

Handrail height < 34" or > 38" Bottom handrail extends < 12" + one tread Cross section of handrail is not compliant Handrail not provided on both sides Surface not stable, firm, and slip-resistant	29.75" - - - -	Alter so the handrails are 34"- 38" high above the ground. Bottom: Ensure that the sloped bottom extension extends one tread depth min. beyond last riser nosing in same direction as stair flight. Provide handrails with 1 1/4" - 2" circular cross sections. Provide a handrail on each side. Repair the surface.	1	-	-
22	East Egress From Lower Level Office	Ext.		Exterior Stair	N/A

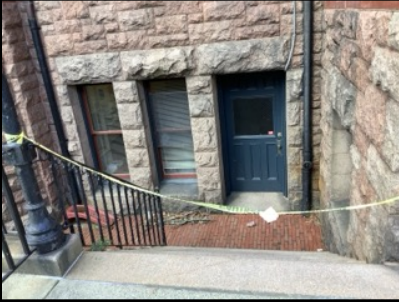
Handrails do not extend 12" from stair at top Bottom handrail extends < 12" + one tread Cross section of handrail is not compliant Handrail not provided on both sides Risers > 7" high	- - - - 8.25"	Top: Ensure handrails extend horizontally above the landing for 12" min. Bottom: Ensure that the sloped bottom extension extends one tread depth min. beyond last riser nosing. Provide handrails with 1 1/4" - 2" circular cross sections. Provide a handrail on each side. Further study will be needed to determine whether it is technically feasible to bring the stair risers into compliance with the ADA Standards.	1	-	-

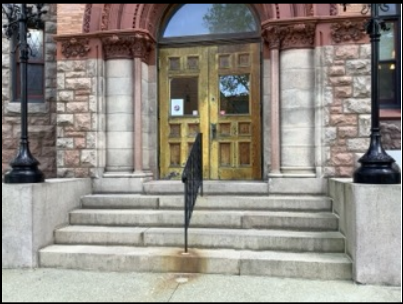
ID	Location	Floor	Room	Element	Type	Photo	Issues	Current Measure	Recommendations	Quantity	Price	Cost Estimation
26	Entrance to Elevator - Northwest Side	Ext.		Exterior Stair	N/A

Handrails do not extend 12" from stair at top Bottom handrail extends < 12" + one tread Handrail not provided on both sides Surface not stable, firm, and slip-resistant	<ul style="list-style-type: none"><li>-</li><li>-</li><li>-</li><li>-</li></ul>	Top: Ensure handrails extend horizontally above the landing for 12" min. beginning above the first riser nosing. Bottom: Ensure that the sloped bottom extension extends one tread depth min. beyond last riser nosing in same direction as stair flight. Provide a handrail on each side. Repair the surface.	1	-	-
27	Northwest Side	Ext.		Exterior Stair	N/A

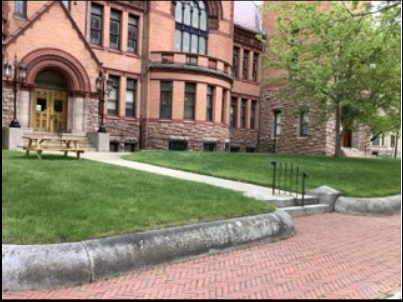
Bottom handrail extends < 12" + one tread Handrail not provided on both sides	<ul style="list-style-type: none"><li>-</li><li>-</li></ul>	Bottom: Ensure that the sloped bottom extension extends one tread depth min. beyond last riser nosing in same direction as stair flight. Provide a handrail on each side.	1	-	-

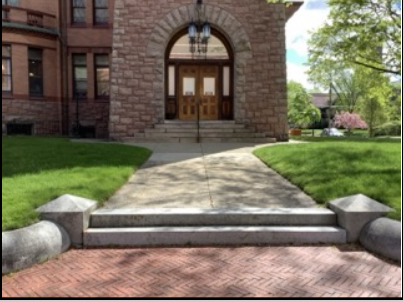
Surface not stable, firm, and slip-resistant Handrails not provided	<ul style="list-style-type: none"><li>-</li><li>-</li></ul>	Repair the surface. Provide handrails on both sides.	1	-	-
Entrance												
29	Main Entrance - South Side	Ext.		Entrance	Main Entrance

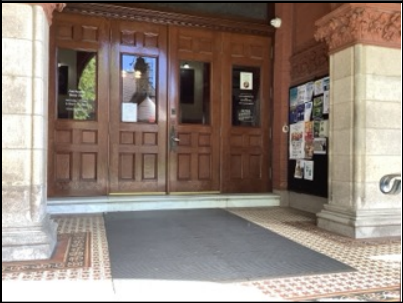
Entrance not on an accessible route Directional sign to accessible entrance not provided	<ul style="list-style-type: none"><li>-</li><li>-</li></ul>	Provide a directional sign indicating the location of the nearest accessible entrance. Provide signs both at this door and at the base of the stairs to this door in order to prevent backtracking.	2	450	\$900
											900	
30	Southwest Side - Egress From Offices	Ext.		Entrance	Other

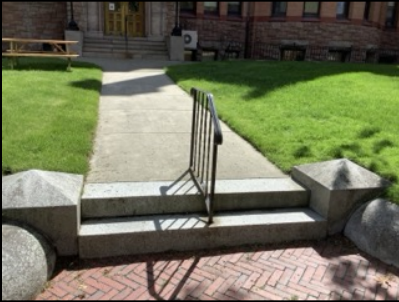
ID	Location	Floor	Room	Element	Type	Photo	Issues	Current Measure	Recommendations	Quantity	Price	Cost Estimation
31	Northwest Side - to Entrance	Ext.		Entrance	Secondary Entrance

Directional sign to accessible entrance not provided	-	At the base of the stairway, provide a directional sign indicating the location of the nearest accessible entrance. Ensure sign is located in a manner to prevent backtracking.	1	450	\$450
											450	
32	Secondary Entrance - Accessible (North Side)	Ext.		Entrance	Secondary Entrance

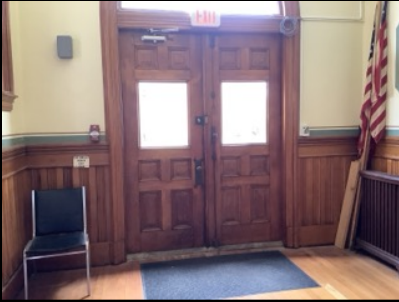
Tactile exit sign not provided Illuminated ISA symbol not provided (MAAB)	- -	Ensure that a tactile exit sign with raised characters and braille is provided at the exit door. Mount the sign between 48"- 60" above the finished floor located on the latch side of the door. When the door is renovated and brought up to compliance and when the illuminated exit sign is repaired or replaced, provide an illuminated sign with the International Symbol of Accessibility (ISA).	1	250	\$250
											250	
35	Secondary Entrance - Accessible (North Side)	1		Means of Egress	N/A

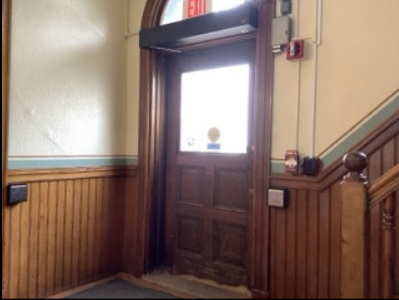
Tactile exit sign not provided Illuminated ISA symbol not provided (MAAB)	- -	Ensure that a tactile exit sign with raised characters and braille is provided at the exit door. Mount the sign between 48"- 60" above the finished floor located on the latch side of the door. When the illuminated exit sign is repaired or replaced, provide an illuminated sign with the International Symbol of Accessibility (ISA).	1	250	\$250

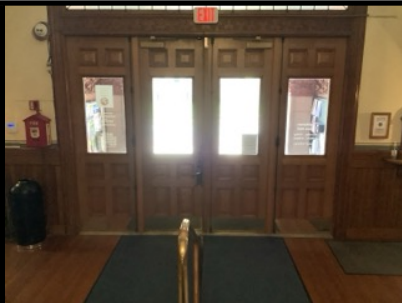
ID	Location	Floor	Room	Element	Type	Photo	Issues	Current Measure	Recommendations	Quantity	Price	Cost Estimation	
36	Main Egress - South Side	0.5		Means of Egress	N/A

Tactile exit sign not provided Directional sign to accessible emergency exit not provided	- -	Ensure that a tactile exit sign with raised characters and braille is provided at the exit door. Mount the sign between 48" - 60" above the finished floor located on the right side of the right most door assuming all door leaves are active. Provide a directional sign indicating the location of the nearest accessible emergency exit.	1	250 250	\$500	
37	Northwest Entry/Exit	1		Means of Egress	N/A

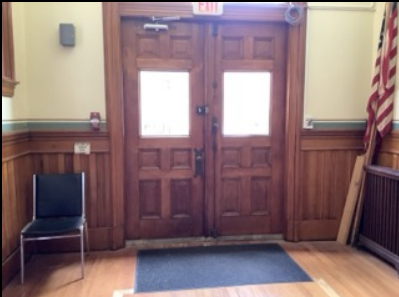
ID	Location	Floor	Room	Element	Type	Photo	Issues	Current Measure	Recommendations	Quantity	Price	Cost Estimation
Doors, Doorways, & Gates												
41	Northwest Entry/Exit	1		Doors, Doorways, & Gates	Emergency Egress

Clear width at door < 32" Mat not securely attached Threshold > 1/2" high	31" - 2"	Install offset hinges to ensure that the door has a clear width of 32 inches. Secure the mat. Alter the threshold to be 1/2" high max.	1	2902 Labor 1000	\$3902
											<b>3902</b>	
42	Town Administrator and Select Board Office	0.5		Doors, Doorways, & Gates	Office

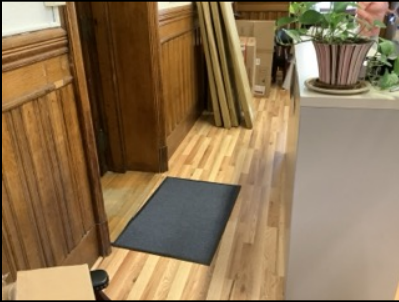
ID	Location	Floor	Room	Element	Type	Photo	Issues	Current Measure	Recommendations	Quantity	Price	Cost Estimation
46	Town Administrator and Select Board Office	0.5		Doors, Doorways, & Gates	Floor Mat

Mat not securely attached	-	Secure the mat.	1	Labor	Labor
47	Registrar's and Town Clerk's Office	0.5		Doors, Doorways, & Gates	Office

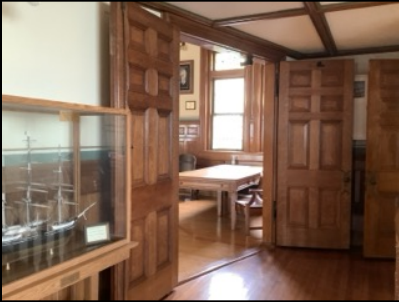
ID	Location	Floor	Room	Element	Type	Photo	Issues	Current Measure	Recommendations	Quantity	Price	Cost Estimation
51	Auditorium	2		Doors, Doorways, & Gates	Meeting Room

Threshold > 1/2" high	-	Alter the threshold to be 1/2" high max. beveled.	1	1000	\$1000
											1000	
52	East Room	2		Doors, Doorways, & Gates	Meeting Room

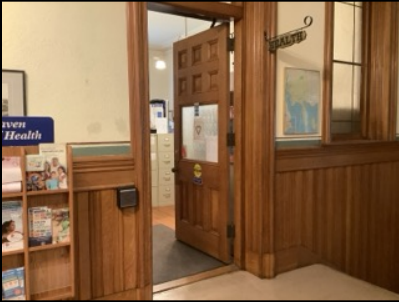
ID	Location	Floor	Room	Element	Type	Photo	Issues	Current Measure	Recommendations	Quantity	Price	Cost Estimation
56	Board of Health	1		Doors, Doorways, & Gates	Office

Threshold > 1/2" high Hardware not compliant	0.75" -	Alter the threshold to be 1/2" high max. beveled. Provide hardware that can be operable with one hand and not require tight grasping, pinching, or twisting of the wrist.	1	1000 750	\$1750
											1750	
57	Office of Conservation and Sustainability	1		Doors, Doorways, & Gates	Office

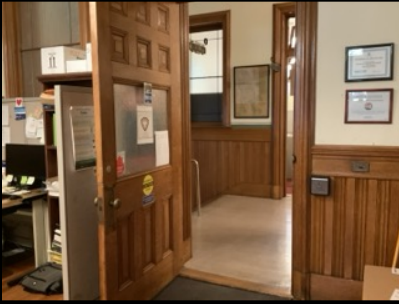
ID	Location	Floor	Room	Element	Type	Photo	Issues	Current Measure	Recommendations	Quantity	Price	Cost Estimation
61	Board of Health	1		Doors, Doorways, & Gates

Hardware not compliant	-	Provide hardware that can be operable with one hand and not require tight grasping, pinching, or twisting of the wrist.	1	750	\$750
62	Board of Health, by Elevator	1		Doors, Doorways, & Gates	Office

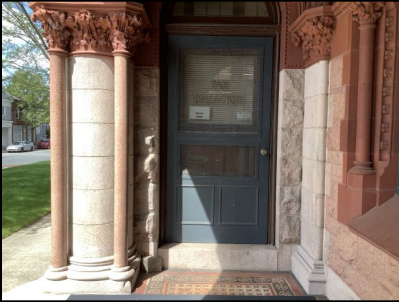
ID	Location	Floor	Room	Element	Type	Photo	Issues	Current Measure	Recommendations	Quantity	Price	Cost Estimation	
66	Tax Collector - Exterior Drop-Box	Ext.		Doors, Doorways, & Gates	N/A

Hardware not compliant	-	Provide hardware that can be operable with one hand and not require tight grasping, pinching, or twisting of the wrist.	1	750	\$750	
											750		
67	Single-User Toilet Room by Auditorium Stage	S		Doors, Doorways, & Gates	Toilet Room

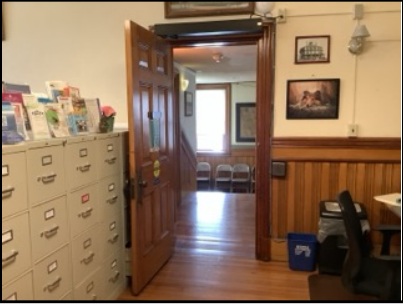
ID	Location	Floor	Room	Element	Type	Photo	Issues	Current Measure	Recommendations	Quantity	Price	Cost Estimation
71	Board of Health to Elevator	1		Doors, Doorways, & Gates	Office

Clear floor space at opener not provided	11.75"	Relocate stored items to provide a 30" x 48" clear floor space at automatic door opener.	1	-	-
Ramps												
72	Southeast Egress - From Lower Level	LL		Ramps	Egress

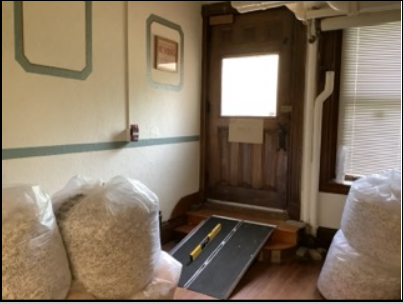
Ramp < 48" wide Running slope >1:12 (8.33%)	29.5" 25%	Provide a ramp with a width that is 48" wide min. Further study will be needed to determine whether it is technically feasible to bring the ramp into full compliance with the ADA Standards.	1	Labor	Labor
Stairways												
73	Lobby	1		Stairways	Interior

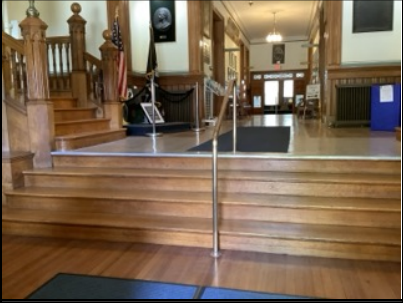
Handrail height < 34" or > 38" Handrail not provided on both sides Handrails do not extend 12" from stairs at top Bottom handrail extends < 12" and one tread	- - - -	Alter so the handrails are 34"- 38" high above the floor. Provide handrail on one side. Top: Ensure handrails extend horizontally above the landing for 12" min. beginning above the first riser nosing. Bottom: Ensure that the sloped bottom extension extends one tread depth min. beyond last riser nosing in same direction as stair flight.	1	-	-

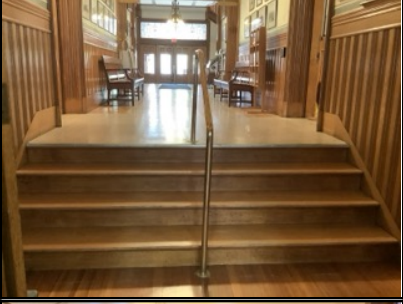
Handrail height < 34" or > 38" Handrail not provided on both sides Handrails do not extend 12" from stairs at top Bottom handrail extends < 12" and one tread	32.5" - - -	Alter so the handrails are 34"- 38" high above the floor. Provide handrail on one side. Top: Ensure handrails extend horizontally above the landing for 12" min. beginning above the first riser nosing. Bottom: Ensure that the sloped bottom extension extends one tread depth min. beyond last riser nosing in same direction as stair flight.	1	-	-
75	Stair to Lower Level	0.5		Stairways	Interior

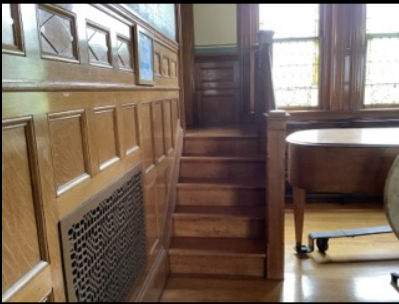
ID	Location	Floor	Room	Element	Type	Photo	Issues	Current Measure	Recommendations	Quantity	Price	Cost Estimation
76	Auditorium to Stage, Elevator, and Toilet Room	2		Stairways	Interior

Handrail not provided on both sides	-	Provide a compliant handrail on one side.	1	-	-
77	To East Room	2		Stairways	Interior

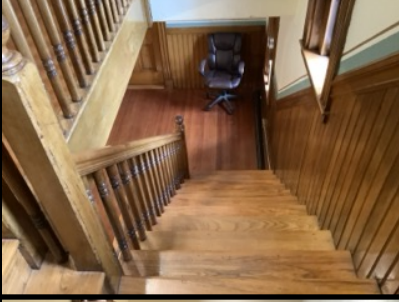
Handrail not provided on both sides	-	Provide a compliant handrail on one side.  Recommendation applies to all levels of the stairway.	1	-	-
80	To Cable Access Department From Elevator	2		Stairways	Interior

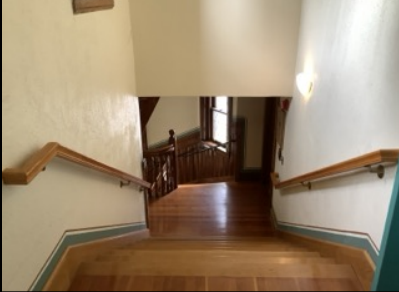
Handrails lack a compliant cross section	-	Provide handrails with 1 1/4" - 2" circular cross sections.	1	-	-

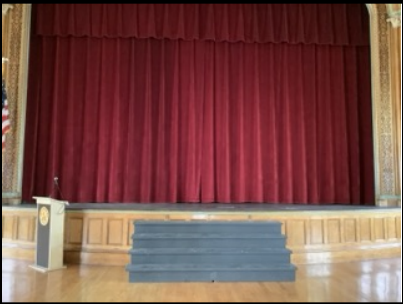
ID	Location	Floor	Room	Element	Type	Photo	Issues	Current Measure	Recommendations	Quantity	Price	Cost Estimation
81	Auditorium	2		Stairways	Interior

Handrails not provided	-	Provide compliant handrails.	1	-	-
Elevator												
82	Elevator - Entry by Board of Health	1		Elevator	Interior

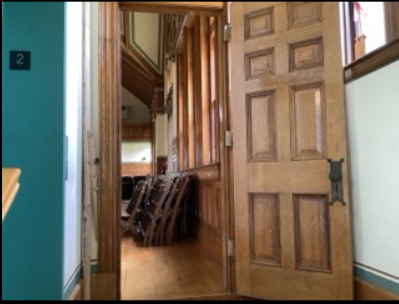
ID	Location	Floor	Room	Element	Type	Photo	Issues	Current Measure	Recommendations	Quantity	Price	Cost Estimation
86	Auditorium (Entry by Elevator)	2		Signage	Designation

Signage is not provided	-	Locate compliant signage with raised characters and braille alongside the door on the latch side.	1	250	\$250
											250	
87	Auditorium to Northwest Stairway and Elevator	2		Signage	Egress

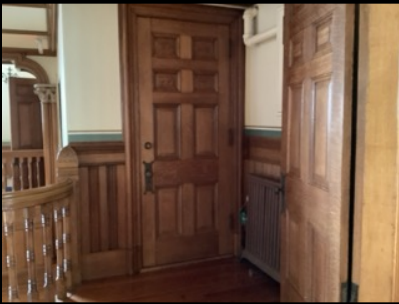
ID	Location	Floor	Room	Element	Type	Photo	Issues	Current Measure	Recommendations	Quantity	Price	Cost Estimation
91	Planning Department (Entry by Auditorium)	2		Signage	Designation

Signage is not provided	-	Locate compliant signage with raised characters and braille alongside the door on the latch side.	1	250	\$250
											250	
92	Auditorium	2		Signage	Designation

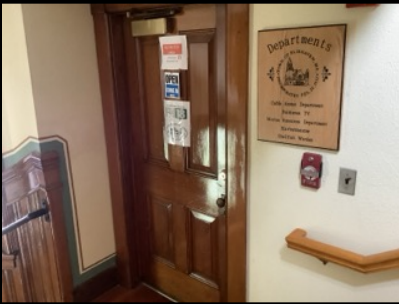
ID	Location	Floor	Room	Element	Type	Photo	Issues	Current Measure	Recommendations	Quantity	Price	Cost Estimation
96	Cable Access Department	1.5		Signage	Designation

Raised characters not provided on sign Braille not provided on sign	- -	Provide text with raised characters duplicated in braille on the sign. Provide braille on the sign.	1	250	\$250
											250	
97	Tax Collector	Ext.		Signage	Designation

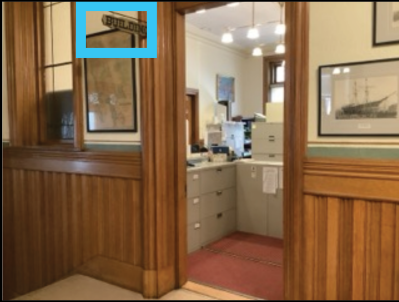
ID	Location	Floor	Room	Element	Type	Photo	Issues	Current Measure	Recommendations	Quantity	Price	Cost Estimation
101	Building Department	1		Signage	Designation

Raised characters not provided on sign Braille not provided on sign Location of tactile sign not compliant	- - -	Provide text with raised characters duplicated in braille on the sign. Locate sign alongside the door on the latch side.	1	250	\$250
											250	
102	Board of Health	1		Signage	Designation

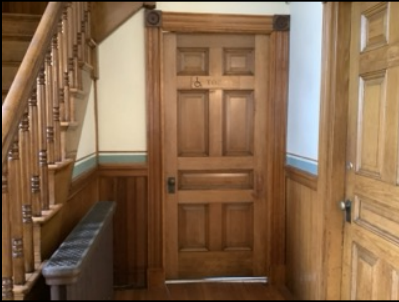
ID	Location	Floor	Room	Element	Type	Photo	Issues	Current Measure	Recommendations	Quantity	Price	Cost Estimation	
106	Single-User Toilet Room	1		Signage	Designation

Raised characters not provided on sign Braille not provided on sign Location of tactile sign not compliant Non-glare finish and contrast not provided on sign	- - - -	Provide text with raised characters duplicated in braille on the sign. Locate sign alongside the door on the latch side. Install a sign with a non-glare finish with characters that have a high contrast to the background.	1	250	\$250	
107	Town Clerk's Office	Ext.		Signage	Designation

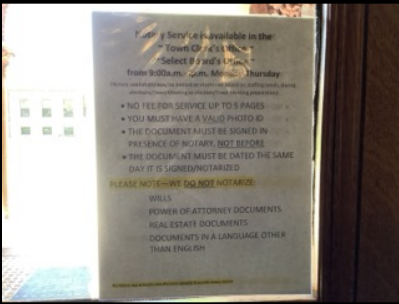
ID	Location	Floor	Room	Element	Type	Photo	Issues	Current Measure	Recommendations	Quantity	Price	Cost Estimation
111	Main Egress-South Side	0.5		Signage

Non-glare finish and contrast not provided on sign	-	Install a sign with a non-glare finish with characters that have a high contrast to the background.	1	Labor	Labor
112	Elevator	1		Signage	Informational

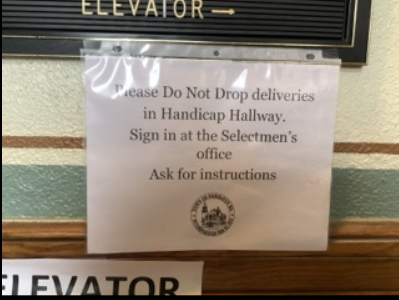
Non-glare finish and contrast not provided on sign	-	Install a sign with a non-glare finish with characters that have a high contrast to the background.  Recommendation applies to all similar signs.	1	Labor	Labor
114	Auditorium to Stage, Elevator, and Toilet Room	2		Signage	Directional

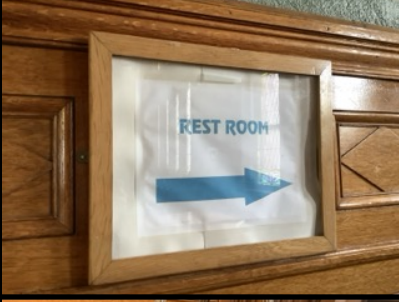
Non-glare finish and contrast not provided on sign	-	Install a sign with a non-glare finish with characters that have a high contrast to the background.	1	Labor	Labor

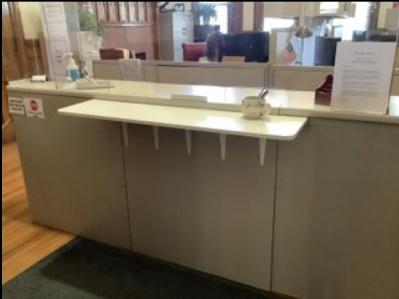
ID	Location	Floor	Room	Element	Type	Photo	Issues	Current Measure	Recommendations	Quantity	Price	Cost Estimation
121	Assessors Office	1		Service Counter	N/A

Counter > 36" high	38.5"	Provide a counter that is 36" max. above the finished floor.	1	1144	\$1144
122	Tax Collector Office	1		Service Counter	N/A

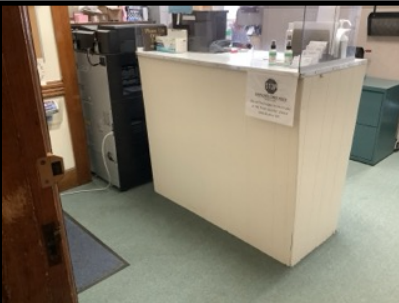
ID	Location	Floor	Room	Element	Type	Photo	Issues	Current Measure	Recommendations	Quantity	Price	Cost Estimation
126	Human Resources Office	LL		Service Counter	N/A

Counter > 36" high	42"	Provide a counter that is 36" max. above the finished floor.	1	1144	\$1144
											1144	
127	Director of Finance/Treasurer, Accountant, and Retirement System	LL		Service Counter	N/A

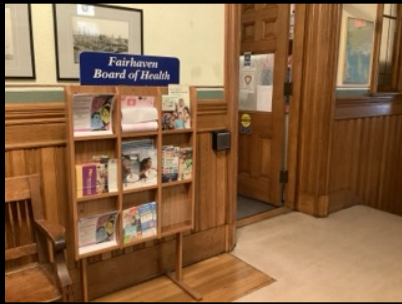
ID	Location	Floor	Room	Element	Type	Photo	Issues	Current Measure	Recommendations	Quantity	Price	Cost Estimation
131	By Board of Health	1		Operable Parts / Reach Range	N/A

Reach < 15" or > 48"(forward/side approach)	51"	Ensure that staff is available to assist visitors who need assistance.	1	Labor	Labor
132		2		Operable Parts / Reach Range	Clothes Rod/Hooks

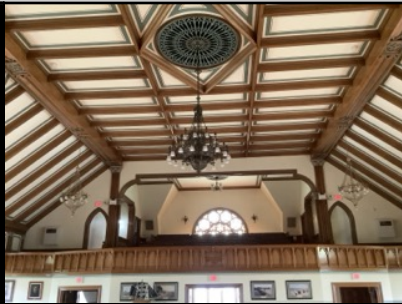
Number of designated wheelchair spaces Minimum # wheelchair spaces not provided	- -	Provide wheelchair spaces with companion seating on the ground floor of the auditorium based on the total auditorium seat count in compliance with Table 221.2.1.1 Number of Wheelchair Spaces in Assembly Areas in the 2010 Standards for Accessible Design.	1	Labor	Labor

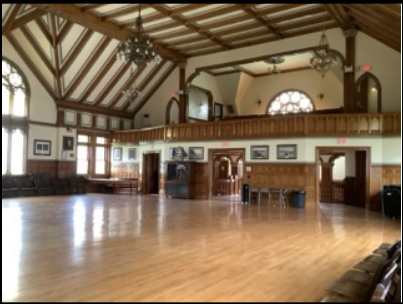
ID	Location	Floor	Room	Element	Type	Photo	Issues	Current Measure	Recommendations	Quantity	Price	Cost Estimation
136	Auditorium	2		Assembly Area	N/A

Assistive listening devices not provided	-	If audible communication is integral to the use of the space, provide an assistive listening system.  <b>Note:</b> Cost for a transmitter, receiver, ear speaker, neck loop and USB charger - Capacity: 50 or more.	1	2194	\$2194
											<b>2194</b>	
137	East Room	2		Assembly Area

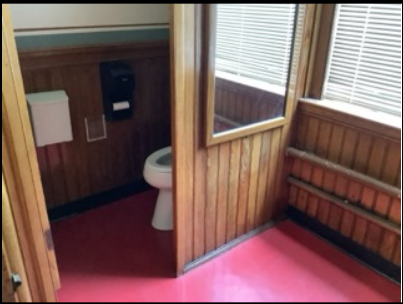
ID	Location	Floor	Room	Element	Type	Photo	Issues	Current Measure	Recommendations	Quantity	Price	Cost Estimation
141	Single-User Toilet Room by Auditorium Stage	S		Overall Access	Toilet Room

Turning space not provided Accessible plumbing fixtures or stalls not provided	- -	Provide a directional sign to the accessible toilet.	1	250	\$250
Lavatory											250	
142	Single-User Toilet Room	1		Lavatory	N/A

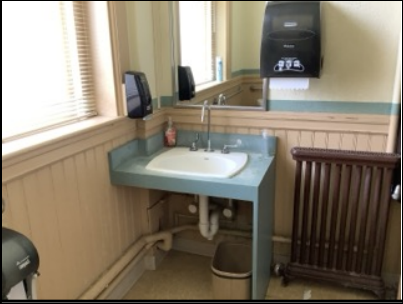
Clear floor space not provided at lavatory Mirror above lavatory w/reflective surface > 40" Dispenser acts as a protruding object	29" 43"	Provide at least one lavatory with a 30" min. by 48" min. clear floor space positioned for a forward approach. Lower mirror so that the bottom surface is at 40" max. above the finished floor. Relocate paper towel dispenser out of the circulation path or provide a cane-detectable barrier under the paper towel dispenser. <b>Note:</b> Costs to make the referenced renovations in this toilet room are included in ID #139.	1	-	-

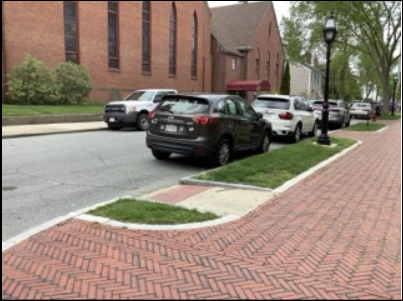
ID	Location	Floor	Room	Element	Type	Photo	Issues	Current Measure	Recommendations	Quantity	Price	Cost Estimation
Accessible On-Street Parking Space												
146	Southwest Side - Intersection at William Street and Center Street	Ext.		Accessible On-Street Parking Space	N/A

-	Recommend providing a compliant on-street parking space at this location with an identification sign that has the International Symbol of Accessibility (ISA) mounted so there is 60" min. measured to the bottom of the sign and 96" max. measured to the top of the sign. <b>Note:</b> Price is for the accessible parking identification sign.	1	-	-
147	Northeast Side - Walnut Street	Ext.		Accessible On-Street Parking Space	N/A

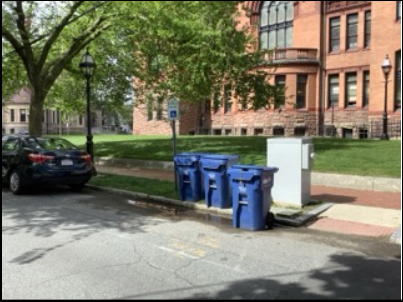
-	Recommend providing a compliant on-street parking space at this location with an identification sign that has the International Symbol of Accessibility (ISA) mounted so there is 60" min. measured to the bottom of the sign and 96" max. measured to the top of the sign. <b>Note:</b> Price is for the accessible parking identification sign.	1	-	-

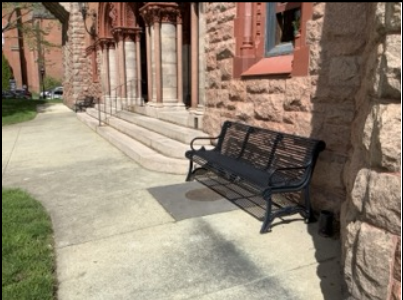
-	Recommend providing a 36" min. by 48" min. stable, firm and slip-resistant surface adjacent to at least one bench in each area where benches are provided positioned to allow a person in a wheeled mobility device and a person sitting on the bench to have their shoulders aligned.	1	-	-
Exterior Stairs												
149	Main Entrance (South Side)	Ext.		Exterior Stairs	N/A

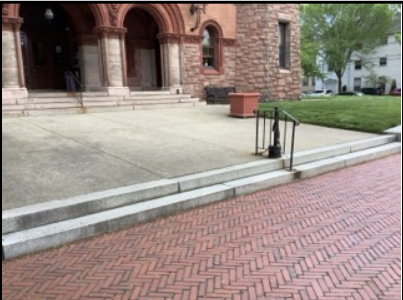
-	Recommend a contrasting color on the treads on all interior and exterior stairs that do not already have a contrasting color on the stair nosings.	1	-	-

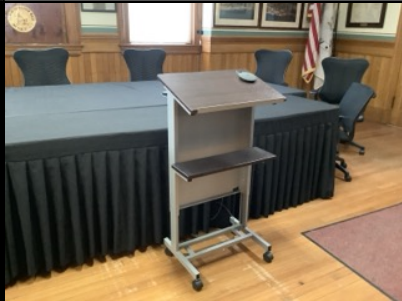
ID	Location	Floor	Room	Element	Type	Photo	Issues	Current Measure	Recommendations	Quantity	Price	Cost Estimation
Podium												
150	Lobby by Accessible Entrance	1		Podium	N/A

-	Recommend a height adjustable podium with knee and toe clearance propositioned for a forward approach.	1	-	-
151	Auditorium	2		Podium	N/A
