Whitfield-Manjiro House

Town of Fairhaven ADA Transition Plan

July 2024

Institute for Human Centered Design

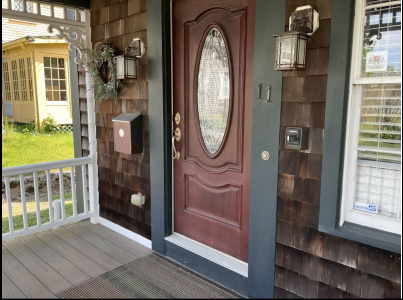
Obstructed by protruding objects	6.5"	Provide a cane-detectable barrier underneath the lamps.	2	398	\$796
											796	
2	West Side Entrance	Ext.		Exterior Access Route	Exterior

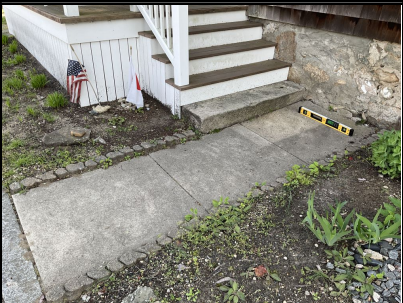
Cross slope > 1:50 (2.00%)	4.4%	Reduce cross slope to be no steeper than 1:50 (2.00%).	1	-	-
3	North Side of House	Ext.		Exterior Access Route	Exterior

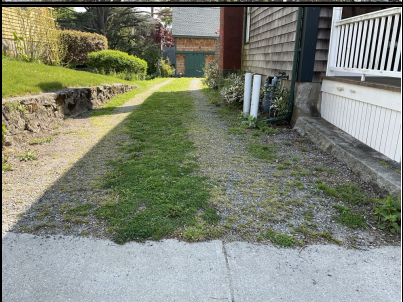
Accessible route not provided	-	Ensure an accessible route is provided to the accessible entrance from the sidewalk.	1	-	-
4	West Side Entrance	Ext.		Exterior Access Route	Exterior

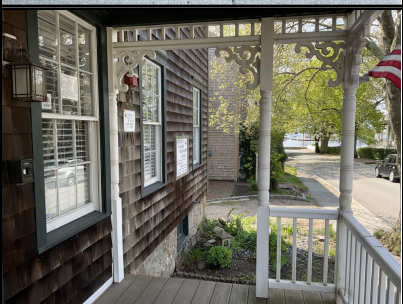
Vertical clearance < 80" above ground	69"	Consider adding signage that says, "Low Headroom" or, "Low Ceiling".	1	450	\$450
											450	
Exterior Ramp

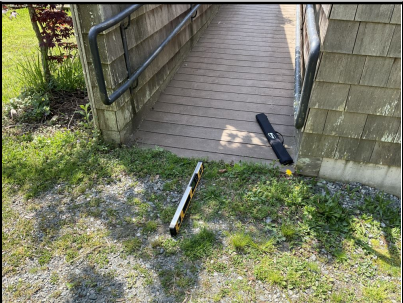
5	East Side Entrance, Bottom Landing	Ext.		Exterior Ramp	N/A

Ramp < 48" wide Landing has a slope > 1:50 in either direction No top or bottom landing provided	41.5" 3.6% -	Rebuild the ramp to be 48" wide min. Alter so that the slope in all directions is no greater than 1:50 (2.00%) Provide landing at the top and bottom of ramp.	1	-	-

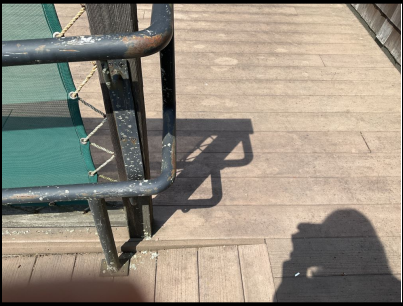
Handrails do not extend 12" past top & bottom	-	Alter handrails to extend horizontally above the landing for 12" min. beyond the top and bottom of ramp runs.	1	-	-
7	East Side Entrance, Top Landing	Ext.		Exterior Ramp	N/A

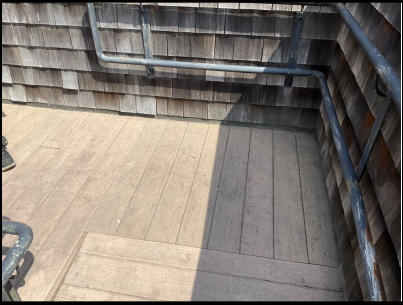
Landing < 60" min. long	42.75"	Rebuild the ramp to provide a 60" min. deep landing.	1	-	-
8	East Side Entrance, Middle Landing	Ext.		Exterior Ramp	N/A

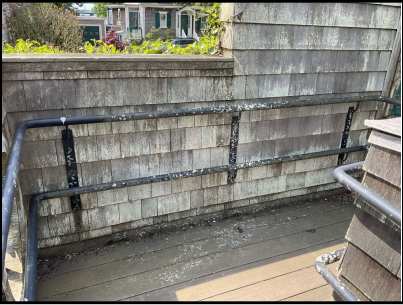
Landing not as wide as ramp	35"	Rebuild the ramp to ensure that the landing is as wide as the ramp.	1	-	-
Exterior Stair												
9	West Side Entrance	Ext.		Exterior Stair	N/A

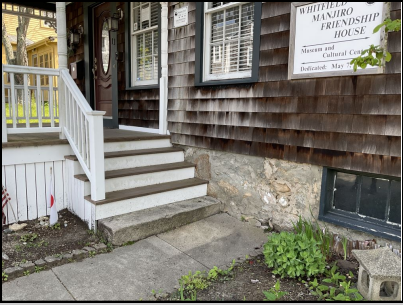
Bottom handrail extends < 12" + one tread Cross section of handrail is not compliant Handrail not provided on both sides	<ul style="list-style-type: none">---	Bottom: Ensure that the sloped bottom extension extends one tread depth min. beyond last riser nosing in same direction as stair flight. Provide handrails with 1 1/4" - 2" circular cross sections. Provide a handrail on each side.	1	<ul style="list-style-type: none">---	<ul style="list-style-type: none">---

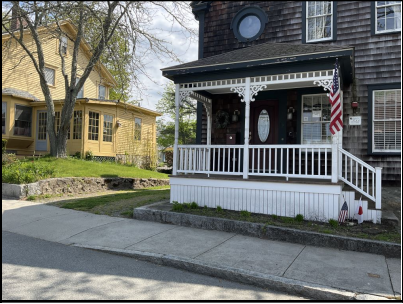
Entrance												
10	West Side Entrance	Ext.		Entrance	Main Entrance

Directional sign to accessible entrance not provided	-	Provide a directional sign indicating the location of the nearest accessible entrance.	1	450	\$450
											450

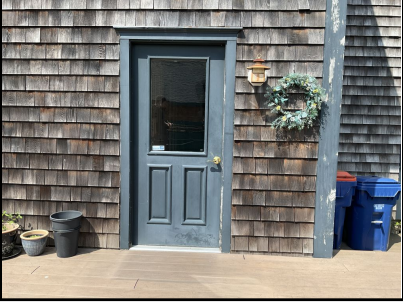
International Symbol of Accessibility not provided	-	Provide a sign with the International Symbol of Accessibility (ISA).	1	450	\$450
Access to Goods and Services												
Means of Egress												
12	East Egress	1		Means of Egress	N/A

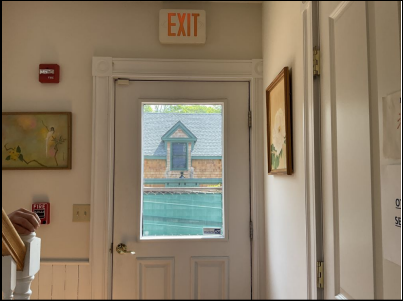
Tactile exit sign not provided Illuminated ISA symbol not provided (MAAB)	- -	Ensure that a tactile exit sign with raised characters and braille is provided at the exit door. Mount the sign between 48" - 60" above the finished floor located on the latch side of the door. When the illuminated exit sign is repaired or replaced, provide an illuminated sign with the International Symbol of Accessibility (ISA).	1	250 -	\$250
Interior Access Route												
13	Classroom	1		Interior Access Route	N/A

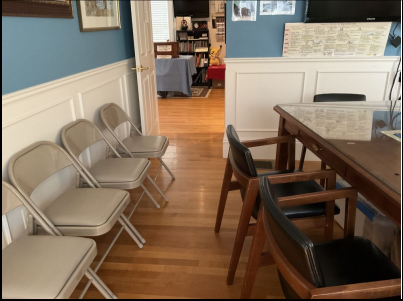
Route < 36" wide	20"	Ensure that a clear width of 36" min. is maintained at the accessible route. Relocate chairs.	1	Labor	Labor

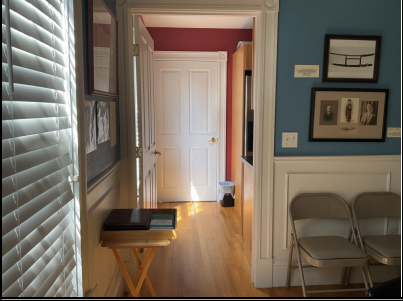
14	Kitchen	1		Interior Access Route	N/A

Route < 36" wide	25.5"	Ensure that a clear width of 36" min. is maintained at the accessible route. Relocate the table.	1	Labor	Labor
15	Historical Kitchen	2		Interior Access Route	N/A

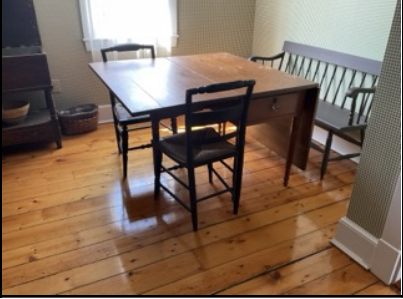
Obstructed by protruding objects	10.5"	Provide a cane-detectable barrier, such as a chair, underneath the overhanging portion. Barriers must have leading edges no higher than 27" so that they are within cane sweep. Barriers can include fixed planters, benches, and guardrails.	1	-	-

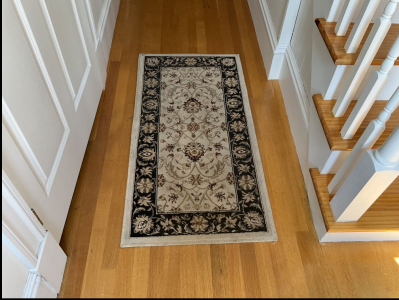
Surface not stable, firm, and slip-resistant	-	Secure mat to the floor. Recommendation applies to all mats.	1	Labor	Labor	
17	Manjiro's Bedroom	2		Interior Access Route	N/A

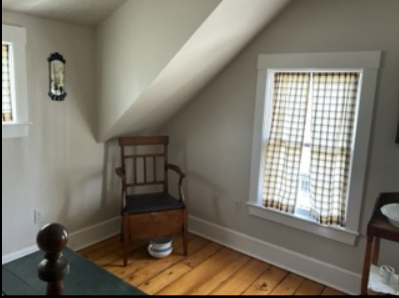
Vertical clearance < 80" above finished floor	68"	Provide a cane-detectable barrier, such as a piece of furniture, underneath the stair. Barriers must have leading edges no higher than 27" so that they are within cane sweep. Barriers can include fixed planters, benches, and guardrails. The existing chair in its current location is not sufficient.	1	-	-	
18	Guest Room	2		Interior Access Route	N/A

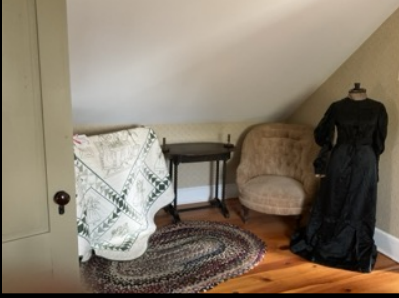
Vertical clearance < 80" above finished floor	65"	Consider adding signage that says, "Low Headroom" or, "Low Ceiling" or provide stanchions blocking off the side of the room where the vertical clearance is lower than 80" above the finished floor.	1	250	\$250

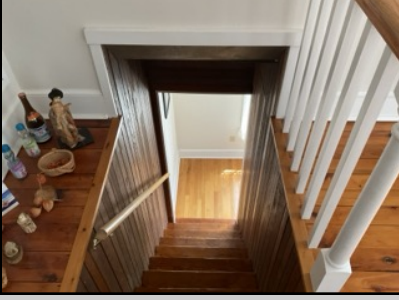
Vertical clearance < 80" above finished floor	73"	Further study will be needed to determine whether it is technically feasible to bring the vertical clearance into full compliance with the ADA Standards. Consider adding signage that says, "Low Headroom" or, "Low Ceiling". In addition, as there are winder stairs present in this stairwell, we recommend that the west stair be used for house tours, rather than the east stairs.	1	250	\$250	
											250		
Doors, Doorways, & Gates													
20	Kitchen	1		Doors, Doorways, & Gates	N/A

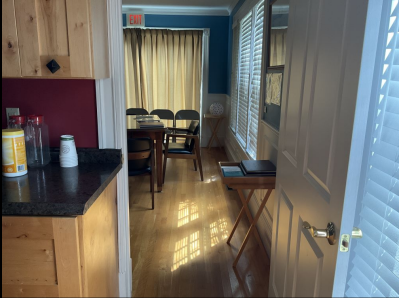
Maneuvering clearance(s) not provided	-	Ensure the door is left open.	1	Labor	Labor

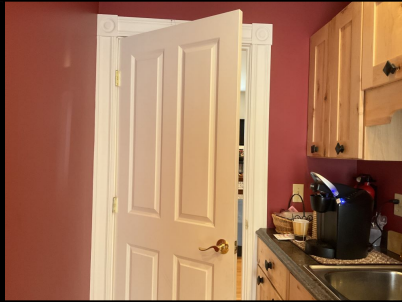
Maneuvering clearance(s) not provided	-	Ensure the door is left open.	1	Labor	Labor
22	Historical Kitchen	2		Doors, Doorways, & Gates	N/A

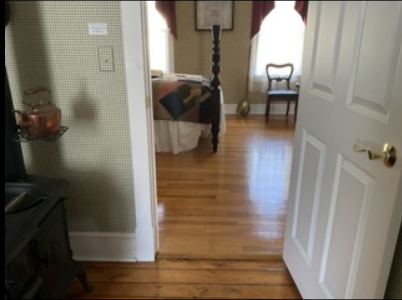
Threshold > 1/2" high	0.75"	Alter the threshold to be 1/2" high max. Recommendation applies to all thresholds exceeding 1/2". Unit cost is provided for one instance of this repetitive item.	1	1000	1000
Stairways												
23	West Staircase	2, 3		Stairways	Interior

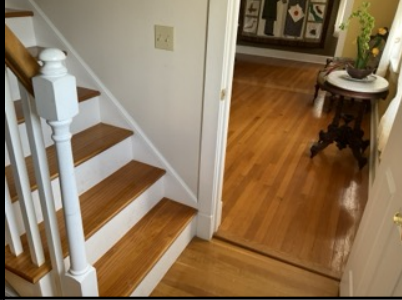
Handrail height < 34" or > 38" Handrail not provided on both sides Bottom handrail extends < 12" and one tread Handrails lack a compliant cross section	40.75"	The main handrail on this stair does not have a grippable profile. Provide a compliant handrail on the wall side with a 1 1/4" to 2" circular cross section..	1	-	-
24	East Staircase	3		Stairways	Interior

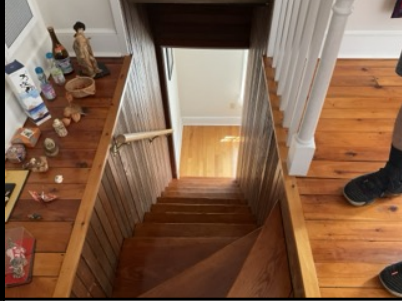
Handrail not provided on both sides	-	Winder stairs may be hazardous for users. Recommend that the west staircase be used for house tours rather than the east stairs.	1	-	-

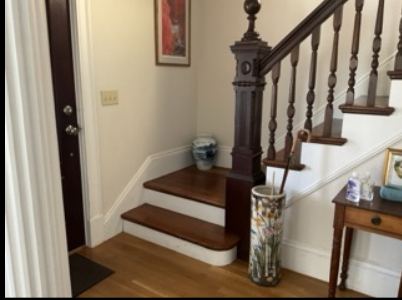
25	West Staircase	1		Stairways	Interior

Handrail not provided on both sides	-	The main handrail on this stair does not have a grippable profile. Provide a compliant handrail on the wall side with a 1 1/4" to 2" circular cross section..	1	-	-

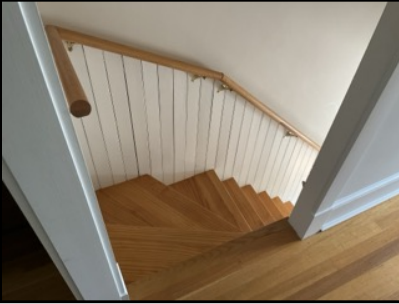
Handrail not provided on both sides Bottom handrail extends < 12" and one tread Handrails not continuous where required	- - -	Winder stairs may be hazardous for users. Recommend that the west staircase be used for house tours rather than the east stairs.	1	-	-
Signage												
27	Classroom	1		Signage	Designation

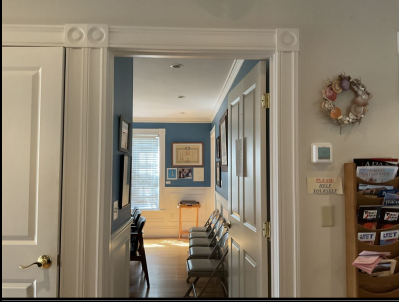
Signage is not provided	-	Locate compliant signage with raised characters and braille alongside the door on the latch side.	1	250	\$250
											250	
28	Kitchen	1		Signage	Designation

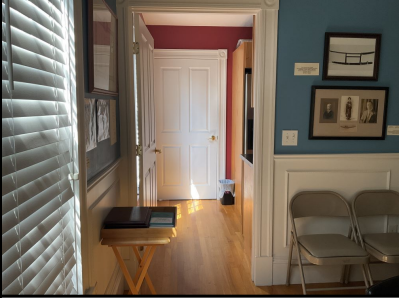
Signage is not provided	-	Locate compliant signage with raised characters and braille alongside the door on the latch side.	1	250	\$250
											250	
29	Kitchen	1		Signage	Designation

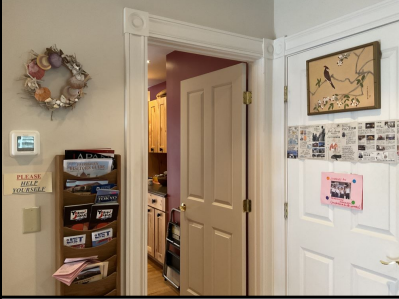
Signage is not provided	-	Locate compliant signage with raised characters and braille alongside the door on the latch side. Ensure a 18" min. by 18" min. clear floor space at the sign.	1	250	\$250

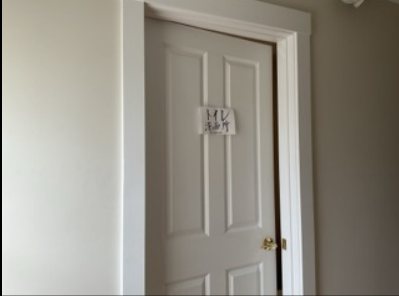
Signage is not provided	-	Locate compliant signage with raised characters and braille alongside the door on the latch side.	1	250	\$250
											250

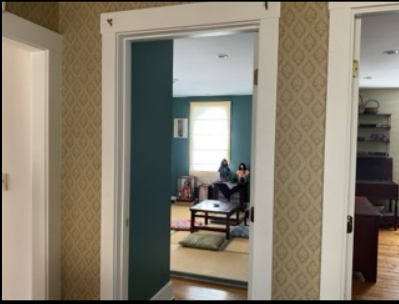
Signage is not provided	-	Locate compliant signage with raised characters and braille alongside the door on the latch side.	1	250	\$250
											250	
32	North Side of House	Ext.		Signage	Directional

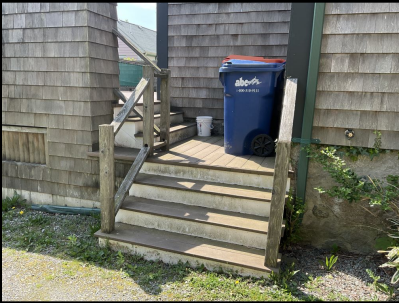
Directional signage is not provided	-	Provide a directional sign with the International Symbol of Accessibility (ISA) indicating the location of the ramp.	1	450	\$450
											450	
33	Single-User Toilet Room	1		Signage	Designation

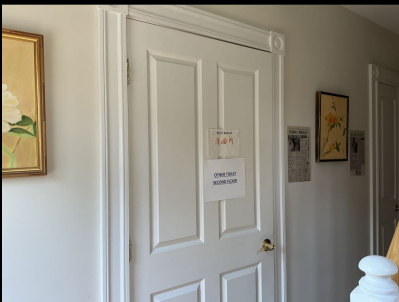
Raised characters not provided on sign Braille not provided on sign International Symbol of Acc. not provided	- - -	Provide text with raised characters duplicated in braille on the sign. Provide braille on the sign. Once the toilet is made fully accessible, replace the sign with a sign containing the International Symbol of Accessibility (ISA).	1	250	\$250

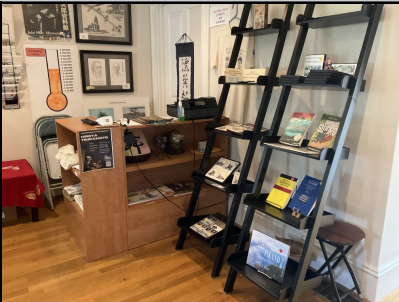
Counter > 36" high	37.5"	Provide a counter that is 36" max. above the finished floor.	1	1144	\$1144
											1144	
Dining or Work Surfaces												
35	Classroom	1		Dining or Work Surfaces	Work Surface

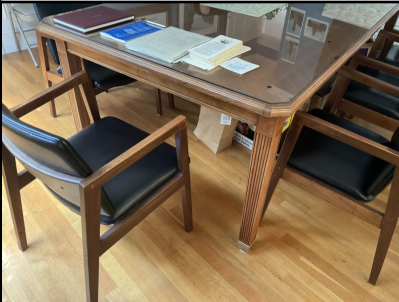
Knee or toe clearance not provided	25"	Provide a work surface with 27" min. high knee and toe clearance.	1	1100	\$1100
											1100

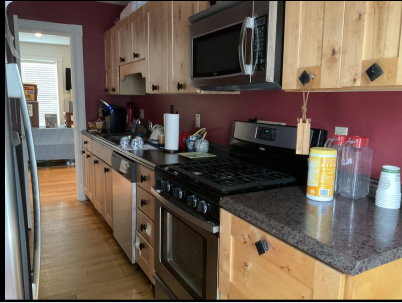
Knee/toe clearance not provided at sink Sink > 34" high Countertop > 34" high Knee/toe clearance not provided at countertop Microwave controls > 48" Pass through kitchen < 40" between opposite sides	- 36" 36" - 64.5" 26"	IHCD was told the kitchen is used for cooking classes. The kitchen would need to go through a large scale renovation to be fully compliant for public use. Until that time, ensure the kitchen itself is only used by staff and that assembly/mixing be done in the classroom.	1	-	-
Toilet & Bathing Rooms												
Lavatory												
37	Single-User Toilet Room	1		Lavatory	N/A

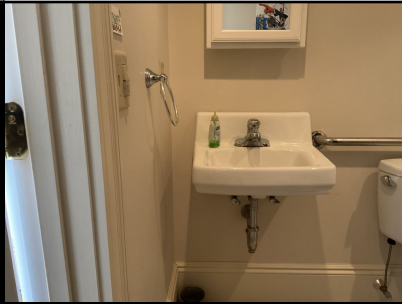
Plumbing underneath is exposed Mirror above lavatory w/reflective surface > 40"	- 52.5"	Insulate or otherwise configure pipes to prevent contact at the lavatory. Lower mirror so that the bottom surface is at 40" max. above the finished floor.	1	150 Labor	\$150

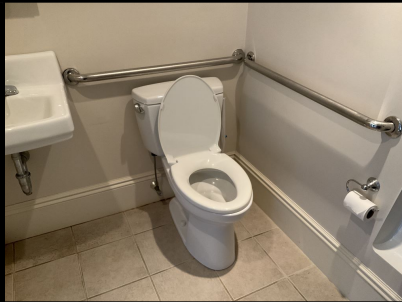
Side grab bar < 54" from back wall Rear grab bar < 42" long (MAAB) Clearance at toilet < 60" clear width	39" - -	Renovate the toilet room to ensure that there is 60" wide min. clear floor space at the toilet.	1	31985	\$31985
											31985	
39	Single-User Toilet Room	1		Single-User Toilet	N/A

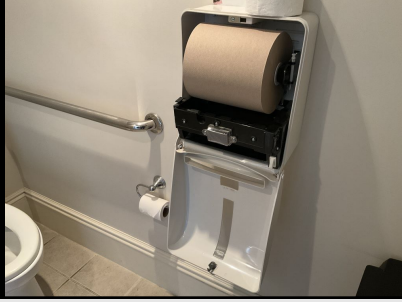
Clearance at toilet < 72" clear depth (MAAB)	8"	Remove and relocate the paper towel dispenser from the clear depth required at the toilet.	1	333	\$333
											333	
Best Practice

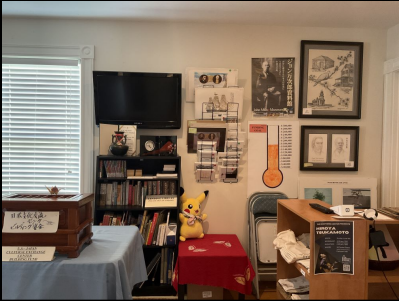
-	Recommend having a printout with images and descriptions of the tour.	1	-	-
41	West Staircase	1

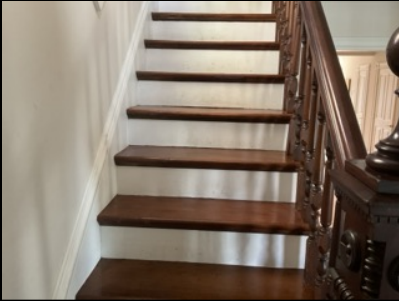
Recommend providing visual contrast on the stair treads. Recommendation applies to all stairs.	1	-	-
