Willow Park

Town of Fairhaven ADA Transition Plan

August 2024

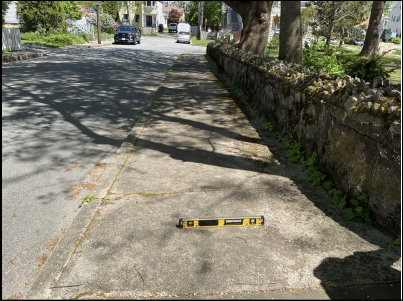
ID	Location	Floor	Room	Element	Type	Photo	Issues	Current Measure	Recommendations	Quantity	Price	Cost Estimation
Approach and Entrance												
Exterior Access Route												
1	Morse Street	Ext.		Exterior Access Route	Sidewalk

Cross slope > 1:50 (2.00%)	7.5%	Reduce cross slope to be no steeper than 1:50 (2.00%).	1	-	-
2	Entrance From Morse Street	Ext.		Exterior Access Route	Exterior

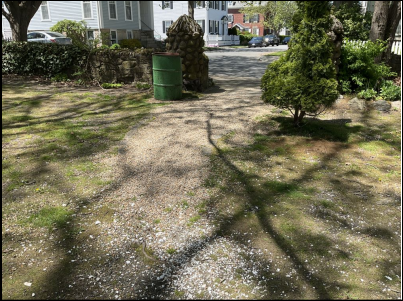
Surface is not stable, firm, and slip-resistant	-	Repair surface to be firm, stable, and slip-resistant.	1	-	-
3	Bike Rack	Ext.		Exterior Access Route	Exterior

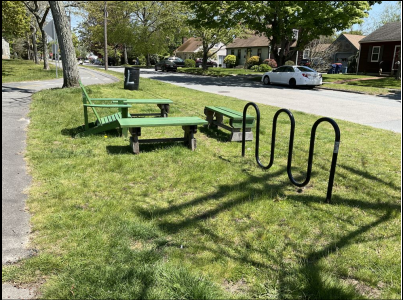
Accessible route not provided	-	Ensure an accessible route is provided to the bike rack.	1	-	-
Entrance												
4	Phoenix Bike Trail	Ext.		Entrance	N/A

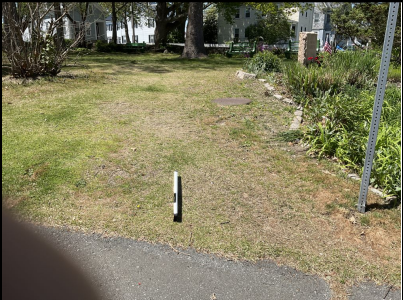
Directional sign to accessible entrance not provided	-	Provide a directional sign or a series of signs directing visitors to the accessible entrance at Morse Street.	1	450	\$450
											450

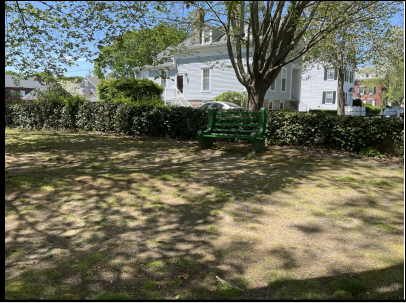
No accessible route to one bench in area	-	Relocate one bench to an accessible route.	1	-	-
Best Practice												
6	Park	Ext.

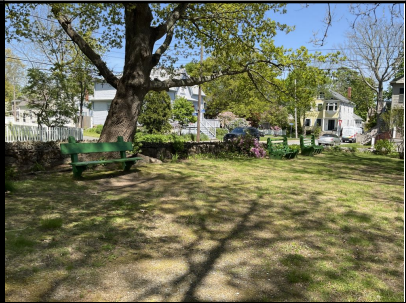
Recommend providing a 36” min. by 48” min. stable, firm and slip-resistant surface adjacent to at least one of the existing benches in each unique program area in the park.	1	-	-
