Building Name: Police and Fire Station

Address: 1 Bryant Lane / 146 Washington Street, Fairhaven, MA

Report By: Amy Dunlap **GSF** 21,876 **Date:** 11/15/17 and
12/6/17

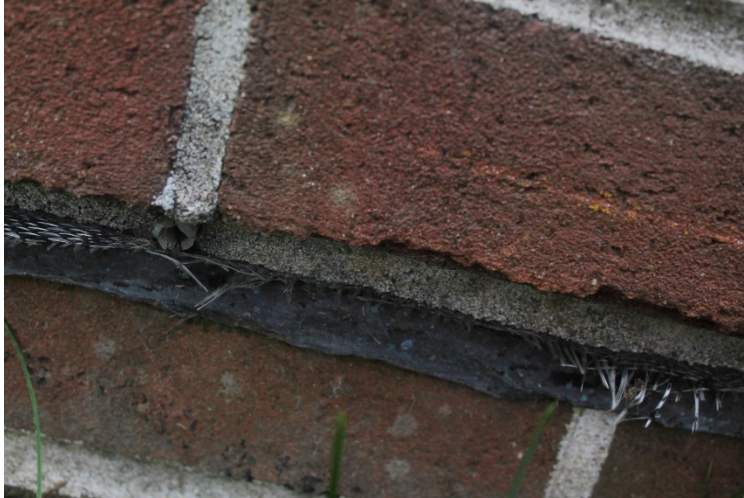
Wall Condition: Brick is in excellent condition. Flexible fabric flashings protruding from above windows, below sills, at base of wall, etc. are exposed and deteriorating. (Photos 1 + 2) Condition of flashing within wall cavity is unknown. Some rotten wood trim was observed at overhead doors, at the second floor level, at gables. (Photo 3) Algae staining was observed at painted stucco areas and masonry. (Photo 4) A precast sill at the basement level is spalling/cracked.

Photo 1: Deteriorated fabric flashing at wall base

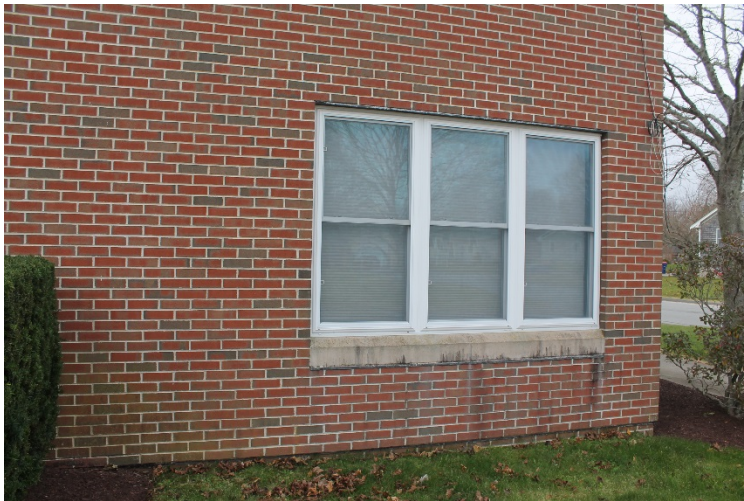
Photo 2: Deteriorated fabric flashing at window head, precast sill and base of wall

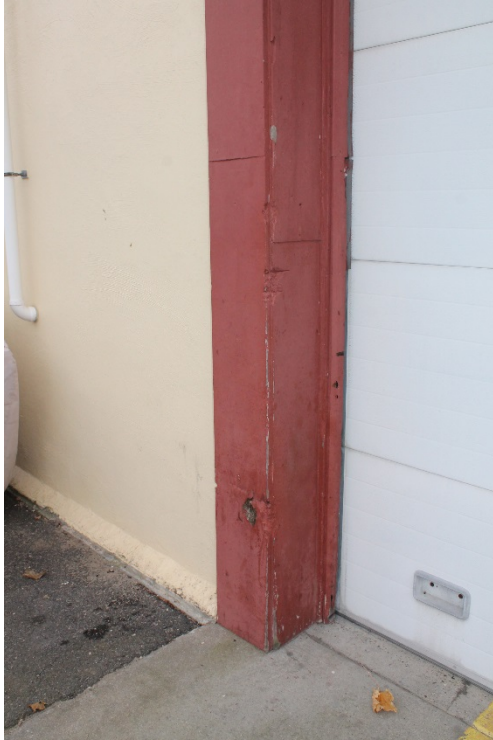
Photo 3: Rotten wood trim at overhead door

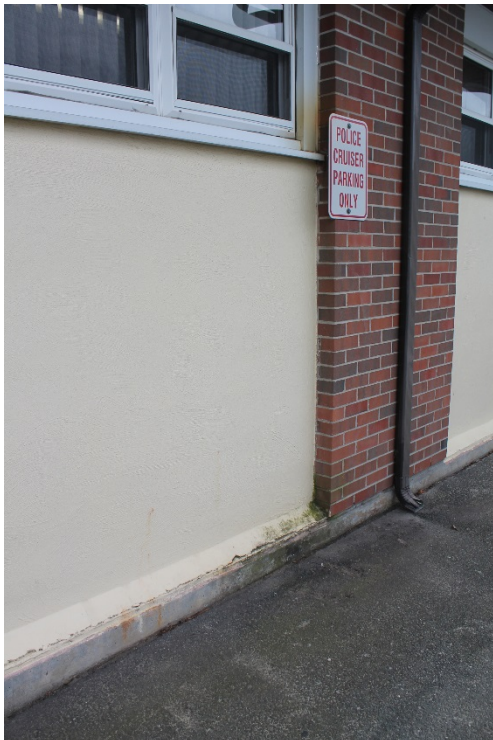
Photo 4: Algae stained stucco

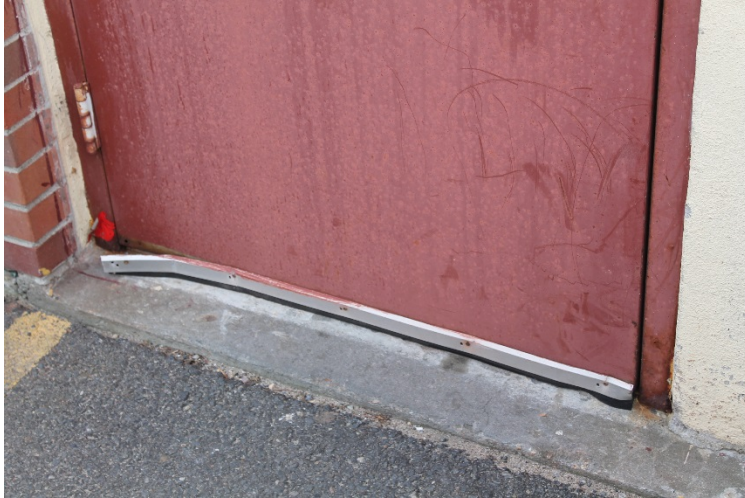
Door Conditions: Some rust observed on overhead doors and at hollow metal doors at grade. Some panels on overhead doors are damaged. Several missing gaskets/sweeps were observed at hollow metal and aluminum storefront doors. (Photo 5)

Photo 5: Damaged sweep at exterior door

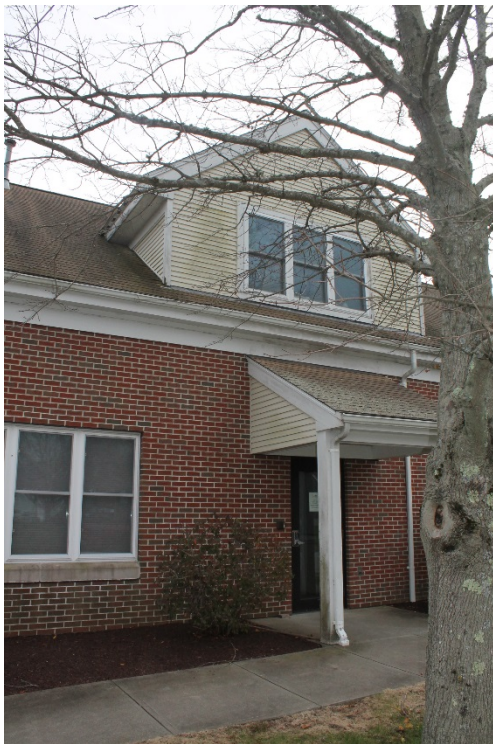
Roof Conditions: Asphalt shingles over ambulance bays in good condition. Shingles in other locations in fair condition. (Photo 6) Staining on the membrane roofing suggests possible ponding has occurred in the past. (Photo 7) No internal roof drains were observed. It appears the intent is for stormwater to drain to downspouts at the roof perimeter. Fire department reported that the roof was replaced approximately two years ago. Some dents were observed in gutters.

Photo 6: Lichen and staining on asphalt shingle roof

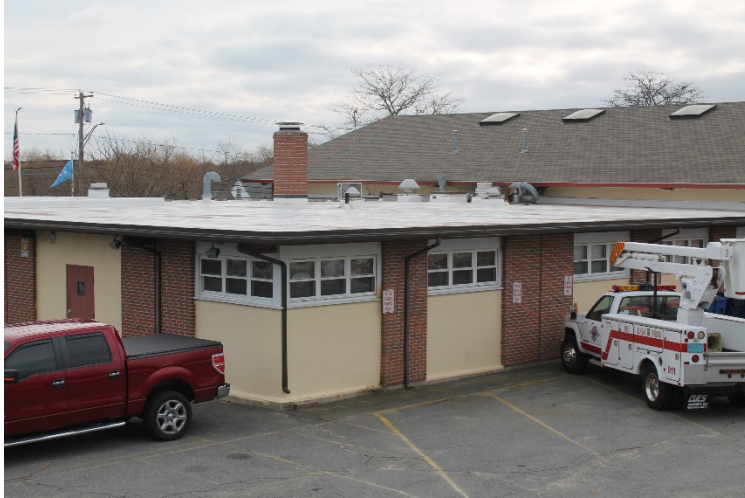
Photo 7: Staining on membrane roof

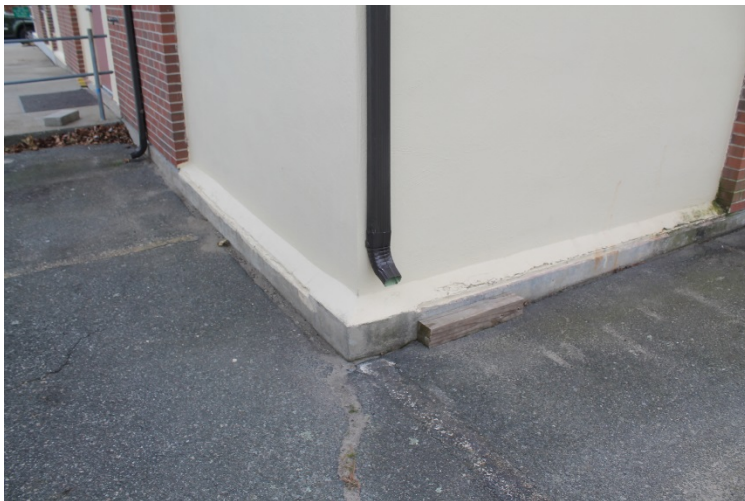
Other Ext. Issues: Wood soffits in excellent condition. Exposed reinforcing steel observed at the foundation wall in one location. Downspouts in some locations spill to grade which slopes back toward the building redirecting water back to the building in these locations. (Photo 8) Exposed waterproofing at the foundation wall was observed in the areaway. (Photo 9) Wood sills at the basement are rotten under the metal cap which is no longer secured. (Photo 10)

Photo 8: Downspout empties at low point where water drains back to building

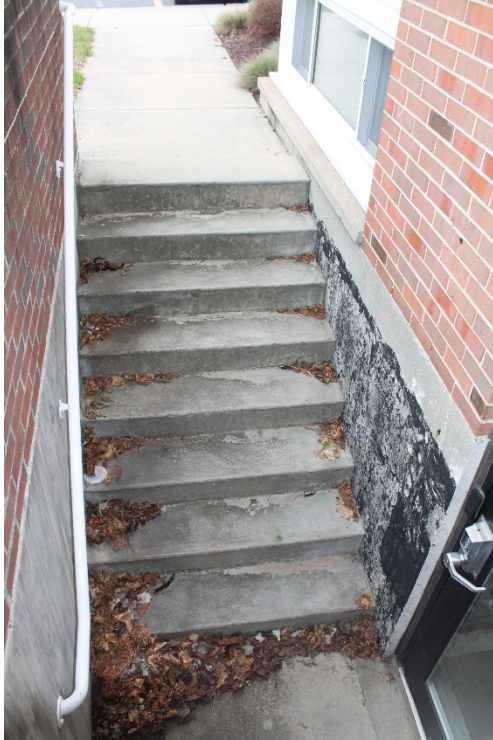
Photo 9: Exposed waterproofing in areaway

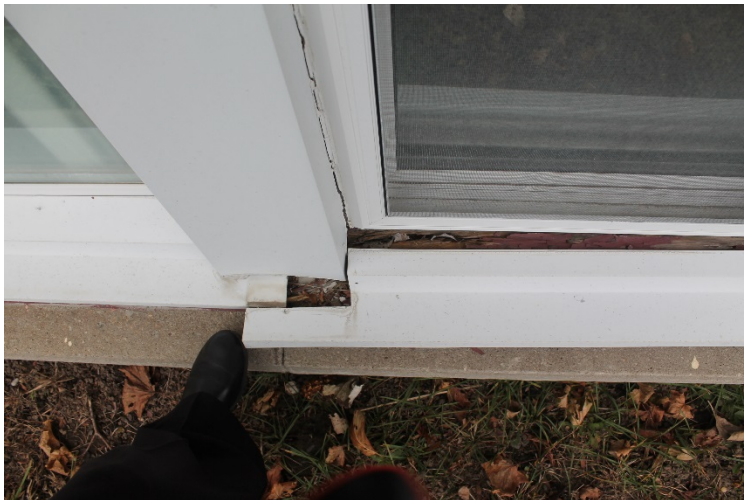
Photo 10: Wood sill is rotten below detached metal cap

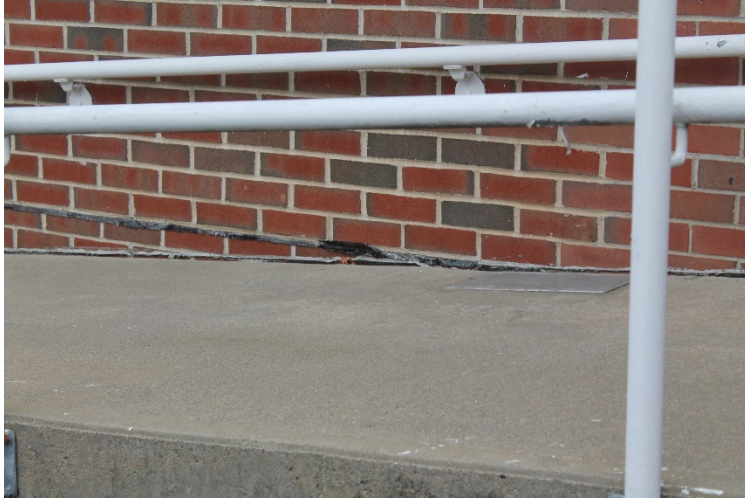
No step flashing was observed at the brick wall at the main entrance ramp into the police station. Original flashing (prior to construction of the ramp) appears to have been left in place with the ramp constructed in front of the wall. This original flashing dies into the ramp. (Photo 11) If there is not flashing above the ramp, water entering the wall cavity will not have a path to drain to the exterior of the building. The expansion joint between the exterior wall and ramp/stair assembly is deteriorating. (Photo 12) Concrete at the stairs is cracking and there is a potential for this concrete to spall. Stairs appear to have experienced some settling and are pulling away from the masonry joint.

Photo 11: Flashing is not stepped at ramp, but dies into walking surface

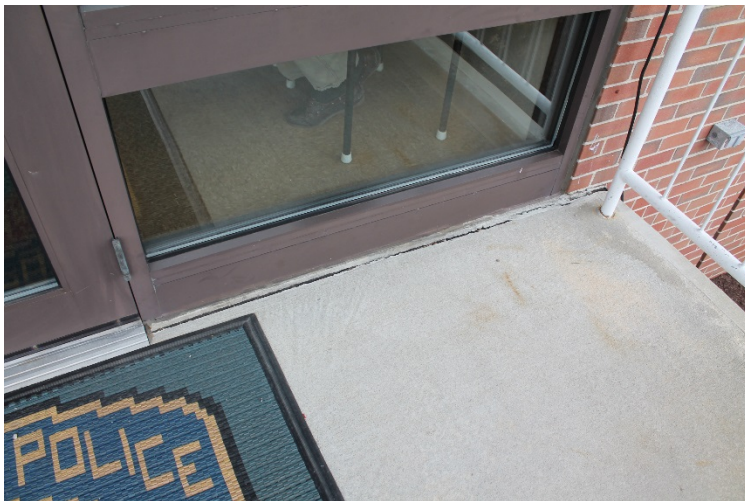
Photo 12: Joint where ramp/stair meets the building is deteriorated and open

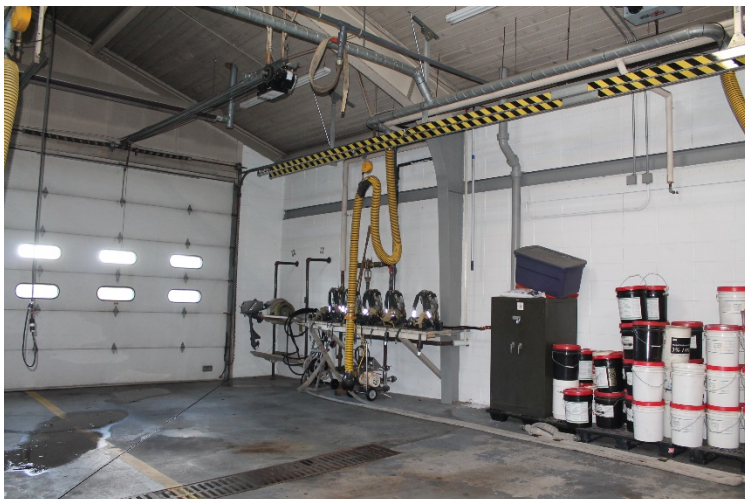
Floor Conditions: Flooring in the new additions is good. VCT is generally in fair condition, with some locations in poor condition with loose tiles observed. Carpet is in fair to poor condition throughout. Ponding was observed on the apparatus bay floor with cracking and peeling paint. (Photo 13) Ceramic tile is in good to fair condition. Laminate flooring is in excellent condition.

Photo 13: Ponding and peeling paint at apparatus bay floor

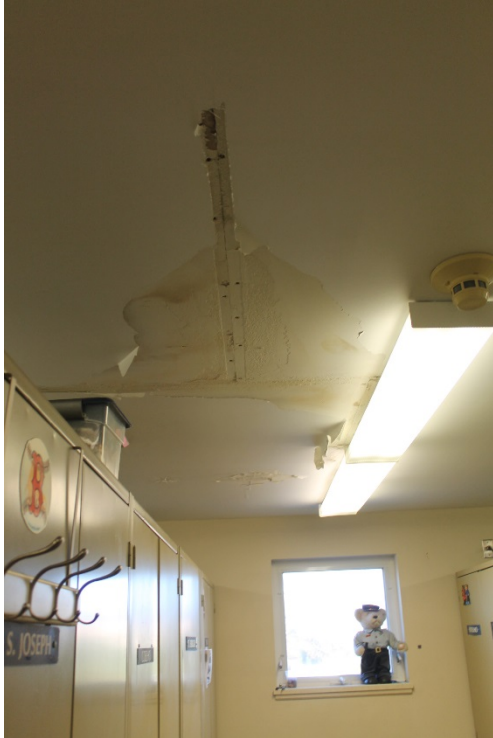
In the police station, ACT ceilings are water stained throughout the building, including some with black stains. Gypsum ceilings in some locations are in poor condition including in the Janitor's closets and locker room. (Photo 14)

Photo 14: Water damaged gypsum wallboard ceiling in locker room

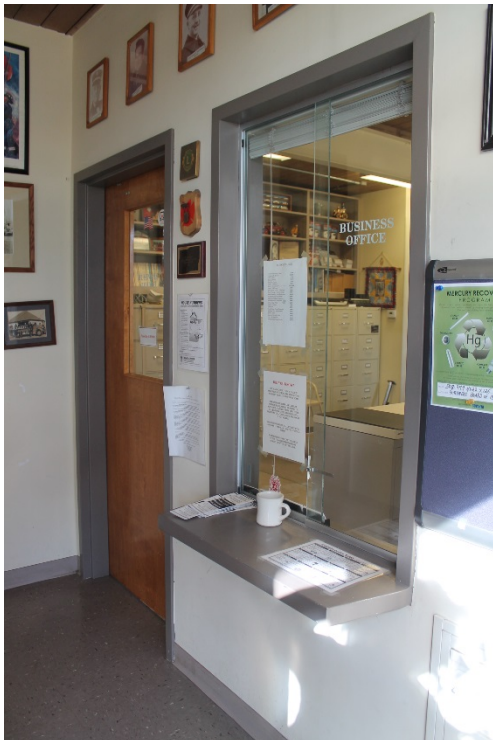
HCP Access: Several original doors have non-compliant hardware (knobs). Transaction counters in fire department lobby project more than allowed into the accessible pathway. (Photo 15)

Photo 15: Transaction counters in fire station project into the accessible pathway

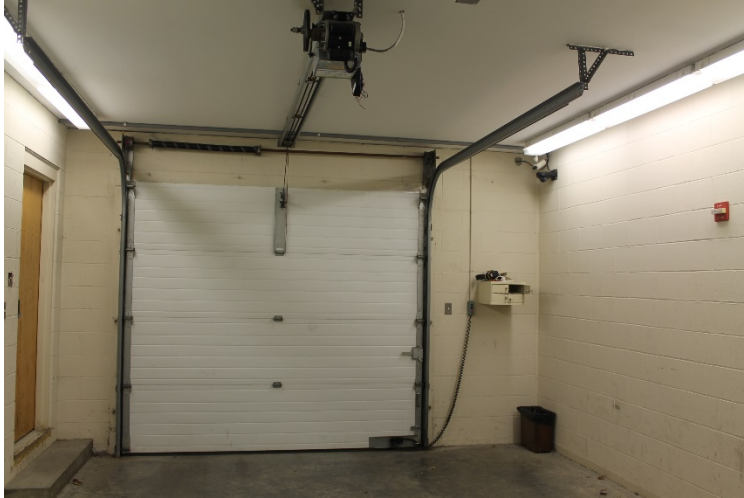
Other: A few rooms have steps into them located at the door threshold which is a safety hazard, code violation and accessibility violation. (Photo 16)

Photo 16: Note steps up to door at left of photo
