Building Name: Fire & Police Station**Address:** 150 Washington Street**Report By:** Victoria Howland**Site Visit Date:** December 7, 2017**EXISTING CONDITIONS:**

EXISTING CONDITIONS

PUBLIC FACILITIES IMPROVEMENT PLAN
150 WASHINGTON STREET
FAIRHAVEN, MA

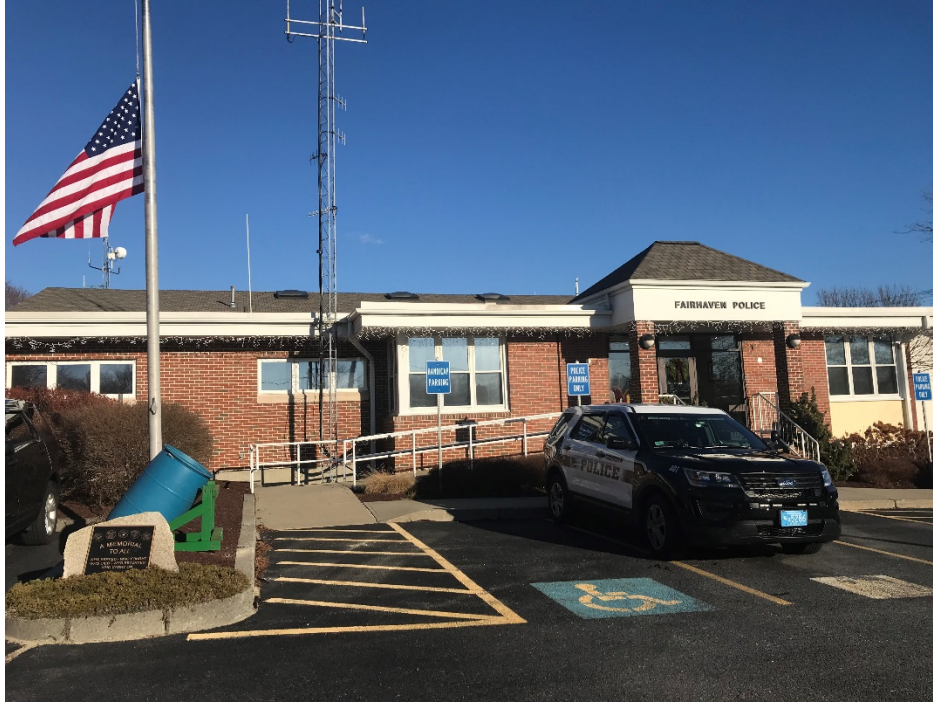
Photo No. 1

The dimensions of the parking spaces and access aisles were compliant with ADA regulations, however a car was parked in part of the access aisle at the Fire Station. The slope of the parking space at the Police Station (4.3%) did not meet ADA requirements. (2% maximum)

Attached Photo Log: Photo 1 – Accessible parking space at Police Station

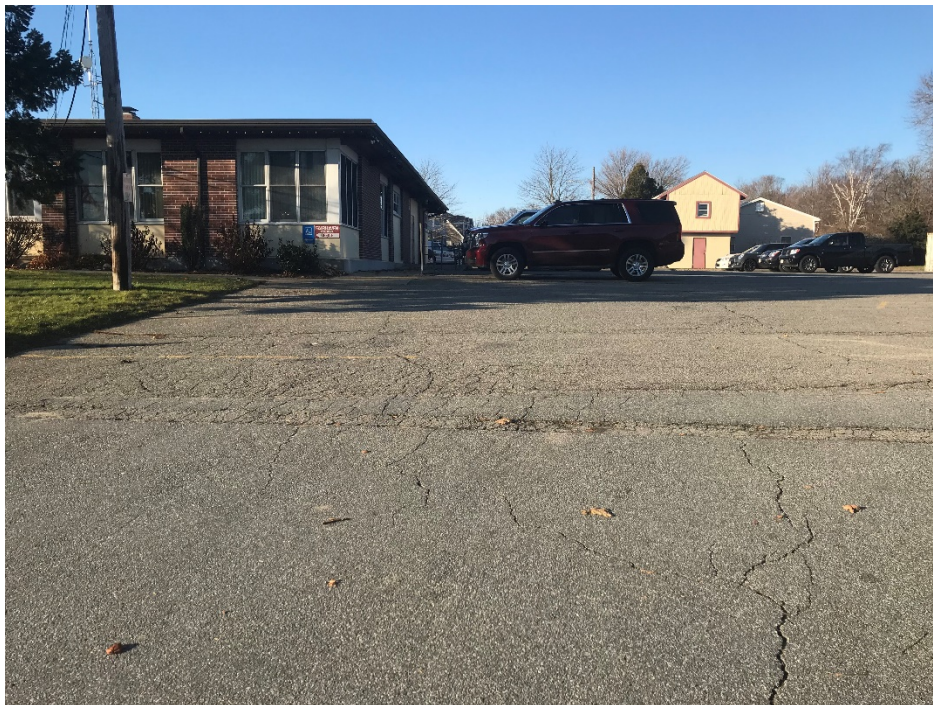
Photo No. 2

There are approximately 58 marked parking spaces in the Fire Station parking lot. Pavement in the lot is in poor condition and cracking was observed throughout the entire lot. Striping in the parking area has faded and therefore circulation through the lot is confusing. One of the curb openings from Washington Street appears to direct vehicles into the marked visitor parking spaces.

Photo 2 – Fire Station parking lot (taken from west entry at Washington Street)

- Repave and restripe Fire Station parking lot.

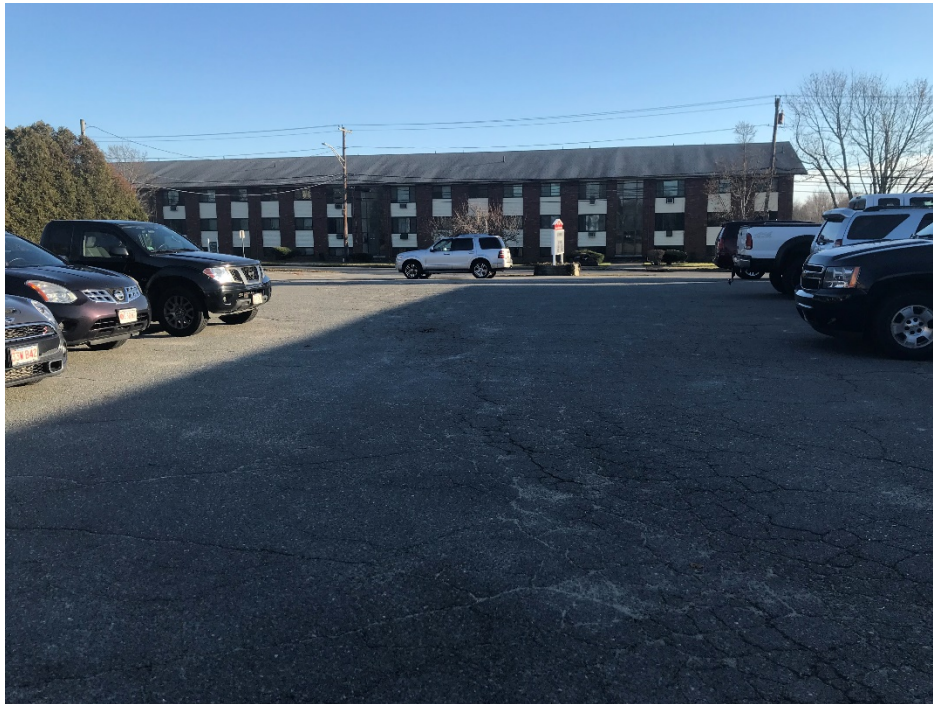
Photo No. 3

Photo 3 – Fire Station parking lot

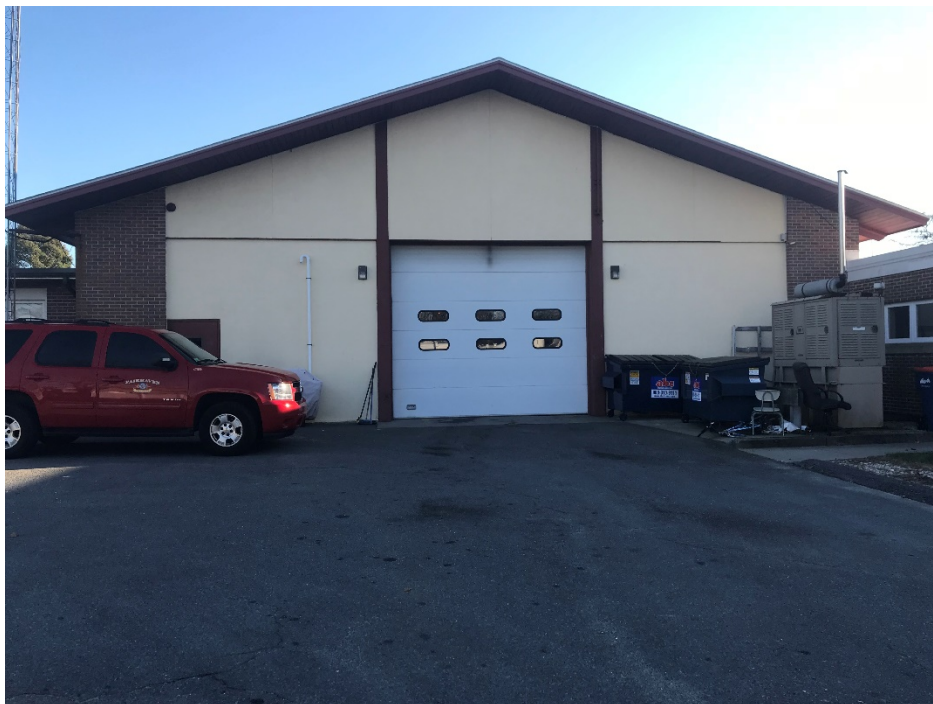
Photo No. 4

Trash Disposal: Trash receptacles and dumpsters for the building are located on the north side of the Fire Station.

Photo 4 – Fire Station and dumpster area (taken from Sunset Lane entry)

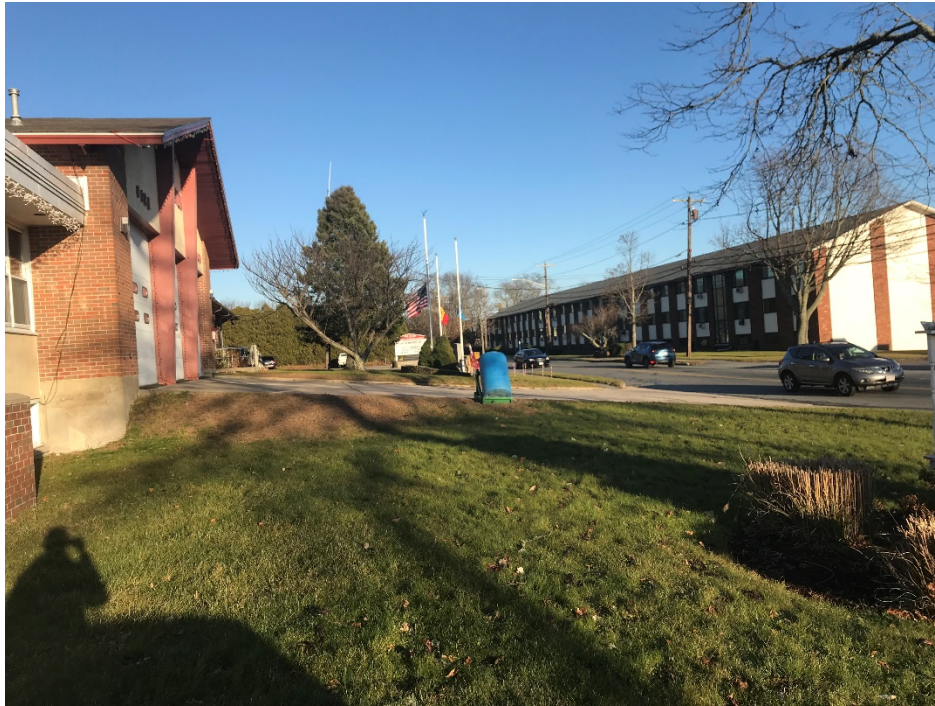
Photo No. 5

The accessible routes to each building entrance was reviewed. The slope of both accessible routes were not compliant with ADA regulations. (9% at Police Station, 6.8% at Fire Station)

Photo 5 – Steep slope between Washington Street and Fire Station.

Regrade accessible parking spot at Fire Station. Regrade accessible route to Fire and Police Stations.

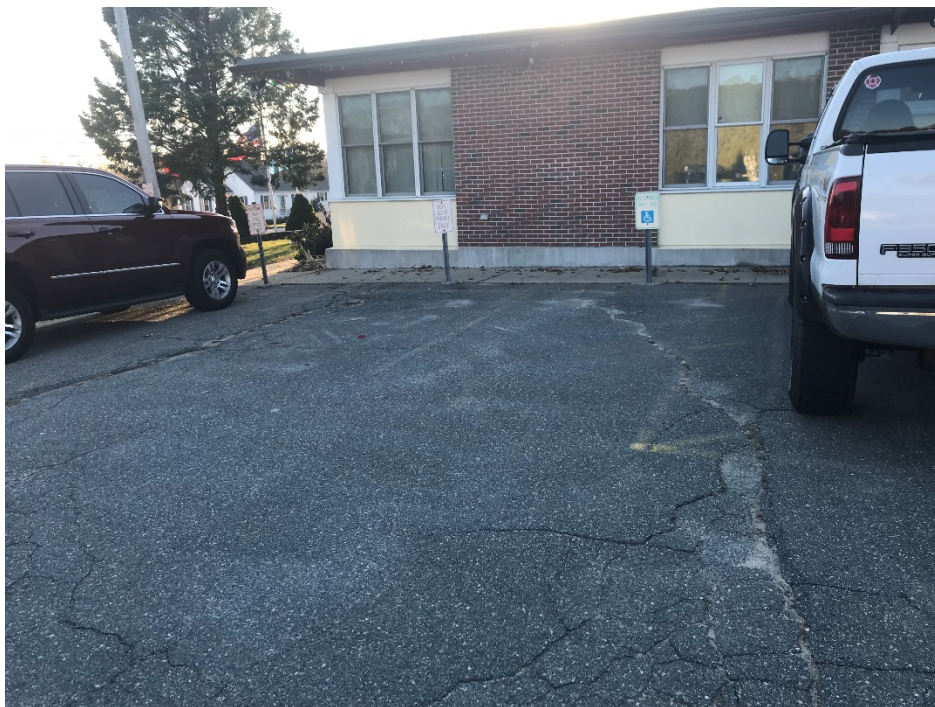
Photo No. 6

ADA Accessibility: The parking lots were checked for general compliance with ADA dimensional and grading regulations. The parking lots each had one marked accessible parking space. The number of marked accessible parking spaces (one) does not comply with the minimum required per ADA (three) for the Fire Station parking lot. The number of marked accessible parking spaces at the Police Station (one) complies with the minimum required per ADA (one). There are no marked accessible van parking spaces.

Photo 6 – Accessible parking space at Fire Station.

Provide two additional accessible parking spaces in the Fire Station parking lot. One of the spaces shall be for accessible van parking.
