Building Name: Fire & Police Facility

Address: 150 Washington Street

Building Use: Joint Police and Fire Stations

Report By: K. Champagne **GSF** Approx. 17,000 SF **Date:** 12/7/17

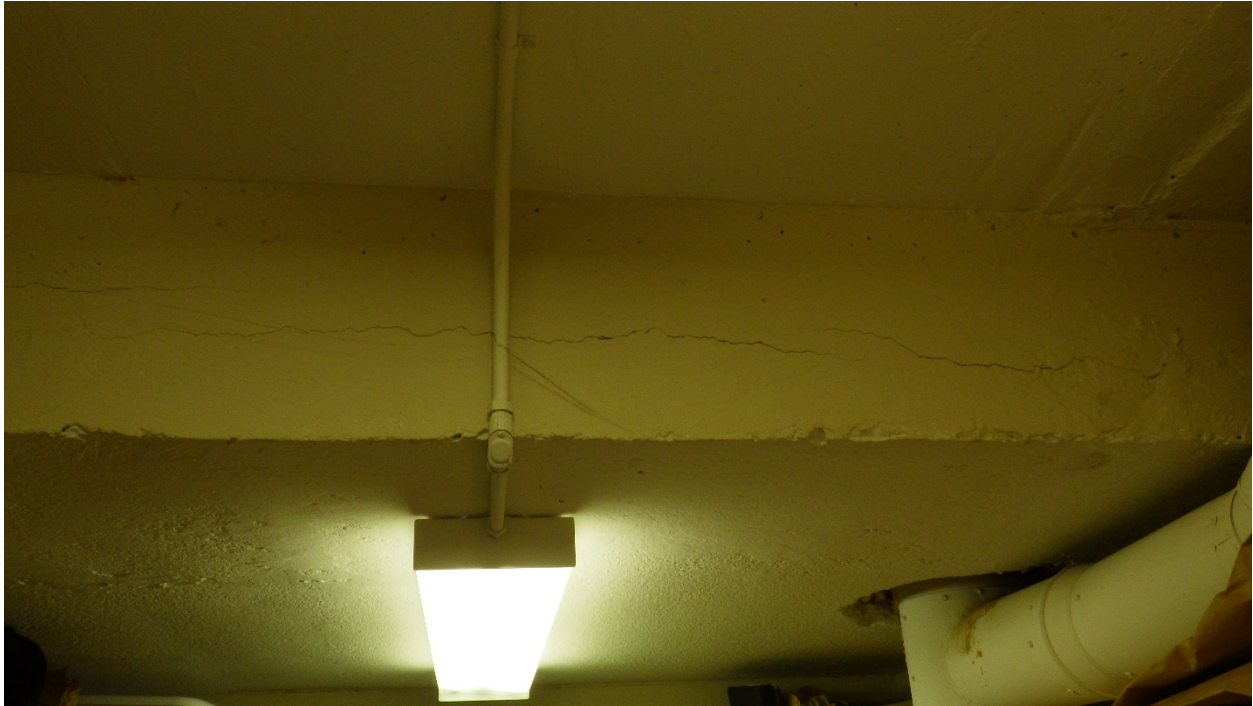
Photo No. 1

Areas of cracking and spalling were observed along the Fire Apparatus Bay approach apron at the building's exterior. A crack was observed in the original Police Station elevated first floor slab within the evidence room.

Attached Photo Log: Photo 1 – Hairline crack (1/16" crack width or less) observed in elevated concrete floor slab within evidence room.

The concrete spalls and cracks along the Fire Station Apparatus Bay exterior apron should be repaired with patching mortar and epoxy crack injection, applied in accordance with manufacturer's recommendations. The crack within the original Police Station elevated first floor slab (in evidence room) is less than 1/16" in width and should be monitored. If the crack widens, it should be routed and filled with epoxy in accordance with manufacturer's recommendations.

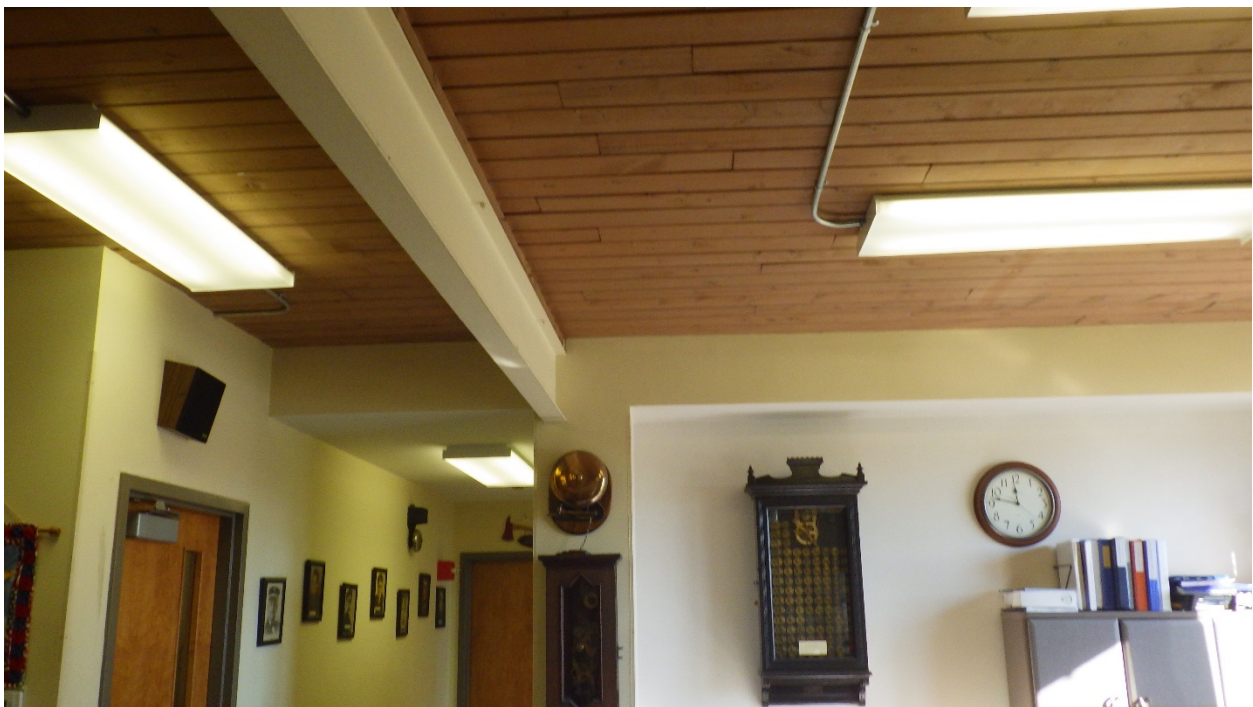
Photo No. 2

Where visible, the roof decking, steel beams, and CMU walls in the original building are generally in sound condition. Roof framing in the Police Addition and Fire Addition was not visible at the time of the visit due to finishes and insulation.

Photo 2 – Typical condition of timber roof planking and supporting steel beam (viewed from within original Fire Station building).

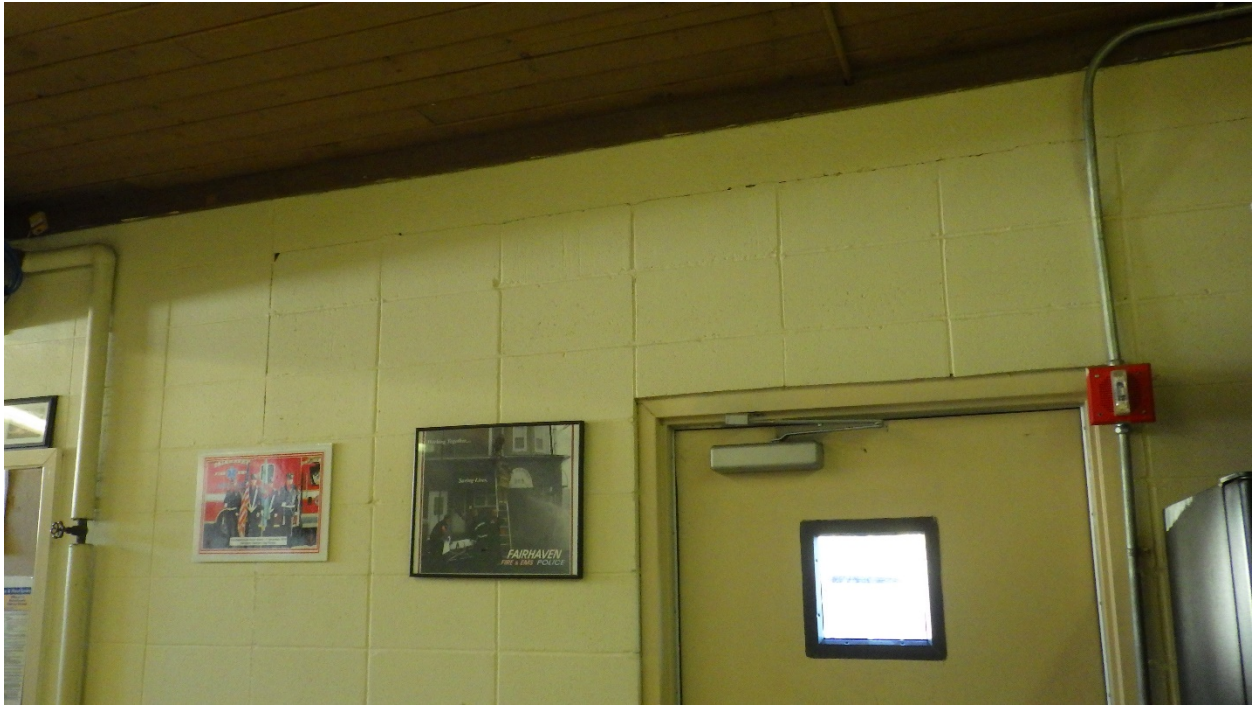
Photo No. 3

GENERAL COMMENTS: Load-bearing and partition walls within the original Fire and Police building are constructed with stack bond masonry and support a timber plank roof (considered a flexible diaphragm per the building code). It is unclear from the original drawings if these CMU walls are unreinforced, but given the age of the original building they are likely either unreinforced or only lightly reinforced. Therefore, for any significant alteration of the building it should be assumed that the attachment of the walls to the existing roof framing will need to be evaluated for code-

Photo 3 – Typical stack-bond CMU wall.

prescribed seismic loads and upgraded as necessary. Connections may require some level of retrofit including, but not necessarily limited to installation of new ledger boards, new anchor rods, and strapping. Note that a "significant alteration" (i.e. Level 3 alteration) is defined by the Massachusetts Existing Building Code as renovations/alterations where the "work area" exceeds 50% of the aggregate area of the building. The work area is defined as "that portion or portions of a building consisting of all reconfigured spaces as indicated on the construction documents."

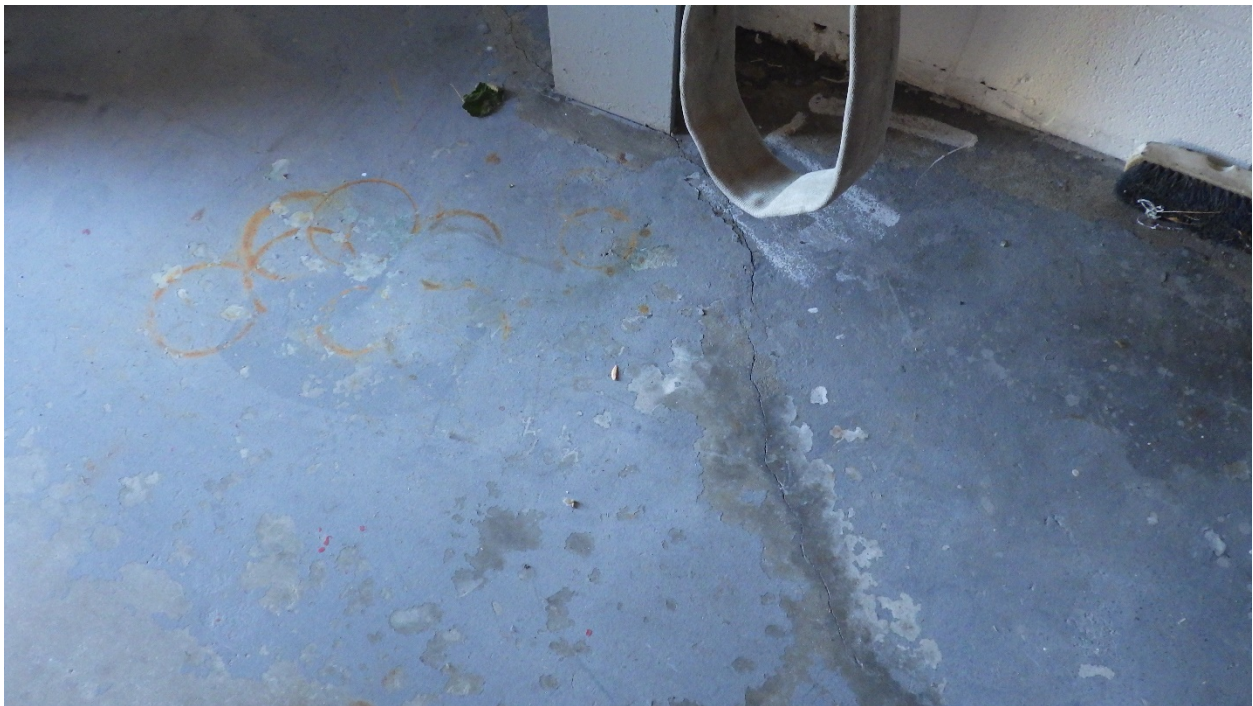
Photo No. 4

Foundation Condition: Where visible, the foundation appears to generally be in sound condition. Some shrinkage cracking was noted in the ground floor slab-on-grade in the Police Addition Apparatus Bay (at changes in slab pitch) and in the ground floor slab-on-grade in the original Fire Apparatus Bay (random cracking). The cracks did not appear to be indicative of active movement and generally shrinkage cracks do not affect the structural integrity of the slab.

Photo 4 – Random shrinkage crack observed along original Fire Station Apparatus Bay slab-on-grade.

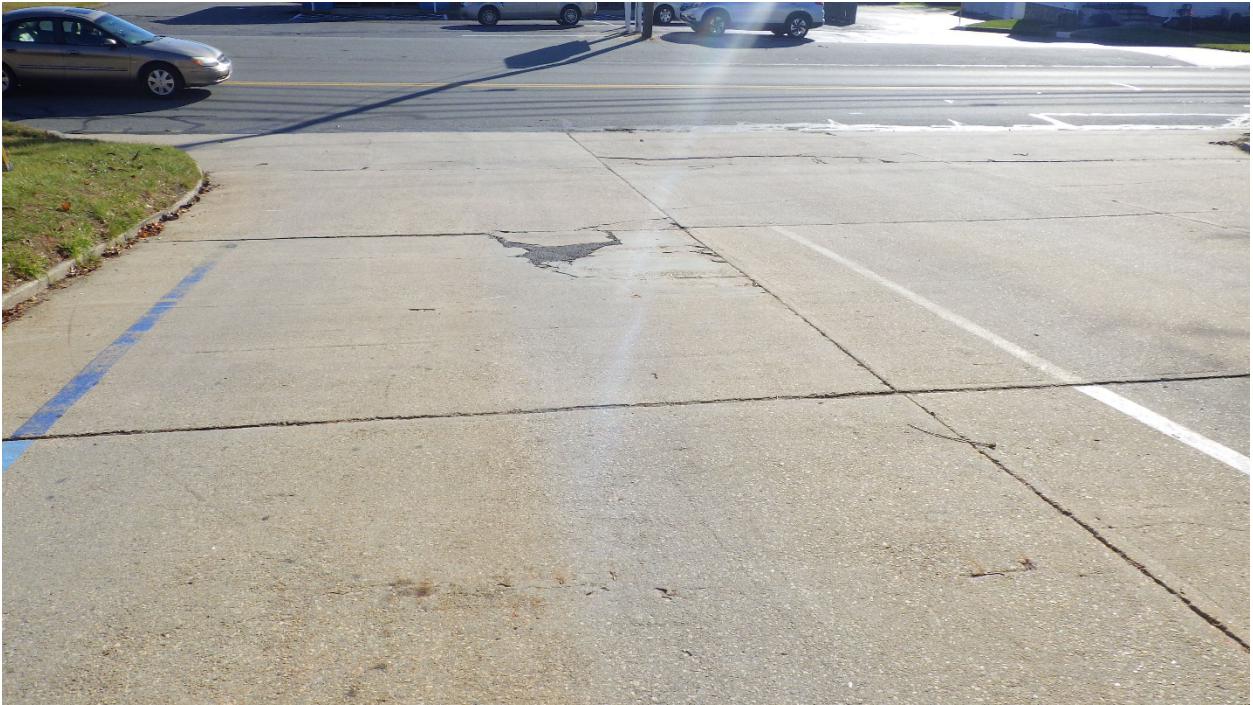
Photo No. 5

Areas of cracking and spalling were observed along the Fire Apparatus Bay approach apron at the building's exterior. The transition between the exterior apron and the interior slab-on-grade has been patched with asphalt.

Photo 5 – Cracking/spalling observed along Fire Station Apparatus Bay approach apron.

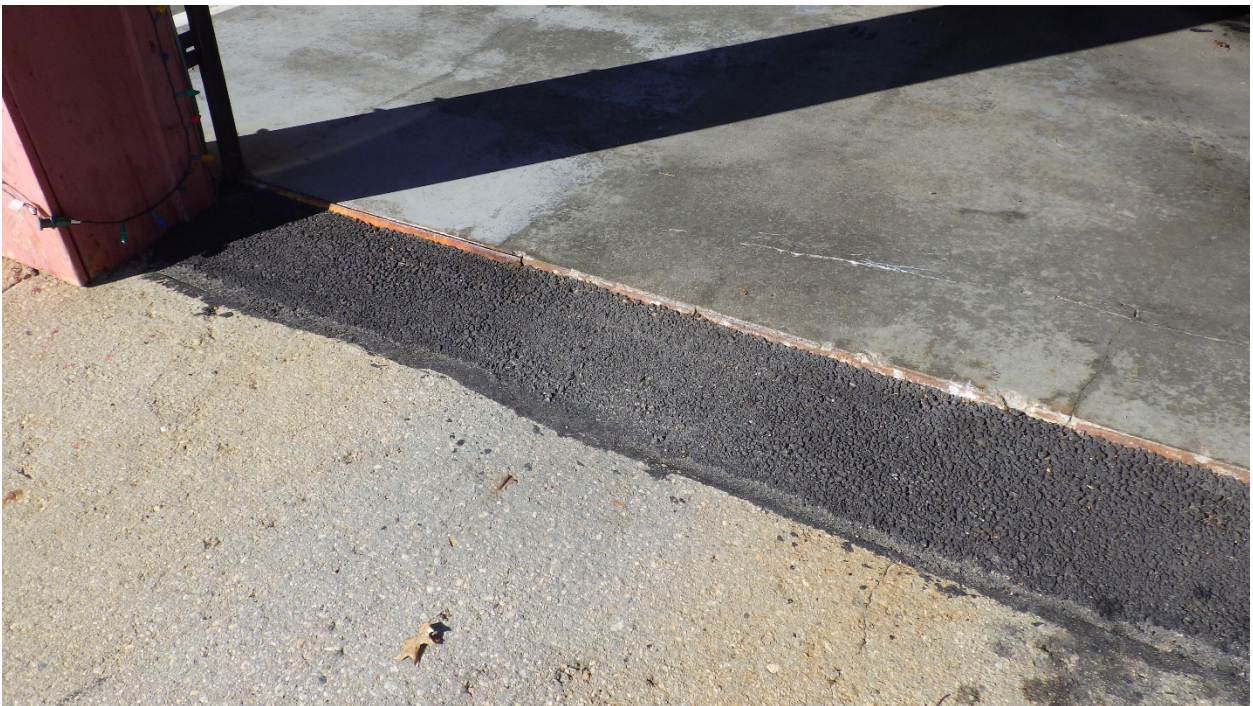
Photo No. 6

Photo 6 – Asphalt patch at transition between Fire Station Apparatus Bay approach apron and interior slab-on-grade.
