| Facility Name | Location | BMP/Feature Description | Inspection Date | Recommended Maintenance | Action Taken |

Town of Fairhaven

**STORM WATER BMP INSPECTION FORM**

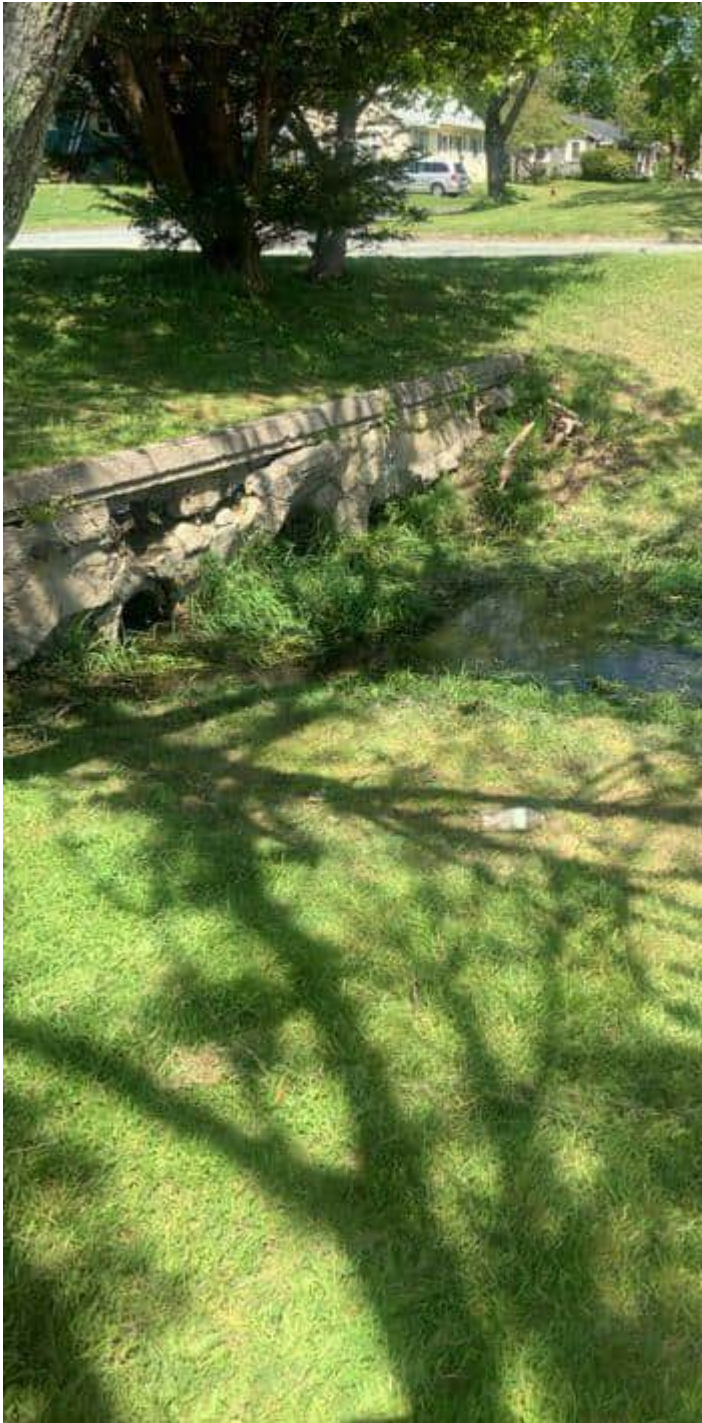
Swale inlet

| Problem | Description | Quantity | Completed (by) | Date |
|---|---|---|---|---|
| Sediment/Debris | Remove trash | | | |

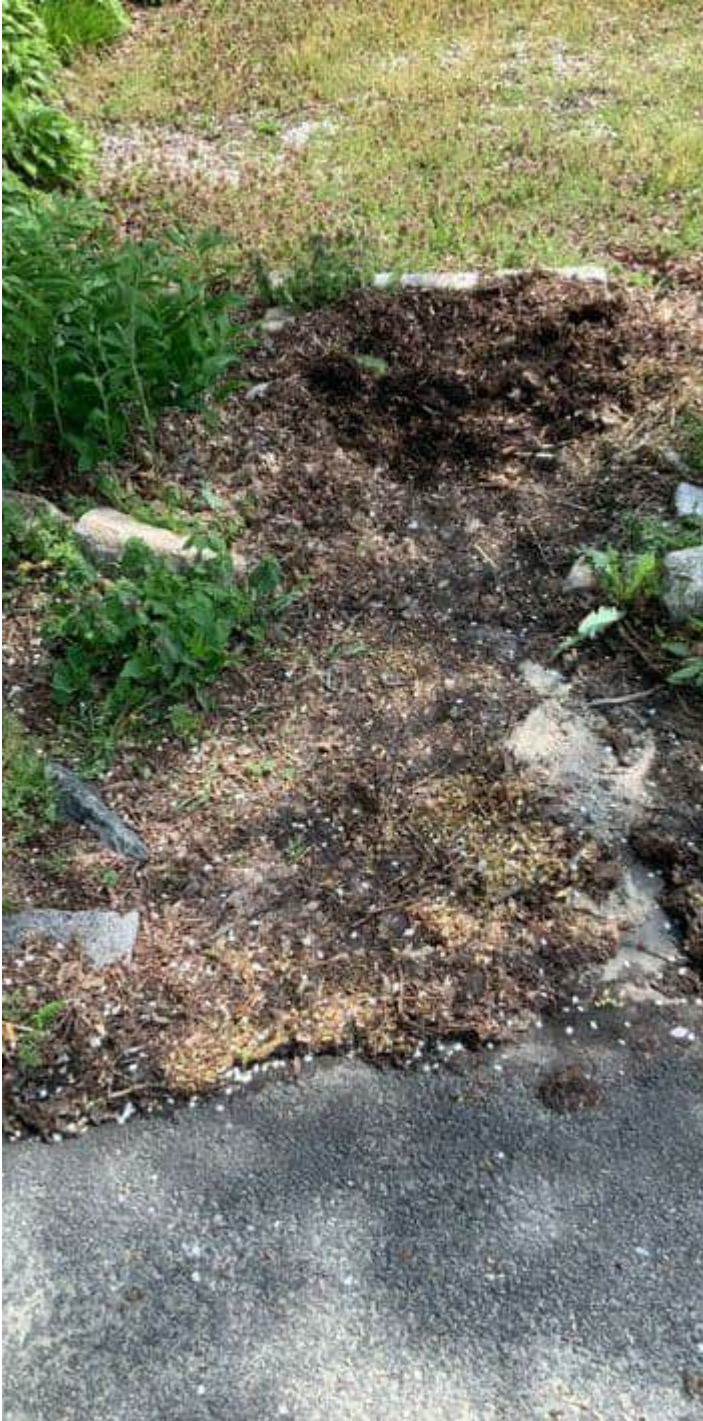
| Problem | Description | Quantity | Completed (by) | Date |
|---|---|---|---|---|
| Sediment/ Debris | Clean sediment and debris from inlet channel | | | |

Clean Sediment and debris from inlet channel

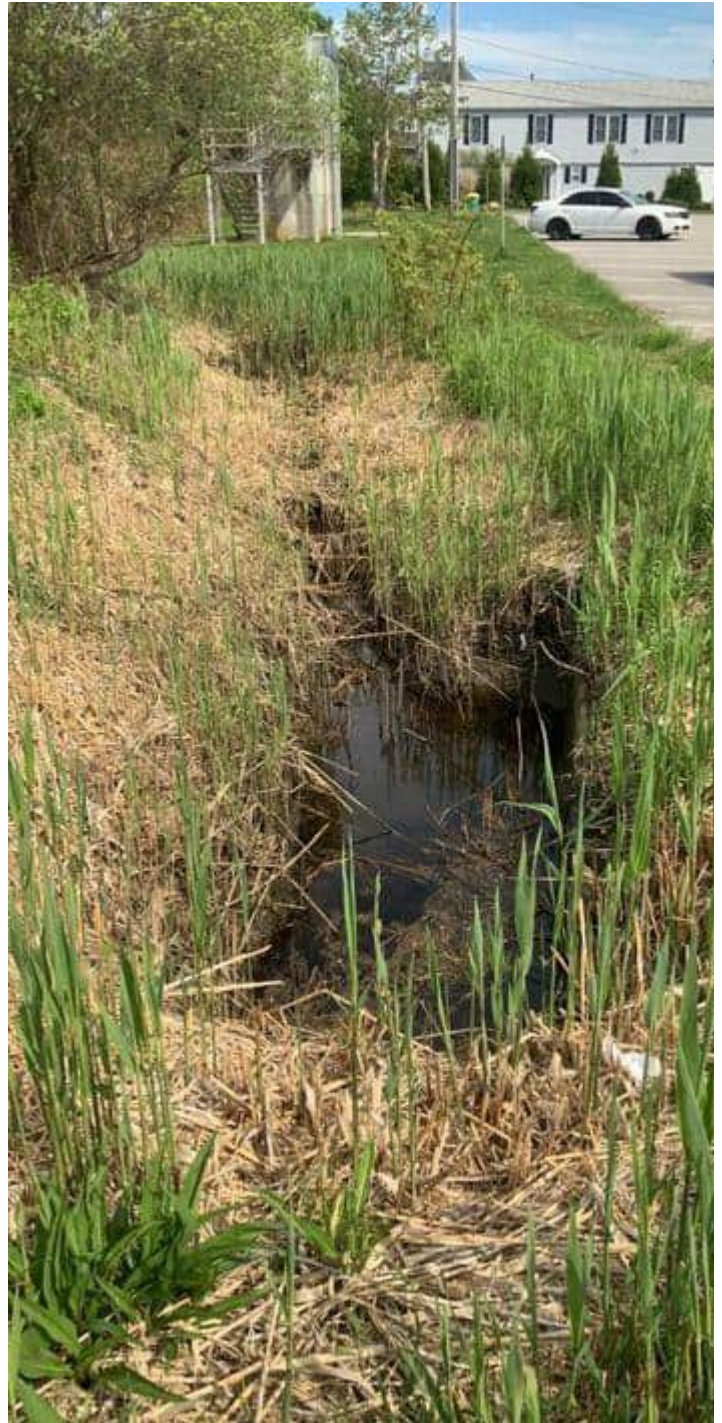
Swale

| Problem | Description | Quantity | Completed (by) | Date |
|---|---|---|---|---|
| Other | Clean vegetation and sediment swale | | | |

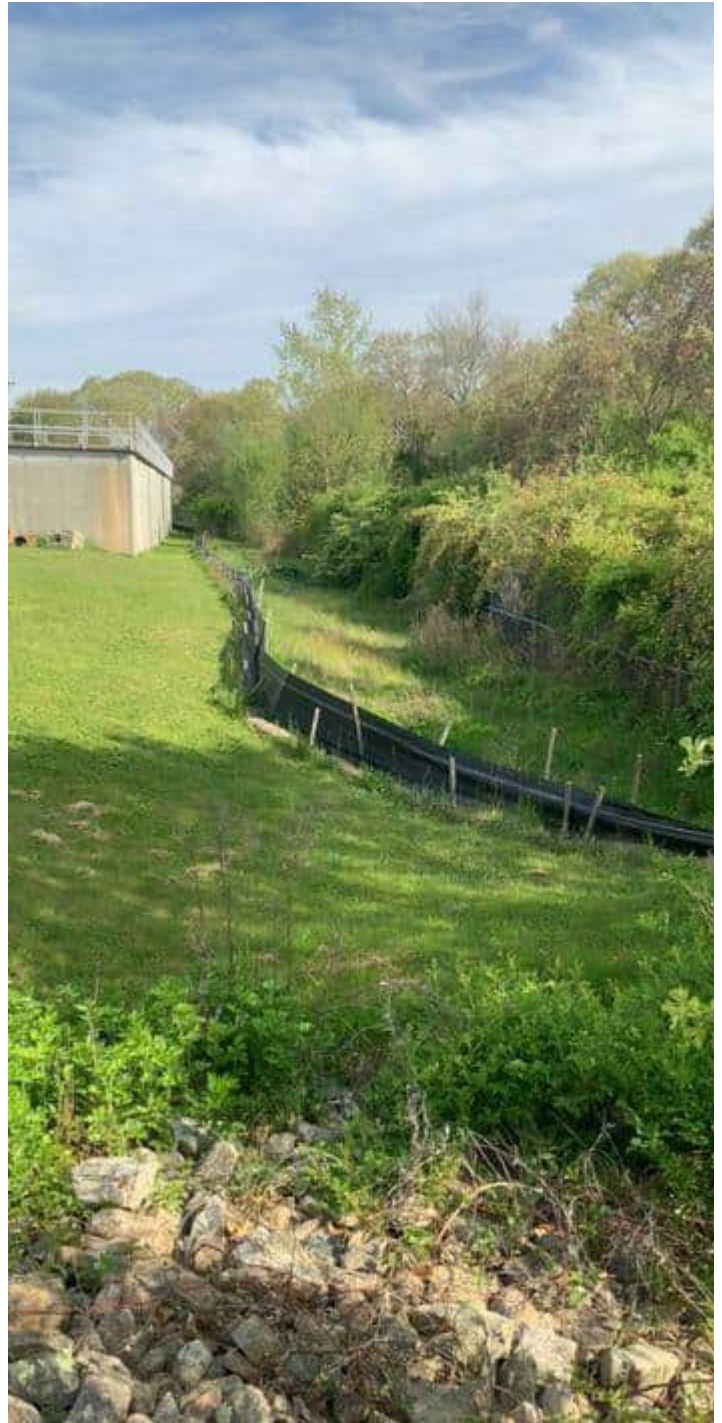
| Dimensions | Measurement | Additional Notes: | Outlet pipe entering swale is ridged and catching sediment |

Swale cut off from erosion control

| Problem | Description | Quantity | Completed (by) | Date |
|---|---|---|---|---|
| Vegetation | Remove excess vegetation and trees | | | |

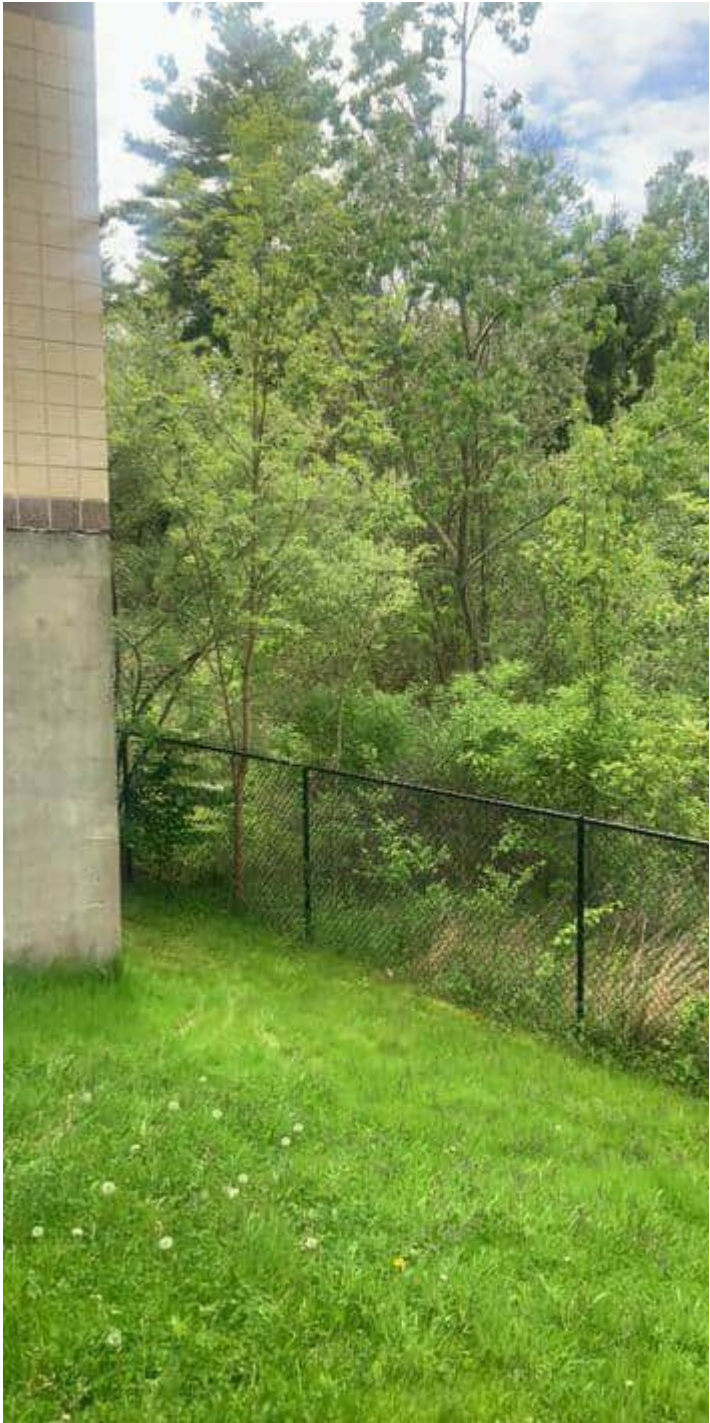
Detention basin

| Problem | Description | Quantity | Completed (by) | Date |
|---|---|---|---|---|
| Vegetation | Remove overgrown mature trees | | | |
| Fence | Cannot access due to locked fence | | | |

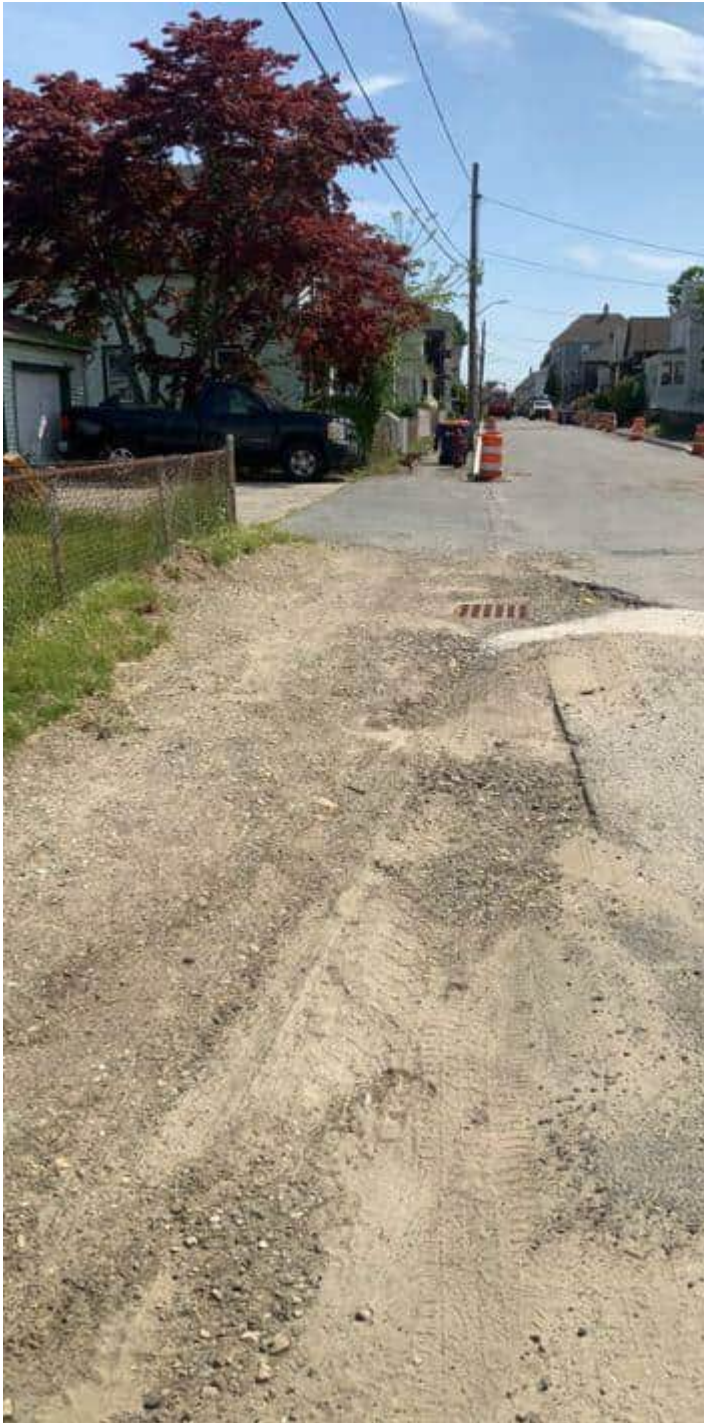
Outside tree box filter 2 removed under construction

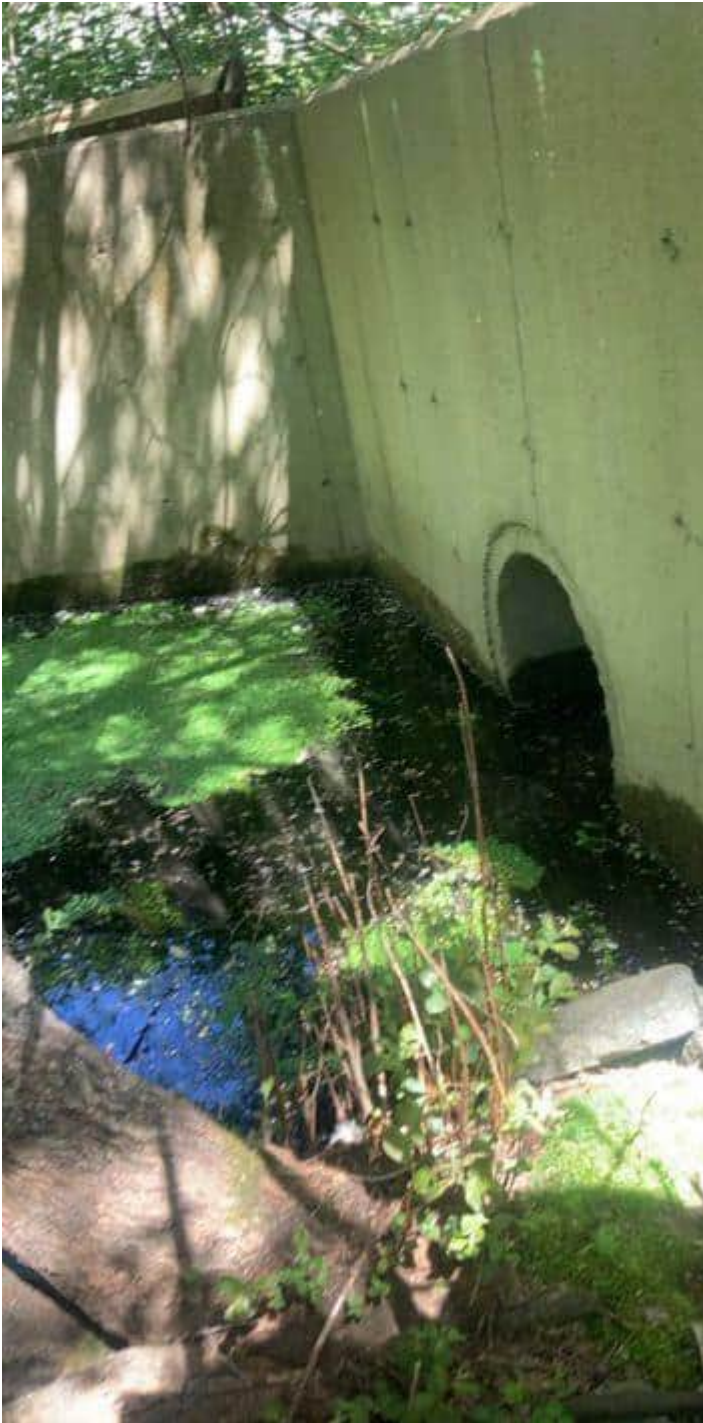
Basin inlet

| Problem | Description | Quantity | Completed (by) | Date |
|---|---|---|---|---|
| Vegetation | Remove vegetation very hard to access | | | |

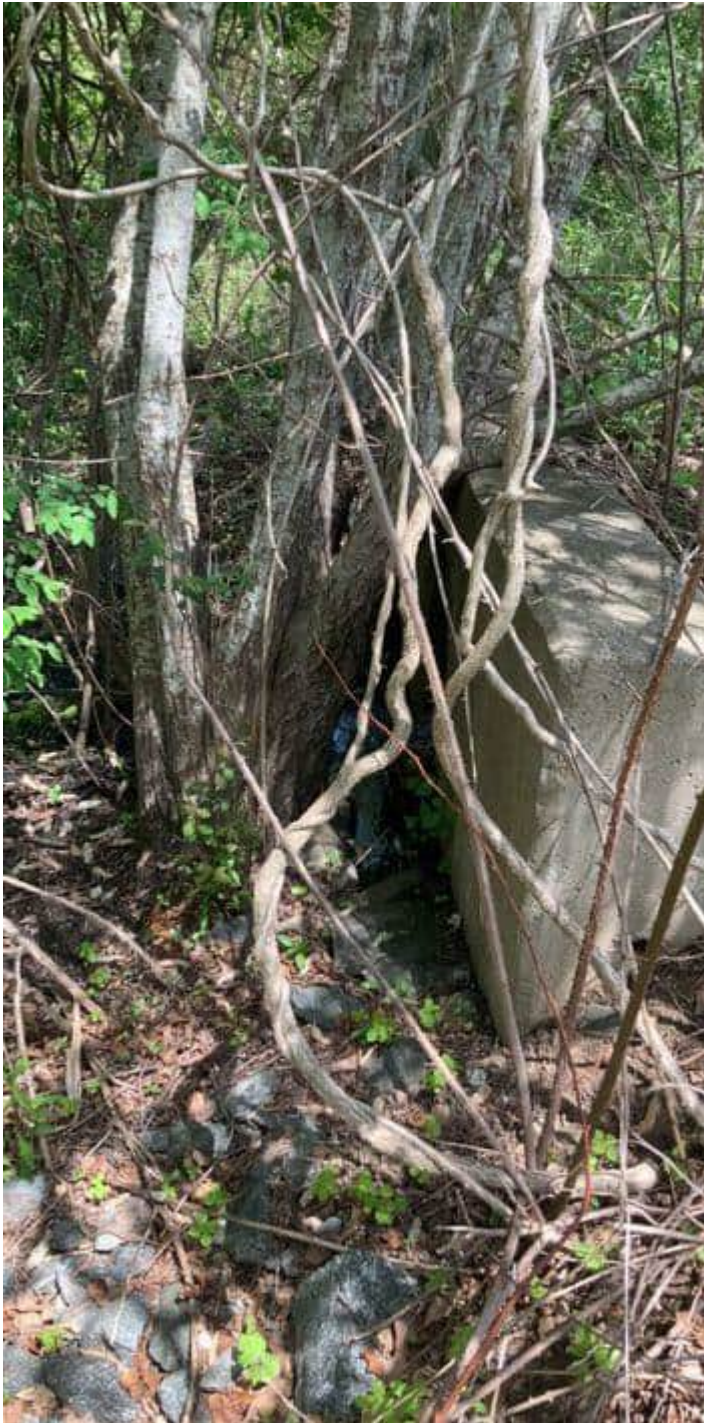
Basin inlet 1

| Problem | Description | Quantity | Completed (by) | Date |
|---|---|---|---|---|
| Sediment/Debris | Remove Trash<br>Sever brush and tree overgrowth | | | |

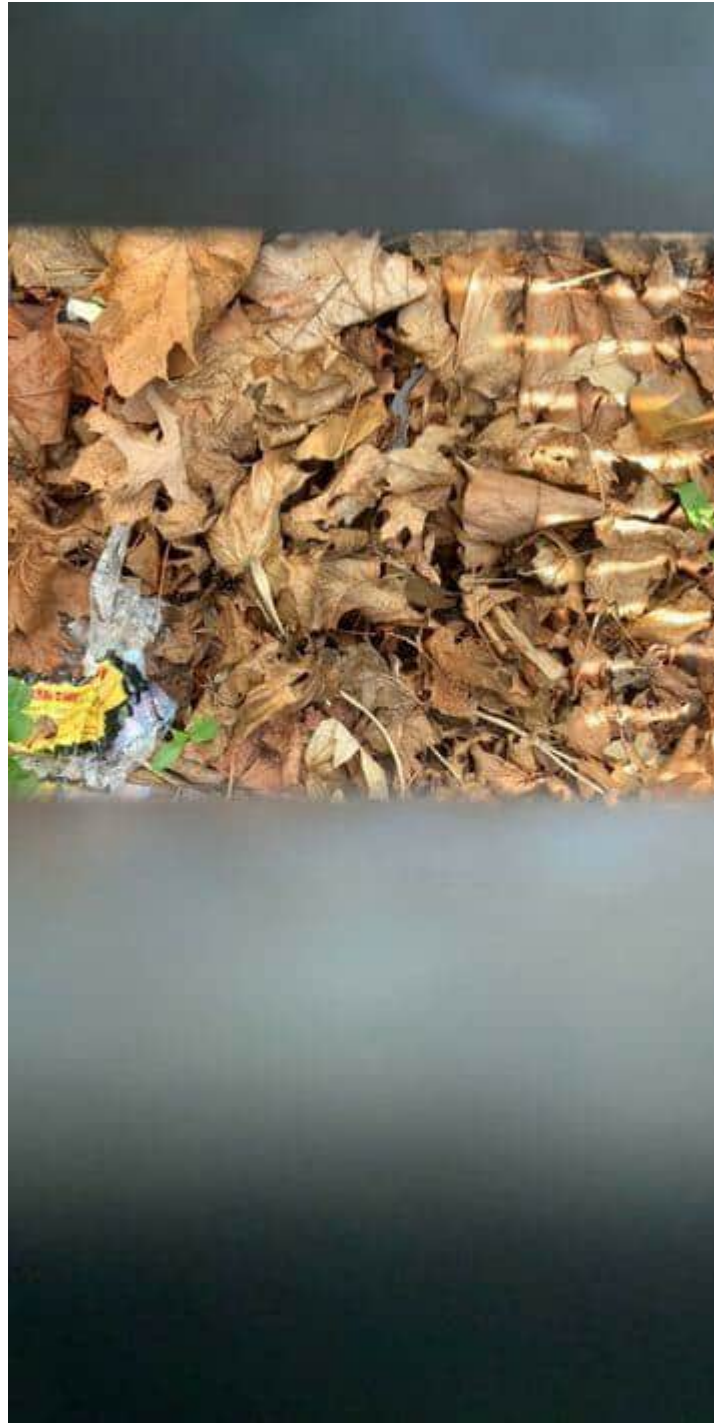
Inside tree box filter

| Problem | Description | Quantity | Completed (by) | Date |
|---|---|---|---|---|
| Sediment/Debris | Clean leaves, sediment and debris from tree box filter | | | |

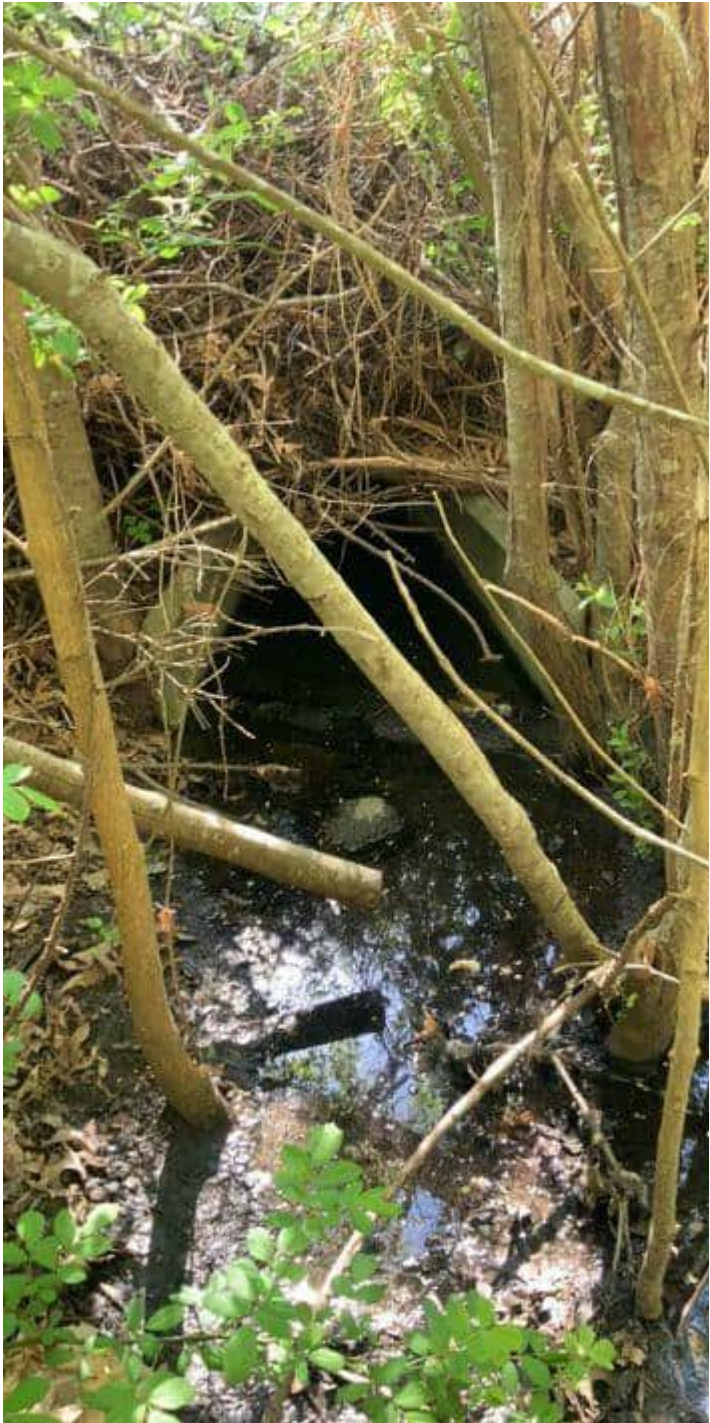
Basin inlet

| Problem | Description | Quantity | Completed (by) | Date |
|---|---|---|---|---|
| Inlet | Remove trees blocking inlet and outlet | | | |

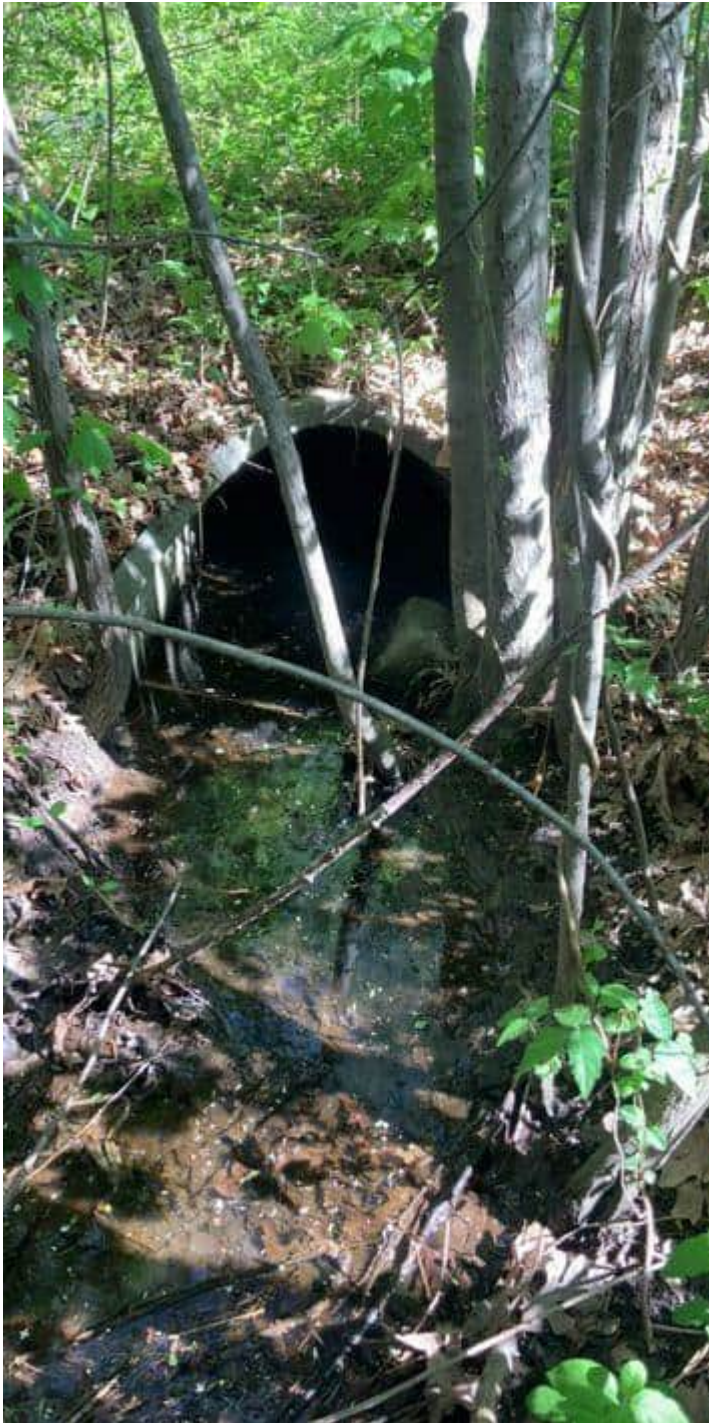
Basin inlet

| Problem | Description | Quantity | Completed (by) | Date |
|---|---|---|---|---|
| Inlet | Clear trees and sediment | | | |

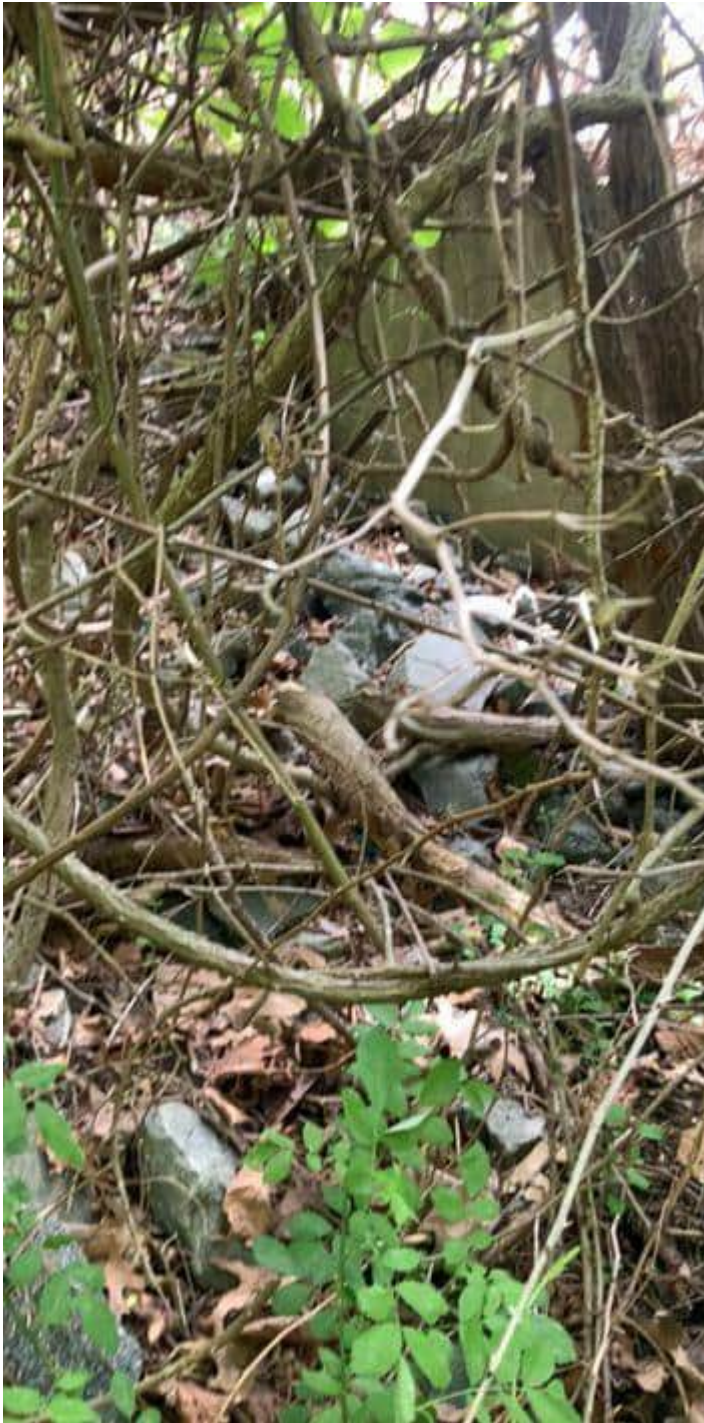
Basin inlet

| Problem | Description | Quantity | Completed (by) | Date |
|---|---|---|---|---|
| Vegetation | Severe overgrowth clear crush Ana vegetation | | | |

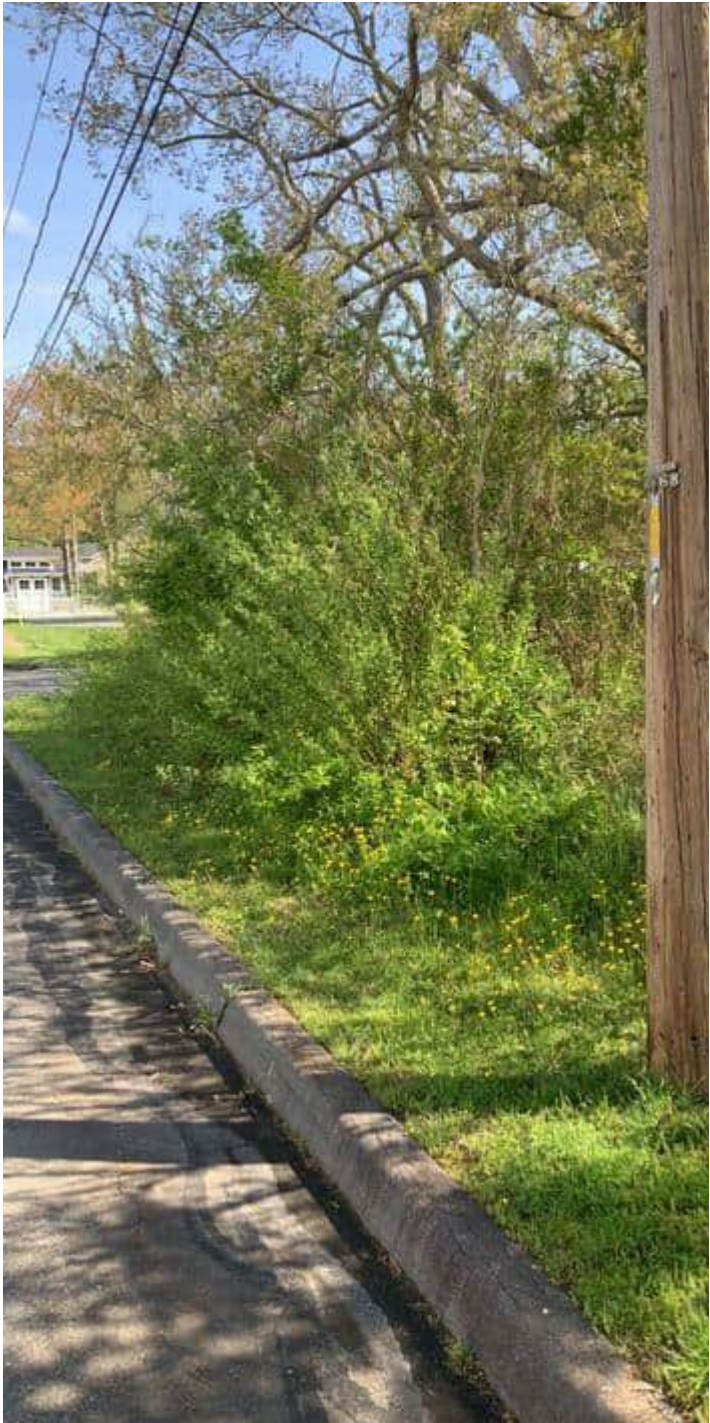
Trench inlet

| Problem | Description | Quantity | Completed (by) | Date |
|---|---|---|---|---|
| Sediment/ Debris | Remove debris and vegetation | | | |

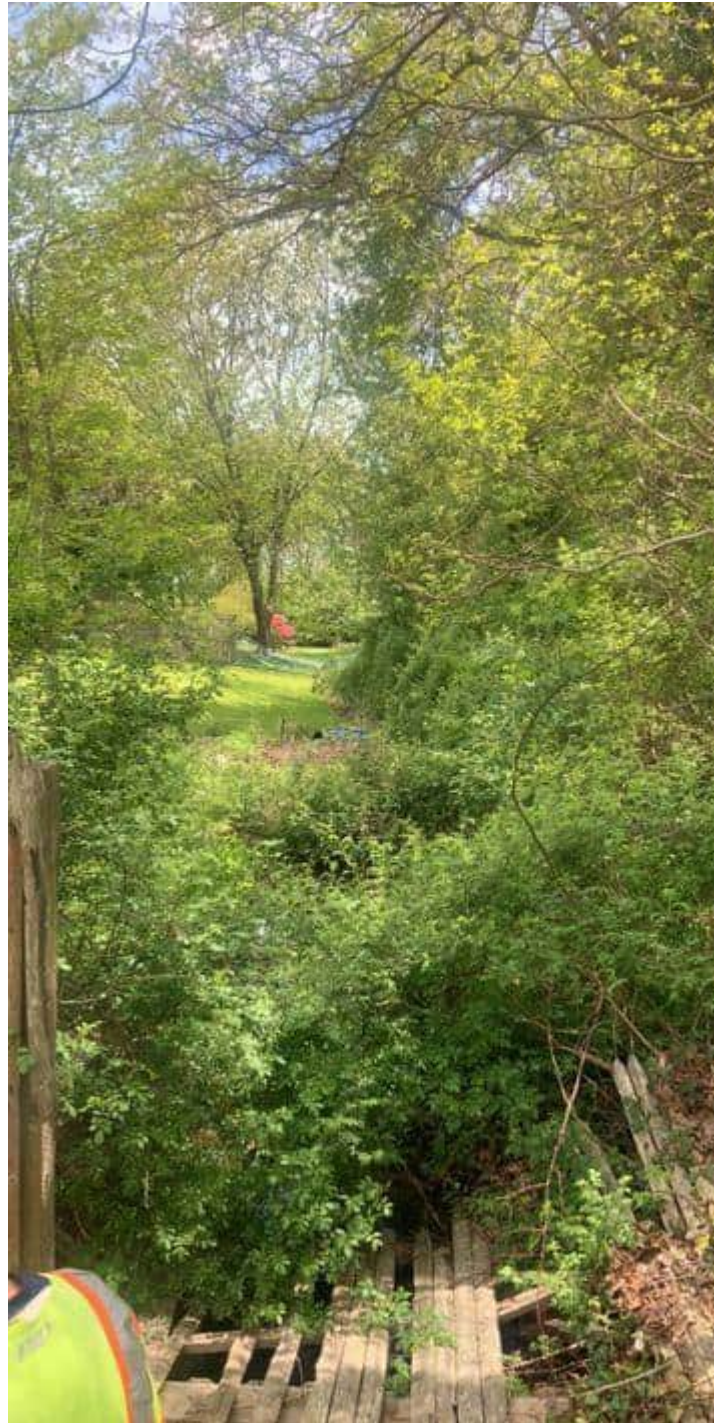
| Facility Name | Location | BMP/Feature Description | Inspection Date | Recommended Maintenance | Action Taken |
|---|---|---|---|---|---|
| Roadway Stormwater Management System | 11 SUVENCHY DRIVE<br>BMP-32 | Drainage Swales | 5/14/2025 | Add riprap into swale to allow water to flow into outlet.<br>Riprap needed to avoid puddling rain and erosion on embankments.<br>Allow easier access to outlet by removing excess vegetation.<br>Remove garden blocking swale, clean out channel. | |

Swale behind 7 Suvency Drive garden blocking swale

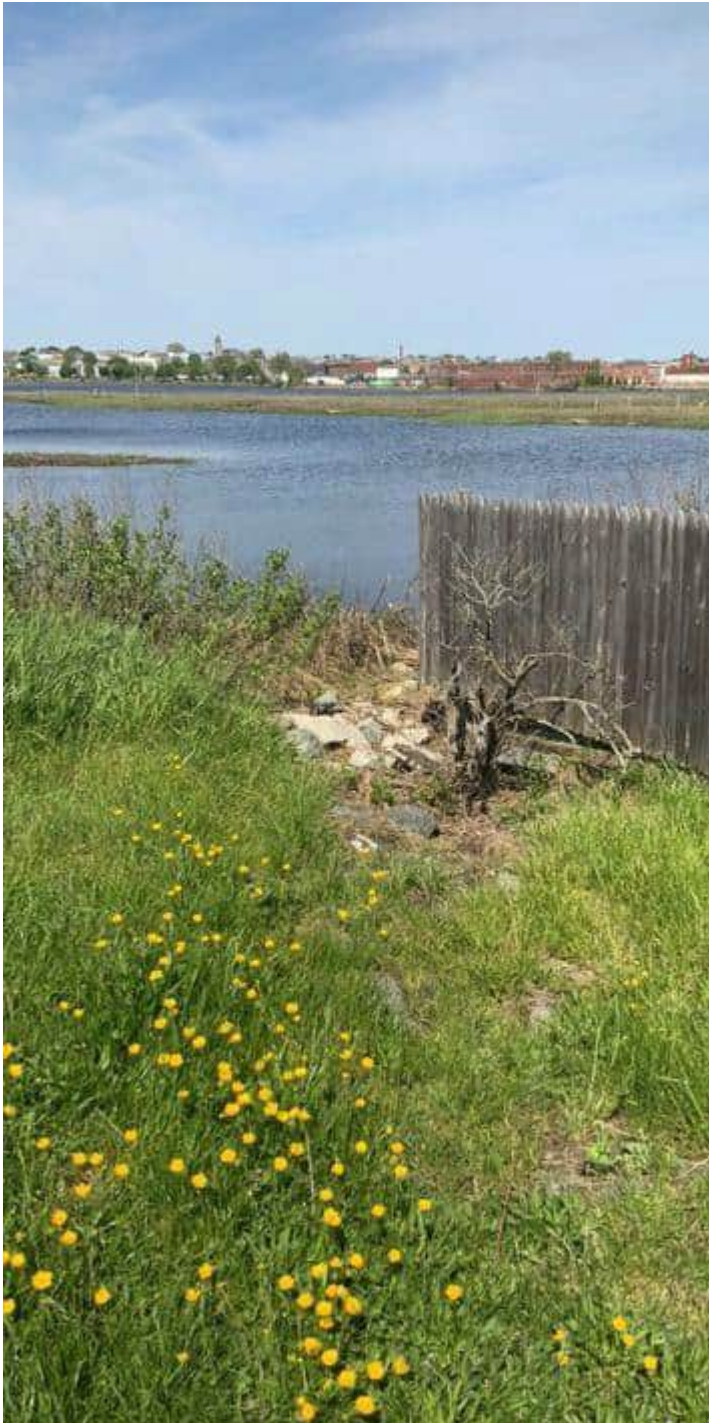
Swale entrance

| Problem | Description | Quantity | Completed (by) | Date |
|---|---|---|---|---|
| Vegetation | Clear vegetation from swale | | | |

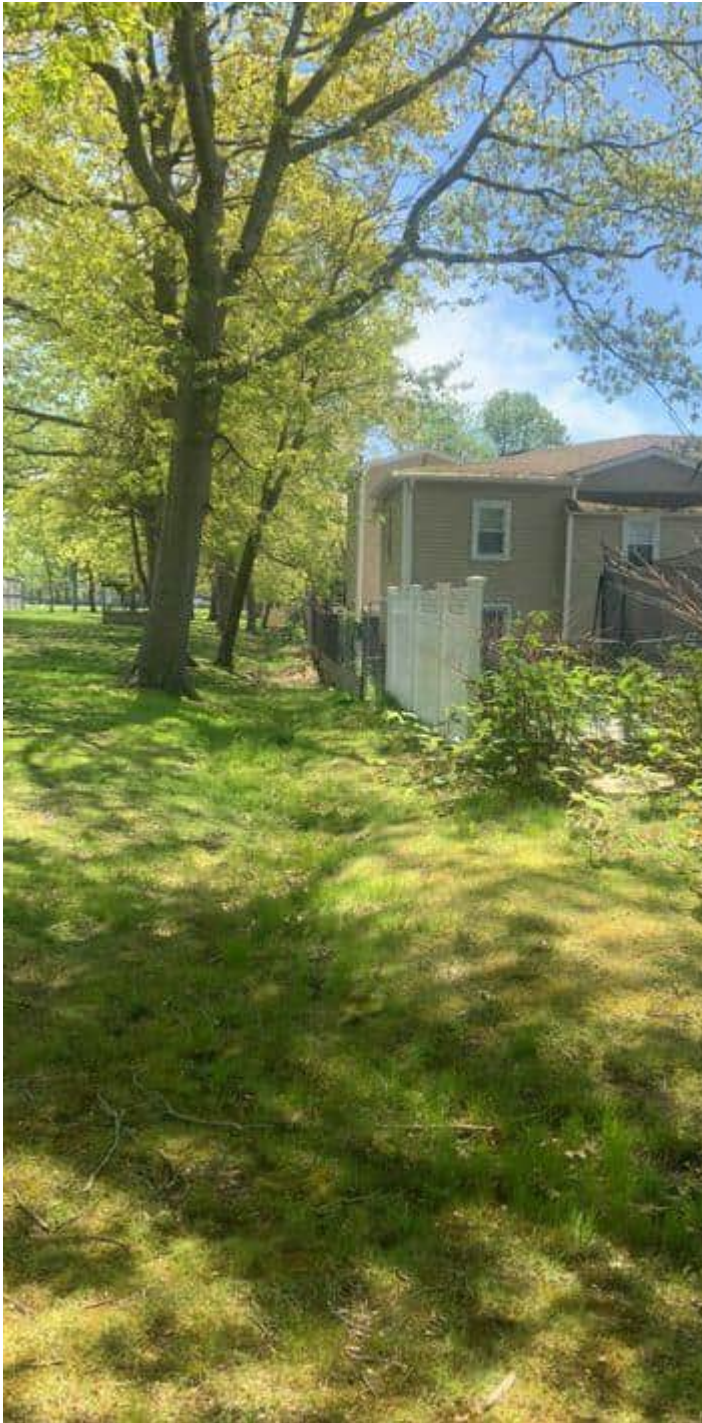
Start of swale leading to infiltration basin

| Problem | Description | Quantity | Completed (by) | Date |
|---|---|---|---|---|
| Vegetation | Cut vegetation in swale | | | |

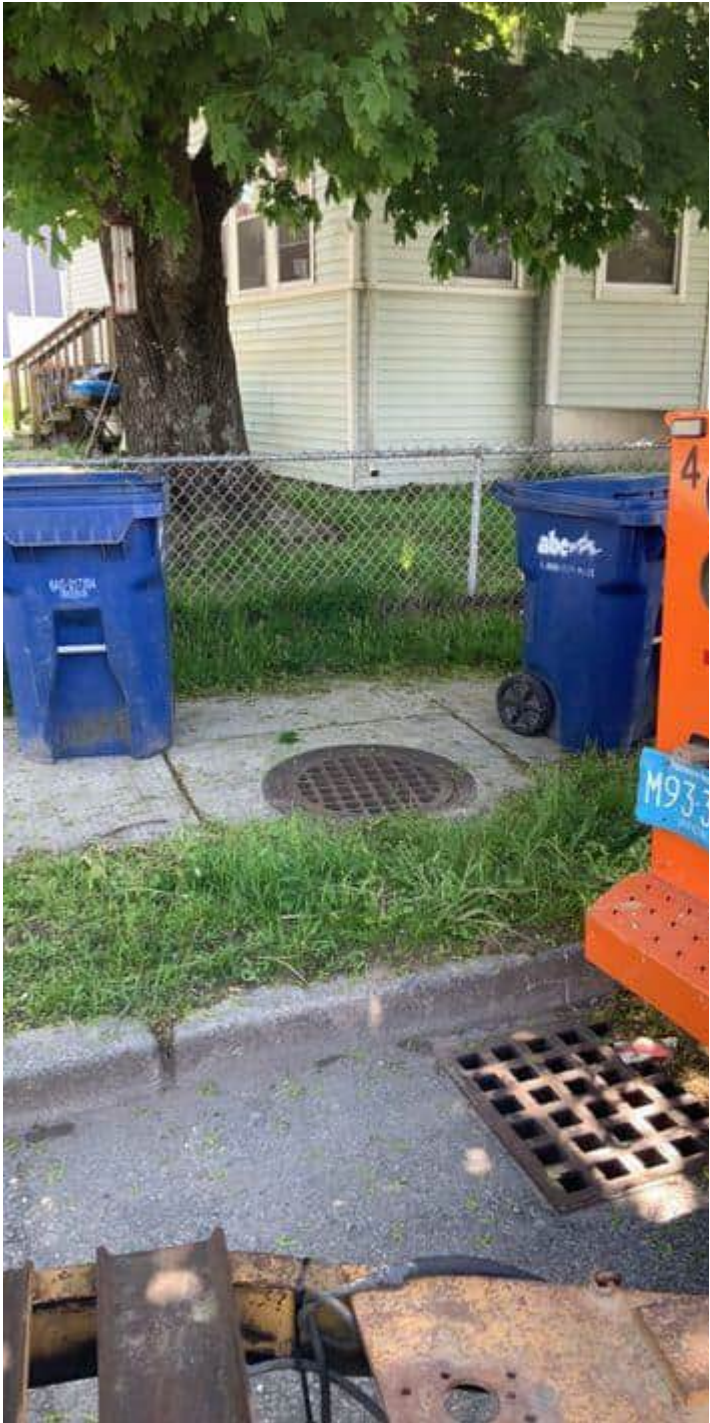
Outside tree box filter

| Problem | Description | Quantity | Completed (by) | Date |
|---|---|---|---|---|
| Sediment/Debris | Remove sediment and debris from structures | | | |
