Animal Control

Town of Fairhaven ADA Transition Plan

November 2024

Institute for Human Centered Design

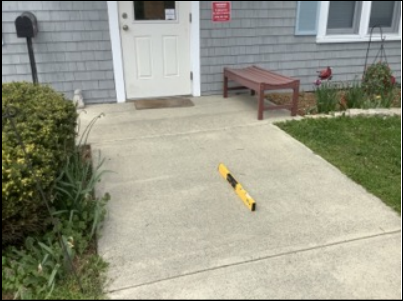
ID	Location	Floor	Room	Element	Type	Photo	Issues	Current Measure	Recommendations	Quantity	Price	Cost Estimation
Approach and Entrance												
Exterior Access Route												
1	To Main Entrance	Ext.		Exterior Access Route	Walkway

Running slope > 1:20 (5.00%)	6.7%	Reduce running slope to be no steeper than 1:20 (5.00%).	1	-	-
2	West Side Dog Area	Ext.		Exterior Access Route	Exterior

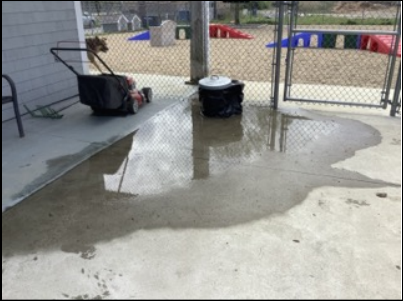
Does not prevent accumulation of water	-	Repair surface.	1	-	-
Off-Street Parking Lot or Garage												
3	Parking Lot	Ext.		Off-Street Parking Lot or Garage	Visitor

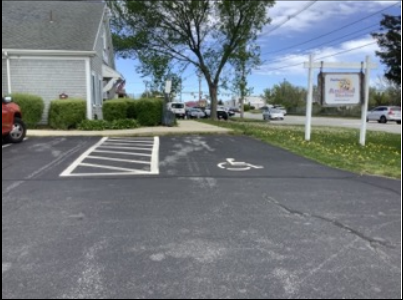
Total # of parking Total # of designated van accessible spaces Access aisle does not adjoin an accessible route Sign with the International Symbol of Acc. not provided Sign does not have the designation "Van Accessible"	10 1 - - -	Ensure the access aisle adjoins an accessible route. Provide a curb ramp. Provide a sign with the International Symbol of Accessibility (ISA) with the bottom of the sign 60" min. above the ground and the top 96" max. above the ground. Add the designation "Van Accessible" to the sign located at the van accessible space. (Cost estimate is for parking signage.)	1	500	\$500

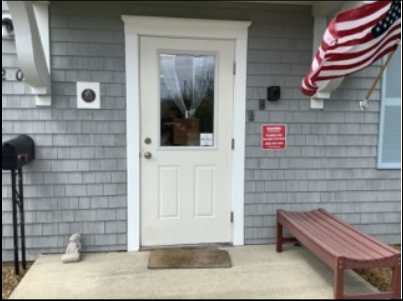
Entrance												
4	Main Entrance	Ext.		Entrance	Main Entrance

Mat not securely attached	-	Secure the mat.	1	Labor	Labor

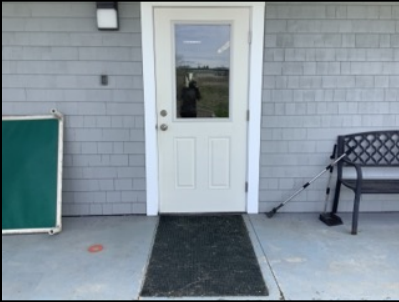
ID	Location	Floor	Room	Element	Type	Photo	Issues	Current Measure	Recommendations	Quantity	Price	Cost Estimation
5	Entrance to Kennel	Ext.		Entrance	Other

Mat not securely attached Hardware not compliant	- -	Secure the mat. Provide hardware that can be operable with one hand and not require tight grasping, pinching, or twisting of the wrist.	1	Labor 750	\$750
Access to Goods and Services												
Means of Egress												
6	Kennels to Outdoor Play Area	1		Means of Egress	209

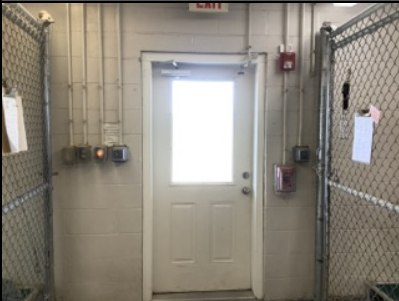
Tactile exit sign not provided Illuminated ISA symbol not provided (MAAB)	- -	Ensure that a tactile exit sign with raised characters and braille is provided at the exit door. Mount the sign between 48"- 60" above the finished floor located on the latch side of the door. Provide an illuminated sign with the International Symbol of Accessibility (ISA).	1	250 200	\$450
7	Main Egress (South)	1		Means of Egress	N/A

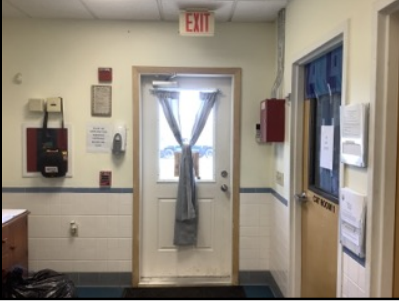
Tactile exit sign not provided Illuminated ISA symbol not provided (MAAB)	- -	Ensure that a tactile exit sign with raised characters and braille is provided at the exit door. Mount the sign between 48"- 60" above the finished floor located on the latch side of the door. Provide an illuminated sign with the International Symbol of Accessibility (ISA).	1	250 200	\$450

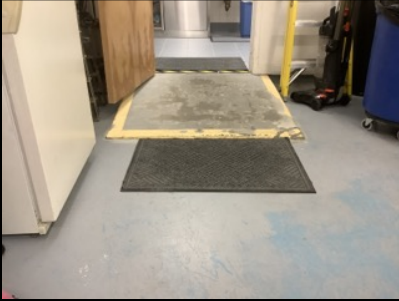
Interior Access Route												
8	Supply/ Garage	1		Interior Access Route	N/A

Level changes > 1/4"	.5"	Alter change in level to be 1/4" high max. at the base of the sloped area.	1	187	\$187
9	Corridor by Prep Area	1		Interior Access Route	N/A

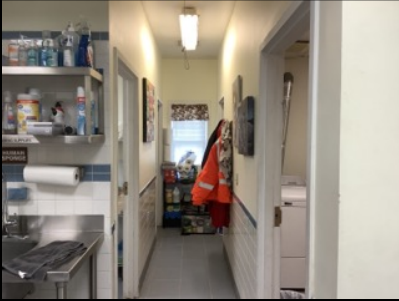
Vertical clearance < 80" above finished floor	77"	Ensure that the attic door pull string is located no lower than 80" above the finished floor.	1	Labor	Labor

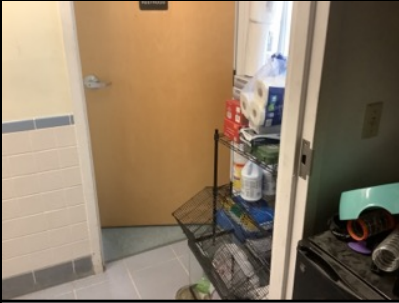
ID	Location	Floor	Room	Element	Type	Photo	Issues	Current Measure	Recommendations	Quantity	Price	Cost Estimation
Doors, Doorways, & Gates												
10	Single-User Toilet Room	1		Doors, Doorways, & Gates	Toilet Room

Maneuvering clearance(s) not provided	36.25"	Provide an automatic door opener due to the narrow width of the corridor.	1	6000	6000
11	Single-User Toilet Room	1		Doors, Doorways, & Gates	Toilet Room

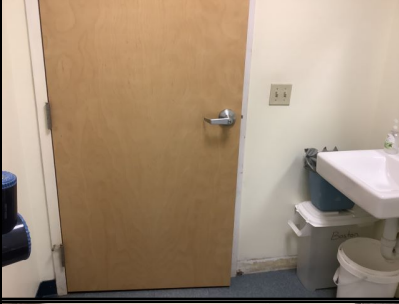
Maneuvering clearance(s) not provided	14"	Provide an automatic door opener.	1	6000	\$6000
											6000	
12	Supply/ Garage	1		Doors, Doorways, & Gates	Other

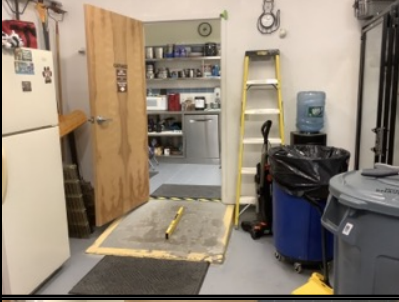
Maneuvering clearance at door > 1:50 (2.00%) Mat not securely attached	8.7% -	Ensure that the door is propped open during business hours or provide an automatic door opener. Secure the mat.	1	Labor	Labor
13	Lobby to Kennels, Small Animal Room, Cat Room 2, etc.	1		Doors, Doorways, & Gates	N/A

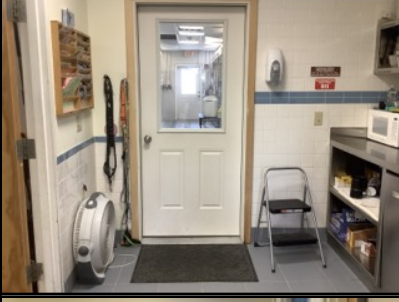
Mat not securely attached	-	Secure the mat. Ensure that all mats throughout the facility are secured.	3	Labor	Labor

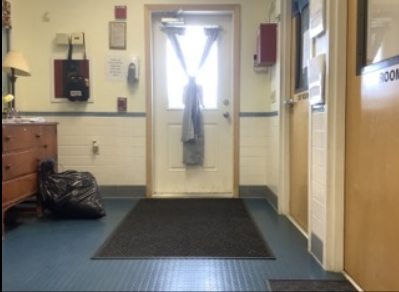
14	Main Egress (South)	1		Doors, Doorways, & Gates	Emergency Egress

Mat not securely attached Closing speed not compliant	- -	Secure the mat. Adjust door closer so that from an open position of 90 degrees, the time required to move the door to an open position of 12 degrees from the latch is 5 seconds min.	1	Labor	Labor

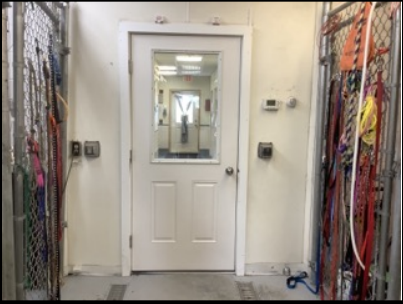
ID	Location	Floor	Room	Element	Type	Photo	Issues	Current Measure	Recommendations	Quantity	Price	Cost Estimation
15	Kennels to Lobby	1		Doors, Doorways, & Gates	Circulation

Hardware not compliant	-	Provide hardware that can be operable with one hand and not require tight grasping, pinching, or twisting of the wrist.	1	750	\$750
											750	
16	East Side Dog Area	Ext.		Doors, Doorways, & Gates	Circulation

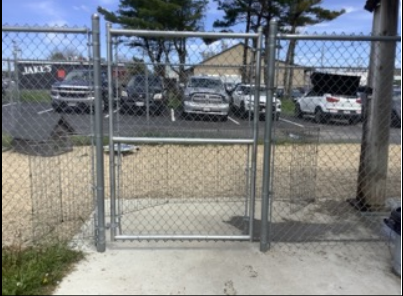
10" solid surface not provided (2010 ADA) Hardware < 34" or > 48" high	- 58"	Swinging door and gate surfaces within 10 inches of the finished floor or ground measured vertically shall have a smooth surface on the push side extending the full width of the door or gate. Ensure hardware is mounted between 34" - 48" above the finished floor.	1	-	-
17	West Side Dog Area	Ext.		Doors, Doorways, & Gates	Circulation

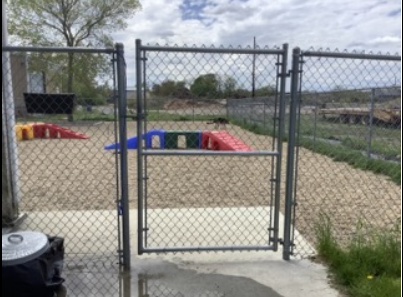
10" solid surface not provided (2010 ADA) Hardware < 34" or > 48" high	- 52"	Swinging door and gate surfaces within 10 inches of the finished floor or ground measured vertically shall have a smooth surface on the push side extending the full width of the door or gate. Ensure hardware is mounted between 34" - 48" above the finished floor.	1	-	-

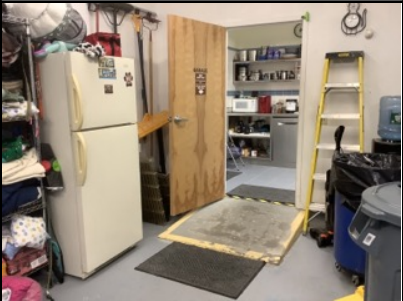
Ramps												
18	Supply/ Garage	1		Ramps	Interior

Running slope >1:12 (8.33%)	8.7%	Further study will be needed to determine whether it is technically feasible to bring the ramp into full compliance with the ADA Standards.	1	-	-
Signage												
19	Lobby to Kennels	1		Signage	Designation

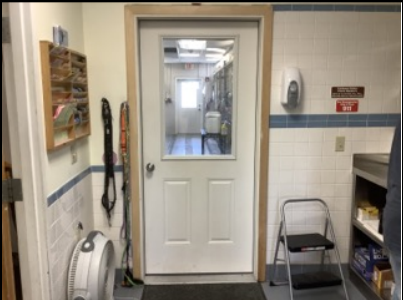
Signage is not provided	-	Locate compliant signage with raised characters and braille alongside the door on the latch side.	1	250	\$250
											250

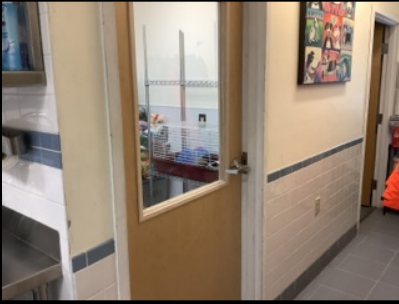
ID	Location	Floor	Room	Element	Type	Photo	Issues	Current Measure	Recommendations	Quantity	Price	Cost Estimation
20	Small Animal Room	1		Signage	Designation

Signage is not provided	-	Locate compliant signage with raised characters and braille alongside the door on the latch side.	1	250	\$250
											250	
21	From Cat Room 2 to 3	1		Signage	Designation

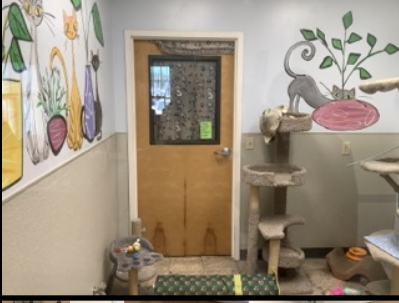
Signage is not provided	-	Locate compliant signage with raised characters and braille alongside the door on the latch side.	1	250	\$250
											250	
22	Supply/ Garage	1		Signage	Designation

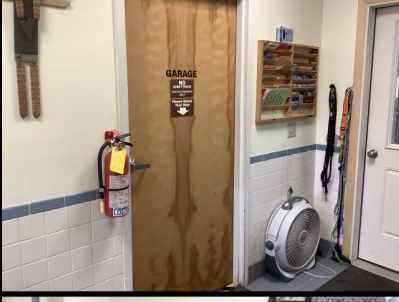
Raised characters not provided on sign Braille not provided on sign Location of tactile sign not compliant	- - -	Provide text with raised characters duplicated in braille on the sign. Locate sign alongside the door on the latch side.	1	250	\$250
											250	
23	Cat Room 3	1		Signage	Designation

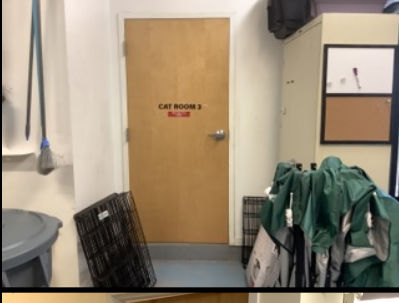
Raised characters not provided on sign Braille not provided on sign Location of tactile sign not compliant	- - -	Provide text with raised characters duplicated in braille on the sign. Locate sign alongside the door on the latch side.	1	250	\$250

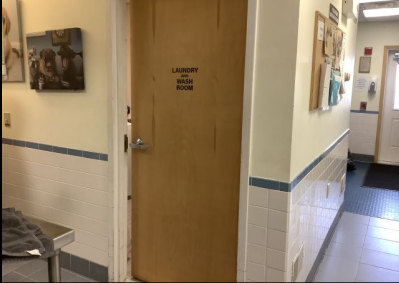
250	
24	Laundry & Wash Room	1		Signage	Designation

Raised characters not provided on sign Braille not provided on sign Location of tactile sign not compliant	- - -	Provide text with raised characters duplicated in braille on the sign. Locate sign alongside the door on the latch side.	1	250	\$250
											250

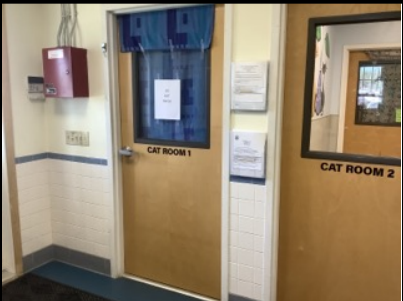
ID	Location	Floor	Room	Element	Type	Photo	Issues	Current Measure	Recommendations	Quantity	Price	Cost Estimation	
25	Cat Rooms 1 and 2	1		Signage	Designation

Raised characters not provided on sign Braille not provided on sign Location of tactile sign not compliant	- - -	Provide text with raised characters duplicated in braille on the sign. Locate sign alongside the door on the latch side.	2	250	\$500	
											500		
26	Main Entrance	Ext.		Signage	Informational

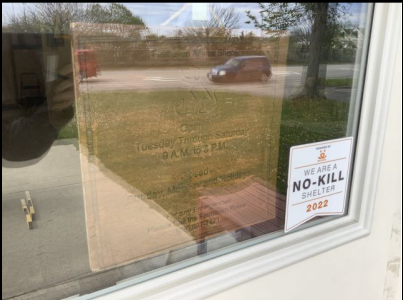
Non-glare finish and contrast not provided on sign	-	Install a sign with a non-glare finish with characters that have a high contrast to the background.	1	450	\$450	
											450		
27	Single-User Toilet Room	1		Signage	Designation

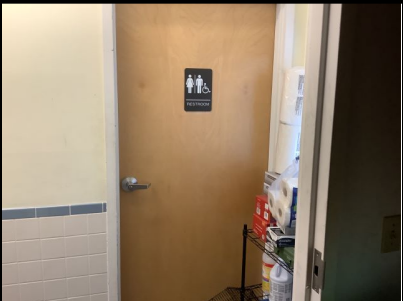
Location of tactile sign not compliant Character style not compliant	- -	Locate sign alongside the door on the latch side. Ensure that characters comply with character proportions, height, stroke thickness, character spacing and line spacing in the 2010 ADA 703.2.	1	250	\$250

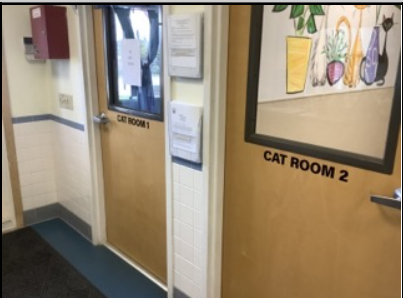
250		
Operable Parts / Reach Range													
28	Adoption Applications Between Cat Rooms 1 and 2	1		Operable Parts / Reach Range	Other

Reach < 15" or > 48"(forward/side approach)	62.5"	Relocate applications to be between 15"- 48" above the finished floor or ensure that staff is available to assist visitors who need assistance.	1	Labor	Labor	
29	Main Egress (South)	1		Operable Parts / Reach Range	Other

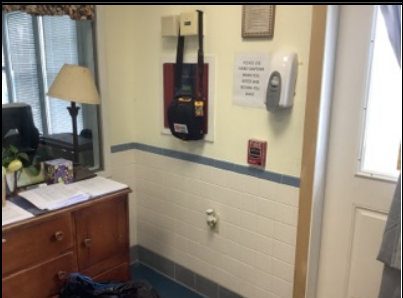
Reach < 15" or > 48"(forward/side approach)	53"	Relocate the defibrillator so that controls are between 15"- 48" above the finished floor.	1	500	\$500	
											500

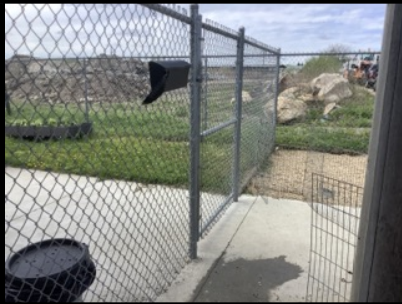
ID	Location	Floor	Room	Element	Type	Photo	Issues	Current Measure	Recommendations	Quantity	Price	Cost Estimation
30	East Side Dog Area - Dog Bags	Ext.		Operable Parts / Reach Range	Trash/Recycling

Reach < 15" or > 48"(forward/side approach)	59"	Relocate dog bags to be between 15"- 48" above the ground.	1	Labor	Labor
31	West Side Dog Area	Ext.		Operable Parts / Reach Range	Trash/Recycling

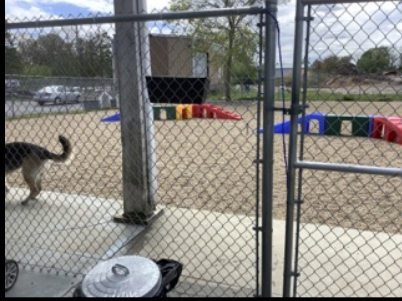
Reach < 15" or > 48"(forward/side approach)	57"	Relocate dog bags to be between 15"- 48" above the ground.	1	Labor	Labor
32	Prep Area	1		Operable Parts / Reach Range	Other

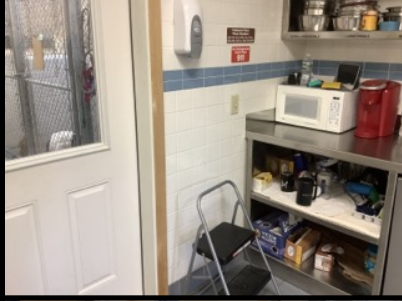
Clear floor space is not provided Reach < 15" or > 48"(forward/side approach)	- 56"	Provide a 30" min. by 48" min. clear floor space at the hand sanitizer and microwave. Relocate hand sanitizer so that controls are between 15"- 48" above the finished floor.	1	Labor 500	\$500
33	Near Kennels	1		Operable Parts / Reach Range	Other

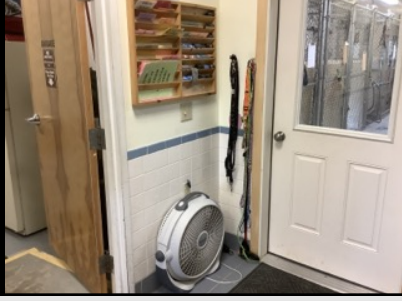
Clear floor space is not provided Reach < 15" or > 48"(forward/side approach)	- 55"	Relocate fan to provide a 30" min. by 48" min. clear floor space at the forms. Ensure that dog bags and behavior tags are located between 15"- 48" above the finished floor.	1	500	\$500

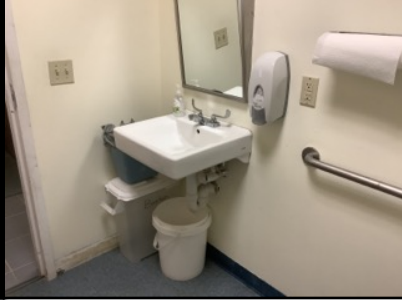
<div>Toilet & Bathing Rooms</div> <div>Lavatory</div>												
34	Single-User Toilet Room	1		Lavatory	N/A

Clear floor space not provided at lavatory	-	Provide at least one lavatory with a 30" min. by 48" min. clear floor space positioned for a forward approach. Relocate the bin.	1	Labor	Labor

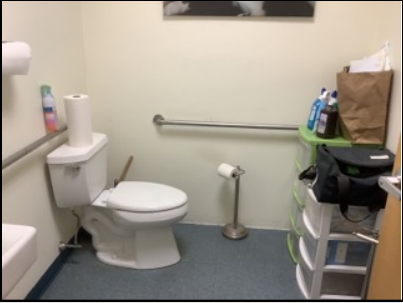
ID	Location	Floor	Room	Element	Type	Photo	Issues	Current Measure	Recommendations	Quantity	Price	Cost Estimation
Single-User Toilet												
35	Single-User Toilet Room	1		Single-User Toilet	N/A

Clearance at toilet < 72" clear depth (MAAB) Item mounted over grab bar (MAAB)	- -	Remove stored items from the toilet room to ensure that there is 72" deep min. clear floor space at the toilet. Relocate paper towels so they are not mounted over the grab bar.	1	Labor 500	\$500
											500	
Additional Access												
Sink												
36	Laundry & Wash Room	1		Sink	N/A

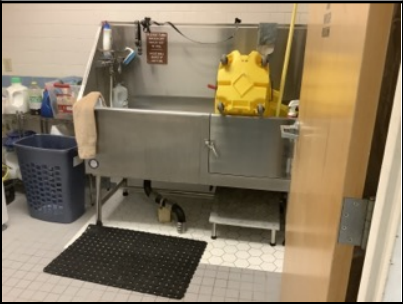
Toe and knee clearances not provided Rim or counter > 34"	- 37.5"	Ensure there is a 27" min. knee clearance positioned for a forward approach. Relocate sink with the front of the rim or counter no higher than 34" above the finished floor.	1	3094	\$3094
											3094	
37	Prep Area	1		Sink	N/A

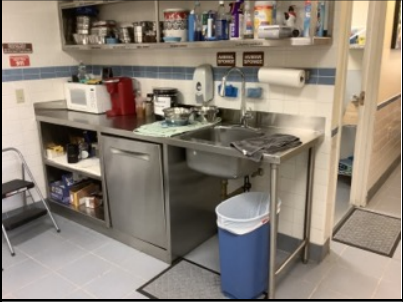
Clear floor space not provided at sink Rim or counter > 34" Exposed plumbing underneath sink	29" 36.5" -	Provide a 30" by 48" clear floor space positioned for a forward approach - relocate the trash bin. Provide a sink with a rim or counter no higher than 34" above the finished floor. Insulate or otherwise configure pipes at sink.	1	Labor 3094 120	\$3214

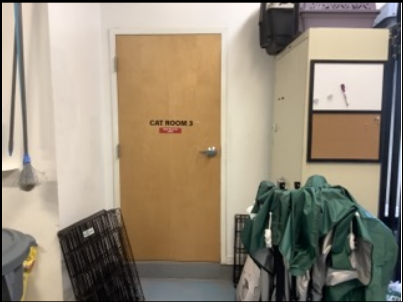
3214	
Best Practice												
38	Cat Room 3	1

Recommend providing a directional sign to the accessible route to Cat Room 3 through Cat Room 2.	1	-	-

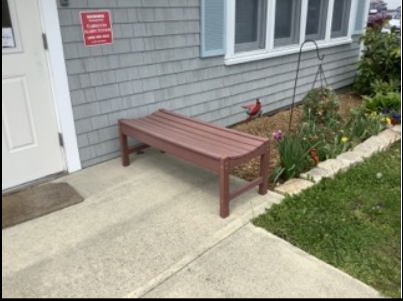
ID	Location	Floor	Room	Element	Type	Photo	Issues	Current Measure	Recommendations	Quantity	Price	Cost Estimation
39	Main Entrance	Ext.

Recommend providing benches with backs and armrests. Recommend providing a 36" min. by 48" min. stable, firm and slip-resistant surface adjacent to at least one bench in each area where benches are provided positioned to allow a person in a wheeled mobility device and a person sitting on the bench to have their shoulders aligned.	1	-	-
