Anthony Field

Town of Fairhaven ADA Transition Plan

November 2024

Institute for Human Centered Design

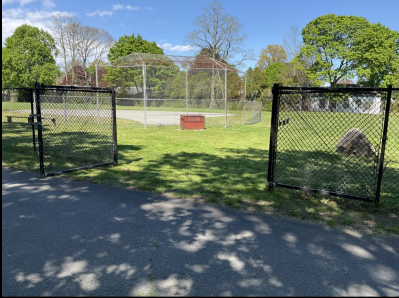
ID	Location	Floor	Room	Element	Type	Photo	Issues	Current Measure	Recommendations	Quantity	Price	Cost Estimation
Approach and Entrance												
Exterior Access Route												
1	Softball Field Entrance on Castle Avenue	Ext.		Exterior Access Route	Walkway

Not provided from all site arrival points	-	Ensure a stable, firm and slip resistant accessible route is provided from the site arrival point to the boundary of sport activity at the softball field.	1	-	-
Play and Sport Areas												
Field												
2	Softball Field First and Third Base Team Seating	Ext.		Field	Softball

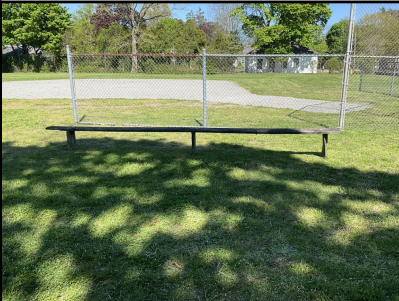
Accessible spaces not provided at team seating No accessible route to all areas of sport activity	- -	Provide a 36" x 48" stable, firm and slip resistant clear ground space at team seating. Install an accessible route to the team seating and between all areas of sport activity.	2	-	-
Court												
3	Field/Route To Basketball Court	Ext.		Court	Basketball

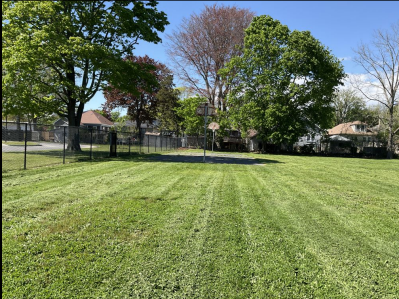
Court is not connected to an accessible route		Provide a stable, firm and slip resistant accessible route to the boundary of sport activity at the basketball court starting from the site arrival point.	1	-	-

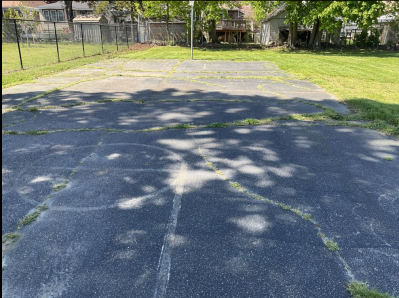
4	Basketball Court	Ext.		Court	Basketball

Court not maintained in operable working condition	-	Ensure that the court is maintained in operable working condition.	1	-	-
