Fairhaven Recreation Department and Council on Aging

Town of Fairhaven ADA Transition Plan

January 2025

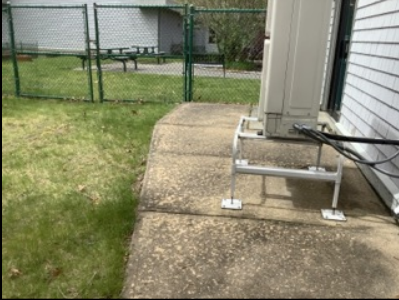
Exterior route < 48" wide	28"	Ensure that a clear width of 48" min. is maintained at the accessible route.	1	-	-
2	Council On Aging - Sidewalk Along North Side of Building	Ext.	-	Exterior Access Route	Sidewalk

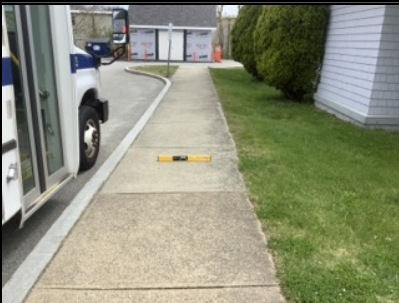
Cross slope > 1:50 (2.00%)	4%	Reduce cross slope to be no steeper than 1:50 (2.00%).	1	-	-
3	Council On Aging - East Entrance/ Egress (Also Meals on Wheels Entrance)	Ext.	-	Exterior Access Route	Sidewalk

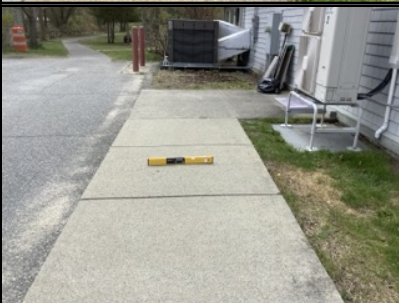
Cross slope > 1:50 (2.00%)	3.8%	Reduce cross slope to be no steeper than 1:50 (2.00%).	1	-	-
4	Council On Aging - Walkway on East Side of Building/From Social Day Room East Egress	Ext.	-	Exterior Access Route	Walkway

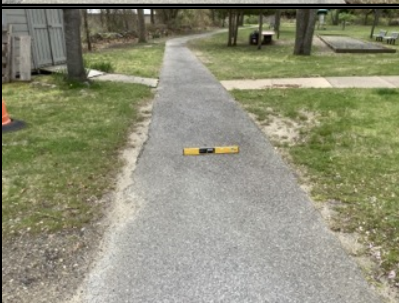
Cross slope > 1:50 (2.00%)	3.3%	Reduce cross slope to be no steeper than 1:50 (2.00%).	1	-	-

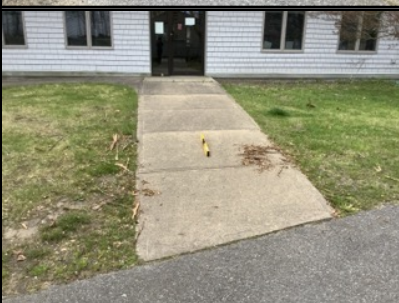
Running slope > 1:20 (5.00%)	7.1%	Reduce running slope to be no steeper than 1:20 (5.00%).	1	-	-

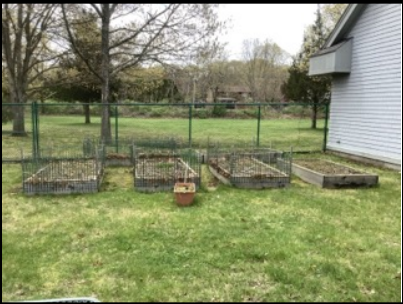
ID	Location	Floor	Room	Element	Type	Photo	Issues	Current Measure	Recommendations	Quantity	Price	Cost Estimation
6	Courtyard - Garden	Ext.	-	Exterior Access Route	Exterior

Accessible route not provided	-	Ensure a stable, firm, and slip-resistant accessible route is provided to the garden beds.	1	-	-
Off-Street Parking Lot or Garage												
7	Parking Lot - Accessible Spaces in Front of Council On Aging Building	Ext.	-	Off-Street Parking Lot or Garage	Visitor

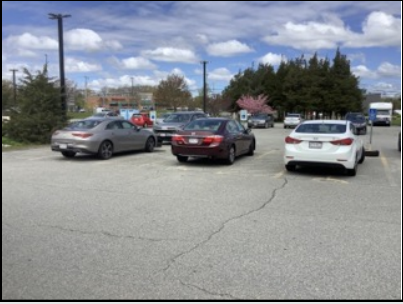
Sign bottom < 60" above finished grade	51"	Relocate all signs to ensure the bottom of the signs are located 60" min. above the ground.	8	Labor	Labor
Access to Goods and Services												
Means of Egress												
8	Recreation Department - West Egress Interior Vestibule Door	1	-	Means of Egress	N/A

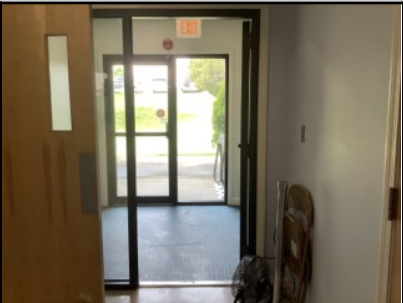
Tactile exit sign not provided Illuminated ISA symbol not provided (MAAB)	- -	Ensure that a tactile exit sign with raised characters and braille is provided at the exit door. Mount the sign between 48" - 60" above the finished floor located on the latch side of the door. When the illuminated exit sign is repaired or replaced, provide an illuminated sign with the International Symbol of Accessibility (ISA).	1	250	\$250

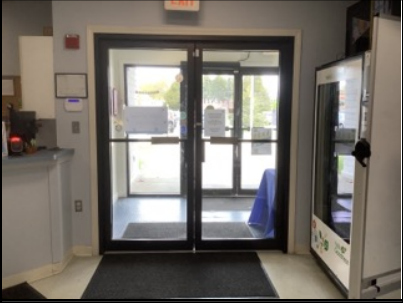
Tactile exit sign not provided Illuminated ISA symbol not provided (MAAB)	- -	Ensure that a tactile exit sign with raised characters and braille is provided at the exit door. Mount the sign between 48" - 60" above the finished floor located on the right side of the right handed door. Relocate the vending machine to provide 18" x 18" of clear floor space at the sign. When the illuminated exit sign is repaired or replaced, provide an illuminated sign with the International Symbol of Accessibility (ISA).	1	250 Labor	\$250
10	Council On Aging - Kitchen/East Egress Interior Vestibule Door	1	-	Means of Egress	N/A

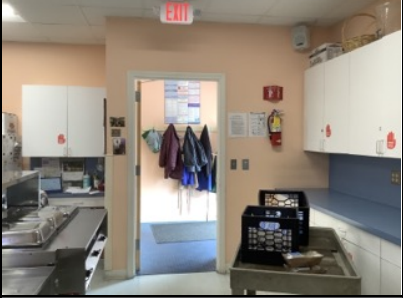
Tactile exit sign not provided Illuminated ISA symbol not provided (MAAB)	- -	Ensure that a tactile exit sign with raised characters and braille is provided at the exit door. Mount the sign between 48" - 60" above the finished floor located on the latch side of the door. When the illuminated exit sign is repaired or replaced, provide an illuminated sign with the International Symbol of Accessibility (ISA).	1	250	\$250

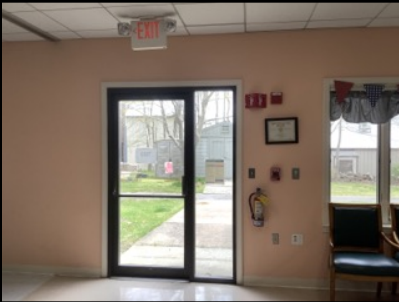
ID	Location	Floor	Room	Element	Type	Photo	Issues	Current Measure	Recommendations	Quantity	Price	Cost Estimation
11	Council On Aging - Social Day Room/ East Egress	1	-	Means of Egress	N/A

Tactile exit sign not provided Illuminated ISA symbol not provided (MAAB)		Ensure that a tactile exit sign with raised characters and braille is provided at the exit door. Mount the sign between 48" - 60" above the finished floor located on the latch side of the door. When the illuminated exit sign is repaired or replaced, provide an illuminated sign with the International Symbol of Accessibility (ISA).	1	250	\$250
											250	
12	Council On Aging - Social Day Room/ South Egress	1	-	Means of Egress	N/A

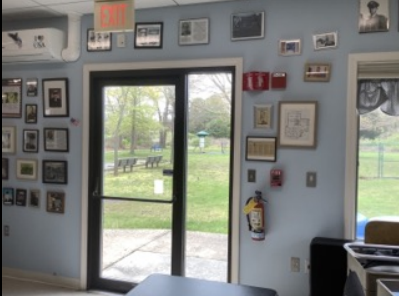
Tactile exit sign not provided Illuminated ISA symbol not provided (MAAB)		Ensure that a tactile exit sign with raised characters and braille is provided at the exit door. Mount the sign between 48" - 60" above the finished floor located on the latch side of the door. When the illuminated exit sign is repaired or replaced, provide an illuminated sign with the International Symbol of Accessibility (ISA).	1	250	\$250

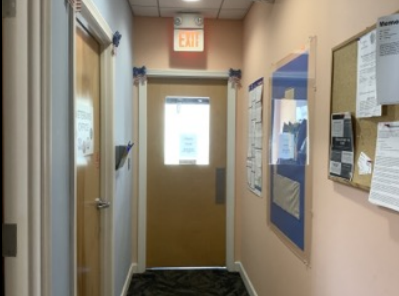
Tactile exit sign not provided Illuminated ISA symbol not provided (MAAB)		Ensure that a tactile exit sign with raised characters and braille is provided at the exit door. Mount the sign between 48" - 60" above the finished floor located on the wall adjacent to the latch side of the door. When the illuminated exit sign is repaired or replaced, provide an illuminated sign with the International Symbol of Accessibility (ISA).	1	250 Labor	\$250
											250	
14	Council On Aging - North Main Entrance/ Egress Interior Vestibule Door	1	-	Means of Egress	N/A

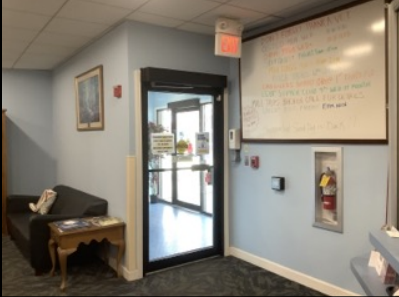
Tactile exit sign not provided Illuminated ISA symbol not provided (MAAB)	- -	Ensure that a tactile exit sign with raised characters and braille is provided at the exit door. Mount the sign between 48" - 60" above the finished floor located on the wall adjacent to the latch side of the door. When the illuminated exit sign is repaired or replaced, provide an illuminated sign with the International Symbol of Accessibility (ISA).	1	250	\$250

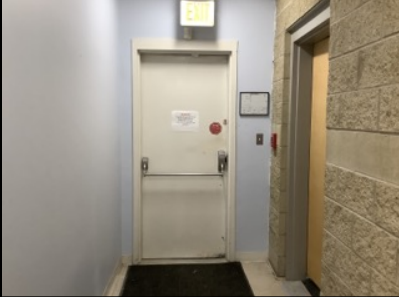
Tactile exit sign not provided Directional sign to accessible emergency exit not provided	- -	Ensure that a tactile exit sign with raised characters and braille is provided at the exit door. Mount the sign between 48" - 60" above the finished floor located on the latch side of the door. Provide a directional sign indicating the location of the nearest accessible emergency exit.	1	250 250	\$500
											500

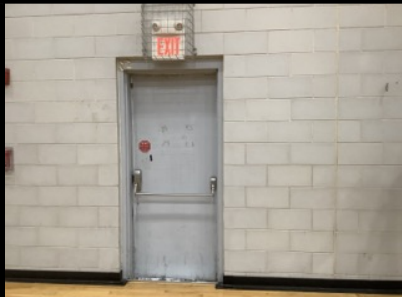
ID	Location	Floor	Room	Element	Type	Photo	Issues	Current Measure	Recommendations	Quantity	Price	Cost Estimation
16	Recreation Department - Gymnasium/ West Egress	1	-	Means of Egress	N/A

Tactile exit sign not provided Directional sign to accessible emergency exit not provided		Ensure that a tactile exit sign with raised characters and braille is provided at the exit door. Mount the sign between 48" - 60" above the finished floor located on the latch side of the door. Provide a directional sign indicating the location of the nearest accessible emergency exit.	1	250 250	\$500
17	Recreation Department - Gymnasium/ South Egress	1	-	Means of Egress	N/A

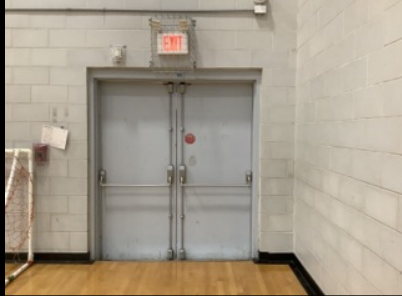
Tactile exit sign not provided Directional sign to accessible emergency exit not provided		Ensure that a tactile exit sign with raised characters and braille is provided at the exit door. Mount the sign between 48" - 60" above the finished floor located on the right side of the right handed door, Provide a directional sign indicating the location of the nearest accessible emergency exit.	1	250 250	\$500

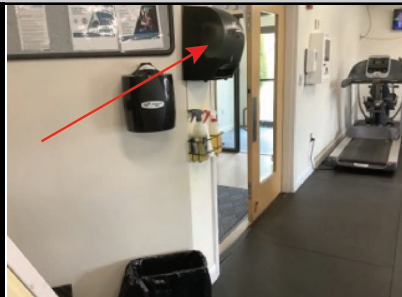
Interior Access Route												
18	Recreation Department - Fitness Center	1	-	Interior Access Route	N/A

Obstructed by protruding objects Reach < 15" or > 48"(forward/side approach)	10.5" 57.5	Relocate the paper towel dispenser so that controls are between 15"- 48" above the finished floor. Locate out of the circulation path. If item acts as a protruding object in the circulation path, provide a cane-detectable barrier underneath. Barriers must have leading edges no higher than 27" so that they are within cane sweep. Barriers can include fixed planters, benches, and guardrails.	1	500	\$500
19	Recreation Department - Fitness Center	1	-	Interior Access Route	N/A

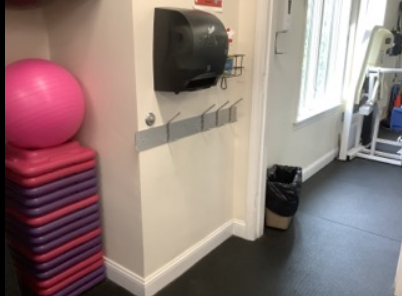
Obstructed by protruding objects	10.5"	Provide a cane-detectable barrier underneath the paper towel dispenser. Barriers must have leading edges no higher than 27" so that they are within cane sweep. Barriers can include fixed planters, benches, and guardrails.	1	398	\$398

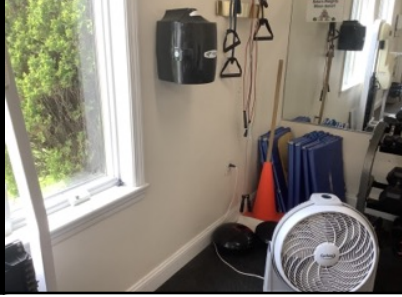
20	Recreation Department - Fitness Center	1	-	Interior Access Route	N/A

Obstructed by protruding objects	10"	Provide a cane-detectable barrier underneath the cleaning wipe dispenser. Barriers must have leading edges no higher than 27" so that they are within cane sweep. Barriers can include fixed planters, benches, and guardrails.	1	398	\$398

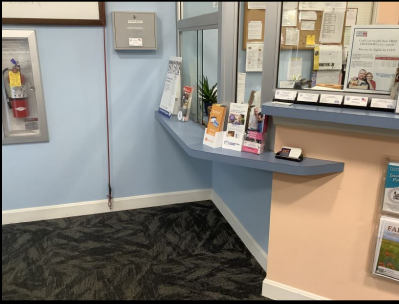
ID	Location	Floor	Room	Element	Type	Photo	Issues	Current Measure	Recommendations	Quantity	Price	Cost Estimation
21	Council On Aging - Lobby	1	-	Interior Access Route	N/A

Obstructed by protruding objects	18"	Provide a cane-detectable barrier underneath underneath both ends of the service counter. Barriers must have leading edges no higher than 27" so that they are within cane sweep. Barriers can include fixed planters, benches, and guardrails.	2	398	\$796
											796	
22	Council On Aging - Recreation Room Entrance From Lobby	1	-	Interior Access Route	N/A

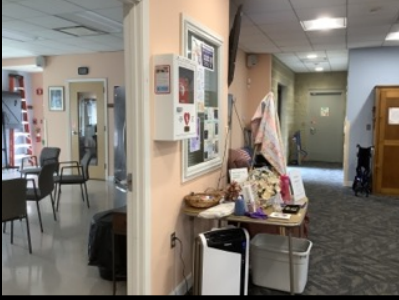
Obstructed by protruding objects	6.5"	When the defibrillator is relocated, provide a cane-detectable barrier underneath the defibrillator. Barriers must have leading edges no higher than 27" so that they are within cane sweep. Barriers can include fixed planters, benches, and guardrails.	1	398	\$398
											398	
23	Recreation Department - Gymnasium Entrance by Lobby	1	-	Interior Access Route	N/A

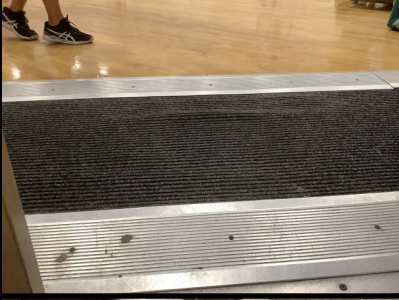
Surface not stable, firm, and slip-resistant Surface not maintained in operable working condition.	-	Repair surface, as the carpet is not securely attached and poses a tripping hazard.	1	Labor	Labor

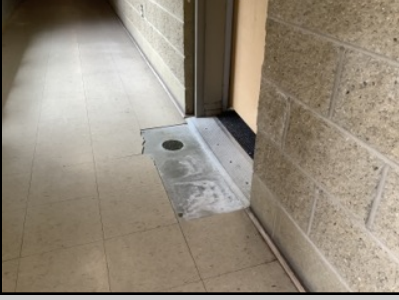
Surface not stable, firm, and slip-resistant Surface not maintained in operable working condition.	-	Repair surface with removed tiles.	1	Labor	Labor
Doors, Doorways, & Gates												
25	Recreation Department - Single-User Toilet Room	1	-	Doors, Doorways, & Gates	Toilet Room

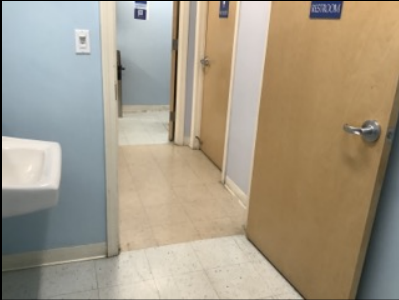
Maneuvering clearance(s) not provided	12"	Provide an automatic door opener.	1	6000	\$6000
											6000

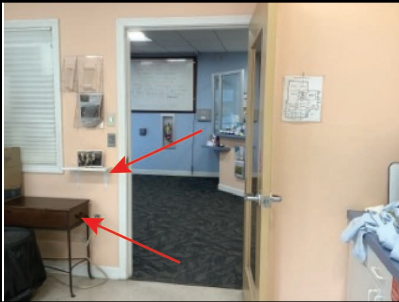
ID	Location	Floor	Room	Element	Type	Photo	Issues	Current Measure	Recommendations	Quantity	Price	Cost Estimation	
26	Council On Aging - Recreation Room	1	-	Doors, Doorways, & Gates	Circulation

Maneuvering clearance(s) not provided	12"	Relocate the table and mounted shelf alongside the door on the latch side to provide 18" of pull-side maneuvering clearance.	1	500	\$500	
27	Council On Aging - Kitchen	1	-	Doors, Doorways, & Gates	Circulation

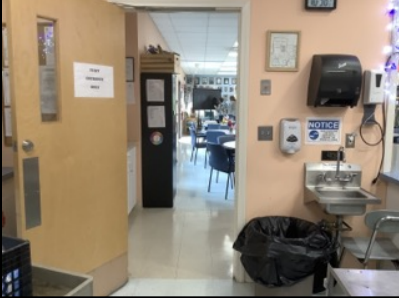
Maneuvering clearance(s) not provided	-	Relocate the trash barrel to provide 18" of pull-side maneuvering clearance alongside the door on the latch side.	1	Labor	Labor	
28	Council On Aging - South Door From Courtyard	Ext.	-	Doors, Doorways, & Gates	Circulation

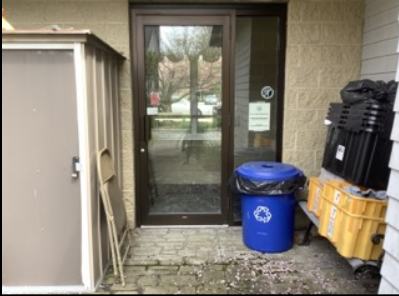
Maneuvering clearance(s) not provided Exterior door requires > 15 lbs. of force to open	3" 20 lbs	Provide a directional sign to the west door of the Council On Aging building from the courtyard.	1	450	\$450

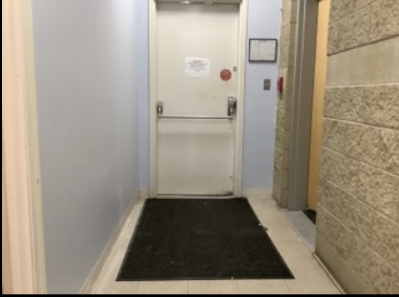
29	Recreation Department - South Egress	1	-	Doors, Doorways, & Gates	Emergency Egress

Mat not securely attached		Secure the mat.	1	Labor	Labor	
30	Council On Aging - East Entrance/ Egress (Also Meals on Wheels Entrance)	1	-	Doors, Doorways, & Gates	Vestibule

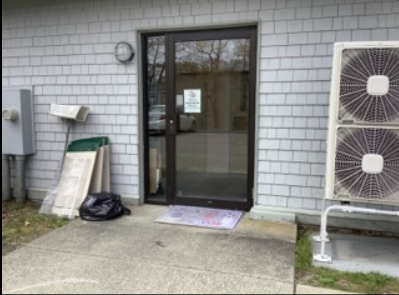
Mat not securely attached	-	Secure the mat.	1	Labor	Labor

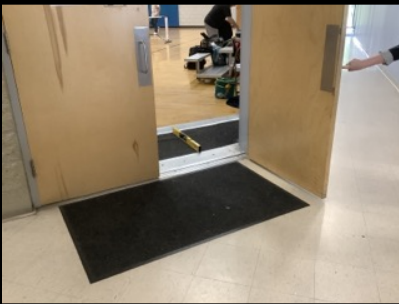
ID	Location	Floor	Room	Element	Type	Photo	Issues	Current Measure	Recommendations	Quantity	Price	Cost Estimation
31	Recreation Department - Gymnasium Entrance by Lobby	1	-	Doors, Doorways, & Gates	Assembly Space

Maneuvering clearance at door > 1:50 (2.00%) Mat not securely attached Door requires > 5 lbs. of force to open	7% - 13 lbs	Provide an automatic door opener. Secure the mat. Ensure that door opening pressure is monitored and kept in compliance at all doors by maintenance staff every 6 months. Interior doors should require no more than 5 lbs. of force.	1	6000 Labor	\$6000
											6000	
32	Council On Aging - East Egress Exterior Door From Hallway of Offices and Kitchen	1	-	Doors, Doorways, & Gates	Other

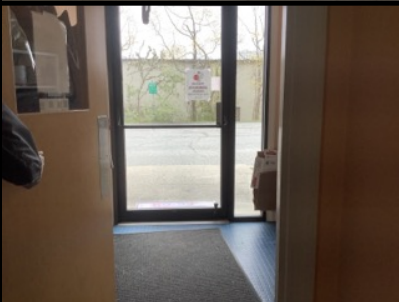
Mat not securely attached Exterior door requires > 15 lbs. of force to open	- 25 lbs	Secure the mat. Adjust closers so doors do not require more than 15 pounds of force to open.	1	Labor	Labor

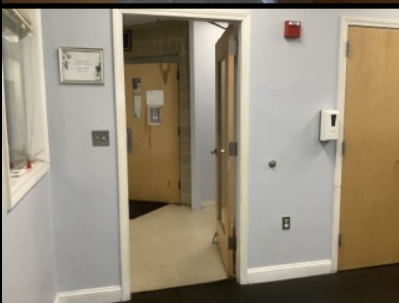
33	Recreation Department - Multi-Purpose Room	1	-	Doors, Doorways, & Gates	Circulation

Door requires > 5 lbs. of force to open	10 lbs	Adjust closers so doors do not require more than 5 pounds of force to open. Applies to all doors with opening forces heavier than allowed.	1	Labor	Labor
34	Recreation Department - Men's and Women's Locker Rooms	1	-	Doors, Doorways, & Gates	Toilet Room

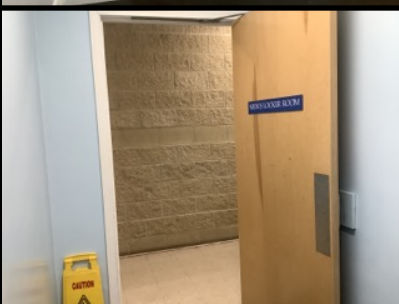
Maneuvering clearance(s) not provided Door requires > 5 lbs. of force to open	15.5" 10 lbs	Provide an automatic door opener. Adjust closers so doors do not require more than 5 pounds of force to open.	2	6000	\$12000
											12000	
35	Council On Aging - Entrance to Recreation Department	1	-	Doors, Doorways, & Gates	Circulation

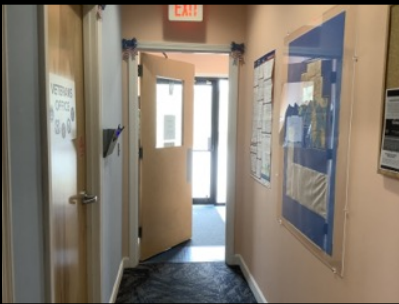
ID	Location	Floor	Room	Element	Type	Photo	Issues	Current Measure	Recommendations	Quantity	Price	Cost Estimation
36	Council On Aging - Hallway of Offices/ Interior Vestibule Door to East Egress	1	-	Doors, Doorways, & Gates	Vestibule

Maneuvering clearance(s) not provided Door requires > 5 lbs. of force to open	5.5" 12 lbs	Provide an automatic door opener. Ensure that door opening pressure is monitored and kept in compliance at all doors by maintenance staff every 6 months. Interior doors should require no more than 5 lbs. of force.	1	6000	\$6000
37	Recreation Department - Fitness Center	1	-	Doors, Doorways, & Gates	Circulation

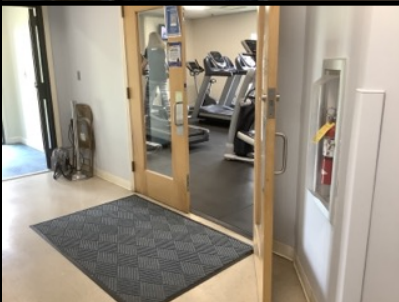
Mat not securely attached Door requires > 5 lbs. of force to open	- 13 lbs	Secure the mat. Adjust closers so doors do not require more than 5 pounds of force to open.	1	Labor	Labor
38	Recreation Department - North Main Entrance/ Egress Interior Vestibule Door	1	-	Doors, Doorways, & Gates	Vestibule

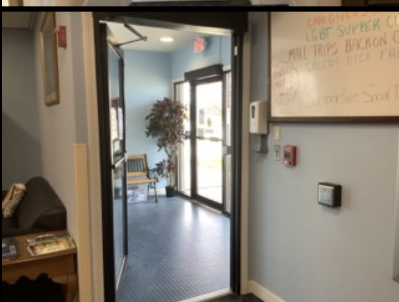
Door requires > 5 lbs. of force to open Closing speed not compliant	15 lbs -	Adjust closers so doors do not require more than 5 pounds of force to open. Adjust door closer for the automatic door opener closer so that from an open position, the door will take at least six seconds to close. (521 CMR: 26.9).	1	Labor	Labor

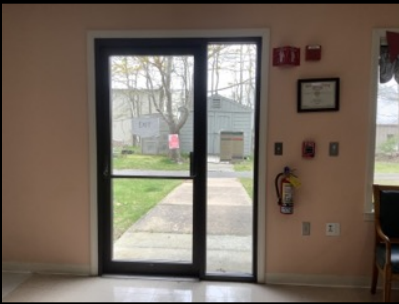
ID	Location	Floor	Room	Element	Type	Photo	Issues	Current Measure	Recommendations	Quantity	Price	Cost Estimation
41	Council On Aging - Social Day Room/ East Egress	1	-	Doors, Doorways, & Gates	Circulation

Exterior door requires > 15 lbs. of force to open	25 lbs	Adjust closers so doors do not require more than 15 pounds of force to open. Applies to all exterior doors in this condition.	1	Labor	Labor
Signage												
42	Recreation Department - Gymnasium	1	-	Signage	Designation

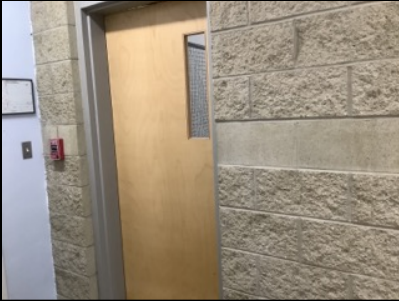
Signage is not provided		Locate compliant signage with raised characters and braille alongside the door on the latch side.	1	250	\$250
											250	
43	Recreation Department - Multi-Purpose Room	1	-	Signage	Designation

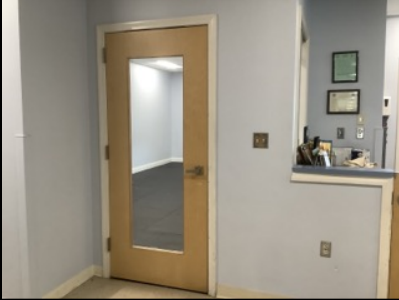
Signage is not provided		Locate compliant signage with raised characters and braille alongside the door on the latch side.	1	250	\$250
											250	
44	Recreation Department - Fitness Center	1	-	Signage	Designation

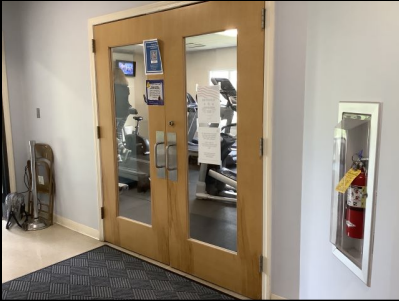
Signage is not provided		Locate compliant signage with raised characters and braille alongside the right side of the right handed door.	1	250	\$250

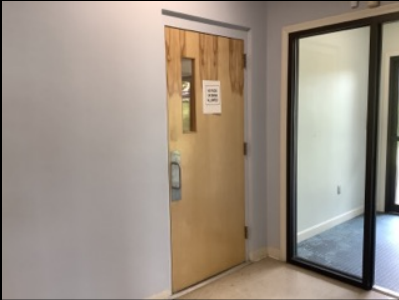
Signage is not provided	-	Locate compliant signage with raised characters and braille alongside the door on the latch side.	1	250	\$250
											250

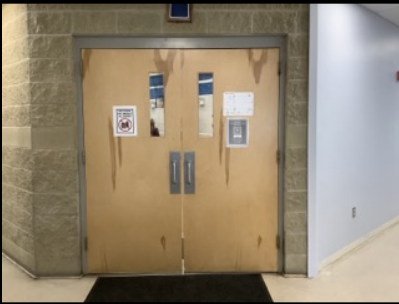
ID	Location	Floor	Room	Element	Type	Photo	Issues	Current Measure	Recommendations	Quantity	Price	Cost Estimation
46	Recreation Department - Gymnasium Entrance by Lobby	1	-	Signage	Designation

Signage is not provided	-	Locate compliant signage with raised characters and braille on the right side of the right-handed door.	1	250	\$250
											250	
47	Recreation Department - Gymnasium Entrance	1	-	Signage	Designation

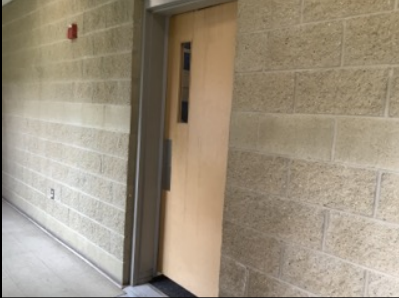
Signage is not provided		Locate compliant signage with raised characters and braille alongside the door on the latch side.	1	250	\$250
											250	
48	Council On Aging - Recreation Room Entrance From Lobby	1	-	Signage	Designation

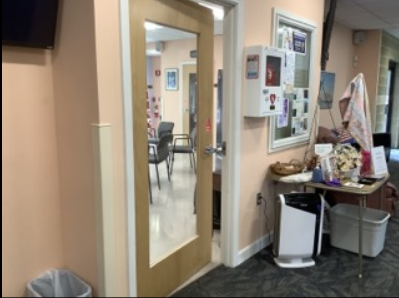
Signage is not provided Signage lacks 18" by 18" clear floor space	- -	Locate compliant designation signage with raised characters and braille alongside the door on the latch side. Ensure that an 18" by 18" clear floor space is provided at the designation sign.	1	250	\$250

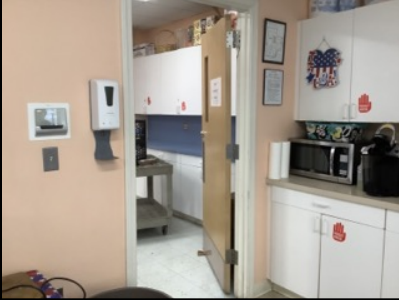
Signage is not provided Signage lacks 18" by 18" clear floor space	- -	Locate compliant signage with raised characters and braille alongside the door on the latch side. When a sign is provided, relocate the soap dispenser and other stored items on the latch side of the door to provide 18" of clear floor space at the sign. Ensure the soap dispenser is located 48" max. high above the finished floor.	1	250 500	\$750
											750	
50	Council On Aging - Veteran's Office	1	-	Signage	Designation

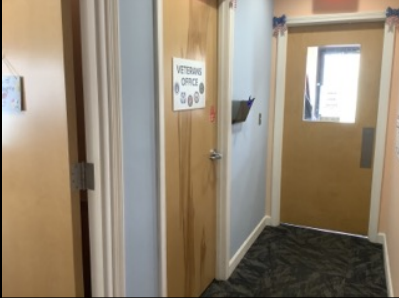
Raised characters not provided on sign Braille not provided on sign Location of tactile sign not compliant Character style not compliant	- - - -	Provide a designation sign with raised characters duplicated in braille on the sign, and with compliant characters (characters should be in sans serif). Locate sign alongside the door on the latch side.	1	250	\$250

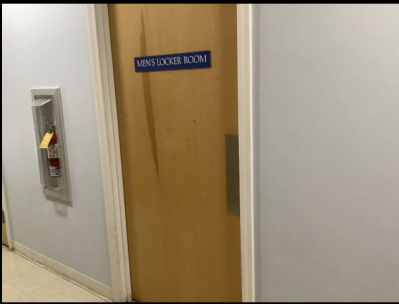
ID	Location	Floor	Room	Element	Type	Photo	Issues	Current Measure	Recommendations	Quantity	Price	Cost Estimation
51	Recreation Department - Men's and Women's Locker Rooms	1	-	Signage	Designation

Raised characters not provided on sign Raised characters < 48" or > 60" above ground Braille not provided on sign Location of tactile sign not compliant	- 61"	Provide text with raised characters duplicated in braille on the sign, with compliant characters. Mount the sign so that the baseline of the lowest tactile character is 48" min. above finished floor and the baseline of the highest tactile character is 60" max. above the finished floor. Locate sign alongside the door on the latch side.	2	250	\$500
52	Recreation Department - Single-User Toilet Room	1	-	Signage	Designation

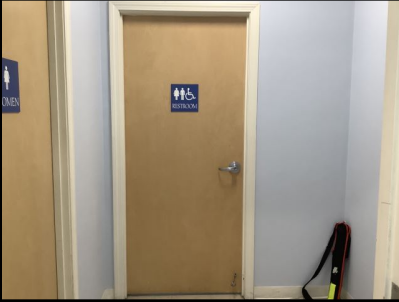
Location of tactile sign not compliant Character style not compliant		Provide a sign with compliant characters. Characters should be sans serif. When a new compliant sign is provided, mount the sign so that the baseline of the lowest tactile character is 48" min. above finished floor and the baseline of the highest tactile character is 60" max. above the finished floor, on the latch side of the door.	1	250	\$250

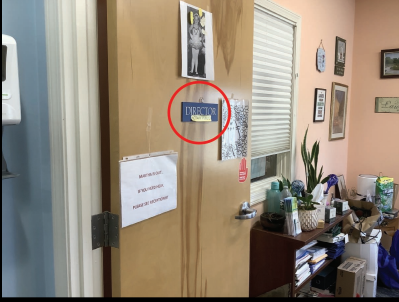
53	Council On Aging - Director's Office	1	-	Signage	Designation

Raised characters not provided on sign Braille not provided on sign Location of tactile sign not compliant Character style not compliant	- - - - -	Provide text with raised characters duplicated in braille on the sign, with compliant characters (characters should be in sans serif). Mount the sign so that the baseline of the lowest tactile character is 48" min. above finished floor and the baseline of the highest tactile character is 60" max. above the finished floor. Locate sign alongside the door on the latch side.	1	250	\$250
54	Council On Aging - Social Day Room	1	-	Signage	Designation

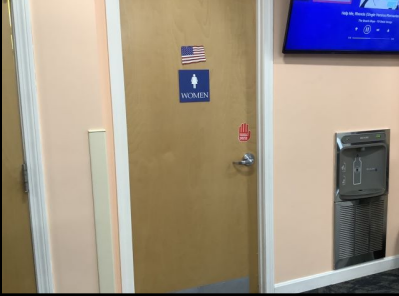
55	Council On Aging - Women's Multi-User Toilet Room	1	-	Signage	Designation

Location of tactile sign not compliant Directional sign to access. toilet not provided Signage lacks 18" by 18" clear floor space Character style not compliant	- - - -	Provide a designation sign with compliant characters (characters should be sans serif). Locate the sign along the door on the latch side. Relocate the television monitor to ensure 18" clear floor space is provided at the sign.	1	250	\$250
											500	
											250	
											250	
											250	
											250

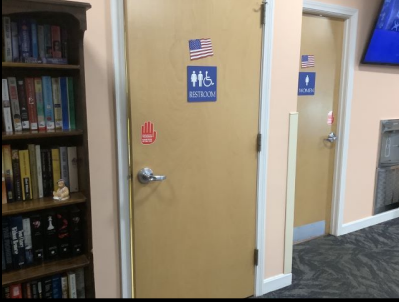
ID	Location	Floor	Room	Element	Type	Photo	Issues	Current Measure	Recommendations	Quantity	Price	Cost Estimation
56	Council On Aging - All-Gender Single-User Toilet Room	1	-	Signage	Designation

Location of tactile sign not compliant Signage lacks 18" by 18" clear floor space Character style not compliant	- - -	Provide a designation sign with compliant characters (characters should be sans serif). Locate the sign along the door on the latch side. Relocate the book shelf to ensure 18" clear floor space is provided at the sign, as well as 18" of pull-side maneuvering clearance along the door on the latch side.	1	250 Labor	\$250
											250	
57	Recreation Department - Men's Inaccessible Multi-User Toilet Room	1	-	Signage	Designation / Directional

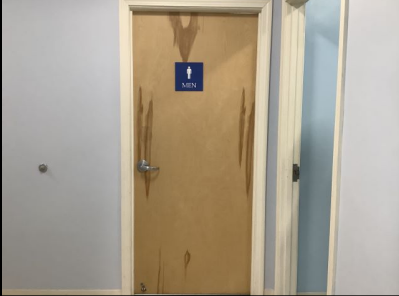
Raised characters < 48" or > 60" above ground Location of tactile sign not compliant Directional sign to access. toilet not provided Character style not compliant	63" - - -	Install a sign indicating the location of the nearest accessible toilet room. Provide a sign with compliant characters. Characters should be sans serif. When a new compliant sign is provided, mount the sign so that the baseline of the lowest tactile character is 48" min. above finished floor and the baseline of the highest tactile character is 60" max. above the finished floor, on the latch side of the door.	1	250 250	\$500

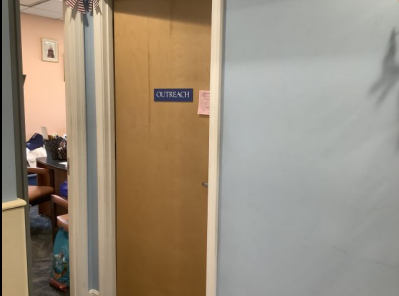
500	
58	Council On Aging - Shine Office	1	-	Signage	Designation

Raised characters not provided on sign Braille misplaced on sign Location of tactile sign not compliant Designation sign is incorrect Character style not compliant	- - - - -	Provide text with raised characters duplicated in braille on the sign, with compliant characters (characters should be in sans serif). Ensure the sign has the correct designation name. Mount the sign so that the baseline of the lowest tactile character is 48" min. above finished floor and the baseline of the highest tactile character is 60" max. above the finished floor. Locate sign alongside the door on the latch side.	1	250	\$250
											250	
59	Recreation Department - Women's Multi-User Toilet Room	1	-	Signage	Designation

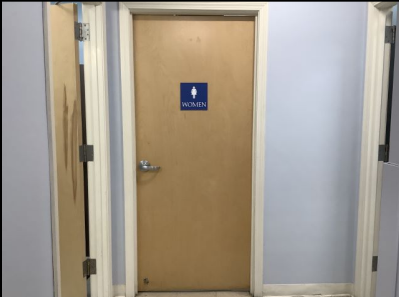
Location of tactile sign not compliant Directional sign to access. toilet not provided Signage lacks 18" by 18" clear floor space Character style not compliant		Install a sign indicating the location of the nearest accessible toilet room. Provide a compliant designation sign with compliant characters (characters should be sans serif). When a new sign is provided, locate the sign on the nearest adjacent wall alongside the door on the hinge side.	1	250 250	\$500

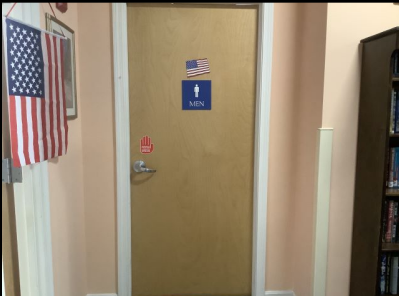
500	
60	Council On Aging - Men's Inaccessible Multi-User Toilet Room	1	-	Signage	Designation

Location of tactile sign not compliant Directional sign to access. toilet not provided Character style not compliant	- - -	Install a sign indicating the location of the nearest accessible toilet room. Provide a compliant designation sign with compliant characters (characters should be sans serif). When a new sign is provided, locate the sign on the nearest adjacent wall alongside the door on the latch side, and relocate the picture frame.	1	250 250	\$500
											500

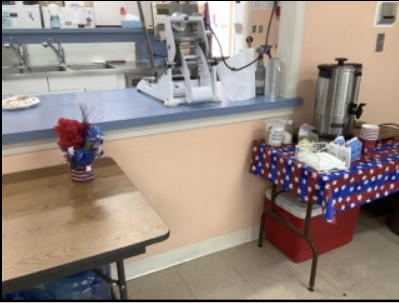
ID	Location	Floor	Room	Element	Type	Photo	Issues	Current Measure	Recommendations	Quantity	Price	Cost Estimation
Service Counter												
61	Council On Aging - Social Day Room	1	-	Service Counter	N/A

Parallel approach w/ part of counter surface < 36" long	-	Clear tables to ensure that the 30" wide by 48" deep clear floor space. If the clear floor space is confined on 3 sides and recessed more than 15", the length for the clear floor space must be at least 60", instead of 48", to ease maneuvering into it.	1	Labor	Labor
Operable Parts / Reach Range												
62	Recreation Department - Women's Locker Room	1	-	Operable Parts / Reach Range	Clothes Rod/Hooks

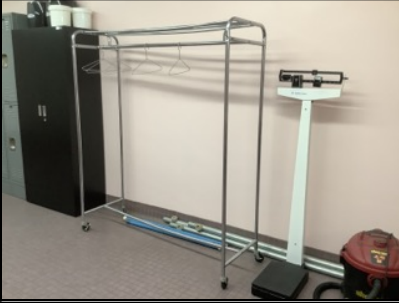
Reach < 15" or > 48"(forward/side approach)	64"	Provide a coat hook located no higher than 48" above the finished floor.	1	75	\$75
											75	
63	Recreation Department - Fitness Center	1	-	Operable Parts / Reach Range	Spray Bottles

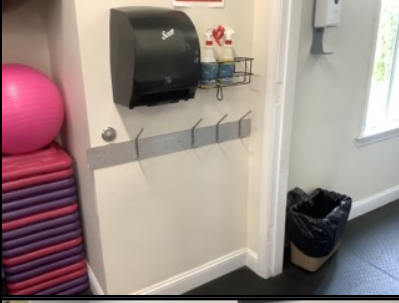
Reach < 15" or > 48"(forward/side approach)	57.5"	Relocate the spray bottle container so that the reach height of the neck of the spray bottles are between 15"- 48" above the finished floor.	1	500	\$500

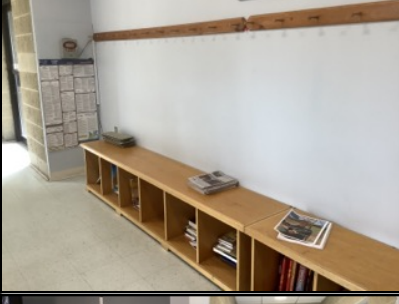
500	
64	Recreation Department - Lobby	1	-	Operable Parts / Reach Range	Clothes Rod/Hooks

Reach < 15" or > 48"(forward/side approach)	62.5"	Provide a coat hook located 48" max. above the finished floor.	1	75	\$75
											75	
65	Recreation Department - Lobby	1	-	Operable Parts / Reach Range	Hand Sanitizer Dispenser

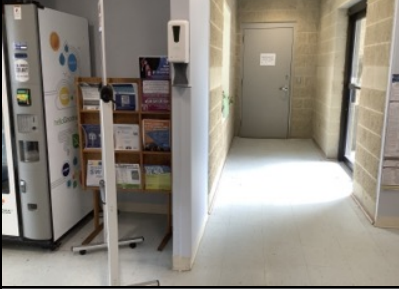
Reach < 15" or > 48"(forward/side approach)	60"	Relocate the hand sanitizer dispenser so that controls are between 15"- 48" above the finished floor.	1	500	\$500
											500

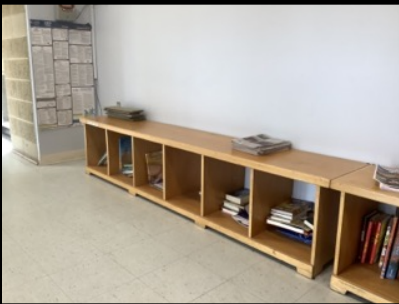
ID	Location	Floor	Room	Element	Type	Photo	Issues	Current Measure	Recommendations	Quantity	Price	Cost Estimation
66	Recreation Department - Lobby	1	-	Operable Parts / Reach Range	Book Shelves

Reach < 15" or > 48"(forward/side approach)	-	Ensure that staff is available to assist visitors who need assistance.	1	Labor	Labor
67	Council On Aging - Recreation Room	1	-	Operable Parts / Reach Range	Clothes Rod/Hooks

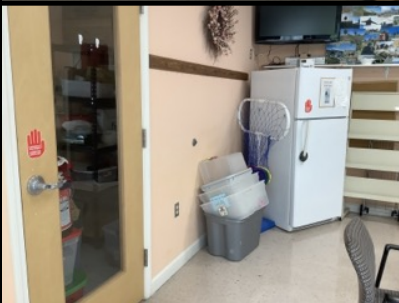
Reach < 15" or > 48"(forward/side approach)	64.25"	Provide an additional coat hook located 48" max. high above the finished floor.	1	75	\$75
											75	
68	Recreation Department - Fitness Center	1	-	Operable Parts / Reach Range	Clothes Rod/Hooks

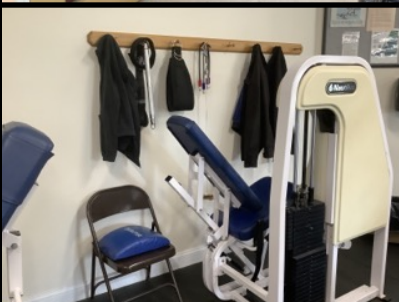
Clear floor space is not provided Reach < 15" or > 48"(forward/side approach)	- 66.5"	Provide a coat hook located 48" max. above the finished floor. Ensure the coat hook is located in an area where 30" min. by 48" min. of clear floor space is provided.	1	75	\$75

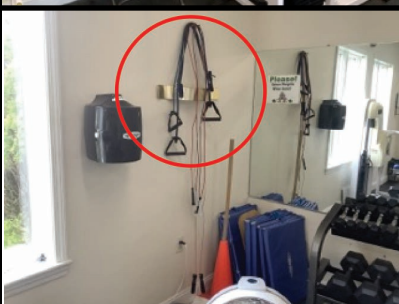
75	
69	Recreation Department - Fitness Center	1	-	Operable Parts / Reach Range	Resistance Bands

Clear floor space is not provided Reach < 15" or > 48"(forward/side approach)	- 71.5"	Relocate the hook that holds the resistance bands to an area where 30" min. by 48" min. of clear floor space is provided. Ensure the hook is located between 15" min. and 48" max. above the finished floor.	1	500	\$500
											500	
70	Recreation Department - Fitness Center	1	-	Operable Parts / Reach Range	Defibrillator

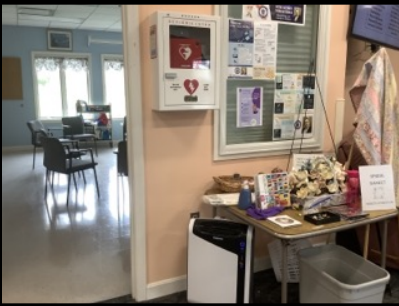
ID	Location	Floor	Room	Element	Type	Photo	Issues	Current Measure	Recommendations	Quantity	Price	Cost Estimation
71	Council On Aging - Recreation Room Entrance From Lobby	1	-	Operable Parts / Reach Range	Defibrillator

Clear floor space is not provided Reach < 15" or > 48"(forward/side approach)	- 60"	Relocate the defibrillator to an area with clear floor space away from the latch side of the door (where designation signage should be provided). When the defibrillator is relocated, ensure it is located 48" max. high above the finished floor.	1	500	\$500
											500	
72	Recreation Department - Fire Extinguisher by Men's Locker Room	1	-	Operable Parts / Reach Range	Fire Extinguisher

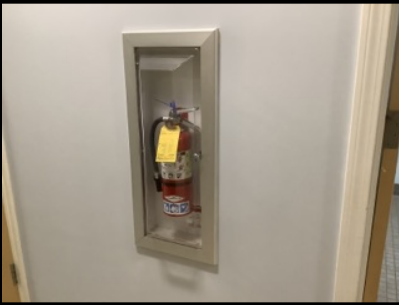
Not compliant	-	Provide a fire extinguisher cover that can be operable with one hand and not require tight grasping, pinching, or twisting of the wrist.	1	-	-
73	Council On Aging - Lobby	1	-	Operable Parts / Reach Range	Armoire Door Pulls

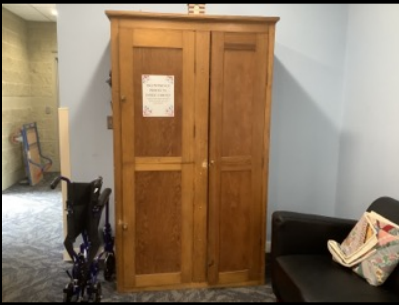
Not compliant		Provide door pulls that can be operable with one hand and not require tight grasping, pinching, or twisting of the wrist.	1	140	\$140

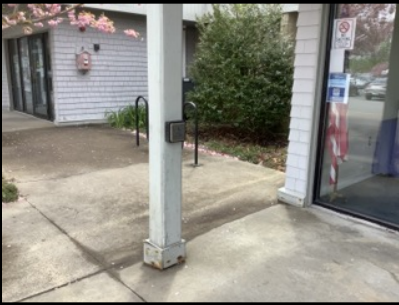
Operable part requires > 5 lbs. of force	10 lbs	Repair the automatic door opener button so that it does not require greater than 5 pounds of force to operate.	1	Labor	Labor
75	Council On Aging - Vestibule Door to North Main Entrance/ Egress	1	-	Operable Parts / Reach Range	Automatic Door Opener Button

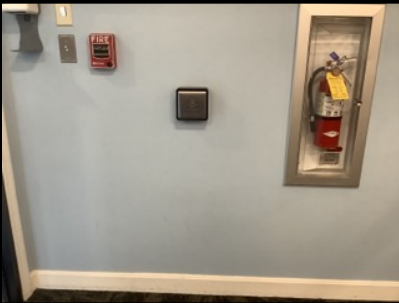
Operable part requires > 5 lbs. of force	10 lbs	Repair the automatic door opener button so that it does not require greater than 5 pounds of force to operate.	1	Labor	Labor

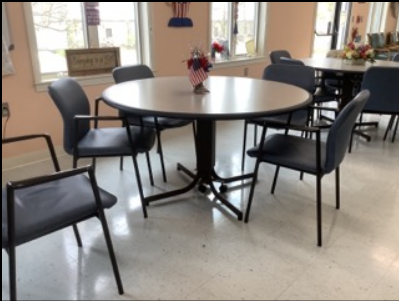
ID	Location	Floor	Room	Element	Type	Photo	Issues	Current Measure	Recommendations	Quantity	Price	Cost Estimation
Dining or Work Surfaces												
76	Council On Aging - Social Day Room	1	-	Dining or Work Surfaces	Work Surface

Knee or toe clearance not provided	-	Provide at least one work surface with 30" min. wide knee and toe clearance.	1	700	\$700
											700	
Assembly Area												
77	Recreation Department - Gymnasium	1	-	Assembly Area	N/A

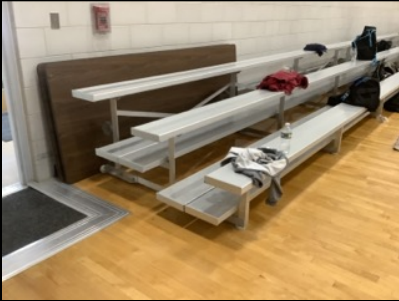
Number of seats Number of designated wheelchair spaces Minimum # wheelchair spaces not provided	100 0 -	Provide 4 wheelchair spaces alongside companion seats.	1	-	-
78	Recreation Department - Gymnasium	1	-	Assembly Area	N/A

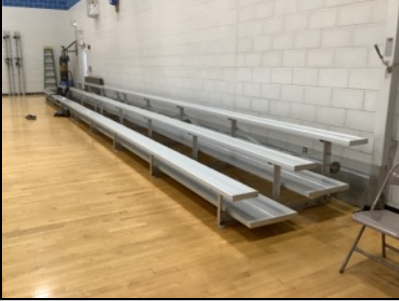
Assistive listening devices not provided		Note: IHCD survey team was not informed of any programs in the gymnasium where audible communication is used. If new programs are held where audible communication is used, ensure compliant assistive listening devices are provided.	1	-	-

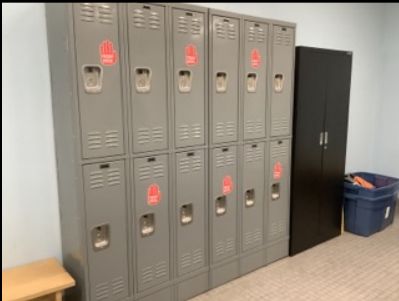
Ensure at least 5% of lockers are in compliance with ADA 803. Note: IHCD was unable to open any of the lockers and determine if lockers were fully compliant.	2	-	-

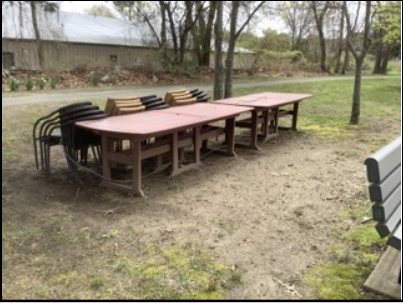
ID	Location	Floor	Room	Element	Type	Photo	Issues	Current Measure	Recommendations	Quantity	Price	Cost Estimation
Picnic Tables												
80	Council On Aging - Picnic Tables By Bocce Ball Court on South Side of Building	Ext.	-	Picnic Tables	N/A

At least 5% accessible spaces not provided 30" clear width not provided Picnic table not on an accessible route	- - -	Ensure that at least 5% (minimum one) of picnic tables are accessible. Provide at least 1 accessible picnic table (or ensure that 5% of picnic tables are accessible) with a 30" by 48" clear floor space. Ensure that the picnic table is connected to an accessible route. (Cost estimate is for the picnic table.)	1	1400	\$1400
											1400	
Exterior Benches												
81	Council On Aging - Bocce Ball Court on South Side of Building	Ext.	-	Exterior Benches	N/A

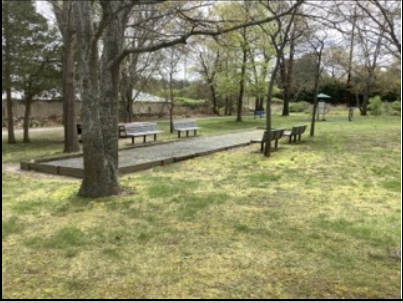
No accessible route to one bench in area	-	Provide an accessible stable, firm, and slip-resistant route to one bench in this area.	1	-	-

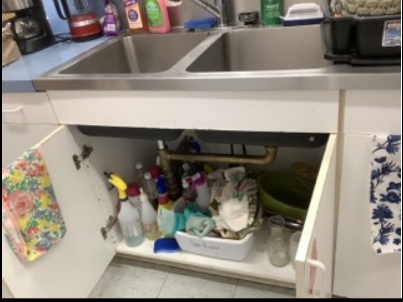
Knee/toe clearance not provided at sink Sink > 34" high Countertop next to sink < 15" wide Plumbing underneath is exposed	- 37" - -	If the sink is used by members of the public, replace cabinet doors under the sink to provide compliant knee and toe clearance. Lower sink to be no higher than 34" positioned for a forward approach. Ensure a countertop that is at least 15" wide is provided next to the sink. Insulate or otherwise configure pipes to prevent contact.	1	3094 1196	\$4290
											4290	
83	Council On Aging - Kitchen	1	-	Kitchens and Kitchenettes	N/A

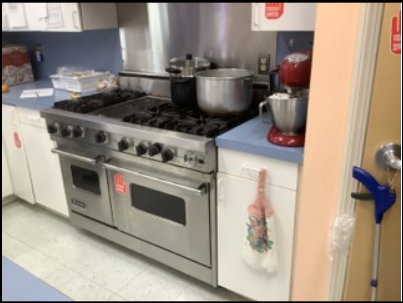
Knee/toe clearance not provided at cooktop Countertop > 34" high Knee/toe clearance not provided at countertop Wall oven type not provided	- 37.5" - -	If this stove and oven is used by members of the public, then provide a cooktop with knee and toe clearance positioned for a forward approach. Lower countertop to provide a work surface no higher than 34" positioned for a forward approach. Ensure knee and toe clearance are provided for 15" wide min. at the countertop next to the cooktop. Ensure that a wall type oven is provided.	1	1000 1144 1300	\$3444

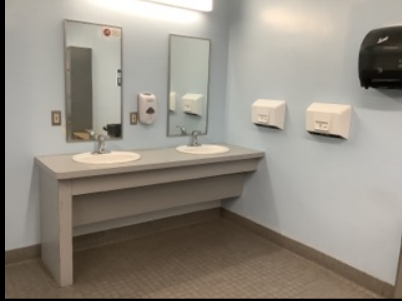
ID	Location	Floor	Room	Element	Type	Photo	Issues	Current Measure	Recommendations	Quantity	Price	Cost Estimation
Lavatory												
84	Recreation Department - Men's and Women's Locker Rooms/ Multi-User Toilet Rooms	1	-	Lavatory	N/A

Toe or knee clearances not provided	25"	Reconfigure panels under at least one lavatory to provide accessible knee and toe clearance positioned for a forward approach.	2	800	\$1600
											1600	
85	Recreation Department - All-Gender Single-User Toilet Room	1	-	Lavatory	N/A

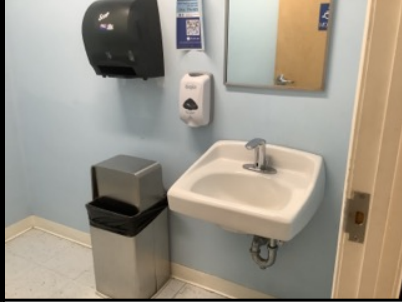
Toe or knee clearances not provided Plumbing underneath is exposed Mirror above lavatory w/reflective surface > 40"	26" - 47"	Relocate the lavatory to provide 27" high min. knee and toe clearance positioned for a forward approach. Insulate or otherwise configure pipes to prevent contact for at least one lavatory. Lower mirror so that the bottom surface is at 40" max. above the finished floor.	1	3094 150 500	\$3744

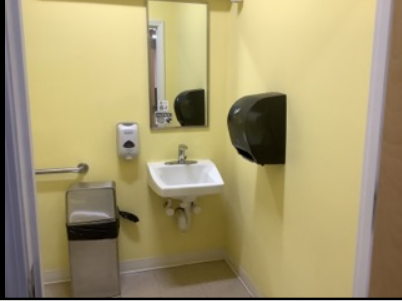
3744	
86	Council On Aging - All-Gender Single-User Toilet Room	1	-	Lavatory	N/A

Mirror above lavatory w/reflective surface > 40"	45.5"	Lower mirror so that the bottom surface is at 40" max. above the finished floor.	1	500	\$500
											500	
Single-User Toilet												
87	Recreation Department - Single-User Toilet Room	1	-	Single-User Toilet	N/A

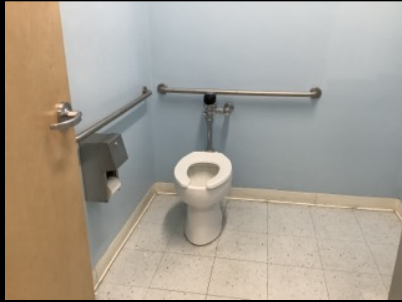
Side grab bar < 54" from back wall	48.5"	Relocate the side grab bar to be 12" max. from the rear wall.	1	800	\$800
											800	
88	Council On Aging - All-Gender Single-User Toilet Room	1	-	Single-User Toilet	N/A

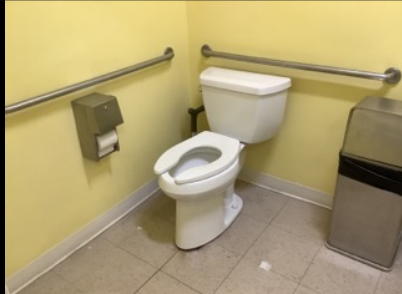
Flush control not on open side Side grab bar < 54" from back wall	- 50"	Relocate the flush control to the open side. Provide a side wall grab bar that is 42" long min. located 12" max. from the rear wall.	1	1000 800	\$1800
											1800

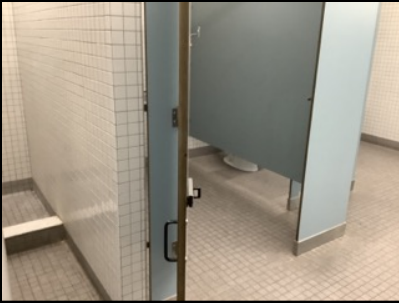
ID	Location	Floor	Room	Element	Type	Photo	Issues	Current Measure	Recommendations	Quantity	Price	Cost Estimation
Toilet Compartment												
89	Recreation Department - Men's and Women's Locker Rooms/Multi-User Toilet Rooms	1	-	Toilet Compartment	Accessible Compartment

Coat hook > 48" (2010 ADA) Door pull not provided	56.5" -	Provide a coat hook located no higher than 48" above the finished floor. Provide a door pull on each side of the door between 34" to 48" above the finished floor that does not require tight grasping, pinching or twisting of the wrist.	2	75 70	\$290
											290	
90	Recreation Department - Men's Locker Room/Multi-User Toilet Room	1	-	Toilet Compartment	Accessible Compartment

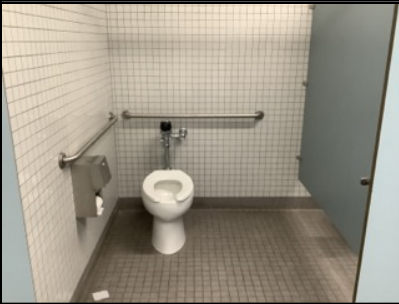
Side grab bar < 54" from back wall	47"	Provide a side wall grab bar that is 42" long min. located 12" max. from the rear wall.	1	800	\$800
											800	
91	Recreation Department - Women's Locker Room/Multi-User Toilet Room	1	-	Toilet Compartment	Accessible Compartment

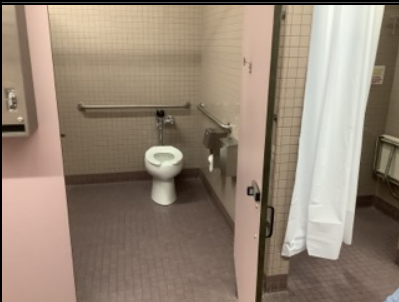
Side grab bar < 54" from back wall	46"	Relocate the side grab bar to be 12" max. from the rear wall.	1	800	\$800

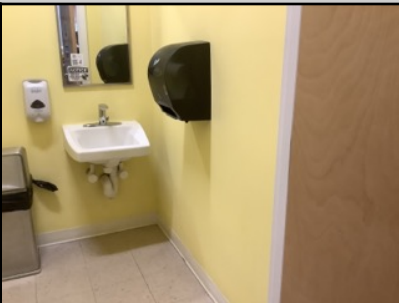
Dispenser acts as a protruding object	10"	Relocate dispenser out of the circulation path. Recommend locating the dispenser above the lavatory.	1	500	\$500
											500	
93	Recreation Department - Women's Locker Room/Multi-User Toilet Room	1	-	Dispensers	Tampon Dispenser

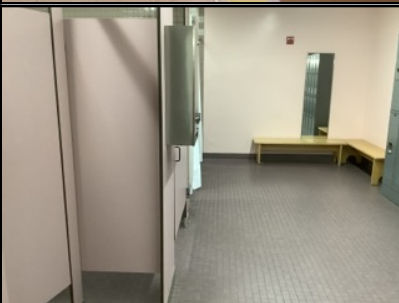
Noncompliant operable part Dispenser acts as a protruding object	- 6.5"	Provide a dispenser that can be operable with one hand and not require tight grasping, pinching, or twisting of the wrist. Relocate dispenser out of the circulation path.	1	1000 500	\$1500
											1500

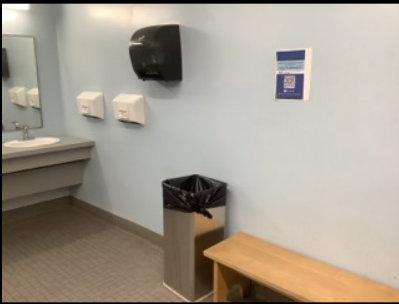
ID	Location	Floor	Room	Element	Type	Photo	Issues	Current Measure	Recommendations	Quantity	Price	Cost Estimation
94	Recreation Department - Men's Locker Room/Multi-User Toilet Room	1	-	Dispensers	Paper Towel Dispenser

Dispenser acts as a protruding object Side reach is > 54"	10" 58"	Relocate the trash can to be located directly underneath the paper towel dispenser. Relocate the paper towel dispenser so that controls are between 15" - 48" above the finished floor.	1	Labor 500	\$500
Shower Compartment												
95	Recreation Department - Men's and Women's Locker Room Transfer Showers	1	-	Shower Compartment	Transfer Type

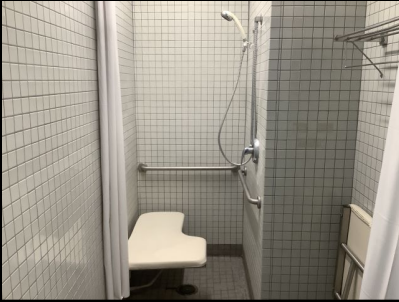
Clear space at transfer shower < 48" x 36" Size of shower compartment not compliant	- 35" D x 41" W	Provide a 48" x 36" clear floor space for a transfer shower. The required clearance must be located so that it aligns with the control wall and extends 12" minimum from the seat wall. This allows proper alignment with the seat for transfer from wheelchairs. Provide a transfer shower that is 36" by 36".	2	6072	\$12144

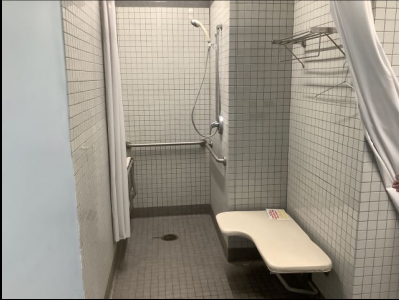
Changing Rooms												
96	Recreation Department - Men's Locker Room, Changing Area	1	-	Changing Rooms	Men's

Room is < 78" x 72" Bench < 24" deep Bench < 48" long Hook > 48" high	53"x 39.5" 22" 34.5" 65"	Provide an accessible changing room that is 78" by 72" min. Provide a bench that is 24" deep and 48" long min. Provide a coat hook located no higher than 48" above the finished floor.	1	7626	\$7626
97	Recreation Department - Women's Locker Room	1	-	Changing Rooms	Women's

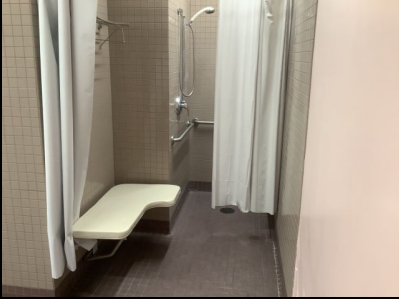
Room is < 78" x 72" Bench < 24" deep Bench < 48" long Hook > 48" high	60" x 39.5" 22" 34.5" 65"	Provide an accessible changing room that is 78" by 72" min. Provide a bench that is 24" deep and 48" long min. Provide a coat hook located no higher than 48" above the finished floor.	1	7626	\$7626
Play and Sport Areas

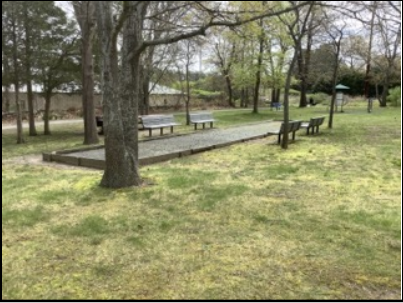
ID	Location	Floor	Room	Element	Type	Photo	Issues	Current Measure	Recommendations	Quantity	Price	Cost Estimation
Court												
98	Council On Aging - Bocce Ball Court on South Side of Building	Ext	-	Court	Bocce Ball

Court is not connected to an accessible route	-	Provide an accessible stable, firm, and slip-resistant route to the court.	1	Labor	Labor
Exercise Machines												
99	Recreation Department - Fitness Center	1	-	Exercise Machines	N/A

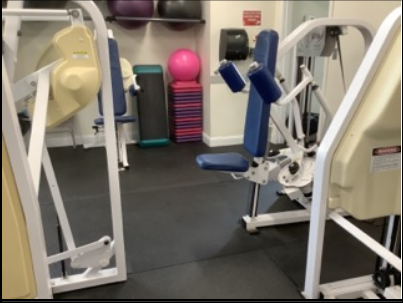
No accessible route to equipment	25"	Relocate exercise equipment to provide an accessible route that is 36" min. wide.	1	Labor	Labor
100	Recreation Department - Fitness Center	1	-	Exercise Machines	N/A

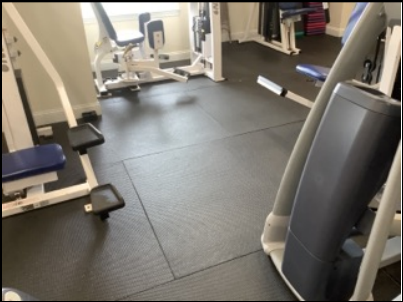
No accessible route to equipment	29"	Relocate exercise equipment to provide an accessible route that is 36" min. wide.	1	Labor	Labor
Best Practice												
Benches												
101	Council On Aging - Bocce Ball Court on South Side of Building	Ext.	-	Benches

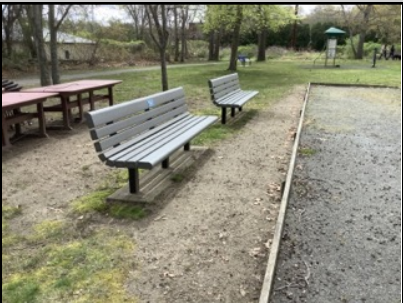
Recommend providing a 36" min. by 48" min. stable, firm and slip-resistant surface adjacent to at least one bench in each area where benches are provided positioned to allow a person in a wheeled mobility device and a person sitting on the bench to have their shoulders aligned.	1	-	-

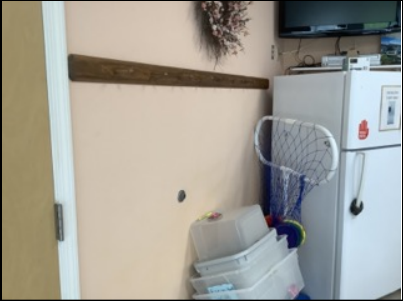
ID	Location	Floor	Room	Element	Type	Photo	Issues	Current Measure	Recommendations	Quantity	Price	Cost Estimation
Coat Hooks												
102	Council On Aging - Recreation Room	1	-	Coat Hooks	N/A

Recommend providing contrast between the coat hooks and the wood beam they are attached to.	1	-	-
Doors												
103	Recreation Department - Men's Inaccessible Multi-User Toilet Room	1	-	Doors

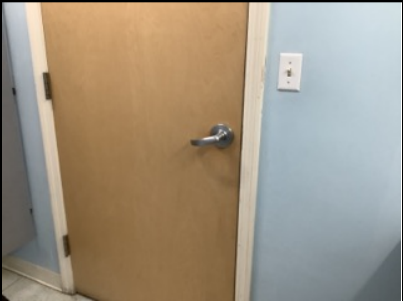
Recommend repairing the door handle, as the IHCD survey team observed it was broken. Applies to the men's inaccessible multi-user toilet room in the Council On Aging Building.	2	-	-
104	Recreation Department - North Main Entrance/ Egress	1	-	Doors
