Fairhaven Recreation Department and Council on Aging

Town of Fairhaven ADA Transition Plan

January 2025

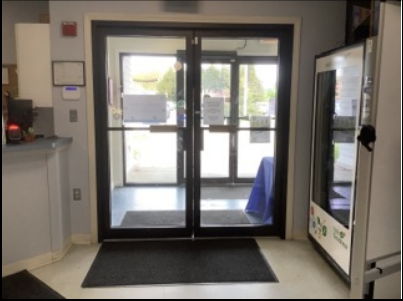
Recommend recalibrating the automatic door opener at the exterior vestibule double doors to open the interior vestibule double doors at the same time. Note: This recommendations was suggested to IHCD by a staff member. The COA also mentioned this concern: "Only the outside door has a push button to access the building. The inside door must be opened by staff".	1	-	-

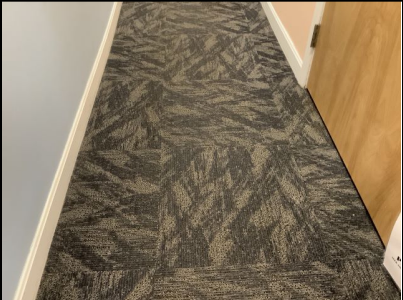
Recommend replacing the carpet, as the carpet pattern may disorient some visitors.	1	-	-

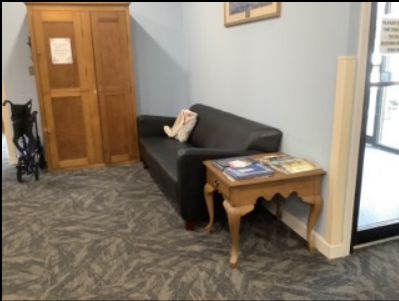
ID	Location	Floor	Room	Element	Type	Photo	Issues	Current Measure	Recommendations	Quantity	Price	Cost Estimation
Furniture												
106	Council On Aging - Lobby	1	-	Furniture	Sofa

Recommend relocating the table that is alongside the sofa to provide 30" x 48" of clear floor space adjacent to the sofa.	1	-	-
107	Council On Aging - Social Day Room	1	-	Furniture	Tables/ Chairs

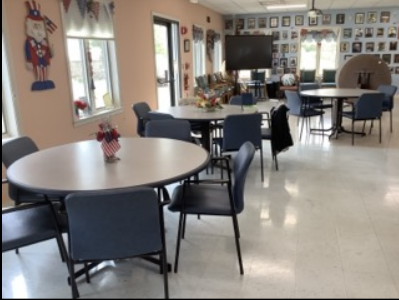
Recommend providing various types of table and seating options.	1	-	-
Parking												
108	Parking Lot - Accessible Spaces In Front Of Council On Aging Building	Ext.	-	Parking	N/A

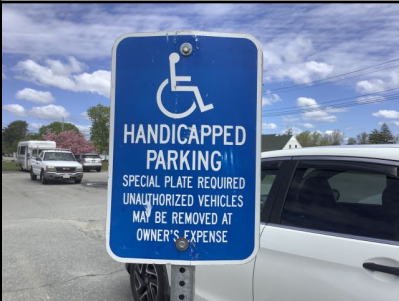
Recommend using the language "Accessible Parking" rather than "Handicapped Parking" on all accessible parking signage.	1	-	-
109	Parking Lot - Accessible Spaces In Front Of Council On Aging Building	Ext.	-	Parking	N/A

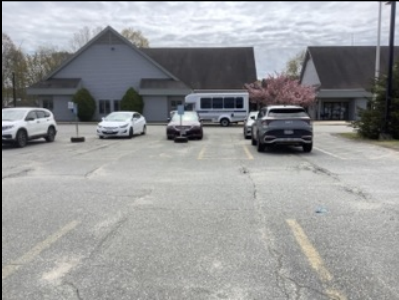
Recommend re-striping all access aisles to provide additional light-to-dark contrast between the striping colors and the asphalt.	1	-	-

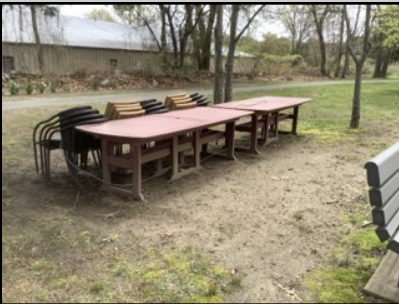
Picnic Table												
110	Council On Aging - Picnic Tables by Bocce Ball Court on South Side of Building	Ext.	-	Picnic Table	N/A

Recommend providing a stable, firm and slip-resistant surface that is 48" clear on all sides of all provided accessible picnic tables.	1	-	-

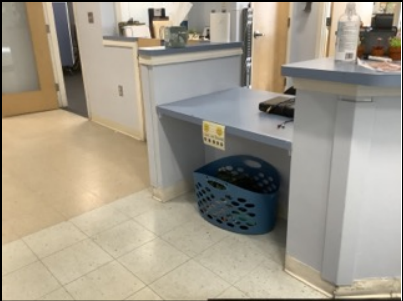
ID	Location	Floor	Room	Element	Type	Photo	Issues	Current Measure	Recommendations	Quantity	Price	Cost Estimation
Service Counter												
111	Recreation Department - Lobby	1	-	Service Counter	N/A

Recommend relocating the basket from underneath the lower portion of the service counter so that a forward approach to the counter can be provided.	1	-	-
Signage												
112	Recreation Department - Fire Extinguisher By Men's Locker Room	1	-	Signage	Blade Signage

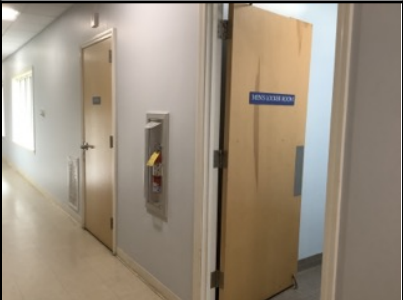
Recommend providing blade signage over all fire extinguishers in the Recreation Department and Council on Aging Buildings. Ensure the bottom edge of all blade signs are located 80" min. above the finished floor.	1	-	-
113	Recreation Department - North Main Entrance/ Egress	1	-	Signage	Designation

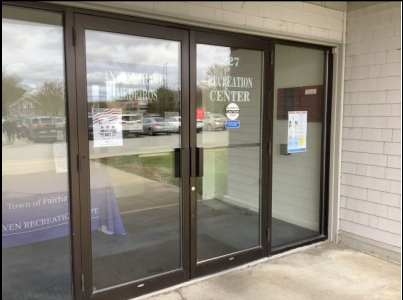
Signs with characters located on glass are difficult to read for people with low vision. Recommend providing a solid background behind the text.	1	-	-

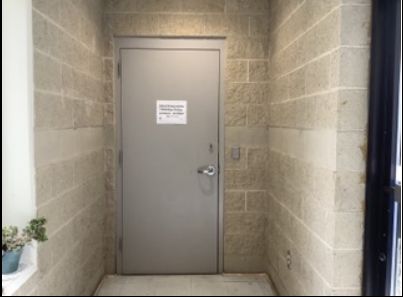
Recommend providing informational signage on both sides of the door that connects the Recreation Department and the Council on Aging, to inform visitors of where each door leads.	1	-	-
