**6641 Building Name:** Fairhaven Fire and Police Station

**Address:** 150 Washington Street

**Report By:** GGD **GSF** 16,637 **Date:** January 5, 2018

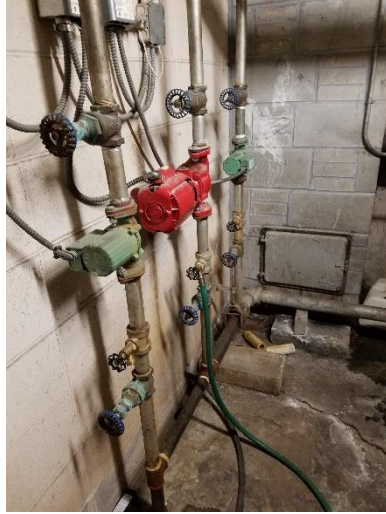
**Condition(s):** The Fire Station's hot water heating system and all related components has surpassed its expected service life and appears to be in fair/poor condition. The split DX system serving the fire station dispatch area is beyond its expected service life and appears to be in fair/ poor condition. The Fire Station apparatus bay heating and exhaust equipment has surpassed its expected service life and appears to be in fair/ poor condition. The destratification fans throughout the Fire Station building have surpassed their

*Fire Station – HW Zone Circulator Pumps*

1. Replace failed apparatus bay exhaust fans and install a gas detection system to control operation of the vehicle-parking area exhaust systems, as a minimum. Our recommendation would be a full HVAC system re-design for greater efficiency, zone control, thermal comfort, and air quality.

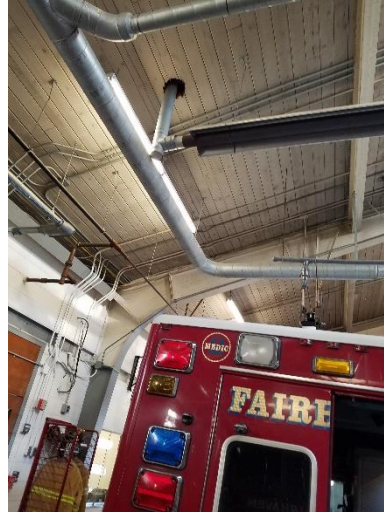
*Fire Station – Gas Fired Radiant Heater*

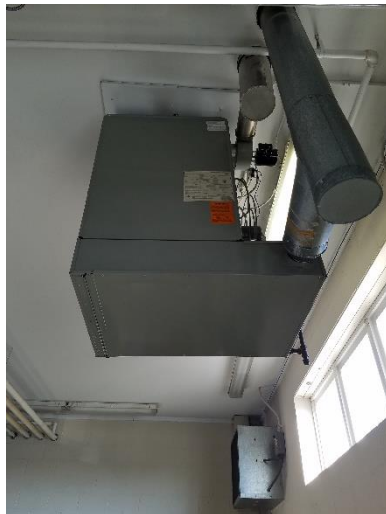
*Police Station – Apparatus Bay  
Gas Fired Unit Heater*

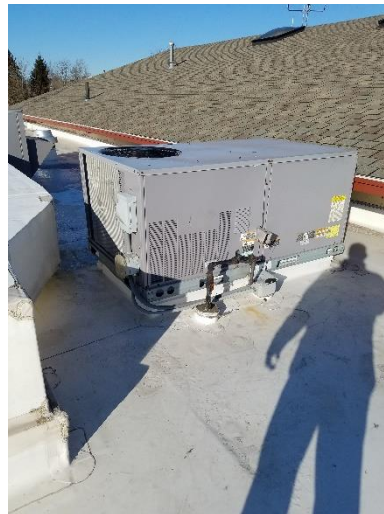
expected service life and appear to be in poor condition. The EMS Apparatus bay and Dive bay exhaust systems were reported as broken/ inoperable and require replacement. The Police station roof-mounted exhaust fans and packaged air handling units appear to have been installed somewhat recently and seem to be in good condition. The police station indoor air-handling units and split DX cooling components appear to be in fair condition but have surpassed their expected service lives. In general, the HVAC systems require replacement and upgrading throughout for code compliance and thermal comfort.

*Police Station – Packaged Roof Mounted  
Air Handling Unit*
