FAIRHAVEN TOWN HALL HISTORIC STRUCTURES REPORT

Prepared for:
Fairhaven Board of Selectmen
40 Center St.
Fairhaven, MA

Prepared by:
J. M. Booth & Associates, Inc Architects
47 N. 2nd St
New Bedford, MA

January 31, 2019

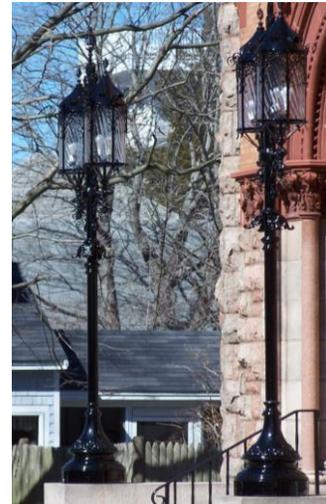
There are missing light fixtures at the east and west areaway stairs. The original poles remain and the conduit for the wiring is still visible, a careful replication of these lights would provide adequate light for these areas which provide egress from the basement offices. The light fixtures seen in this historic photo, provided by the Millicent Library, will provide enough detail to recreate the fixtures. The poles are still standing and can be used as the support for the fixtures.

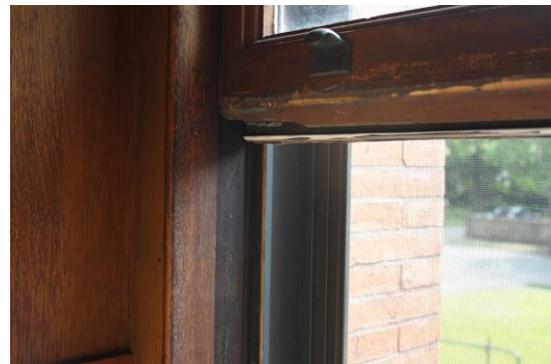
The windows on all levels were restored in the mid 1980s. Thermal pane glass was installed in the original frames and the sash balances were restored. The balances consist of weights and chains. The weights run in a pocket within the wall. The system is adequate for the balance of the windows. A plastic weatherstripping was installed, which has seen its effective usefulness. The plastic, designed to provide a spring action to seal the windows have become distressed and no longer provide the spring action. We recommend replacing the weatherstripping with a bronze metal tee shaped weatherstripping set into the jamb. This will seal the windows to windborne infiltration. The lock rail, or meeting rails of the two sash at the center of the opening, will need to be inspected to ensure that a proper lock rail weatherstripping system has been installed.

At the bottom of the lower sash, a bulb type weatherstripping was installed. We recommend removal of this weatherstripping and installing a bronze tee shape weatherstripping. This type of weatherstripping extends up into a kerf cut in the bottom of the sash effectively sealing the sash. The kerf cut exists so the installation of the weatherstripping would be an economical repair. The recommended weatherstripping are shown below.

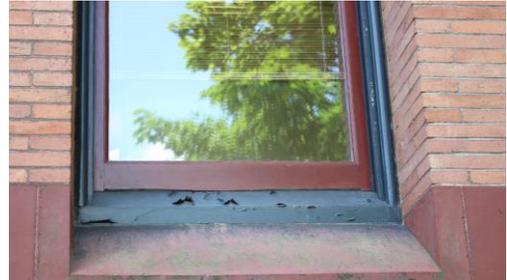
The exterior of the windows will need to be painted as an ongoing maintenance practice. The frames, restored in the 1996 restoration project are in good condition but need to be routinely prepared and painted, approximately every five years.

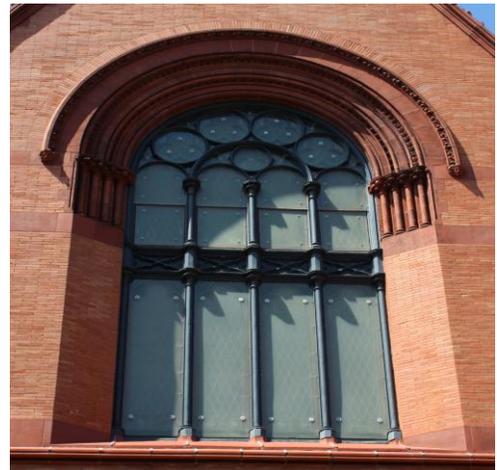
The ornate stained glass and leaded glass panels were covered with an acrylic panel to protect these irreplaceable windows from the weather and vandalism. The unique exterior covering was vented to minimize heat buildup in the summer months. The south windows on the Center Street Elevation have begun to yellow and should be replaced to maximize the visual appearance from the exterior.

These windows will need to be carefully evaluated by a stained glass conservator as many of the lead comes, the “h” shaped lead that holds the glass together, have evidence of failure. This report excludes this work as we are not capable of evaluating the window glazing. A budget line item will be carried in the statement of probable construction cost, but it will need to be confirmed by a conservator.

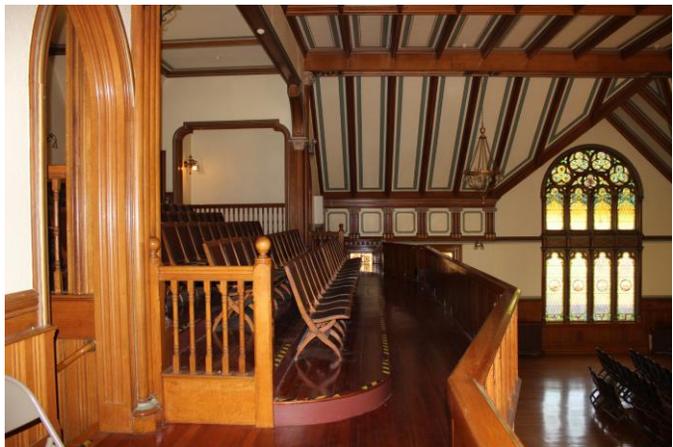
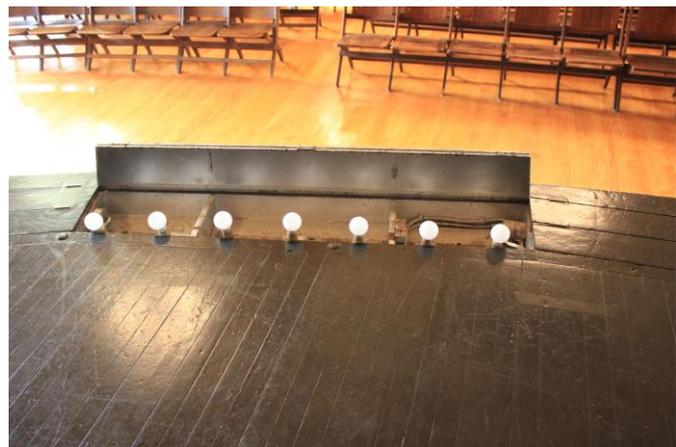
A review of the stage found it to be accessible by the elevator with a stop in the west wing space. Foot lights on the stage are old containing incandescent light bulbs. The wood trap doors are difficult to operate and we recommend that these lights be modernized before using.

A fire Curtain exists at the proscenium opening but it is difficult to operate and lacks the required fusible link and counterweight system designed to minimize smoke and fire from rising up the stagehouse into the attic. This curtain should be modernized, although the curtain itself should be acceptable for its intended purpose. We also found the stage curtain rigging system to be in poor condition. A modern rigging system should be considered for this curtain as well. The curtain can be seen in the photograph to the right as a gray folded curtain behind the wood proscenium in front of the maroon curtain. This curtain is essential in safeguarding the building in the event of a fire.

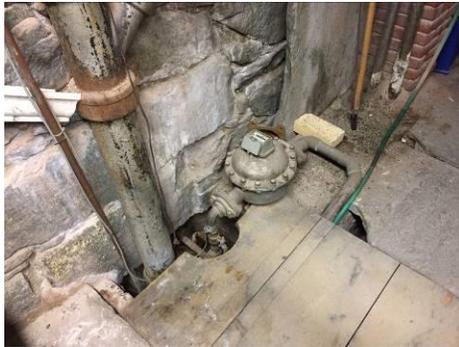
Water Meter

The main domestic water service is located in the Mechanical Room. The service is 2" in size and includes an old Empire meter. The main domestic cold-water distribution is 2" in size.

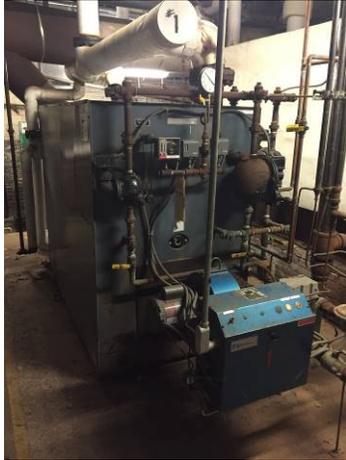
HB Smith Boiler

Please note, the original boiler was not removed and was abandoned in place when the presently operating boiler was installed in 1993. The boiler with abandoned piping takes up a considerable amount of space within the mechanical room.

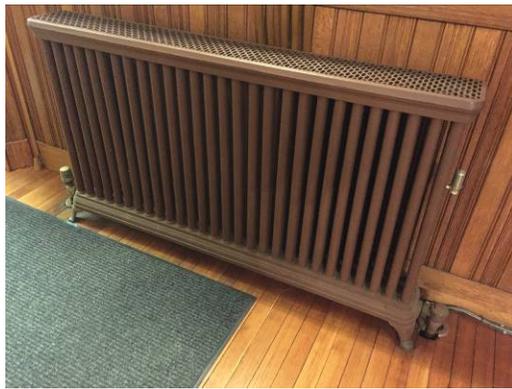
Typical Cast Iron Radiator Installed Throughout

Cast iron steam radiators are utilized throughout building for heating purposes. Certain locations have bare steam piping that is used for heat. In spaces where the occupant is cold, we witnessed small electric heaters. All of the cast iron radiators are controlled via a unit-mounted thermostatic control valve which acts as thermostat for individual occupant temperature control.

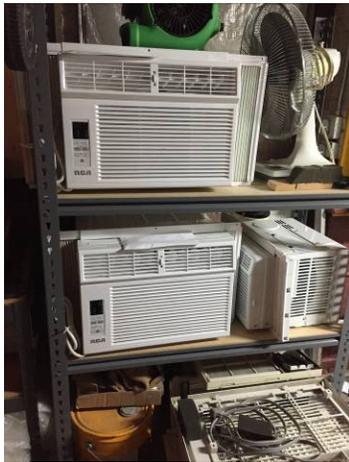
Stored Window Air Conditioners

Air conditioning is provided through the use of residential style window-mounted air conditioners. They are located in several offices, where required. There is a ductless split air conditioning unit located for the IT equipment at the basement level. The associated condensing unit is installed outside on the West wall.

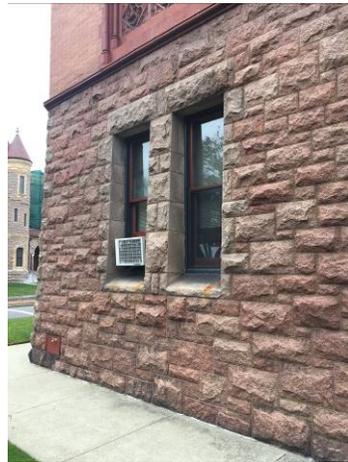
Typical Window Mounted Air Conditioner

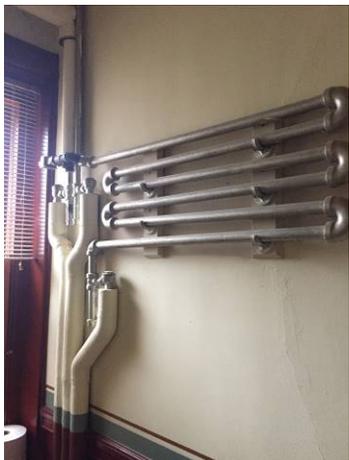
The toilet rooms are not provided with any mechanical exhaust systems. All ventilation occurs through the use of operable windows. Steam heat is provided for most toilet rooms using cast iron radiators or a bare pipe assembly. As indicated in the ventilation section, utilization of operable windows for ventilation should be verified to ensure code required window area is met.

Women's Room Heat (Basement)

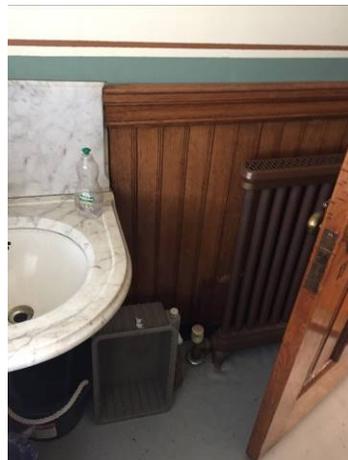
Upper Floor Toilet Room

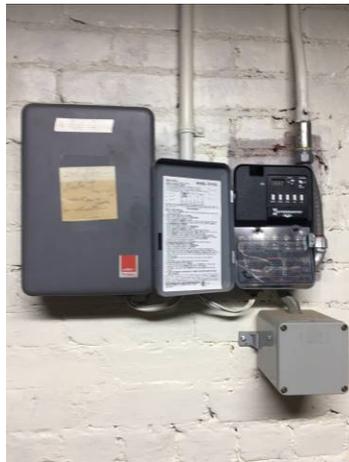
The temperature control system is located in the basement. The system will maintain a lower space temperature in the auditorium when it is not occupied.

Auditorium Control

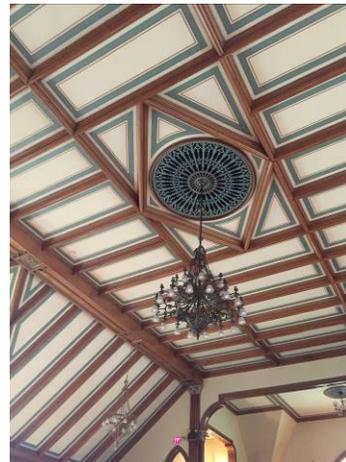
Decorative grille within Auditorium

Our understanding is the Town has a proposal in hand to air condition the Auditorium. It was described to us that two units will be installed behind the grilles located near the stage. Ductwork will be installed behind the wall and will run up to the attic space where it will distribute air through the decorative grille located in the middle of the Auditorium.

We recommend installing the Unico System. The Unico system utilizes small supply tubing that can fit within existing wall cavities and floors. This allows for minimal disruption to the building, without the extensive remodeling. The largest system has a capacity for 5 tons of cooling, so two or more units will be required. A possible solution would be two within the Auditorium and one at the stage. For more information visit www.unicosystems.com

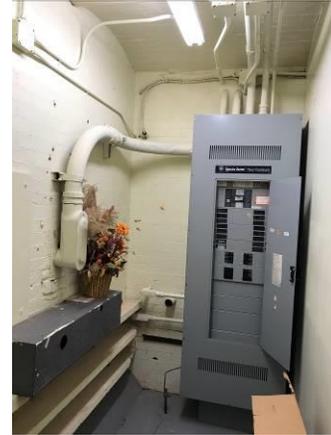
The main distribution panel was manufactured by GE Spectra Series is located in the main electrical closet and is in good condition.

Main Distribution Panel

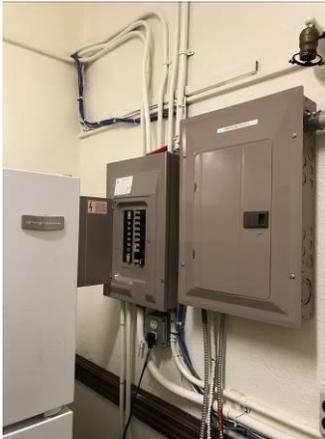
Working clearance for panels in Work Room is blocked by refrigerator.

Office Panels in Work Room

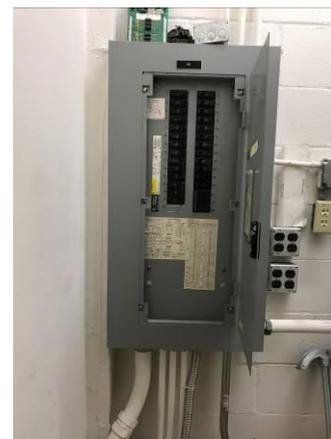
Panels have been installed on an as needed basis and consists of different manufacturers. The stage panelboard replaced the older panel however the existing wiring remained and was extended to new panel.

Stage Panel

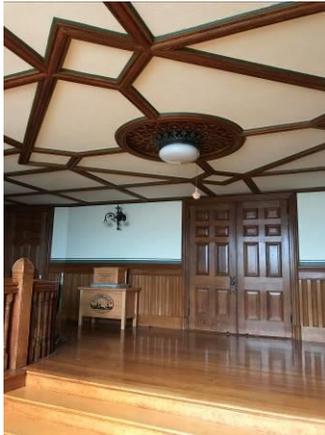
Second floor hall has a surface ornamental globe fixture with screw-in CFL lamps controlled with a pull chain. Ornamental wall sconces are controlled with integral rotary switches on each globe socket. The globes have been replaced.

*2nd Floor Hall Globe Fixture
& Wall Sconces*

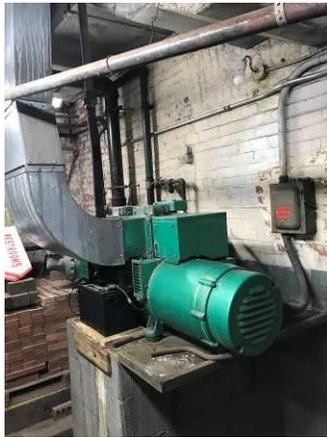
The existing 15 kW generator is old and inadequate. The emergency lighting systems is not code compliant and consists of lights on the generator as well as self-contained battery units with inadequate coverage. Exit signs are generally old and some do not have battery back-up and provide inadequate coverage.

The emergency standby system is in poor condition and is marginal and not code compliant. The generator voltage and phase is not consistent with the main building characteristics.

Generator

The life safety systems are in poor condition and not code compliant. These systems should be replaced. Code requires full separation of emergency system from standby loads requiring 2 transfer switches, fire rated feeders and fire rated dedicated emergency rooms.

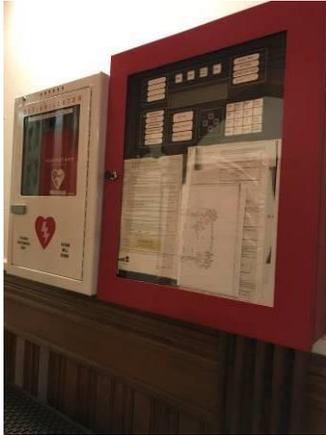
The fire alarm system, although functional, is obsolete and should be replaced under a renovation.

FACP

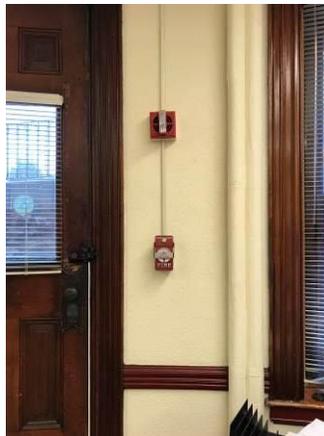
The audio/visual devices consist of horn/strobes. Horn/strobe coverage is inadequate. The existing fire department standpipe risers are not supervised.

Horn/Strobe & Pull Station

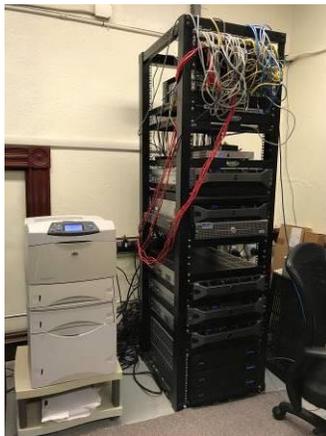
The MDF is not located within a dedicated room. The tel/data cabling infrastructure is generally CAT5 and 5E. A floor mounted rack is located in the open Basement on a 6" wooden subfloor. Three 30A/1P plug-in rack mounted UPS back-up Dell servers. The communications wiring typically runs exposed throughout the building and generally improperly supported from other trades piping.

MDF Rack

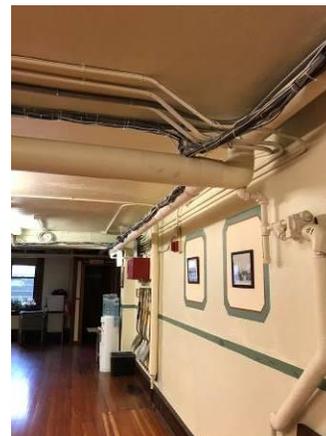
Exposed Communications Wiring

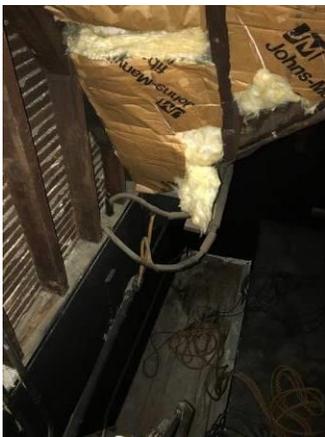
The general wiring method is pipe and wire, MC cable and surface metal raceways, occasional Romex was noted. A lot of unused old wiring has been abandoned in place, especially above the Stage.

Attic Old Wiring
