Cushman Park

Town of Fairhaven ADA Transition Plan

November 2024

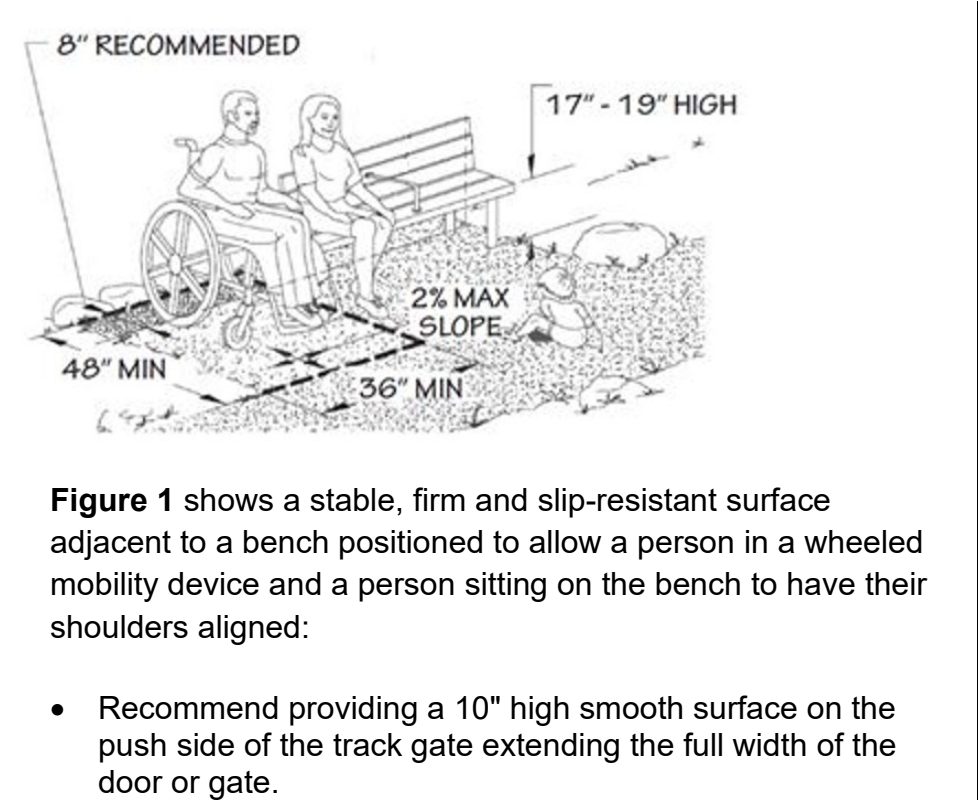
- Recommend providing path lighting on the route from the parking lot to the park.
- Recommend repairing or replacing the gate to the track to make it easier to open. Ensure that it is kept in operable working condition.
- Recommend providing a 36” min. by 48” min. stable, firm and slip-resistant surface adjacent to at least one of the existing benches in each unique program area in the park in a manner that is substantially similar to what is shown in Figure 1.
