East Fairhaven Elementary School

Town of Fairhaven ADA Transition Plan

October 2024

Institute for Human Centered Design

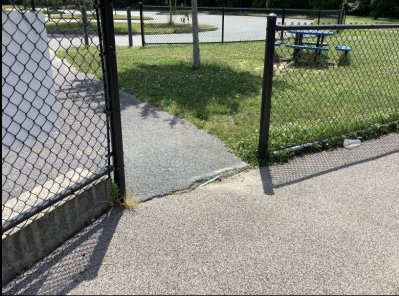
Running slope > 1:20 (5.00%) Level changes > 1/4"	7.3% 1.5"	Reduce running slope to be no steeper than 1:20 (5.00%). Alter change in level to be 1/4" high max.	1	-	-
7	Entry Gate to Playground Closest to Parking	Ext.	-	Exterior Access Route	Walkway

Level changes > 1/4"	1.5"	Alter change in level to be 1/4" high max.	1	-	-
8	Outside of Playground Farthest From Parking	Ext.	-	Exterior Access Route	Walkway

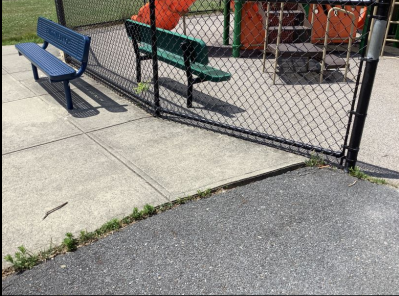
Level changes > 1/4"	1.5"	Alter change in level to be 1/4" high max.	1	-	-
9	Walkway to East Entrance of School	Ext.	-	Exterior Access Route	Sidewalk

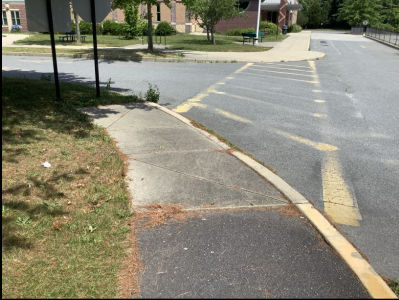
Accessible route not provided	-	Ensure an accessible route is provided to the memorial.	1	-	-
Curb Ramp												
13	Path to Basketball Court	Ext.	-	Curb Ramp	N/A

Transition from curb ramp to street not flush	0.75"	Ensure transition from curb ramp to street is flush or free of changes in level.	1	-	-
14	Path to Basketball Court	Ext.	-	Curb Ramp	N/A

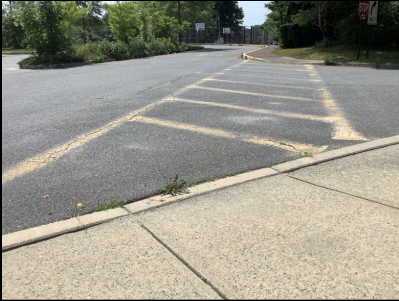
Transition from curb ramp to street not flush	0.75"	Ensure transition from curb ramp to street is flush or free of changes in level.	1	-	-

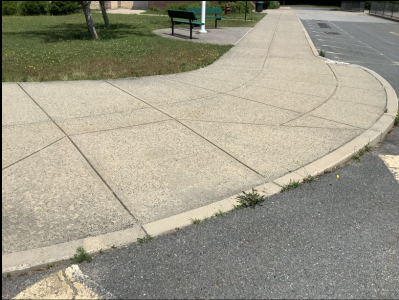
15	Curb Ramp on South/East Corner of Car Drop Off	Ext.	-	Curb Ramp	N/A

Transition from curb ramp to street not flush	1.25"	Ensure transition from curb ramp to street is flush or free of changes in level.	1	-	-

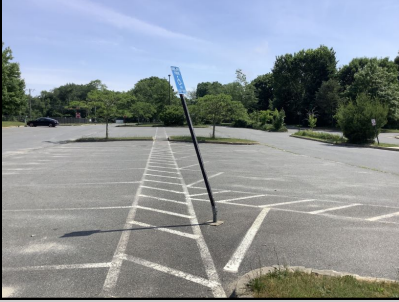
Sign with the International Symbol of Acc. not provided	-	Provide a sign with the International Symbol of Accessibility (ISA) with the bottom of the sign 60" min. above the ground and the top 96" max. above the ground.	1	500	\$500
											500	
17	Single Accessible Space in East Parking Lot	Ext.	-	Off-Street Parking Lot or Garage	Visitor

Sign with the International Symbol of Acc. not maintained.	-	Maintain the pole of the sign so it is not bent.	1	Labor	Labor
Passenger Loading Zones												
19	Car Drop Off by East Entrance	Ext.	-	Passenger Loading Zones	N/A

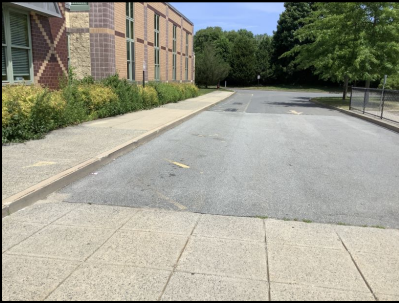
Marking not provided at access aisle	-	Repaint the marking in the passenger loading zone, including the raised accessible portion.	1	-	-

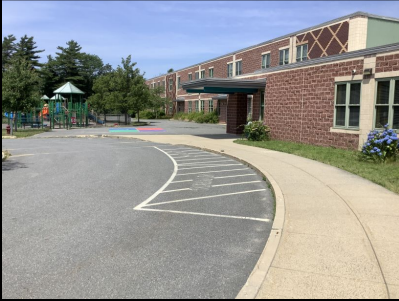
21	Bus Drop Off Outside South Entrance	Ext.	-	Passenger Loading Zones	N/A

Sign with ISA not provided (MAAB)	-	Provide a sign that includes the International Symbol of Accessibility (ISA) at the head of the space. Locate the sign so that the bottom is 60" min. above the ground and the top is 96" max. above the ground.	1	500	\$500
											500	
18	Car Drop Off by East Entrance	Ext.	-	Passenger Loading Zones	N/A

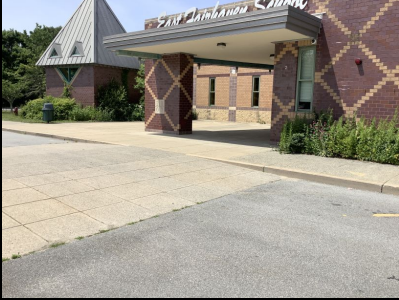
Sign with ISA not provided (MAAB)	-	Provide a sign that includes the International Symbol of Accessibility (ISA) at the head of the space. Locate the sign so that the bottom is 60" min. above the ground and the top is 96" max. above the ground.	1	500	\$500
											500	
Access to Goods and Services

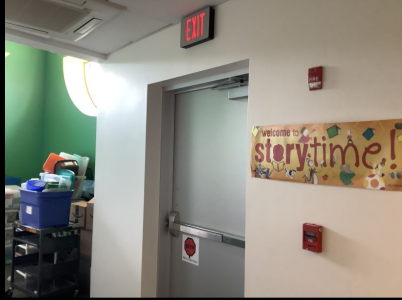
Tactile exit sign not provided Illuminated ISA symbol not provided (MAAB)	- -	Ensure that a tactile exit sign with raised characters and braille is provided at the exit door. Mount the sign between 48" - 60" above the finished floor located on the latch side of the door. Provide an illuminated sign with the International Symbol of Accessibility (ISA). (Cost is for one tactile exit sign and one illuminated sign with the International Symbol of Accessibility (ISA)).	1	250 200	\$450
											450	
23	Story Area, All Accessible Direct Egress Doors	1	110 C	Means of Egress	N/A

Tactile exit sign not provided Illuminated ISA symbol not provided (MAAB)	- -	Ensure that a tactile exit sign with raised characters and braille is provided at the exit door. Mount the sign between 48" - 60" above the finished floor located on the latch side of the door. Provide an illuminated sign with the International Symbol of Accessibility (ISA). (Cost is for one tactile exit sign and one illuminated sign with the International Symbol of Accessibility (ISA)).	1	250 200	\$450

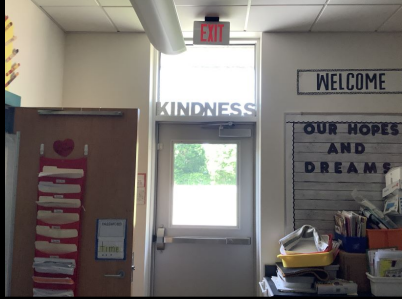
450	
24	Kindergarten, All Classrooms on LL	LL	-	Means of Egress	N/A

Tactile exit sign not provided Illuminated ISA symbol not provided (MAAB)	- -	Ensure that a tactile exit sign with raised characters and braille is provided at the exit door. Mount the sign between 48" - 60" above the finished floor located on the latch side of the door. Provide an illuminated sign with the International Symbol of Accessibility (ISA). (Cost is for one tactile exit sign and one illuminated sign with the International Symbol of Accessibility (ISA)).	1	250 200	\$450
											450	
Interior Access Route												
25	Library	1	110	Interior Access Route	N/A

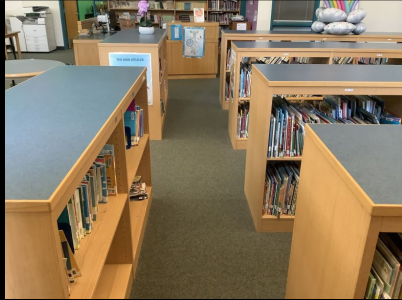
Route < 36" wide	32"	Ensure that a clear width of 36" min. is maintained at the accessible route.	1	Labor	Labor
26	Gym	1	-	Interior Access Route	N/A

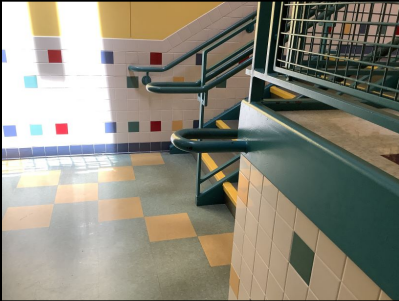
Obstructed by protruding objects	14"	Provide a cane-detectable barrier underneath the projecting object. Barriers must have leading edges no higher than 27" so that they are within cane sweep. Barriers can include fixed planters, benches, and guardrails. Applies to the other identical protruding object in the gym.	2	398	\$796
28	Stairway on East/West Corridor from Level 1 to LL	1	-	Interior Access Route	N/A

Obstructed by protruding objects	14.4"	Provide a cane-detectable barrier underneath the projecting handrail in the middle of the staircase. Barriers must have leading edges no higher than 27" so that they are within cane sweep. Applies to top and bottom of this set of stairs.	4	398	\$1592
29	Exam Room Within Nurse's Office	1	101 B	Interior Access Route	N/A

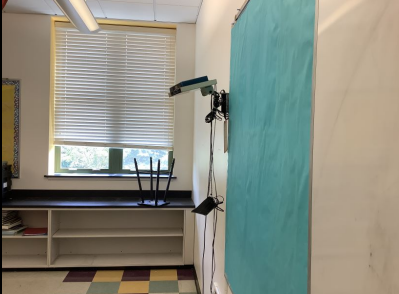
Obstructed by protruding objects	5", 79.5"	Provide a cane-detectable barrier underneath the projecting object with wires. Barriers must have leading edges no higher than 27" so that they are within cane sweep. Barriers can include fixed planters, benches, and guardrails.	1	398	\$398
31	Grade 3	2	235	Interior Access Route	N/A

Obstructed by protruding objects	15"	Provide a cane-detectable barrier under the object. Barriers must have leading edges no higher than 27" so that they are within cane sweep. Barriers can include fixed planters, benches, and guardrails.	1	398	\$398

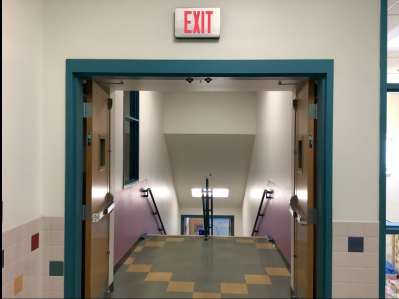
Signage is not provided		Locate compliant designation signage for the gymnasium with raised characters and braille alongside the door on the latch side.	1	250	\$250
											250	
43	Stairwell 2	2	-	Signage	Egress

Signage is not provided	-	Locate compliant stair egress sign with raised characters and braille on the right side of the double doors.	1	250	\$250
											250	
44	Innovation	2	230	Signage	Designation

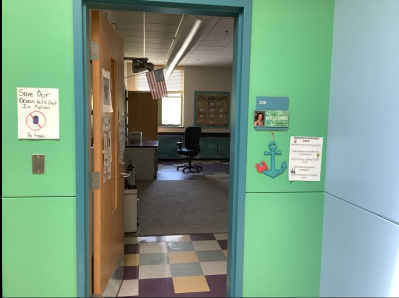
Raised characters not provided on sign Braille not provided on sign	- -	Ensure the teacher designation sign does not block any raised characters or braille that indicate "Classroom" on the designation sign behind.	1	Labor	Labor
45	Library	1	110	Signage	Designation

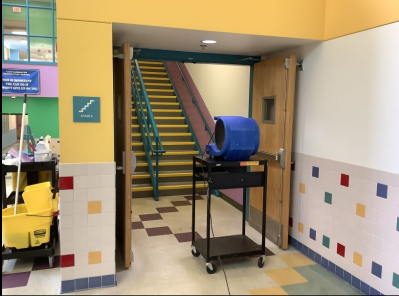
Location of tactile sign not compliant		Locate compliant designation signage to the gymnasium on the right side of the rightmost door.	1	Labor	Labor
48	Stairwell 2	1	-	Signage	Designation

Location of tactile sign not compliant	-	Locate one sign to the right of the right-hand door.	2	Labor	Labor
49	Reception	1	100	Signage	Designation

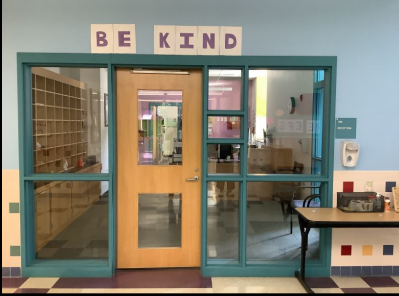
Location of tactile sign not compliant	-	Locate sign on the glass alongside the door on the latch side.	1	Labor	Labor
50	Speech Room	LL	121	Signage	Designation

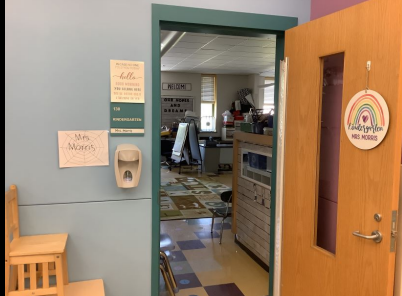
Signage lacks 18" by 18" clear floor space	-	Relocate the trash can to provide a clear floor space of 18" min. by 18" min. at the designation sign.	1	Labor	Labor
53	Kindergarten	LL	130	Signage	Designation

Signage lacks 18" by 18" clear floor space	-	Relocate furniture to provide a clear floor space of 18" min. by 18" min. at the designation sign.	1	Labor	Labor
54	Preschool	LL	131	Signage	Designation

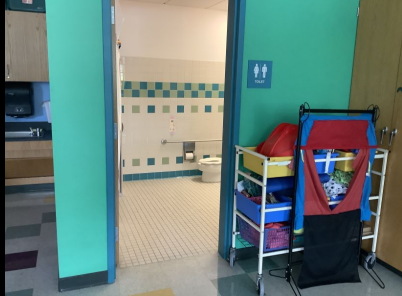
Signage lacks 18" by 18" clear floor space		Relocate objects to provide a clear floor space of 18" min. by 18" min. at the designation sign.	1	Labor	Labor
55	Exam Room Within Nurse's Office	1	101 B	Signage	Designation

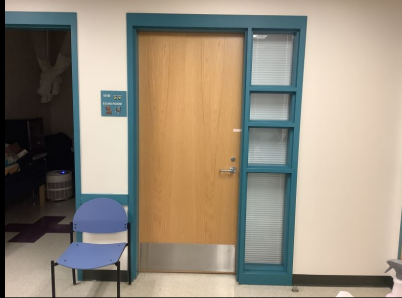
Location of tactile sign not compliant Signage lacks 18" by 18" clear floor space	- -	Locate sign alongside the door on the latch side. Relocate the chair to provide a clear floor space of 18" min. by 18" min.	1	Labor	Labor

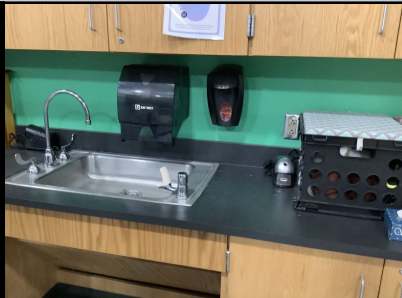
Operable Parts / Reach Range												
56	Music/Stage Platform Common Area	1	-	Operable Parts / Reach Range	Soap Dispensar

Reach < 15" or > 48"(forward approach)	50"	Relocate soap dispenser so that controls are between 15"- 48" above the finished floor.	1	500	\$500
											500

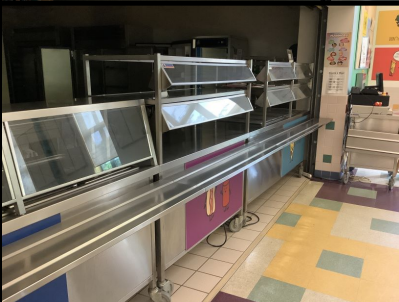
Reach < 15" or > 48"(forward/side approach)	60.5"	Ensure that staff is available to assist visitors who need assistance.	1	Labor	Labor
58	Cafeteria	1	124	Operable Parts / Reach Range	Food Service Shelf

Reach < 15" or > 48"(forward/side approach)	49.5"	Relocate the food service shelf so that controls are between 15"- 48" above the finished floor, or ensure staff can assist.	1	-	-
59	Exam Room Within Nurse's Office	1	101 B	Operable Parts / Reach Range	Eyewash

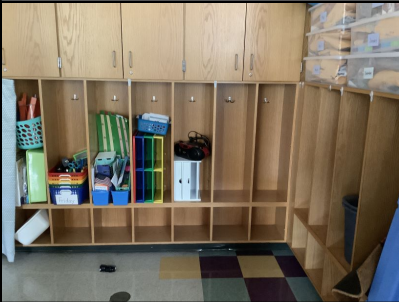
Not compliant		Provide hardware that can be operable with one hand and not require tight grasping, pinching, or twisting of the wrist.	1	-	-
Children's Reach Ranges												
60	Preschool	LL	131	Children's Reach Ranges	Coat Hooks

Reach < 20" or > 36" (Ages 3 - 4)	49.25"	Relocate so the coat hook is between 20" and 36" above the finished floor. Applies to cubbies in Kindergarten Room 130.	2	75	\$150

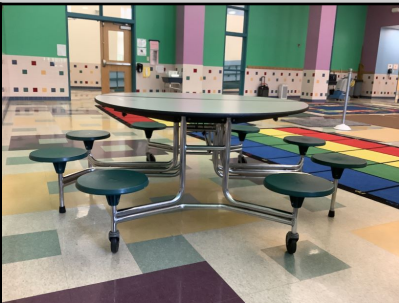
150	
Dining or Work Surfaces												
61	Cafeteria	1	124	Dining or Work Surfaces	Dining Surface

At least one or 5% accessible tables not provided	-	Ensure that at least one dining surface is accessible.	1	1100	\$1100
											1100

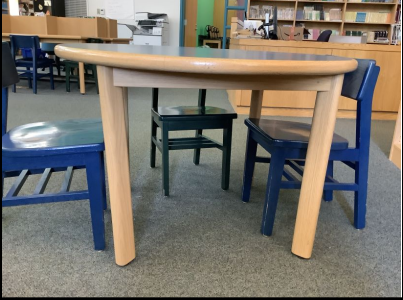
At least one or 5% accessible tables not provided	-	Ensure that at least one work surface is accessible. Applies to all classrooms where at least one or 5% of accessible work surfaces are not provided.	1	700	\$700
											700	
63	Library	1	110	Dining or Work Surfaces	Work Surface

At least one or 5% accessible tables not provided Knee or toe clearance not provided	- 23.5"	Ensure that at least one individual work surface has at least 30" wide knee and toe clearance.	1	700	\$700
											700	
64	Innovation	2	230	Dining or Work Surfaces	Work Surface

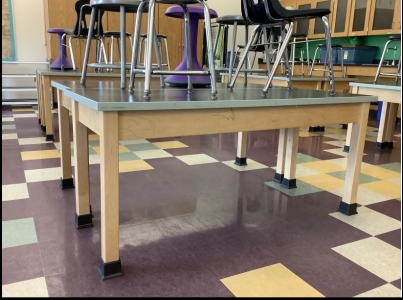
Knee or toe clearance not provided	21"	Provide at least one work surface with 24" min. high knee and toe clearance.	1	700	\$700
											700	
65	Office 114 Noguera	LL	-	Dining or Work Surfaces	Work Surface

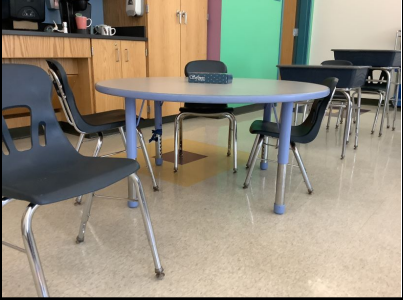
700	
66	Special Ed. Preschool	LL	117	Dining or Work Surfaces	Work Surface

Knee or toe clearance not provided	24"	Provide at least one work surface with 30" min. wide knee and toe clearance. Applies to Grade 1 Classroom 139, Grade 2 Classroom 144, Grade 3 Classroom 235.	4	700	\$2800
											2800

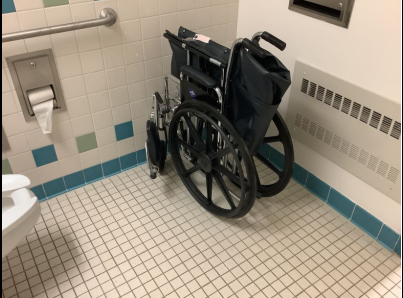
Side grab bar < 54" from back wall	48.5"	Relocate the side wall grab bar to be located 12" exactly from the rear wall.	1	800	\$800
											800	
73	Nurse's Office Single-User Toilet Room	1	-	Single-User Toilet	N/A

Clearance at toilet < 72" clear depth (MAAB)	-	Move wheelchair out of the clear space required at the toilet.	1	Labor	Labor
74	Nurse's Office Single-User Toilet Room	1	-	Single-User Toilet	N/A

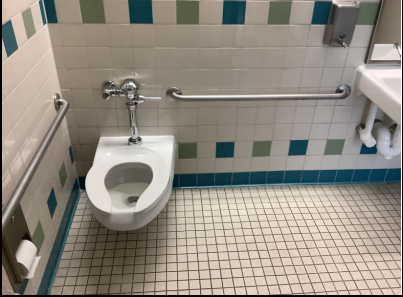
30" x 48" clear floor space not provided	-	Move objects underneath baby changing table to provide a 30" min. by 48" min. clear floor space positioned for a forward approach.	1	Labor	Labor
Toilet Rooms for Children												
Single-User Toilet (Children)												
79	Toilet Room Within Special Education Classroom	LL	117	Single-User Toilet (Children)	All Gender

Item located over grab bar	-	Relocate the soap dispenser so that it is not above the rear grab bar.	1	500	\$500
											500	
80	Kindergarten	LL	130	Single-User Toilet (Children)	All Gender

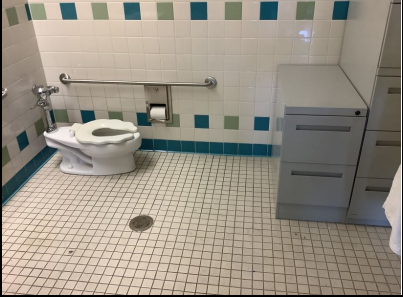
Clearance at toilet < 72" clear deep	-	Move cabinets to ensure that there is 72" deep at the toilet.	1	Labor	Labor
81	Toilet Room Within Special Education Classroom	LL	117	Single-User Toilet (Children)	All Gender

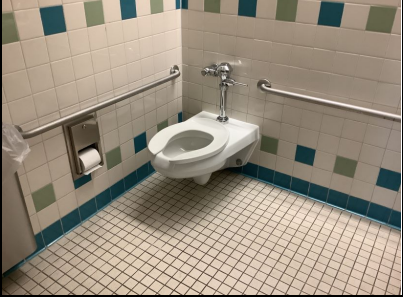
Toilet seat < 12" or > 15" high (K - 3) Side grab bar < 54" from back wall	17" 45"	Install a toilet with a seat between 12"- 15" high above the finished floor. Locate the side wall grab bar exactly 12" from the rear wall.	1	2816 800	\$3616

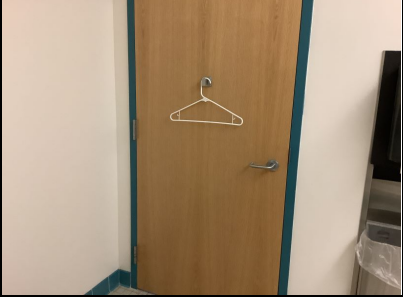
Coat hook higher than 36"	55"	Provide a lower coat hook no higher than 36" above the finished floor.	2	75	\$150
											150

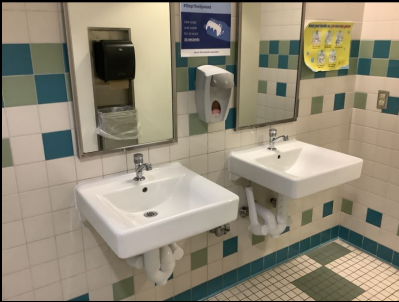
Controls > 48" high	49.25"	Relocate the paper towel dispenser so the operable part is 48" max. above the finished floor.	2	500	500
Overall Access (Children)												
86	Boys' Multi-User Toilet Room Next to Gym and on Floor LL	1	-	Overall Access (Children)	Toilet Room

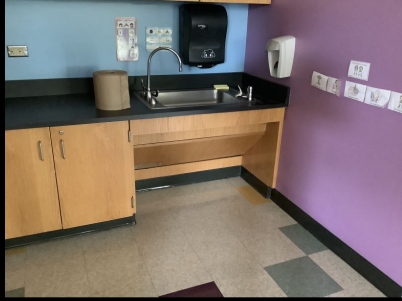
Knee/toe clearance <27" at sink > 31" high	25.5"	Provide at least one sink with 27" high knee and toe clearance positioned for a forward approach (per 521 CMR 12.3), or seek a variance with the Massachusetts Architectural Access Board, if one was not obtained during construction.	1	2192	\$2192

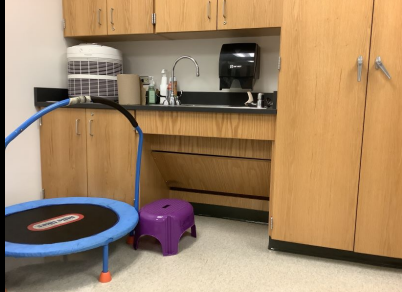
Sink not on an accessible route	-	Relocate the objects that block access to the sink.	1	Labor	Labor

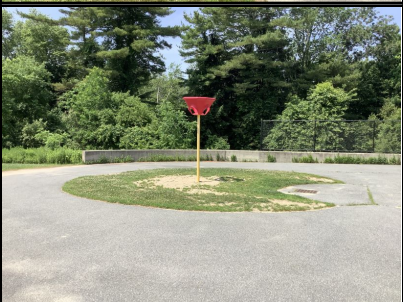
Accessible route not provided to playground Accessible route not provided to play components	- -	Install an accessible route to and around the playground. Provide a compliant impact-attenuating surface to and around the play components.	1	-	-
Best Practice												
95	Stage in Gymnasium	1	-
