# Elizabeth Hastings Middle School

## Town of Fairhaven ADA Transition Plan

December 2024

Institute for Human Centered Design

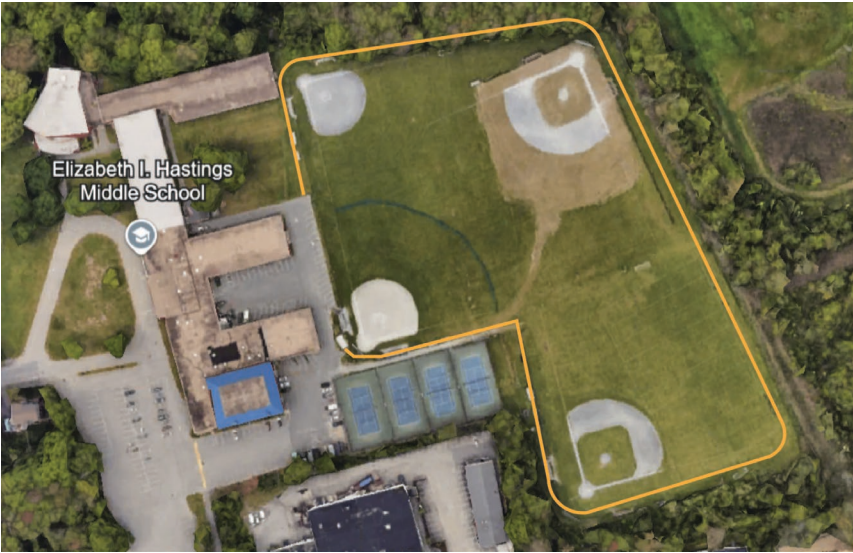
**Figure 1:** In the following image, the yellow line shows one approximate route to connect all fields and areas of team and spectator seating from the parking on the east side of the building to the two baseball fields, the soccer field, and two softball fields:

Accessibility issues include lack of an accessible route to five (5) fields, lack of accessible spaces at each spectator seating area, lack of an accessible route to each team seating area and each spectator seating area, and fields not maintained in operable working condition.

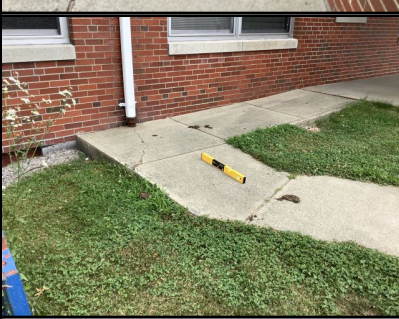
Running slope > 1:20 (5.00%)	6.1%	Reduce running slope to be no steeper than 1:20 (5.00%).	1	-	-
5	Route From North Parallel Parking Space With the ISA to Main Entrance Outside Bus Drop Off	Ext.	-	Exterior Access Route	Walkway

Running slope > 1:20 (5.00%)	7.8%	Reduce running slope to be no steeper than 1:20 (5.00%).	1	-	-

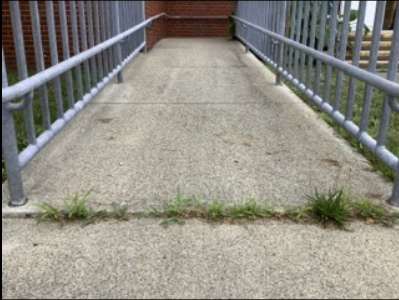
Level changes > 1/4"	2"	Alter change in level to be 1/4" high max.	1	-	-	
7	Exterior Ramp Next to Auditorium	Ext.	-	Exterior Access Route	Walkway

Level changes > 1/4"	1"	Alter change in level to be 1/4" high max.	1	-	-	
8	Ramp to South Egress Door Next to Staff Room 28	Ext.	-	Exterior Access Route	Walkway

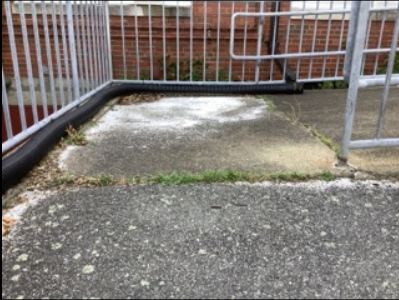
Level changes > 1/4"	1"	Alter change in level to be 1/4" high max.	1	-	-	
9	Route From North Parallel Parking Space With the ISA to Main Entrance Outside Bus Drop Off	Ext.	-	Exterior Access Route	Walkway

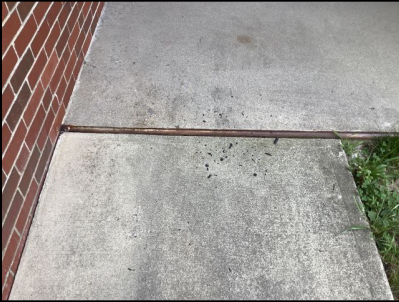
Surface openings > 1/2" Level changes > 1/4"	0.75" 1"	Ensure that the surface opening is no greater than 1/2" max. Alter change in level to be 1/4" high max.	1	-	-	
10	Auditorium Entrance	Ext.	-	Exterior Access Route	Walkway

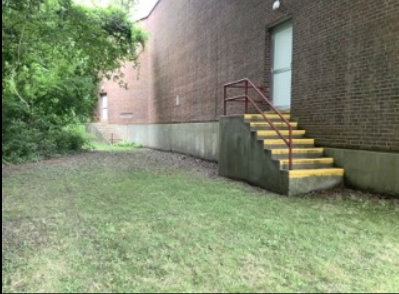
15	Both Egress Stairs Behind Auditorium	Ext.	-	Exterior Access Route	Exterior

Accessible route not provided		Ensure an accessible route is provided to both egress staircases behind the auditorium.	2	-	-

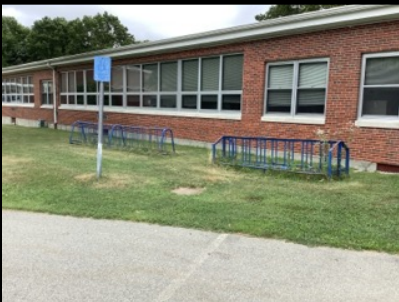
Accessible route not provided	-	Ensure an accessible route is provided to the bike rack.	1	-	-
17	Bike Racks by Main Entrance Outside Bus Drop Off	Ext.	-	Exterior Access Route	Exterior

Accessible route not provided	-	Ensure an accessible route is provided to the bike racks.	1	-	-
Off-Street Parking Lot or Garage												
18	Parking by South Wing Entrance	Ext.	-	Off-Street Parking Lot or Garage

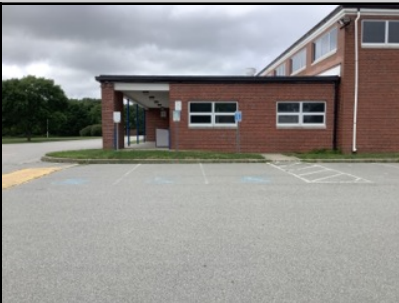
Total # of parking Total # of designated car accessible parking spaces	116 3	Provide 2 additional accessible car spaces. (Cost is for two signs.)	2	500	\$1000
19	Accessible Parking by South Wing Entrance	Ext.	-	Off-Street Parking Lot or Garage	Visitor

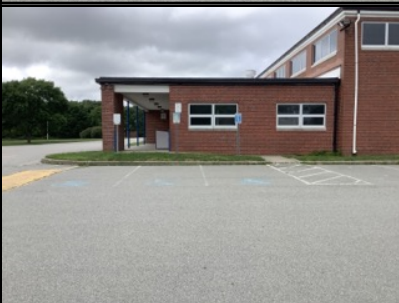
Total # of designated van accessible spaces Access aisle not provided Sign does not have the designation "Van Accessible"	0 - -	Convert the middle space one into a compliant access aisle. Provide an additional car accessible space to the right of the access aisle, on the right side of this photo, and relocate the accessible parking sign to this space. At the accessible space on the right of this photo, add the designation "Van Accessible" to the sign. (Cost is for one sign.)	1	- 500	\$500

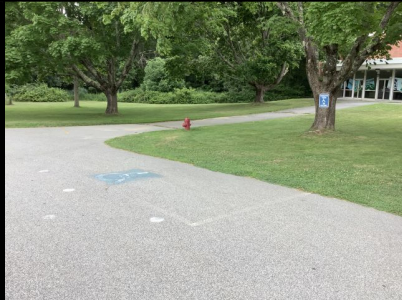
Sign bottom < 60" above finished grade	34"	Locate sign with the bottom of the sign 60" above the ground.	1	Labor	Labor
Exterior Ramp												
23	Ramp to South Egress Door Next to Staff Room 28	Ext.	-	Exterior Ramp	N/A

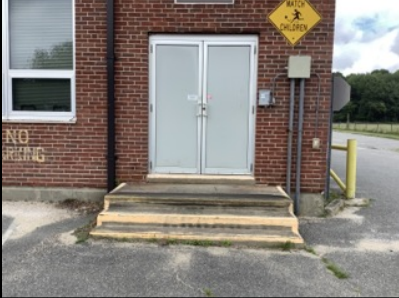
Handrail not provided on both sides Tread widths or riser heights are not uniform	- -	Provide a handrail on each side. Further study will be needed to determine whether it is technically feasible to bring the stair risers into full compliance with the ADA Standards, however stairs may be hazardous for users.	1	-	-

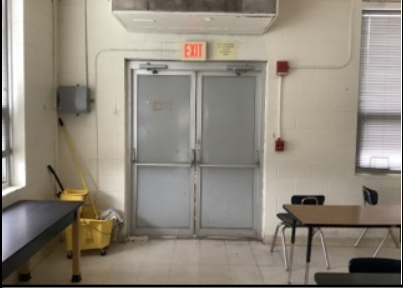
750	
35	S.T.E.M. Classroom/ South Egress Door	1	7	Means of Egress	N/A

Tactile exit sign not provided Directional sign to accessible emergency exit not provided	- -	Ensure that a tactile exit sign with raised characters and braille is provided at the exit door. Mount the sign between 48" - 60" above the finished floor located on the latch side of the door. Provide a directional sign indicating the location of the nearest accessible emergency exit.  Applies to all inaccessible emergency exits.	1	250 250	\$500
											500

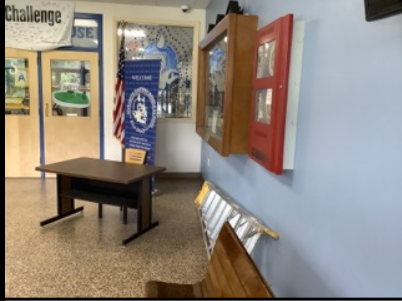
Route < 36" wide	28"	Remove or relocate the privacy partition to ensure that a clear width of 36" min. is maintained at the accessible route.	1	Labor	Labor
38	Main Entrance Outside Bus Drop Off	1	-	Interior Access Route	N/A

Obstructed by protruding objects	11"	Provide a cane-detectable barrier underneath the shelf. Barriers must have leading edges no higher than 27" so that they are within cane sweep. Barriers can include fixed planters, benches, and guardrails.	1	398	\$398

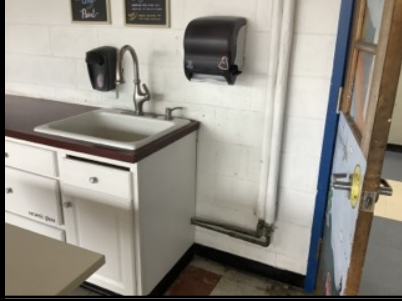
398	
39	Auditorium	1	5B	Interior Access Route	N/A

Obstructed by protruding objects	9"	Provide a cane-detectable barrier underneath the paper towel dispenser. Barriers must have leading edges no higher than 27" so that they are within cane sweep. Barriers can include fixed planters, benches, and guardrails.  Applies to all paper towel dispensers that act as a protruding object.	1	398	\$398
											398	
40	Boys' and Girls' Multi - User Toilet Rooms - 8th Grade Wing	1	-	Interior Access Route	N/A

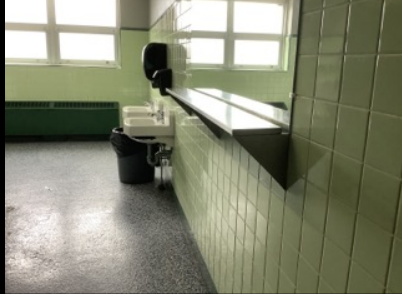
Obstructed by protruding objects	7"	Provide a cane-detectable barrier underneath each side of the shelf. Barriers must have leading edges no higher than 27" so that they are within cane sweep. Barriers can include fixed planters, benches, and guardrails.  Applies to all multi-user bathrooms with shelves in this condition.	1	398	\$398
											398

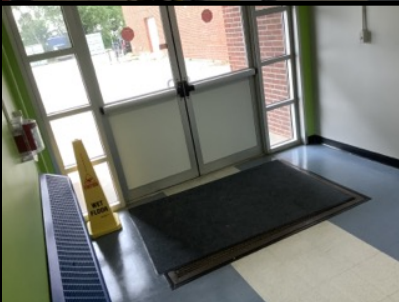
Surface not stable, firm, and slip-resistant	-	Secure the mat.	1	Labor	Labor
Doors, Doorways, & Gates												
43	Nurse Suite - Door Leading to Toilet Room	1	-	Doors, Doorways, & Gates	Classroom

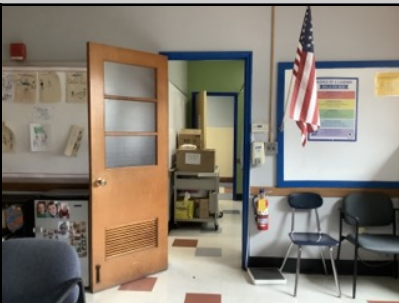
Clear width at door < 32"	30.5"	Install offset hinges to ensure that the door has a clear width of 32 inches.	1	2902	\$2902
											2902	
44	Quiet Room Across From Auditorium	1	-	Doors, Doorways, & Gates	Classroom

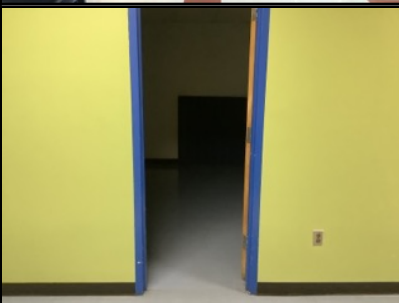
Clear width at door < 32"	28"	Widen the door so that there is 32" min. clear width.	1	4376	\$4376

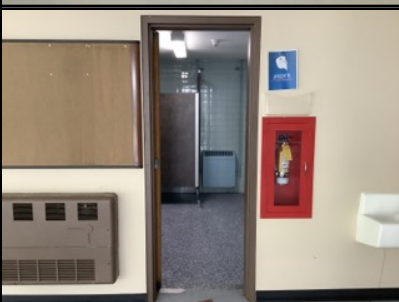
4376	
45	Men's and Women's Multi-User Toilet Rooms Next to Auditorium	1	-	Doors, Doorways, & Gates	Toilet Room

Clear width at door < 32"	29"	Widen the door so that there is 32" min. clear width.	2	4376	\$8752
											8752

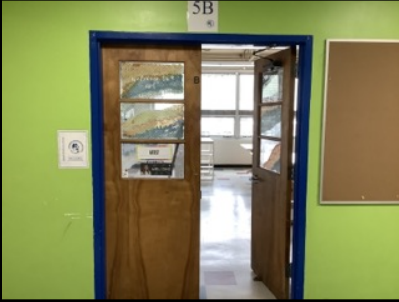
If double-leaf door, neither compliant	28"	Ensure that at least one of the active leaves is at least 32" min. wide, or provide an automatic door opener that opens both leaves at once.	1	6000	\$6000
											6000	
48	Cafeteria/ Food Service	1	-	Doors, Doorways, & Gates	Circulation

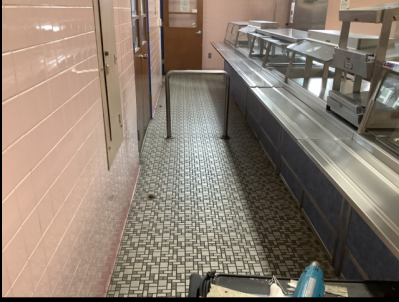
Maneuvering clearance(s) not provided	-	Ensure both doors that are part of the food service line are always left open during hours of operation.	1	Labor	Labor

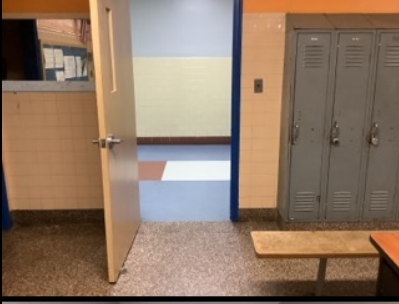
49	Boys' Locker Room	1	-	Doors, Doorways, & Gates	Toilet Room

Maneuvering clearance(s) not provided	16"	Provide an automatic door opener.	1	6000	\$6000
											6000	
50	Boys' and Girls' Multi - User Toilet Rooms - 8th Grade Wing	1	-	Doors, Doorways, & Gates	Toilet Room

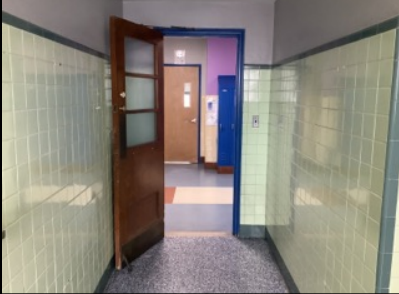
Maneuvering clearance(s) not provided	13"	Provide an automatic door opener.	2	6000	\$12000
											12000

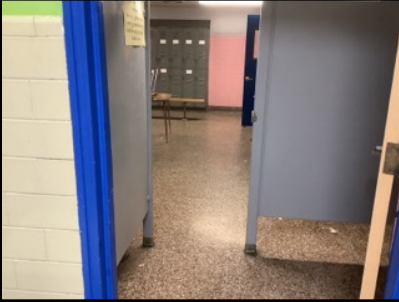
Maneuvering clearance(s) not provided	5"	Provide an automatic door opener.	1	6000	\$6000
											6000	
52	Girls' Locker Room	1	-	Doors, Doorways, & Gates	Circulation

Maneuvering clearance(s) not provided	-	If the maneuvering clearance at the pull side of the door is less than 18", provide an automatic door opener.	1	6000	\$6000
											6000	
53	Girls' and Boys' Multi-User Toilet Rooms - 6th Grade Wing	1	-	Doors, Doorways, & Gates	Toilet Room

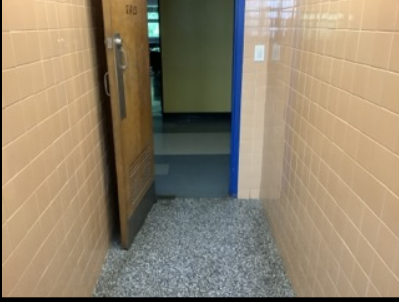
Clear width at door < 32" Maneuvering clearance(s) not provided	26" 10"	Widen the door so that there is 32" min. clear width. Provide an automatic door opener. Another option could be to provide an accessible single-user toilet room in this wing. Cost estimate is for widening the door and providing an automatic door opener.	1	4376 6000	\$10376

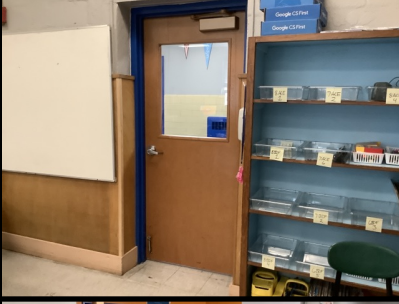
10376	
54	Media Classroom	1	12	Doors, Doorways, & Gates	Classroom

Maneuvering clearance not provided at recess > 6"	13"	Install an automatic door opener.	1	6000	\$6000
											6000	
55	Guidance Suite - Grade 8 Wing	1	-	Doors, Doorways, & Gates	Office

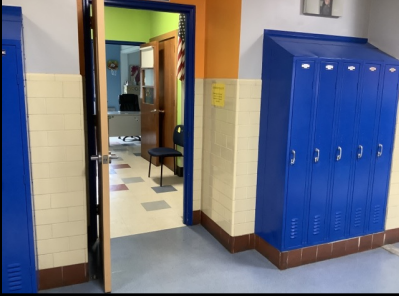
Maneuvering clearance not provided at recess > 6"	28"	Provide an automatic door opener.  Applies to all pull side doors in this condition. Unit cost is provided for one instance of this repetitive item.	1	6000	\$6000
											6000

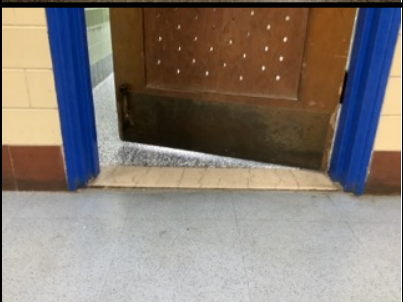
Threshold not beveled	-	Bevel the threshold.	1	195	\$195
											195	
58	Boys' Multi-User Toilet Room - 8th Grade Wing, Boys' and Girls' Multi-User Toilet Rooms Outside Gym	1	-	Doors, Doorways, & Gates	Toilet Room

Threshold not beveled	-	Bevel the threshold.	3	195	\$585
											585	
59	Toilet Room in Nurse's Suite	1	-	Doors, Doorways, & Gates	Office

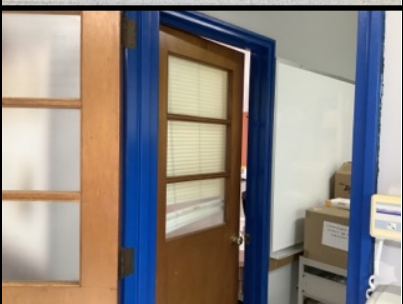
Hardware not compliant	-	Provide hardware that can be operable with one hand and not require tight grasping, pinching, or twisting of the wrist.	1	750	\$750

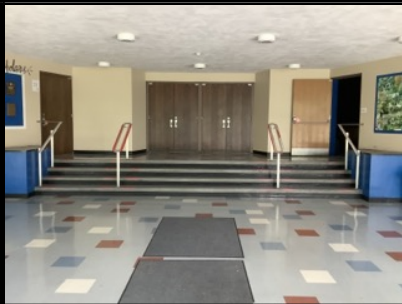
Handrails do not extend 12" from stairs at top Bottom handrail extends < 12" and one tread Handrails lack a compliant cross section	3"	Top: Ensure handrails extend horizontally above the landing for 12" min. beginning above the first riser nosing. Bottom: Ensure that the sloped bottom extension extends one tread depth min. beyond last riser nosing in same direction as stair flight. Provide handrails with 1 1/4" - 2" circular cross sections.	2	-	-

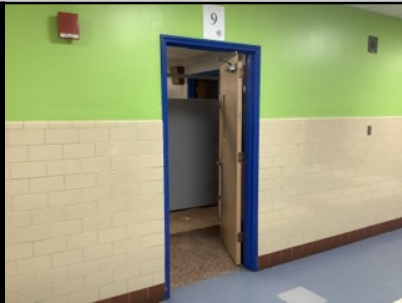
Signage												
63	Girls' Locker Room	1	-	Signage	Designation

Signage is not provided	-	Locate compliant signage with raised characters and braille alongside the door on the latch side.  Applies to all student program rooms with no designation signage.	1	250	\$250
											250	
64	Gymnasium Entrance Door - Right	1	-	Signage	Designation

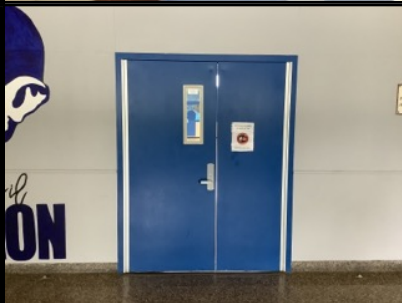
Signage is not provided	-	Locate compliant signage with raised characters and braille on the inactive leaf.	1	250	\$250
											250	
65	Guidance Suite - Grade 8 Wing	1	-	Signage	Designation

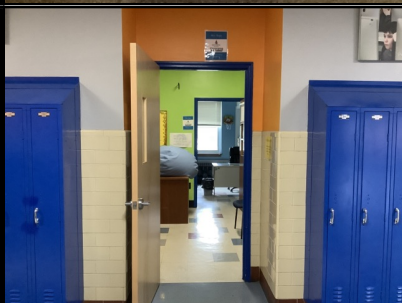
Signage is not provided Raised characters not provided on sign Braille not provided on sign	- - -	Locate compliant signage with raised characters and braille alongside the door on the latch side. Provide text with raised characters duplicated in braille on the sign.	1	250	\$250
											250

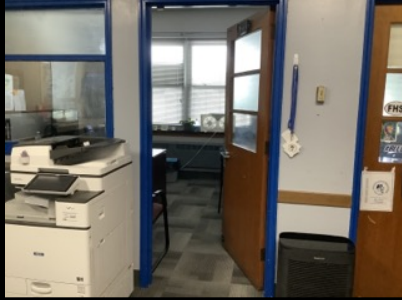
Signage is not provided Signage lacks 18" by 18" clear floor space	- -	Locate compliant signage with raised characters and braille alongside the door on the latch side. Relocate the printer to provide a clear floor space of 18" min. by 18" min. at the sign.	1	250 Labor	\$250
											250	
68	Cafeteria Entrance	1	-	Signage	Designation

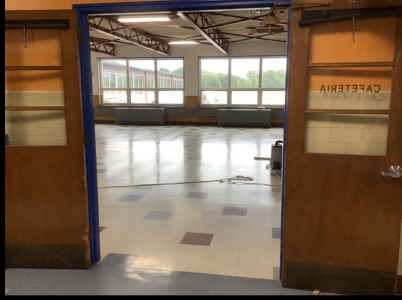
Signage is not provided Raised characters not provided on sign Braille not provided on sign	- - -	Locate compliant signage with raised characters and braille alongside the door on the right side of the rightmost door. Provide text with raised characters duplicated in braille on the sign.	1	250	\$250

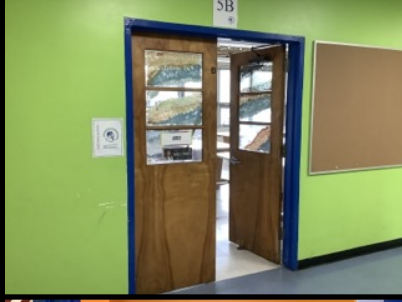
250	
69	Art Classroom	1	5B	Signage	Designation

Signage is not provided Location of tactile sign not compliant	- -	Locate compliant signage with raised characters and braille alongside the door to the right of the right-hand door.	1	250	\$250
											250	
70	Guidance Suite - Grade 8 Wing	1		Signage	Informational

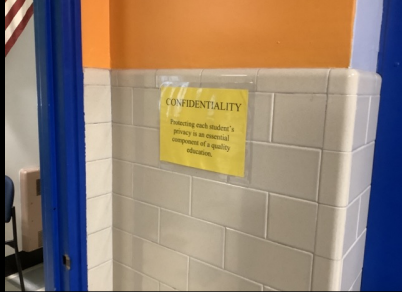
Non-glare finish and contrast not provided on sign	-	Install a sign with a non-glare finish with characters that have a high contrast to the background.  Applies to all informational signs in this condition.	1	250	\$250
											250

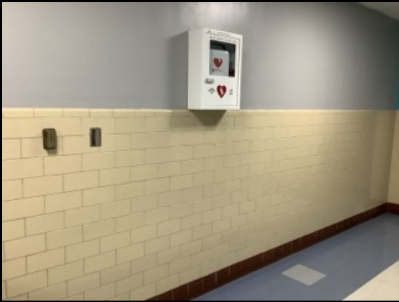
250	
Operable Parts / Reach Range												
74	Corridor Leading to Staff Room 28	1	-	Operable Parts / Reach Range	AED

Reach < 15" or > 48"(forward/side approach)	68.5"	Relocate the defibrillator so that controls are between 15"- 48" above the finished floor.	1	500	\$500
											500	
Dining or Work Surfaces												
75	Student Services Guidance - Grade 8 Wing	1	-	Dining or Work Surfaces	Work Surface

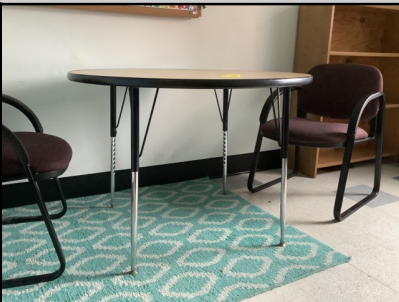
At least one or 5% accessible tables not provided Knee or toe clearance not provided	- 24" wide	Ensure that at least one dining or work surface is accessible, with 30" min. wide knee and toe clearance.	1	700	700

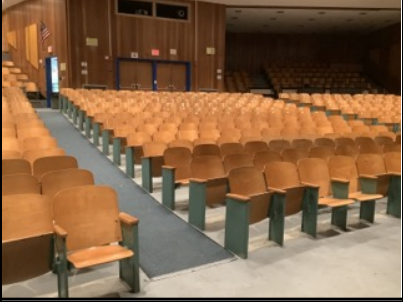
Number of seats Number of designated wheelchair spaces Minimum # wheelchair spaces not provided Designated aisle seats < 5%	703 0 - 0	Provide 9 compliant wheelchair spaces. At least 4 (5%) of the total number of aisle seats provided must be identified by a sign or marker and have folding or retractable armrests. (Cost estimate is for aisle seat renovations, not for compliant wheelchair spaces.)	1	3600	\$3600
											3600	
78	Gymnasium			Assembly Area	N/A

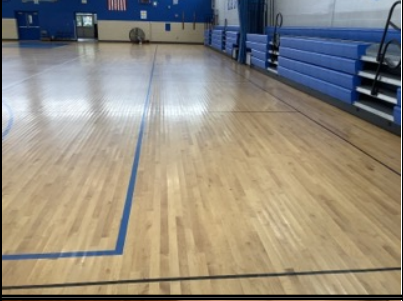
Minimum # wheelchair spaces not provided		Bleachers could not be fully surveyed. Based on the bleacher count, the Town should ensure that the number of wheelchair spaces complies with Table 221.2.1 in the 2010 ADA Standards.	1	-	-

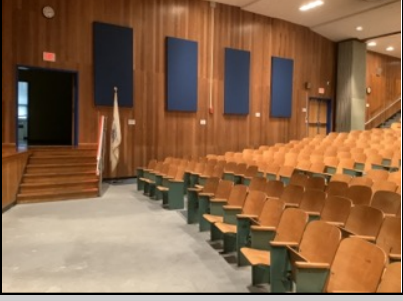
79	Auditorium, Gymnasium	1	-	Assembly Area	N/A

Assistive listening devices not provided	-	If audible communication is integral to the use of the space, provide an assistive listening system. <b>Note:</b> Assistive listening system receiver count was not confirmed. Ensure that assistive listening devices are provided based on the 2010 ADA Standards, Table 219.3.	2	Labor	Labor
Locker Room												
80	Boys' Locker Room	1	-	Locker Room	Boys'

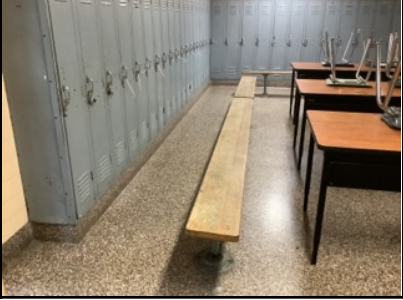
30" clear not provided alongside bench Back support not provided at bench Bench < 24" deep	- 9"	Provide a 30" min. by 48" min. clear space along the side of the bench so that wheelchair users can transfer. Provide at least one bench with back support or that is affixed to a wall with room on the side to transfer, and that is 24" deep.	1	260	\$260
											260

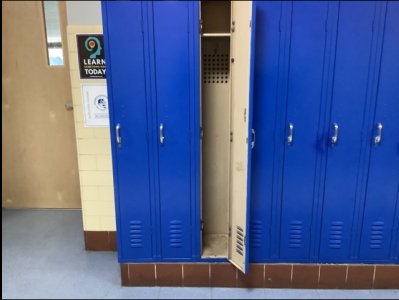
5% of lockers are not accessible Storage > 48" high Hook > 48" high	- 57" 56"	Provide at least one accessible locker (or ensure 5% of all lockers are accessible) . Ensure that at least 5% of lockers are accessible, and no higher than 48 inches above the floor. Locate hook no higher than 48" above the finished floor. (Cost estimate for one locker.)	1	660	\$660
											660	
Picnic Tables

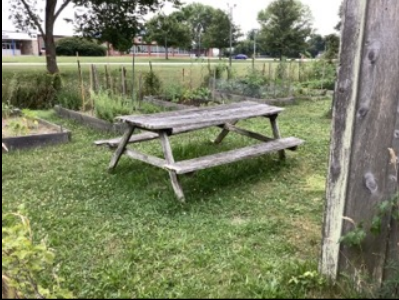
83	Outdoor Garden	1	-	Picnic Tables	N/A

At least 5% accessible spaces not provided Toe or knee clearance at tables not provided Picnic table not on an accessible route	- - -	Ensure that at least 5% (minimum one) of picnic tables are accessible. Provide at least 1 picnic table (or ensure that 5% of picnic tables) have toe and knee clearance. Ensure that the picnic table is connected to an accessible route. (Cost estimate is for an accessible picnic table.)	1	1400	\$1400
											1400	
84	Exterior Picnic Tables Between 6th and 8th Grade Wings	1	-	Picnic Tables	N/A

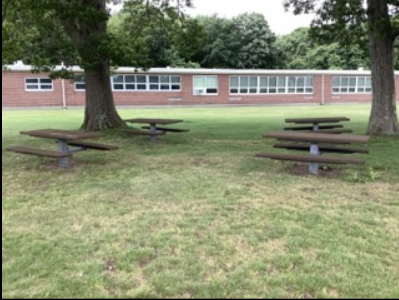
Picnic table not on an accessible route	-	Ensure that at least one picnic table is connected to an accessible route.	1	1400	\$1400
											1400	
Toilet & Bathing Rooms												
Overall Access												
85	Boys' and Girls' Multi - User Toilet Rooms - 6th and 8th Grade Wings, Next to Gymnasium/ South Wing	1	-	Overall Access	Toilet Room

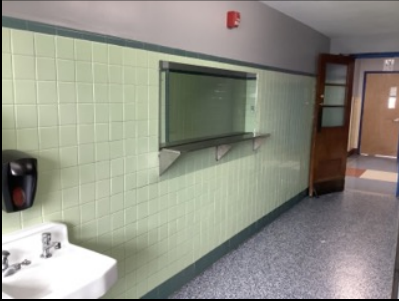
Mirror with reflective surface >35"	41"	Relocate the mirror so that the bottom edge of the reflective surface is no higher than 35" above the finished floor.	6	500	\$3000

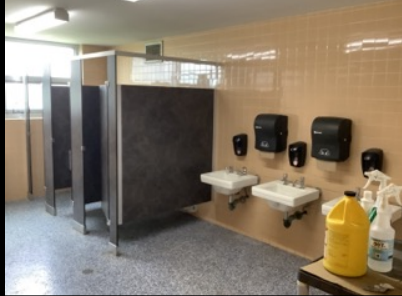
Accessible plumbing fixtures or stalls not provided	-	Provide one accessible wheelchair compartment.	2	8037	\$16074
											<b>16074</b>	
88	Girls' and Boys' Multi-User Next to Gymnasium/ South Wing Entrance	1	-	Overall Access	Toilet Room

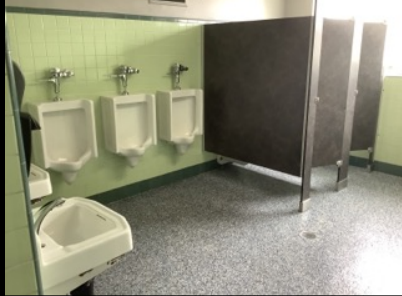
Accessible plumbing fixtures or stalls not provided	-	Provide one accessible wheelchair compartment.	2	8037	\$16074
											<b>16074</b>	
89	Boys/Girls' Multi Users - Across From Principal Suite	1	-	Overall Access	Toilet Room

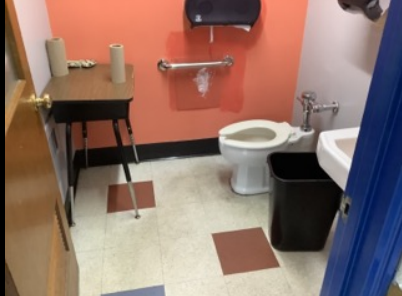
<b>16074</b>	
90	Toilet Room in Nurse's Suite	1	-	Overall Access	Toilet Room

Accessible plumbing fixtures or stalls not provided	72" by 65.5"	Add an accessible single-user toilet room.	1	31985	\$31985
											<b>31985</b>

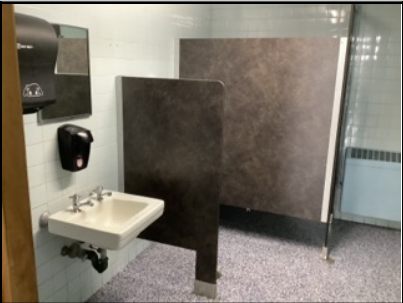
Plumbing underneath is exposed	-	Insulate or otherwise configure pipes to prevent contact for at least one lavatory.	1	150	\$150
93	Boys' and Girls' Multi - User Toilet Rooms - 8th Grade Wing	1	-	Lavatory	N/A

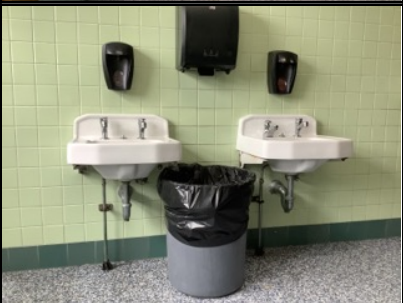
Toe or knee clearances not provided Plumbing underneath is exposed	23" -	Provide at least one lavatory with knee and toe clearance positioned for a forward approach. Insulate or otherwise configure pipes to prevent contact for at least one lavatory. Applies to the boys' and girls' multi users toilet rooms across from principal suite, in the 6th grade wing, and next to gymnasium/south wing entrance.	8	2192 150	\$18736

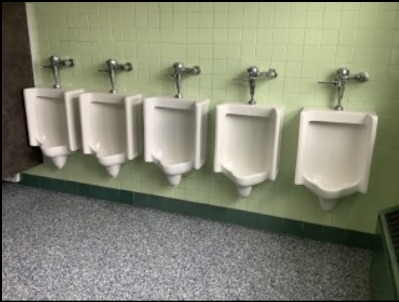
Rim > 17" high	23"	Provide at least one urinal with the rim no higher than 17" above the finished floor.  Applies to the boys' multi-user next to the gymnasium/south wing entrance, and in the 6th grade wing.	3	2111	\$6333
											6333	
Shower Compartment												
100	Boys' Locker Room, Girls' Locker Room	1	-	Shower Compartment	N/A

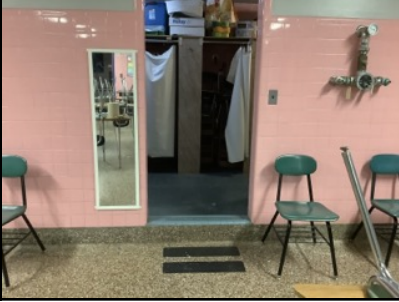
Shower not on an accessible route	-	Remove curb.	2	1048	\$2096

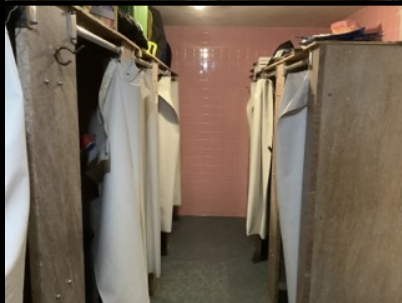
Accessible shower not provided	-	Provide at least one accessible shower. (Cost estimate for an accessible transfer shower.)	1	7894	\$7894
											7894	
Portable Toilet												
103	Portable Toilet Next to East Egress Door - 8th Grade Wing	Ext.	-	Portable Toilet	N/A

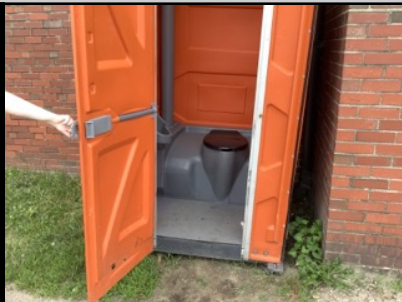
Not located on an accessible route Accessible portable toilets not provided	- -	Locate portable toilet on an accessible route. Ensure that at least 5% of portable toilets is accessible. (Cost estimate is for an accessible portable toilet that complies with the 2010 ADA Standards and CMR.)	1	4600	\$4600

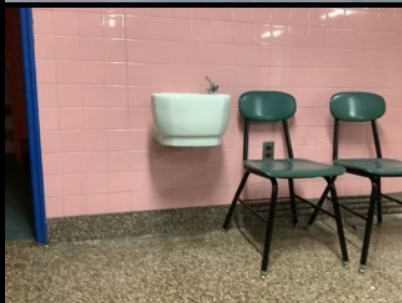
No drinking fountain provided for standing users Knee or toe clearance not provided	- 21.5"	Install a Hi-Lo drinking fountain. Provide knee and toe clearance, 27" min. high at drinking fountain for seated users.	1	4216	\$4216

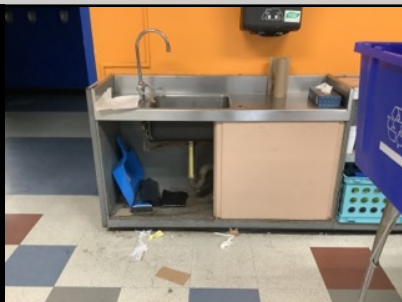
4216	
Sink												
109	Science Classroom - Garcia	1	44	Sink	N/A

Clear floor space not provided at sink Exposed plumbing underneath sink	- -	Provide a 30" by 48" clear floor space positioned for a forward approach. Insulate or otherwise configure pipes at sink.	1	1500 150	\$1650
											1650	
110	S.T.E.M. Classroom	1	7	Sink	N/A

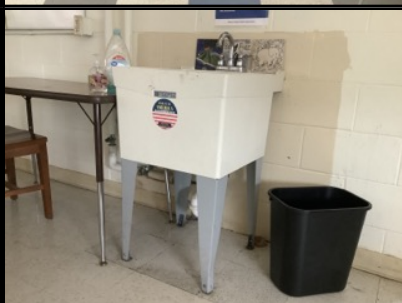
Toe and knee clearances not provided	19"	Provide an additional sink that has 27" min. knee clearance positioned for a forward approach.  Cost estimate is for installing a new sink.	1	2192	\$2192
											2192

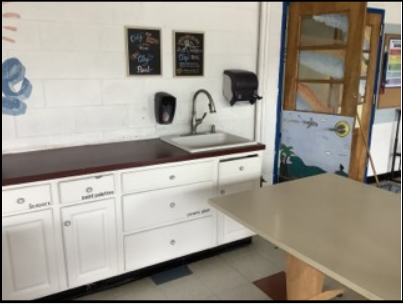
Toe and knee clearances not provided Rim or counter > 34"	- 36.5"	Ensure there is a 27" min. knee clearance positioned for a forward approach. Relocate sink with the front of the rim or counter no higher than 34" above the finished floor.	2	3094	\$6188
6188												
Play and Sport Areas												
Field												
112	North Softball Field - First Base Dugout	Ext.	-	Field	Softball

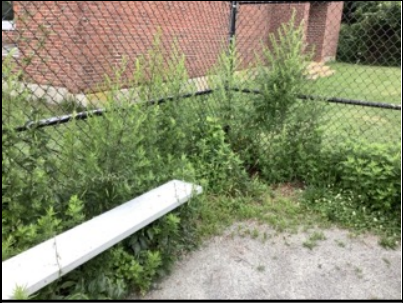
Accessible spaces not provided at team seating	-	Provide a 36" x 48" clear floor space at team seating.	1	-	-
113	North Baseball Field	Ext.	-	Field	Baseball

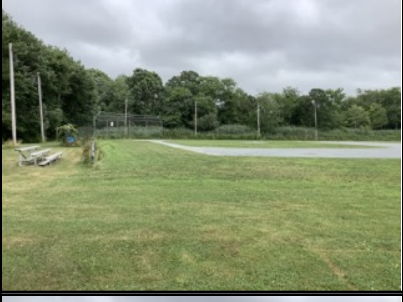
Accessible spaces not provided at sidelines seating Field not connected to an accessible route No accessible route to all areas of sport activity	- - -	Provide a 36" x 60" clear floor space at sidelines seating. Provide an accessible route to the boundary of area of sport activity.  Install an accessible route between all areas of sport activity.	1	-	-

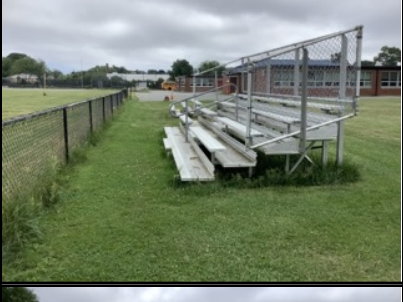
114	North Softball Field - First Base Spectator Seating	Ext.	-	Field	Softball

Accessible spaces not provided at sidelines seating No accessible route	- -	Provide a 36" x 60" clear floor space at sidelines seating. Install an accessible route to the bleachers.	1	-	-
115	South Baseball Field - Third Base Spectator Seating	Ext.	-	Field	Baseball

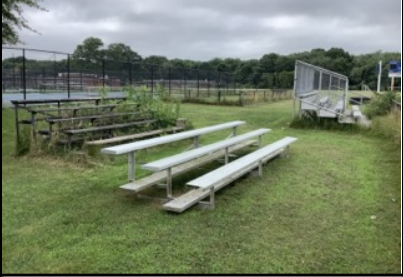
Accessible spaces not provided at sidelines seating No accessible route	- -	Provide a 36" x 60" clear floor space at sidelines seating. Install an accessible route to the sidelines seating areas.	1	-	-

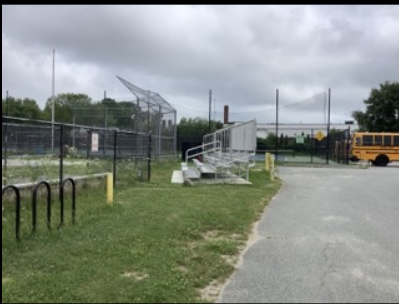
ID	Location	Floor	Room	Element	Type	Photo	Issues	Current Measure	Recommendations	Quantity	Price	Cost Estimation
116	South Softball Field - First Base Spectator Seating	Ext.	-	Field	Softball

Accessible spaces not provided at sidelines seating No accessible route	- -	Provide a 36" x 60" clear floor space at sidelines seating. Install an accessible route to the spectator seating.	1	-	-
117	North Softball Field	Ext.	-	Field	Softball

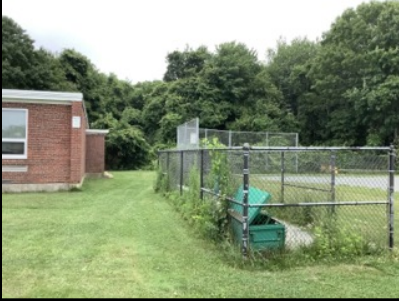
Field not connected to an accessible route	-	Provide an accessible route to the field.	1	-	-
118	Football Field	Ext.	-	Field	Football

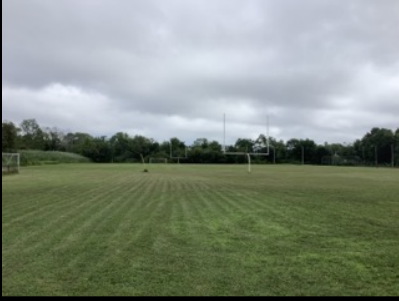
Field not connected to an accessible route No accessible route to all areas of sport activity	- -	Provide an accessible route to the field.  Install an accessible route between all areas of sport activity.	1	-	-
119	South Baseball Field	Ext.	-	Field	Baseball

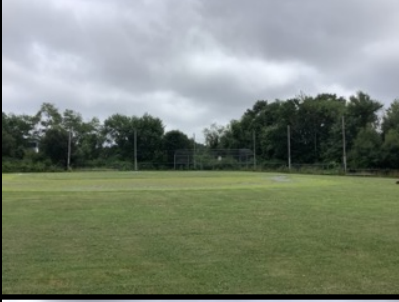
Field not connected to an accessible route No accessible route to all areas of sport activity	- -	Provide an accessible route to the field.  Install an accessible route between all areas of sport activity.	1	-	-

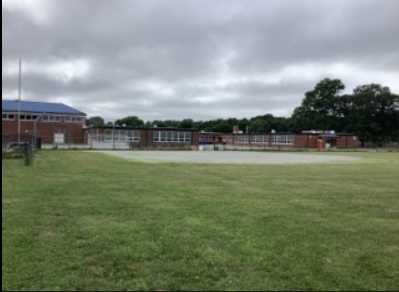
120	South Softball Field	Ext.	-	Field	Softball

Field not connected to an accessible route No accessible route to all areas of sport activity	- -	Provide an accessible route to the field.  Install an accessible route between all areas of sport activity.	1	-	-

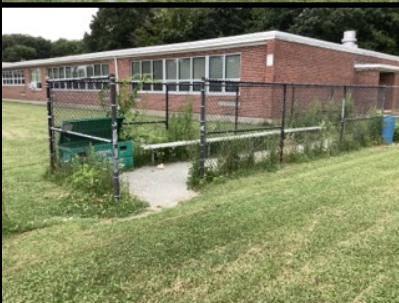
123	North Softball Field - First Base and Third Base Team Seating Areas	Ext.	-	Field	Softball

No accessible route to all areas of sport activity	-	Install an accessible route between all areas of sport activity including the team seating areas.	2	-	-
124	North Softball Field	Ext.	-	Field	Softball

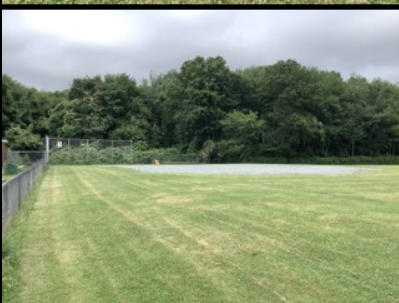
No accessible route to all areas of sport activity	-	Install an accessible route between all areas of sport activity, including between the boundary of sport activity of all of the soccer, baseball, football and softball fields.	1	-	-
125	North Soccer Field	Ext.	-	Field	Soccer

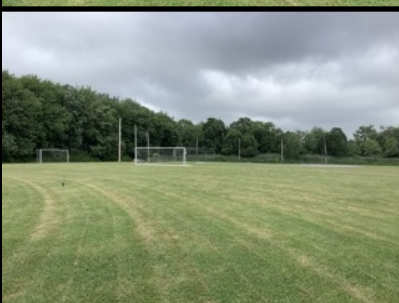
Field not connected to an accessible route No accessible route to all areas of sport activity	- -	Provide an accessible route to the field.  Install an accessible route between all areas of sport activity.	1	-	-
Best Practice

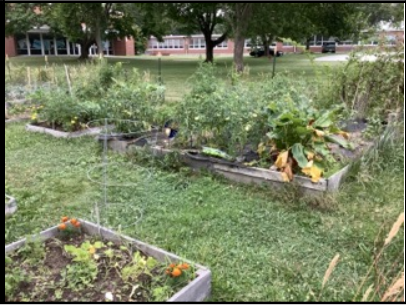
ID	Location	Floor	Room	Element	Type	Photo	Issues	Current Measure	Recommendations	Quantity	Price	Cost Estimation
Gardens												
130	Outdoor Garden Plant Bed	Ext.	-	Gardens	N/A

10"	Consider providing raised garden beds that have knee and toe clearance for a forward approach for wheelchair users.	1	-	-
Signage												
131	Corridor/ Outside Cafeteria	1	-	Signage	N/A

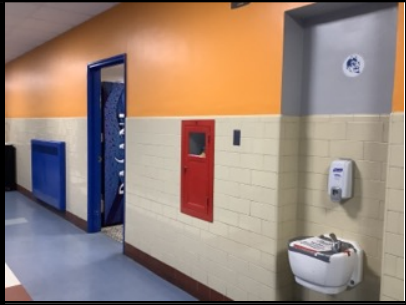
Recommend blade sign over the fire extinguisher, located no lower than 80" above the floor.  Applies to all fire extinguishers in the building.	1	-	-
132	Accessible Entrance to Auditorium	1	-	Signage	N/A

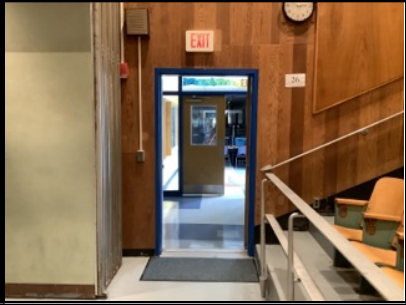
Recommend providing directional signage to the accessible entrance to the stage.	1	-	-
133	Auditorium Entrance	Ext.	-	Signage	N/A

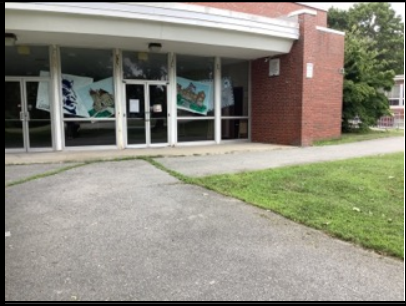
-	Recommend providing a directional sign to the ramp to the accessible auditorium entrance.	1	-	-
134	Accessible Parking Next to Main Entrance Outside Bus Drop Off	Ext.	-	Signage	N/A

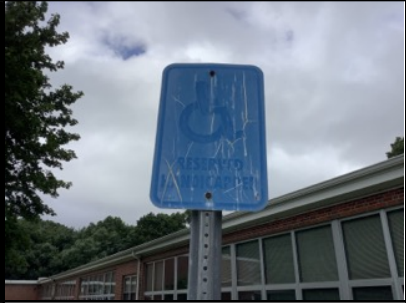
Recommend using the term "Accessible Parking" instead of "Handicapped Parking".	1	-	-

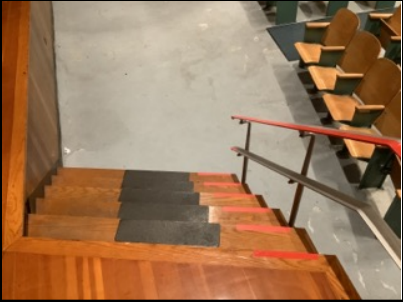
ID	Location	Floor	Room	Element	Type	Photo	Issues	Current Measure	Recommendations	Quantity	Price	Cost Estimation
Stairs												
135	Auditorium Stage	1	-	Stairs	N/A

Recommend providing a solid and continuous stripe applied to the horizontal leading edge of each interior and exterior stair tread so that each tread is readily apparent when viewed in descent at each stair in and outside the building.	1	-	-
