# Fairhaven High School

## Town of Fairhaven ADA Transition Plan

January 2025

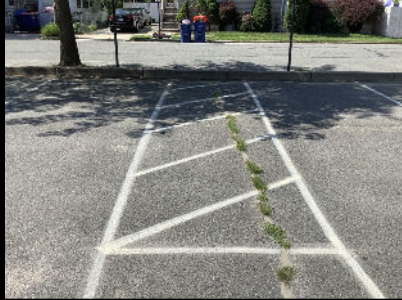
ID	Location	Floor	Room	Element	Type	Photo	Issues	Current Measure	Recommendations	Quantity	Price	Cost Estimation
Approach and Entrance												
Exterior Access Route												
1	Accessible Parking by North Entrance/ Adjacent to Larch Avenue	Ext.	-	Exterior Access Route	Access Aisle

Route not maintained in operable working condition	-	Repair the cracks where grass is growing to ensure the accessible route is maintained in operable working condition.	1	-	-
2	Next to Staff Parking on East Side of Parking/Next to Football Field	Ext.	-	Exterior Access Route	Curb Ramp

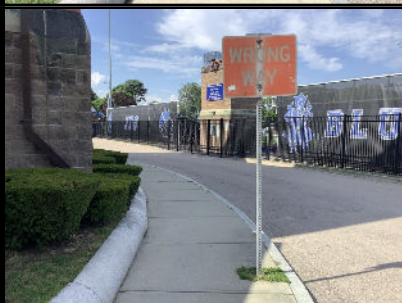
4	Walkway on Southeast Corner of Building	Ext.	-	Exterior Access Route	Sign on Sidewalk

Obstructed by protruding objects	75"	Position sign so the base of the sign is 80" min. above the sidewalk.	1	398	\$398
											398	
5	New Building, Ramp to South/Main Entrance	Ext.	-	Exterior Access Route	Walkway

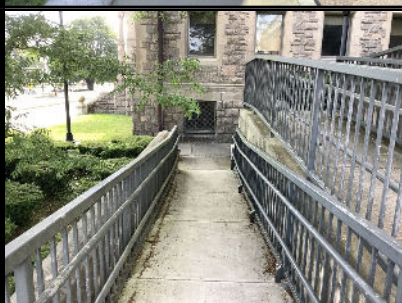
Obstructed by protruding objects	58.75"	Trim low hanging branches in trees over the lowest ramp run to a height of 80" min. above the ground.	1	-	-

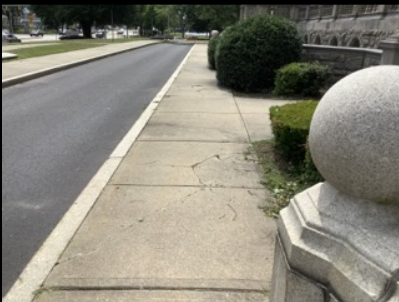
Route not maintained in operable working condition		Repair cracks in the concrete to ensure the accessible route is maintained in operable working condition.	1	-	-	
8	Main Building, Route Between Both South Egress Doors From Basement	Ext.	-	Exterior Access Route	Walkway

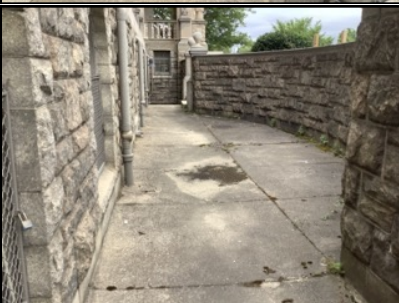
Does not prevent accumulation of water	-	Repair surface.	1	-	-	
9	Sidewalk in Front of Stairs From South Egress Door 6	Ext.	-	Exterior Access Route	Sidewalk

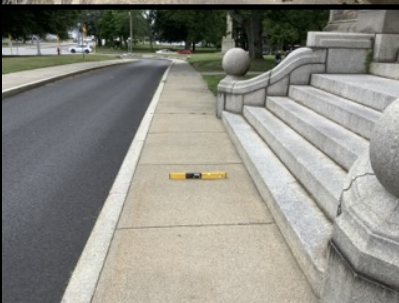
Cross slope > 1:50 (2.00%)	3.3%	Reduce cross slope to be no steeper than 1:50 (2.00%).	1	-	-

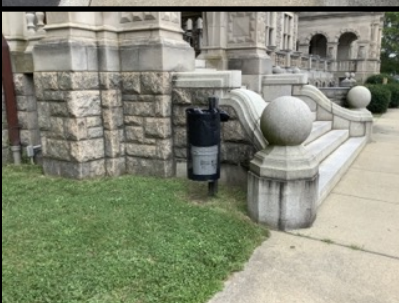
10	Main Building, Stairs From South Egress Door 6	Ext.	-	Exterior Access Route	Sidewalk

Accessible route to trash can not provided		Relocate trash container to an accessible route or provide an accessible route to the trash container.	1	Labor	Labor

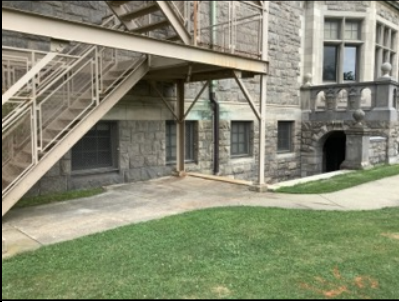
Vertical clearance < 80" above ground	75"	Provide a cane-detectable barrier underneath stair.	1	-	-
13	Route Next to Accessible Parking by Northwest Corner of Library	Ext.	-	Exterior Access Route	Walkway

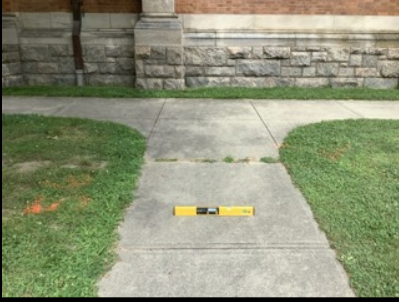
Cross slope > 1:50 (2.00%) Level changes > 1/4" Route not maintained in operable working condition	2.7% 0.75" -	Reduce cross slope to be no steeper than 1:50 (2.00%). Alter change in level to be 1/4" high max. Repair cracks in the concrete where grass is growing from to ensure the accessible route is maintained in operable working condition.	1	-	-

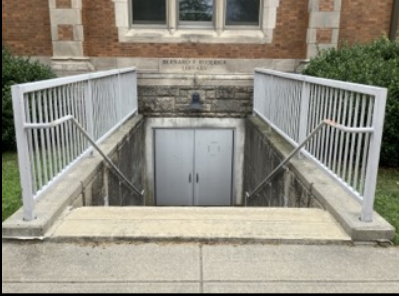
Level changes > 1/4"	1.5"	Alter change in level to be 1/4" high max.	1	-	-

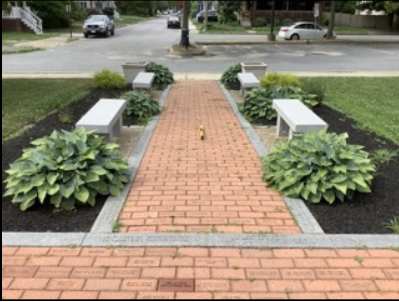
Running slope > 1:20 (5.00%)	6.4%	Reduce running slope to be no steeper than 1:20 (5.00%).	1	-	-	
18	Memorial Walkway to North Library Egress Door	Ext.	-	Exterior Access Route	Walkway

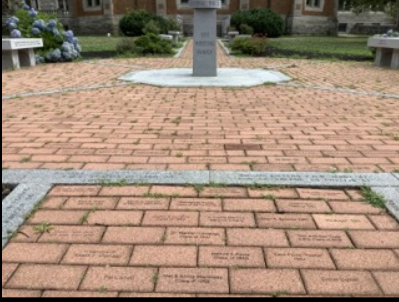
Level changes > 1/4"	1"	Alter change in level to be 1/4" high max.	1	-	-	
19	Sidewalk Near Northwest Corner of Auditorium	Ext.	-	Exterior Access Route	Sidewalk

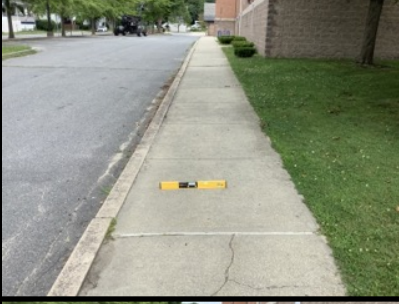
Cross slope > 1:50 (2.00%)	4.4%	Reduce cross slope to be no steeper than 1:50 (2.00%).	1	-	-	
20	Sidewalk Near Northwest Corner of Auditorium	Ext.	-	Exterior Access Route	Sidewalk

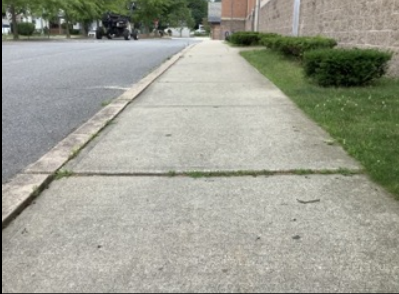
Level changes > 1/4"	1"	Alter change in level to be 1/4" high max.	1	-	-

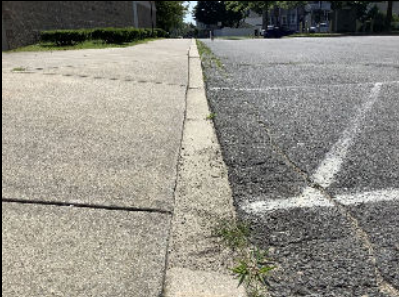
ID	Location	Floor	Room	Element	Type	Photo	Issues	Current Measure	Recommendations	Quantity	Price	Cost Estimation
Curb Ramp												
21	Curb Ramp in Front of North Entrance	Ext.	-	Curb Ramp	Perpendicular

Transition from curb ramp to street not flush	1"	Ensure transition from curb ramp to street is flush or free of changes in level.	1	-	-
22	Curb Ramp in Front of North Entrance	Ext.	-	Curb Ramp	Perpendicular

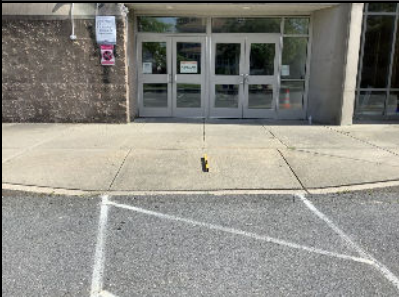
Running slope is > 1:12 (8.33%)	12.6%	Reduce running slope to be no steeper than 1:12 (8.33%).	1	-	-
23	Curb Ramp in Front of North Entrance	Ext.	-	Curb Ramp	Blended Transition

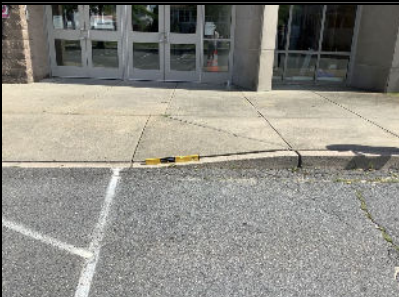
Curb ramp flares > 1:10 (10%)	11.5%	Reduce slope at curb ramp flares to be no steeper than 1:10 (10%).	1	-	-
24	Next to Staff Parking on East Side of Parking/Next to Football Field	Ext.	-	Curb Ramp	N/A

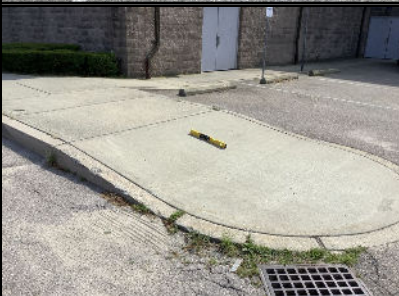
Running slope is > 1:12 (8.33%) Transition from curb ramp to street not flush	11.3% -	Reduce running slope to be no steeper than 1:12 (8.33%). Ensure transition from curb ramp to street is flush or free of changes in level.	1	-	-

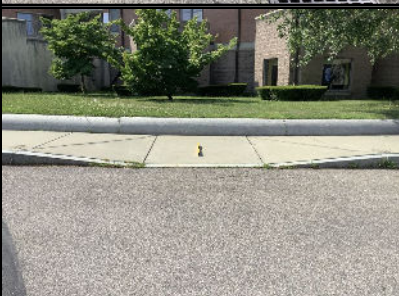
25	Curb Ramp on Southeast Corner of Building/ Across From Visitor Parking	Ext.	-	Curb Ramp	Blended Transition

Running slope is > 1:12 (8.33%)	10.8%	Reduce running slope to be no steeper than 1:12 (8.33%).	1	-	-

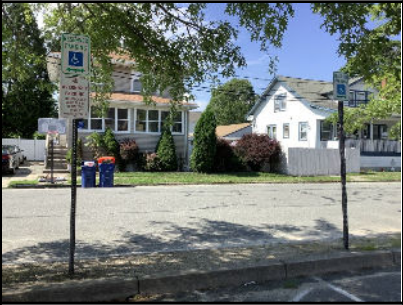
Sign top > 96" above finished grade	104"	Locate sign with the top of the sign 96" above the ground. Ensure that once the sign is repositioned, the base of the sign is at least 60" above the ground.	2	Labor	Labor
28	Visitor Parking on South/East Corner of Building/Next to Football Field	Ext.	-	Off-Street Parking Lot or Garage	Visitor

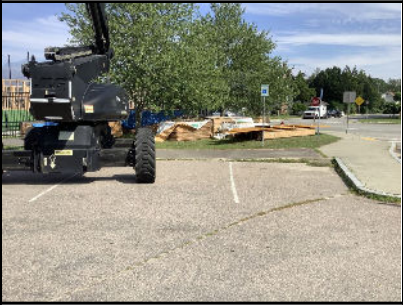
Running or cross slope at space > 1:50 (2.00%) Sign does not have the designation "Van Accessible" Sign top > 96" above finished grade Striping at access aisle is noncompliant (MAAB)	4.8% - 101" -	Reduce running or cross slope to be no steeper than 1:50 (2.00%). Add the designation "Van Accessible" to the sign located at the van accessible space. Locate sign with the top of the sign 96" max. above the ground. Ensure that access aisles are clearly marked with diagonal stripes.	1	Labor	Labor

- When striping at the access aisle is provided at the van accessible parking space by the football field, recommend continuing the striping to the curb ramp.

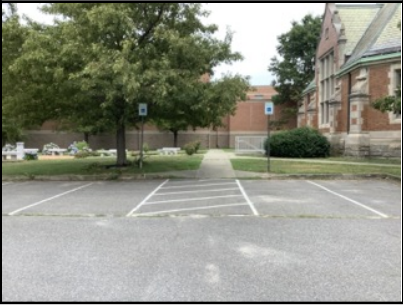
29	Accessible Parking by Northwest Corner of Library	Ext.	-	Off-Street Parking Lot or Garage	Visitor

Sign top > 96" above finished grade	120"	Locate sign with the top of the sign 96" max. above the ground measured to the top of the sign. Ensure that once the sign is repositioned, the base of the sign is at least 60" above the ground.	1	Labor	Labor
Exterior Ramp												
30	New Building, Ramp to South/Main Entrance	Ext.	-	Exterior Ramp	N/A

- Recommend providing a barrier at the top of the ramp by the west egress to help prevent injury.
  - Recommend realigning the access aisle and accessible parking spaces by the northwest corner of the Library, so that the center of the access aisle is aligned with the center of the curb ramp.

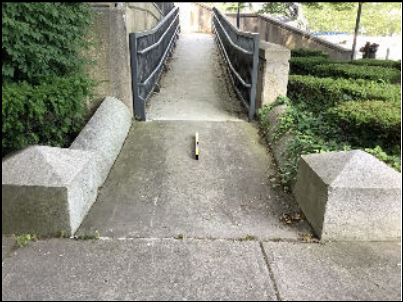
Running slope > 1:12 (8.33%) Handrails are not provided Handrails do not return properly	9.5% -	Reduce running slope to be no steeper than 1:12 (8.33%). Provide handrails with 1-1/4" to 1-1/2" circular cross sections. Ensure that handrail extensions return to a wall, guard, or the landing surface, or shall be continuous to the handrail of an adjacent ramp run.	1	-	-

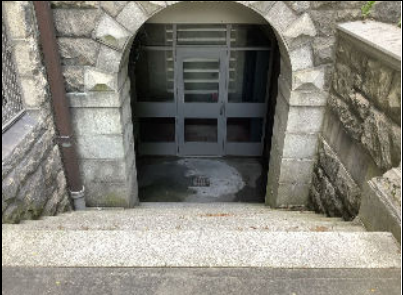
Handrail not provided on both sides		Provide a handrail on each side.	1	-	-
33	Main Building, Both Egress Stairs on Southeast Side of the Main Building Facing Route 6	Ext.	-	Exterior Stair	N/A

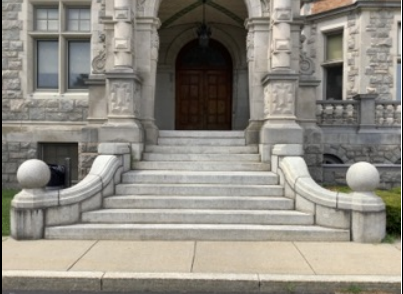
Handrails not provided		Provide handrails on both sides.	2	-	-
34	Main Building, South Staircases From Basement Egress Door By Teacher's Lounge	Ext.	-	Exterior Stair	N/A

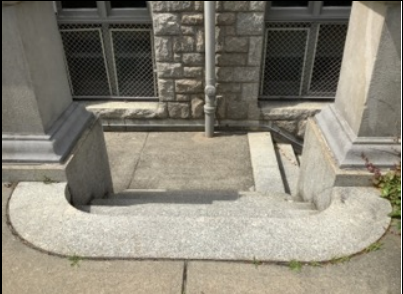
Handrail not provided on both sides		Provide a handrail on each side.	1	-	-
35	Main Building, South Staircase From Egress Between TV Studio and Classroom 002M	Ext.	-	Exterior Stair	N/A

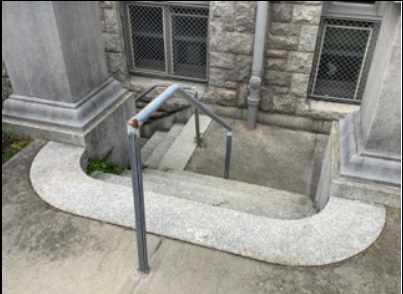
Handrail height < 34" or > 38" Handrail not provided on both sides Surface not stable, firm, and slip-resistant	29"	Alter so the handrails are 34"- 38" high above the finished floor or ground. Provide a handrail on each side of the stair, and remove the middle handrail. Surface seemed to be slippery to surveyors. (Please see ID #264 for recommended guidance to address this issue.)	1	-	-

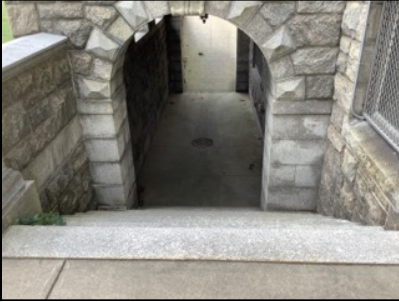
Handrail not provided on both sides		Provide a handrail on each side.	1	Labor	Labor	
38	Main Building, Stairs to Picnic Area Behind Classroom 006M	Ext.	-	Exterior Stair	N/A

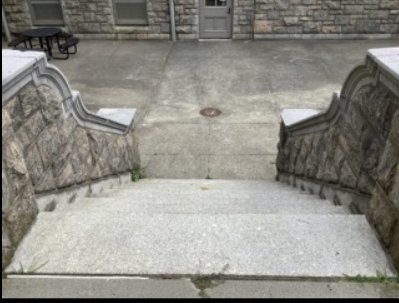
Handrail not provided on both sides	-	Provide a handrail on each side.	1	Labor	Labor	
39	Main Building, Stairs to Exterior Doors 15 & 16	Ext.	-	Exterior Stair	N/A

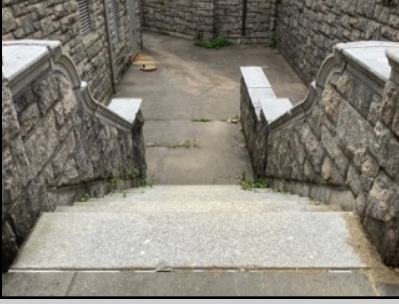
Handrail not provided on both sides		Provide a handrail on each side.	1	-	-	
Entrance													
40	New Building, Auditorium Entry Doors/ Next to North Entrance	G	011	Entrance	Auditorium Entrance

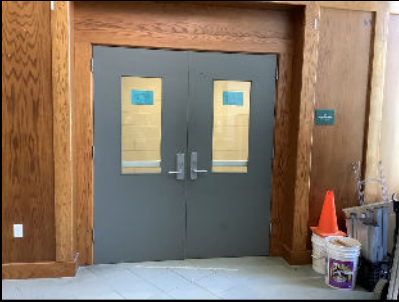
Directional sign to accessible entrance not provided	-	Provide a directional sign indicating the location of the nearest accessible entrance to the auditorium.	1	250	\$250

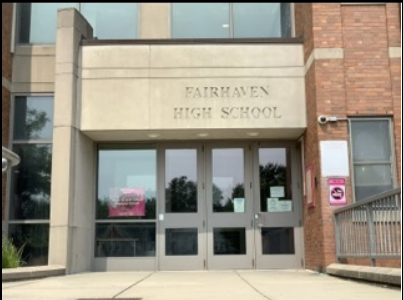
International Symbol of Accessibility not provided	-	Provide a sign with the International Symbol of Accessibility (ISA).	2	450	\$900
											900	
Access to Goods and Services												
Means of Egress												
43	New Building, Stair Entrance Door on Auditorium Stage	B	011	Means of Egress	N/A

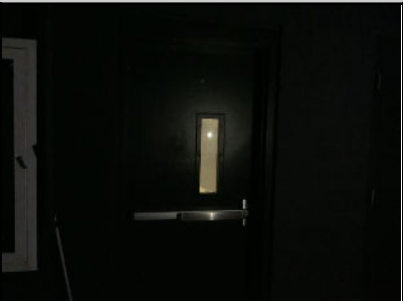
Directional sign to accessible emergency exit not provided	-	Provide a directional sign indicating the location of the nearest accessible emergency exit.	1	250	\$250

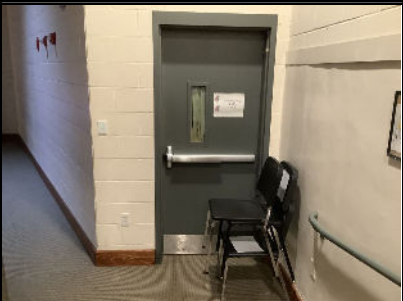
Directional sign to accessible emergency exit not provided	-	Provide a directional sign indicating the location of the nearest accessible emergency exit.	1	250	\$250
											250	
45	New Building, North Stair Next to Auditorium, Staircase on South Side of Auditorium	Ground Level	-	Means of Egress	N/A

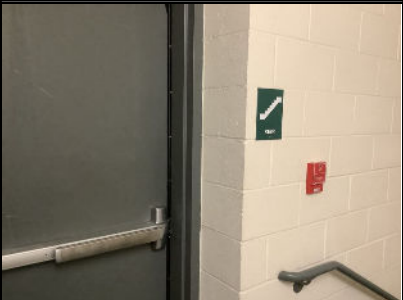
Tactile exit sign not provided	- -	Ensure that a tactile exit sign with raised characters and braille is provided at the exit door. Mount the sign between 48" - 60" above the finished floor located on the latch side of the door.	2	250	\$500
											500

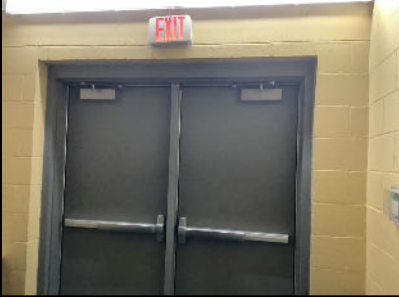
Tactile exit sign not provided	-	Ensure that a tactile exit sign with raised characters and braille is provided at the exit door. Mount the sign between 48" - 60" above the finished floor located on the right hand side of the right door.	1	250	\$250

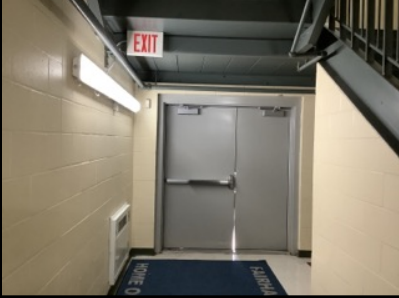
Tactile exit sign not provided Illuminated ISA symbol not provided (MAAB)	- -	Ensure that a tactile exit sign with raised characters and braille is provided at the exit door. Mount the sign between 48" - 60" above the finished floor located on the latch side of the door. When the illuminated exit sign is repaired or replaced, provide an illuminated sign with the International Symbol of Accessibility (ISA).	1	250	\$250
											250	
49	New Building, Stairwell Next to Kitchen and Classrooms 104, 208, Floors 1 and 2	2	-	Means of Egress	N/A

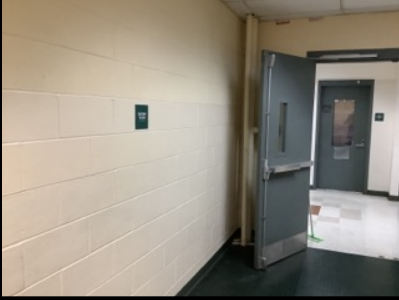
Floor level designation not compliant	-	Ensure floor level designations is located on the right of the right-handed door, located 48" - 60" above the finished floor.  Applies to all areas in both stairwells where floor level designation signage is improperly located.	1	Labor	Labor

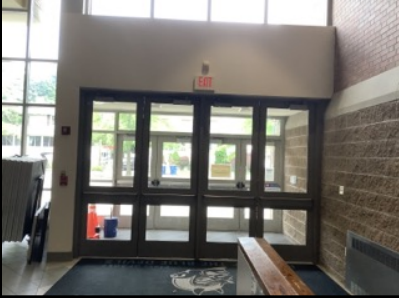
50	New Building, North Secondary Entrance and South Main Entrance	B	-	Means of Egress	N/A

Tactile exit sign not provided Illuminated ISA symbol not provided (MAAB)		Ensure that a tactile exit sign with raised characters and braille is provided at the exit door. Mount the sign between 48" - 60" above the finished floor located on the latch side of the door. When the illuminated exit sign is repaired or replaced, provide an illuminated sign with the International Symbol of Accessibility (ISA).	2	250	\$500
											500

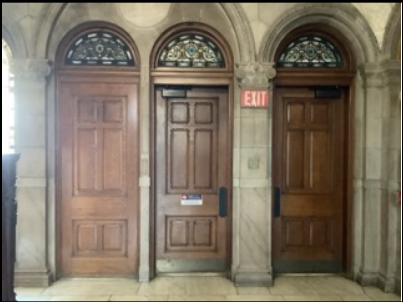
Tactile exit sign not provided Directional sign to accessible emergency exit not provided	- -	Ensure that a tactile exit sign with raised characters and braille is provided at the exit door. Mount the sign between 48" - 60" above the finished floor located on the latch side of the door. Provide a directional sign indicating the location of the nearest accessible emergency exit.	2	250 250	\$1000

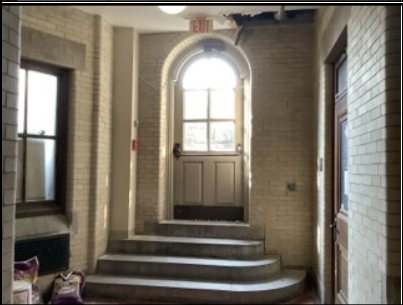
53	Main Building, Egress Between TV Studio and Classroom 002M (Southwest Egress Door)	B	-	Means of Egress	N/A

Tactile exit sign not provided Directional sign to accessible emergency exit not provided	- -	Ensure that a tactile exit sign with raised characters and braille is provided at the exit door. Mount the sign between 48" - 60" above the finished floor located on the latch side of the door. Provide a directional sign indicating the location of the nearest accessible emergency exit.	1	250 250	\$500
54	Main Building, Egress by Teacher's Lounge 007M (Southeast Egress Door)	B	-	Means of Egress	N/A

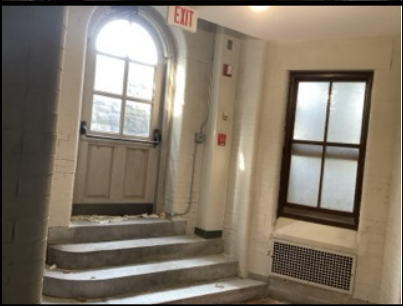
Tactile exit sign not provided Directional sign to accessible emergency exit not provided	- -	Ensure that a tactile exit sign with raised characters and braille is provided at the exit door. Mount the sign between 48" - 60" above the finished floor located on the latch side of the door. Provide a directional sign indicating the location of the nearest accessible emergency exit.	1	250 250	\$500

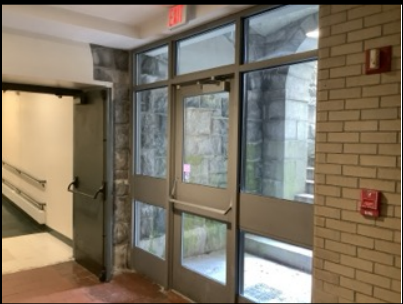
55	Main Building, South Egress Across From Room 046M	B	-	Means of Egress	N/A

Tactile exit sign not provided Directional sign to accessible emergency exit not provided		Ensure that a tactile exit sign with raised characters and braille is provided at the exit door. Mount the sign between 48" - 60" above the finished floor located on the latch side of the door. Provide a directional sign indicating the location of the nearest accessible emergency exit.	1	250 250	\$500

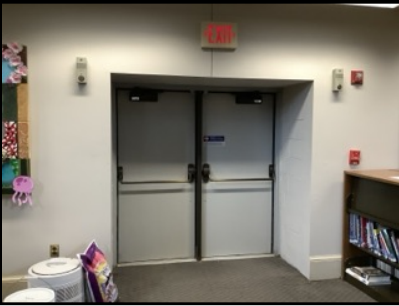
Tactile exit sign not provided Directional sign to accessible emergency exit not provided		Ensure that a tactile exit sign with raised characters and braille is provided at the exit door. Mount the sign between 48" - 60" above the finished floor located on the wall adjacent to the right door. Provide a directional sign indicating the location of the nearest accessible emergency exit.	1	250 250	\$500

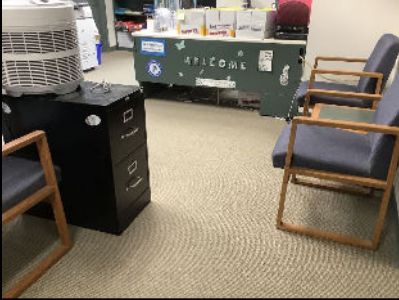
ID	Location	Floor	Room	Element	Type	Photo	Issues	Current Measure	Recommendations	Quantity	Price	Cost Estimation
61	New Building, Guidance Suite	1	102	Interior Access Route	N/A

Route < 36" wide	30.75"	Relocate the chairs and cabinet to ensure that a clear width of 36" min. is maintained at the accessible route.	1	Labor	Labor
62	New Building, School Psychologist	1	102	Interior Access Route	N/A

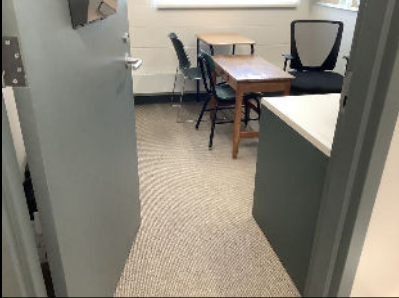
Route < 36" wide	29"	Relocate objects behind the door and the cabinet on the right to ensure the door can open to 90 degrees and that a clear width of 36" min. is maintained at the accessible route.	1	Labor	Labor
63	New Building, Principal/ Secretary Suite - Reception	1	-	Interior Access Route	N/A

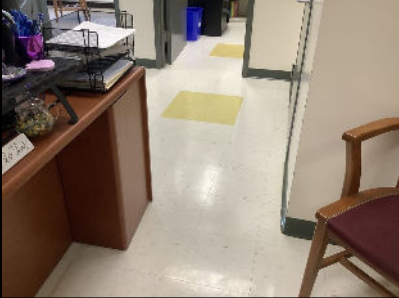
Route < 36" wide	28"	Relocate the desk on the left to ensure that a clear width of 36" min. is maintained at the accessible route.	1	Labor	Labor
64	New Building, Principal/ Secretary Suite - Reception	1	-	Interior Access Route	N/A

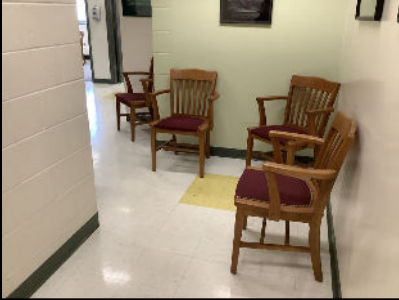
Route < 36" wide	-	Relocate the chairs to ensure that a clear width of 36" min. is maintained at the accessible route.	1	Labor	Labor

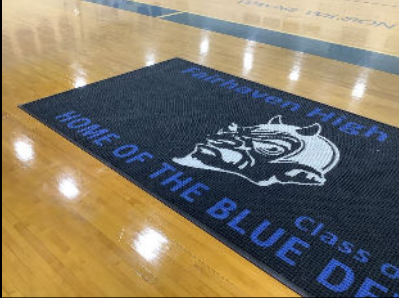
65	New Building, Gymnasium	1	108	Interior Access Route	N/A

Surface not stable, firm, and slip-resistant		Secure the mat.	1	Labor	Labor

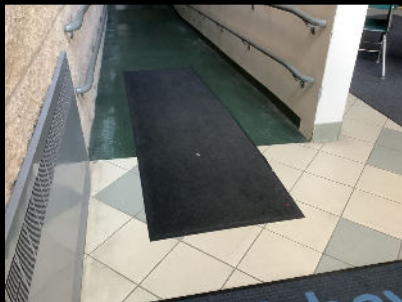
Surface not stable, firm, and slip-resistant	-	Secure the mat.	1	Labor	Labor	
68	New Building, Woman's Multi-User - Level 2 Corridor	2	-	Interior Access Route	N/A

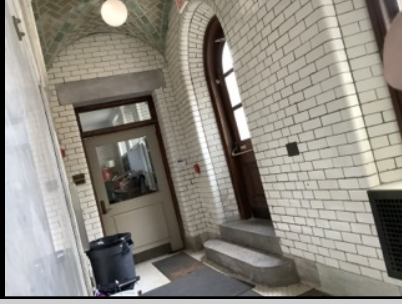
Accessible vertical route not provided	- -	If picnic and courtyard is used by members of the public, provide accessible vertical access to the courtyard and picnic area.(Cost is for a platform lift.) Further study may be required in order to determine the best way to provide accessible access to the courtyard and picnic area.	1	70000	\$70000

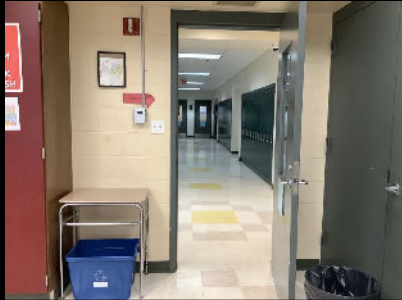
Maneuvering clearance(s) not provided	9"	Relocate the desk to maintain 18" of pull side maneuvering clearance on the latch side of the door.	1	Labor	Labor

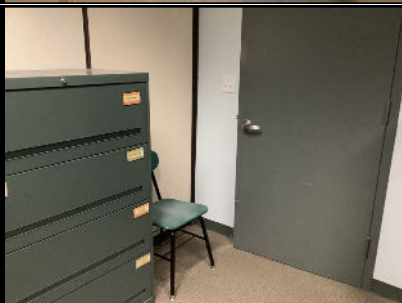
Maneuvering clearance(s) not provided	36.5"	Relocate the cabinet and chair to provide 48" of clear floor space in front of the latch side of the door and to maintain maneuvering clearance at the door.	1	Labor	Labor
79	New Building, Gender-Neutral Single-User Toilet Room in Health Suite	1	103	Doors, Doorways, & Gates	Toilet Room

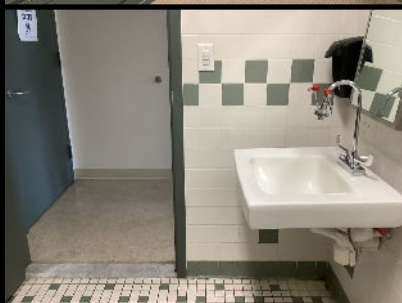
Maneuvering clearance(s) not provided	13"	Provide an automatic door opener.	1	6000	\$6000

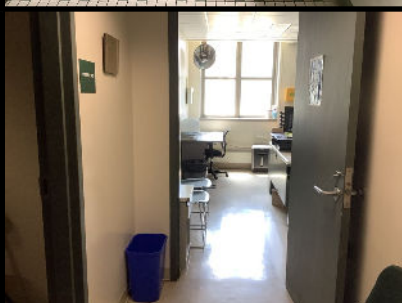
80	New Building, Health Suite	1	103	Doors, Doorways, & Gates	Office

Maneuvering clearance(s) not provided	13"	Provide an automatic door opener.	1	6000	\$6000

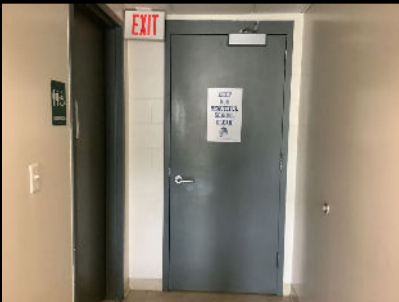
ID	Location	Floor	Room	Element	Type	Photo	Issues	Current Measure	Recommendations	Quantity	Price	Cost Estimation
81	New Building, Health Suite	1	103	Doors, Doorways, & Gates	Circulation

Maneuvering clearance(s) not provided	14"	Provide an automatic door opener.	1	6000	\$6000
											6000	
82	New Building, Guidance Suite	1	102	Doors, Doorways, & Gates	Office

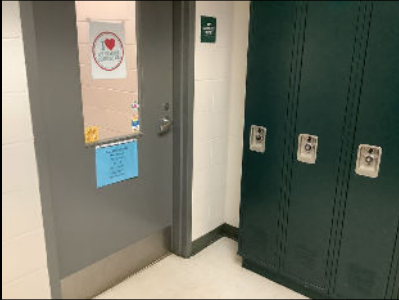
Maneuvering clearance(s) not provided	-	Remove lockers to maintain 48" clear space approaching the door, 12" min. push side maneuvering clearance at the door and 18" x 18" min. clear floor space at the sign.	1	-	-
83	New Building, Principal/ Secretary Suite	1	-	Doors, Doorways, & Gates	Circulation

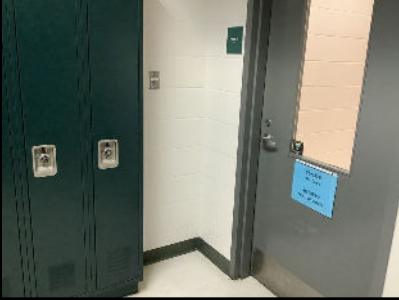
Maneuvering clearance(s) not provided	23.25	Remove lockers to maintain 48" clear space approaching the door, 12" min. push side maneuvering clearance at the door and 18" x 18" min. clear floor space at the sign.	1	-	-
84	New Building, Math Classroom Grades 9-12	1	104	Doors, Doorways, & Gates	Classroom

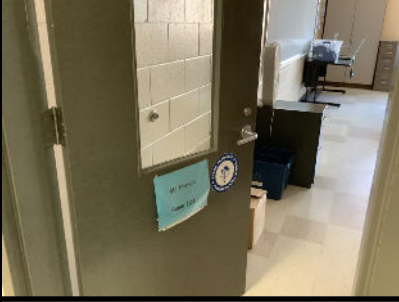
Hardware not maintained in operable working condition.	-	Ensure the door hardware is maintained in operable working condition.	1	Labor	Labor

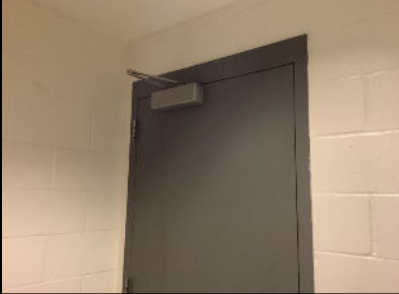
85	New Building, Woman's Multi-User - Across From Main Office	1	-	Doors, Doorways, & Gates	Toilet Room

Closing speed not compliant	-	Adjust door closer so that from an open position of 90 degrees, the time required to move the door to an open position of 12 degrees from the latch is 6 seconds min. (MAAB, 26.9).	1	Labor	Labor

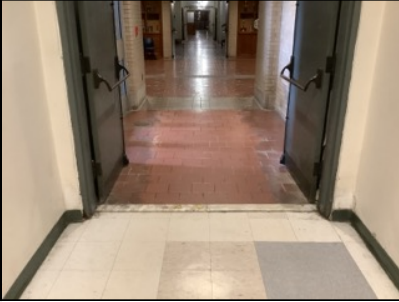
Threshold > 1/2" high	0.75"	Alter the threshold to be 1/2" high max.	1	1000	\$1000
											1000	
88	Main Building, Boys' and Girls' Multi-User Toilet Rooms East	B	-	Doors, Doorways, & Gates	Toilet Room

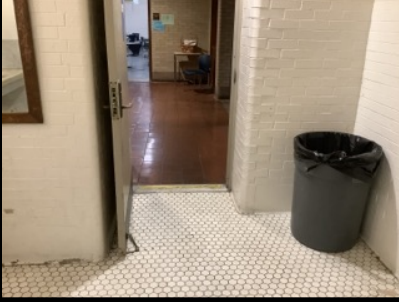
Maneuvering clearance not provided at recess > 6" Threshold > 1/2" high	15.5" 1.5"	Install an automatic door opener. Alter the threshold to be 1/2" high max.	2	6000 1000	\$14000
											14000	
89	Main Building, Senior Cafeteria Entrance Doors	B	009M	Doors, Doorways, & Gates	Assembly Space

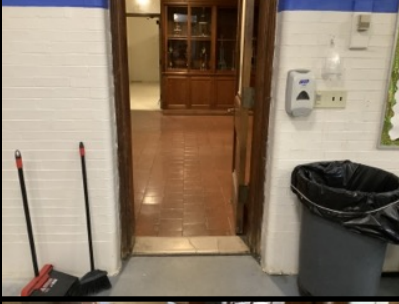
Maneuvering clearance not provided at recess > 6" Threshold > 1/2" high	19" 1.5"	Install an automatic door opener./Reverse the swing of the door to provide maneuvering clearance. Alter the threshold to be 1/2" high max.	2	6000 1000	\$14000

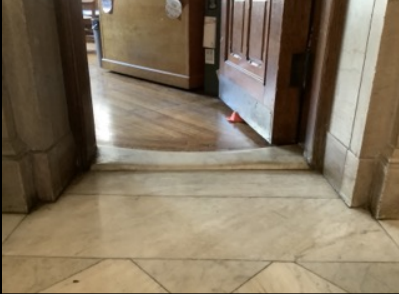
Threshold > 1/2" high	1.5"	Alter the threshold to be 1/2" high max.	1	1000	\$1000
											1000

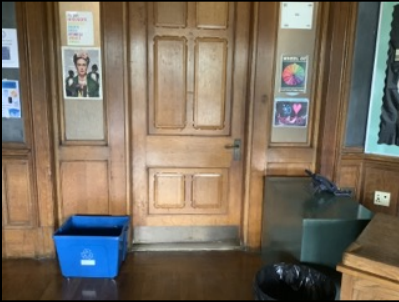
ID	Location	Floor	Room	Element	Type	Photo	Issues	Current Measure	Recommendations	Quantity	Price	Cost Estimation
91	Main Building, Classroom 105M	1	105M	Doors, Doorways, & Gates	Classroom

Maneuvering clearance(s) not provided Threshold > 1/2" high	9" 1.5"	Relocate stored items at the latch side of the door to maintain 12" min. push side maneuvering clearance.	1	Labor	Labor
92	Main Building, Automatic Door Opener for Classroom 108M	1	108M	Doors, Doorways, & Gates	Classroom

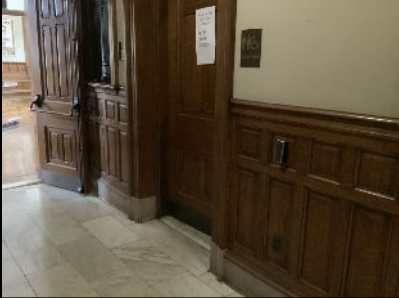
Automatic door opener not operable	-	Repair or replace the automatic door opener.	1	Labor	Labor
93	Main Building, Route to Classroom 108M, Entrance Door to Classroom 108M	1	108M	Doors, Doorways, & Gates	Circulation

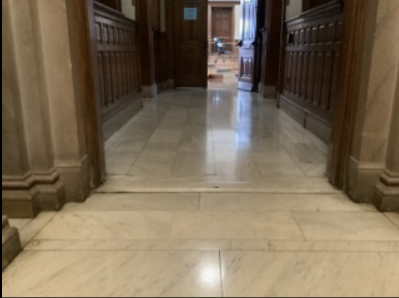
Threshold > 1/2" high	0.75"	Alter the threshold to be 1/2" high max.	2	1000	\$2000
											2000	
94	Main Building, TV Studio	B	004M	Doors, Doorways, & Gates	Classroom

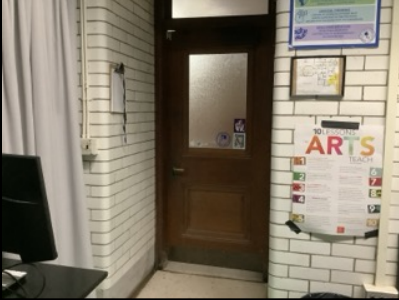
Maneuvering clearance not provided at recess > 6" Threshold not beveled	42" -	Install an automatic door opener. Bevel the threshold.	1	6000 1000	\$7000

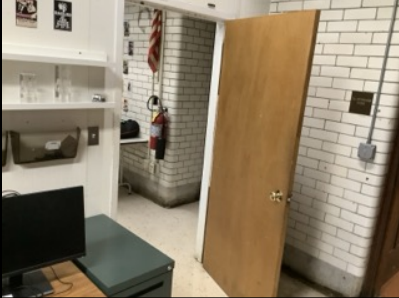
Maneuvering clearance(s) not provided Hardware not compliant	- -	Relocate the cabinet to maintain 18" of pull side clearance on the latch side of the door. Provide hardware that can be operable with one hand and not require tight grasping, pinching, or twisting of the wrist.	1	Labor 750	\$750
											750

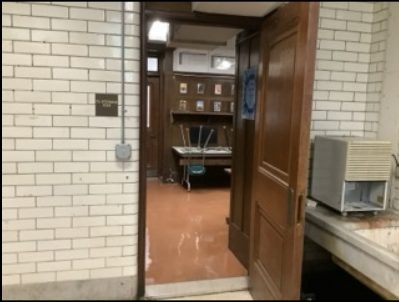
ID	Location	Floor	Room	Element	Type	Photo	Issues	Current Measure	Recommendations	Quantity	Price	Cost Estimation	
96	Main Building, TV Storage	B	012M	Doors, Doorways, & Gates	Classroom

Threshold > 1/2" high Hardware not compliant	1" -	Alter the threshold to be 1/2" high max. Provide hardware that can be operable with one hand and not require tight grasping, pinching, or twisting of the wrist.	1	1000 750	\$1750	
97	Main Building, TV Studio - To West Egress	B	004M	Doors, Doorways, & Gates	Classroom

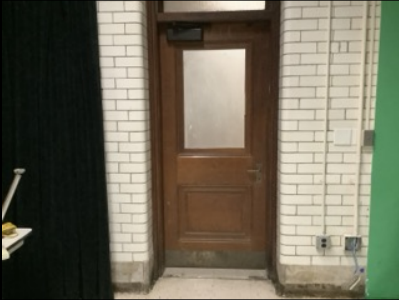
Threshold > 1/2" high Door requires > 5 lbs. of force to open	1" 8 lbs.	Alter the threshold to be 1/2" high max. Adjust closers so doors do not require more than 5 pounds of force to open.	1	1000 Labor	\$1000	
98	Main Building, MCAS Testing	B	016M	Doors, Doorways, & Gates	Classroom

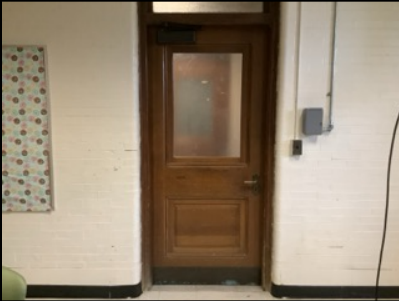
Door requires > 5 lbs. of force to open	8 lbs.	Adjust closers so doors do not require more than 5 pounds of force to open. Applies to all doors in the Main Building in this condition.	1	Labor	Labor

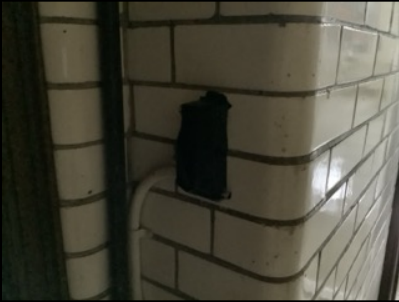
99	Main Building, Classroom 006M to North Picnic Table Patio	B	006M	Doors, Doorways, & Gates	Classroom

Automatic door opener not operable	-	Repair or replace the automatic door opener.	1	Labor	Labor	
100	Main Building, Classroom 006M to Picnic Tables Egress (North Side)	B	006M	Doors, Doorways, & Gates	Classroom

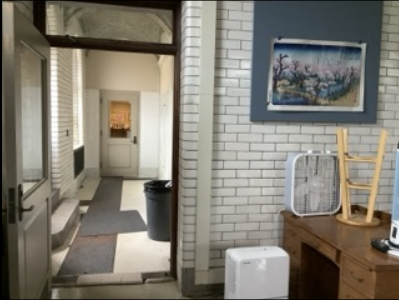
Maneuvering clearance not provided at recess > 6	-	Install an automatic door opener.	1	6000	\$6000	
											6000

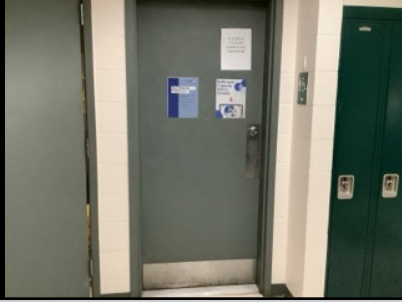
Maneuvering clearance not provided at recess > 6"	13"	Install an automatic door opener.	1	6000	\$6000
											6000	
Ramps												
104	New Building, Auditorium	B	011	Ramps	Interior

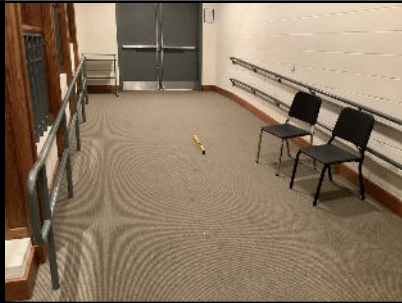
Running slope >1:12 (8.33%)	9.3%	Further study will be needed to determine whether it is technically feasible to bring the ramp into full compliance with the ADA Standards. Relocate chairs away from ramp railings and to a location that does not interfere with the ramp run.	1	-	-

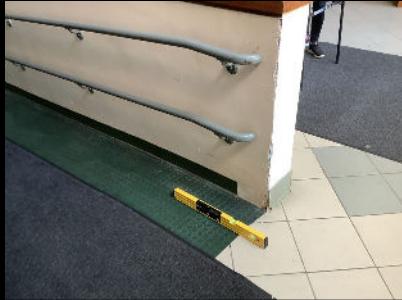
105	New Building, Ramp by North Entrance/ Near Auditorium	Ground Level	-	Ramps	Interior

Handrails do not extend 12" past top & bottom Handrails do not return properly	- -	Alter handrails to extend horizontally above the landing for 12" min. beyond the top and bottom of ramp runs. Once extensions are provided, ensure handrails return properly at the end of the ramp.	1	-	-

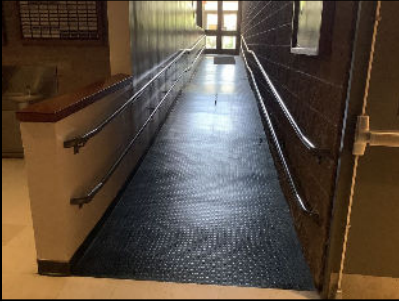
Running slope >1:12 (8.33%)	10.3%	Further study will be needed to determine whether it is technically feasible to bring the ramp into full compliance with the ADA Standards.	1	-	-
108	New Building, Ramp Going to Band Room/Next to Room 011	B	-	Ramps	Interior

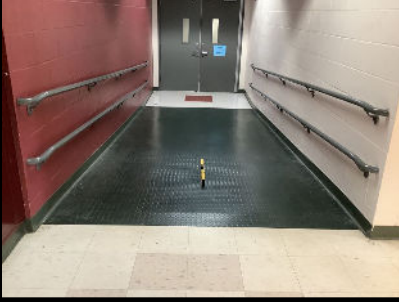
Running slope >1:12 (8.33%) Handrails do not extend 12" past top & bottom Handrails do not return properly	8.8% 7" -	Further study will be needed to determine whether it is technically feasible to bring the ramp into full compliance with the ADA Standards. Alter handrails to extend horizontally above the landing for 12" min. beyond the top and bottom of ramp runs.	1	-	-

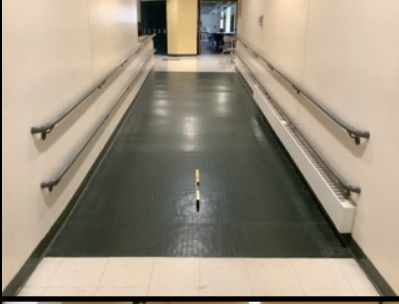
109	New Building, Ramp Between New Building and Main Building	B	-	Ramps	Interior

Running slope >1:12 (8.33%)	8.8%	Further study will be needed to determine whether it is technically feasible to bring the ramp into full compliance with the ADA Standards.	1	-	-
110	Main Building to New Building	2	-	Ramps	Interior

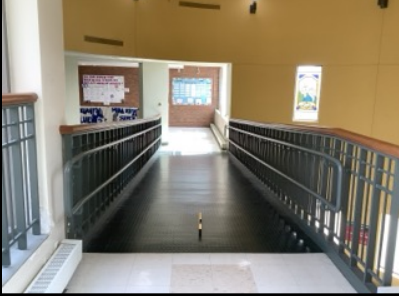
Running slope >1:12 (8.33%)	8.8%	Further study will be needed to determine whether it is technically feasible to bring the ramp into full compliance with the ADA Standards.	1	-	-

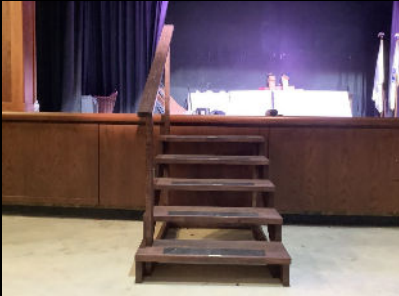
ID	Location	Floor	Room	Element	Type	Photo	Issues	Current Measure	Recommendations	Quantity	Price	Cost Estimation
Stairways												
111	New Building, Auditorium	B	011	Stairways	Interior

Handrails do not extend 12" from stairs at top Bottom handrail extends < 12" and one tread Handrails lack a compliant cross section Stair has open risers Handrails do not return properly	3.5"	Top: Ensure handrails extend horizontally above the landing for 12" min. beginning above the first riser nosing. Bottom: Ensure that the sloped bottom extension extends one tread depth min. beyond last riser nosing in same direction as stair flight. Provide handrails with 1 1/4" - 2" circular cross sections. Ensure stairs have closed risers. Ensure that handrail extensions return to the guard rail.	1	-	-
112	New Building, North Stair Next to Auditorium	B	-	Stairways	Interior

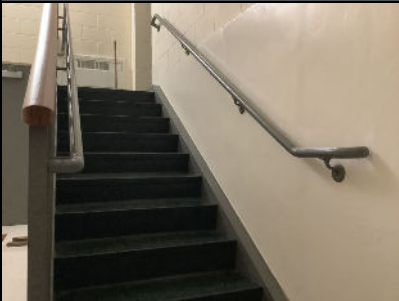
Handrail height < 34" or > 38"	40.25	Alter so the handrails are 34"- 38" high above the floor.	1	-	-

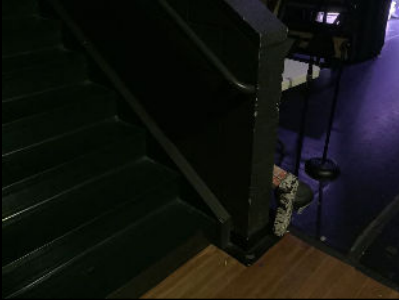
113	New Building, Staircase on South Side of Auditorium	B	011	Stairways	Interior

Bottom handrail extends < 12" and one tread	6"	Bottom: Ensure that the sloped bottom extension extends one tread depth min. beyond last riser nosing in same direction as stair flight. Once extensions are provided, ensure handrails return properly.	1	-	-
114	Main Building, Egress Between TV Studio and Classroom 002M	B	-	Stairways	Interior

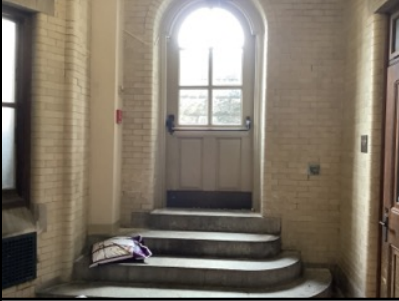
Handrails not provided	-	Provide handrails.  Applies to the egress staircase by Teacher's Lounge 007M (Southeast Egress Door).	2	-	-
115	Main Building, East and West Staircases	B	-	Stairways	Interior

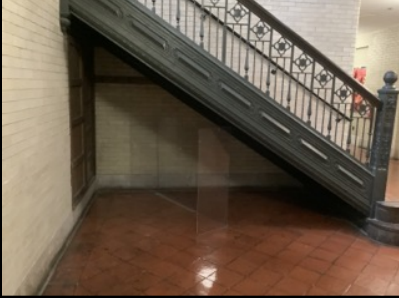
Handrails do not extend 12" from stairs at top Bottom handrail extends < 12" and one tread Handrails lack a compliant cross section Handrails not continuous where required	- - - -	Top: Ensure handrails extend horizontally above the landing for 12" min. beginning above the first riser nosing. Bottom: Ensure that the sloped bottom extension extends one tread depth min. beyond last riser nosing in same direction as stair flight. Provide handrails with 1 1/4" - 2" circular cross sections. Provide continuous handrails.	2	-	-

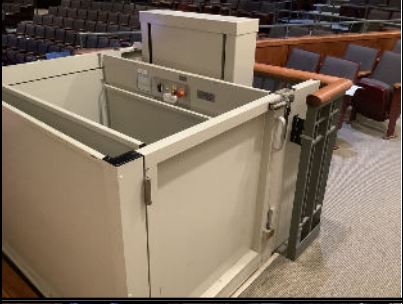
Door requires > 5 lbs. of force to open	30 lbs	Adjust closers so doors do not require more than 5 pounds of force to open.  Applies to both doors of the platform lift.	2	Labor	Labor
118	New Building, Auditorium	B	011	Platform Lift	N/A

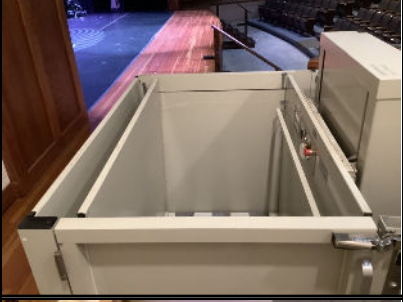
Lift with door on narrow end is < 36" x 54"	30"	Further study will be needed to determine whether it is technically feasible to bring the lift into full compliance with the ADA Standards and 521 CMR.	1	-	-
119	New Building, Auditorium	B	011	Platform Lift	N/A

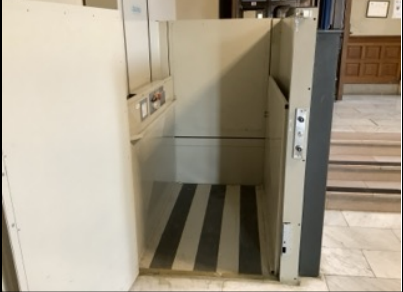
120	Main Building, Both Lifts to Knipe Auditorium by Room 209M and 204M	2	-	Platform Lift	N/A

Lift with door on narrow end is < 36" x 54"	34.5"x58"	Further study will be needed to determine whether it is technically feasible to bring the lift into full compliance with the ADA Standards and 521 CMR.	2	-	-

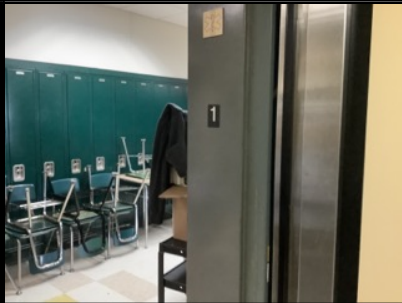
Tactile stars not provided at main entry level		Provide a tactile star on both sides of the elevator door jambs at the main egress floor. At other floors, provide appropriate floor number signage on the elevator door jambs with raised characters and braille.	2	96	\$192
Signage											192	
124	New Building, Main Entry/Front Entrance	1	-	Signage	Informational

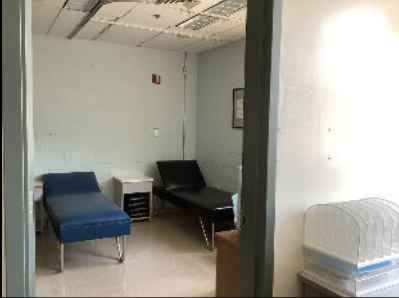
Signage is not provided		Locate compliant signage with raised characters and braille alongside the door on the latch side.  When a compliant designation sign is provided, relocate the items on the latch side of the door to provide a clear floor space of 18" min. by 18" min. at the sign.	1	250	\$250
											250	
128	New Building, Assistant Principal	1	101	Signage	Designation

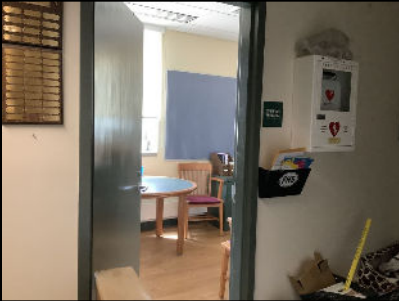
Signage lacks 18" by 18" clear floor space	-	Relocate the defibrillator and storage bin to provide a clear floor space of 18" min. by 18" min. at the sign.	2	500	\$1000

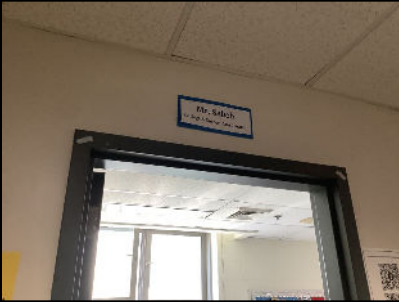
Character style not compliant	-	Provide a sign with compliant characters. Characters should be sans serif.  Applies to all informational signs in this condition.	1	250	\$250
											250	
130	New Building, Principal/Secretary Suite	1	-	Signage	Designation

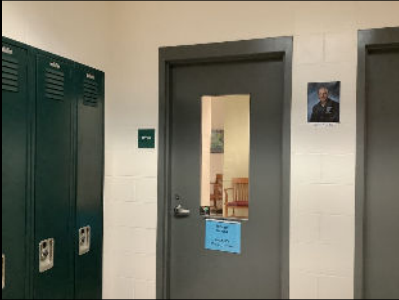
Designation sign is incorrect	-	Provide a compliant tactile designation sign that indicates this is the Principal/Secretary Suite, in text with raised characters duplicated in braille on the sign.	1	250	\$250
											250

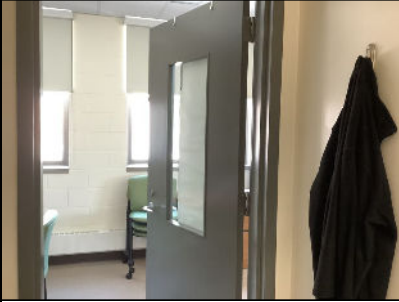
Signage is not provided		Locate compliant signage with raised characters and braille alongside the door on the latch side.	1	250	\$250
											250	
133	New Building, Men's Multi-User Toilet Room - Across From Main Office	1	-	Signage	Designation

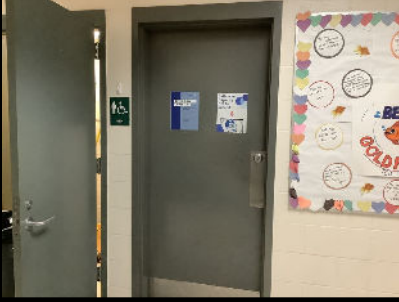
Location of tactile sign not compliant	-	Locate sign alongside the door on the latch side.	1	500	\$500

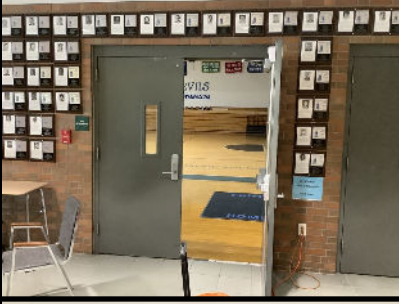
Location of tactile sign not compliant		Locate the designation sign to the right of the right-hand door.	1	Labor	Labor
135	New Building, Gymnasium Entry Doors - Right Double Door Set	1	108	Signage	Designation

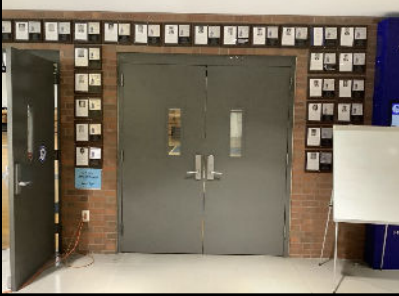
Signage is not provided		Locate compliant signage with raised characters and braille alongside the door to the right of the right-hand door.	1	250	\$250
											250

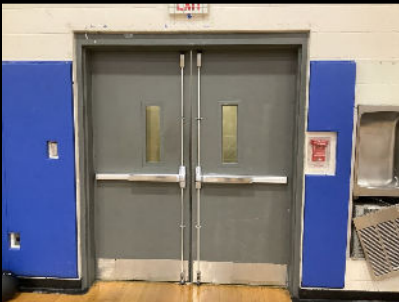
Signage is not provided	-	Locate compliant signage to the stairwell beyond these doors with raised characters and braille alongside the door on the latch side.	1	250	\$250	
											250		
137	New Building, Gymnasium - Single Door to Stairwell	1	108	Signage	Egress

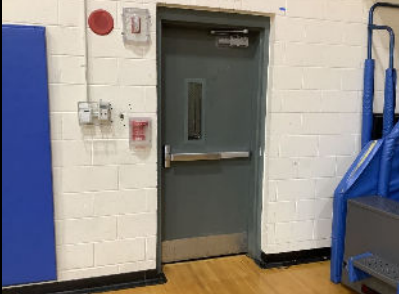
Signage is not provided		Locate compliant signage to the stairwell beyond this door with raised characters and braille alongside the door on the latch side.	1	250	\$250	
											250		
138	New Building, Auditorium Entry Doors/ Next to North Entrance	Ground Level	011	Signage	Designation

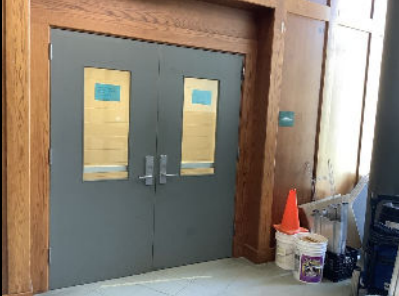
Signage lacks 18" by 18" clear floor space	-	Relocate stored items to provide a clear floor space of 18" min. by 18" min.	1	Labor	Labor	
139	New Building, North Entrance	Ext.	-	Signage	Informational

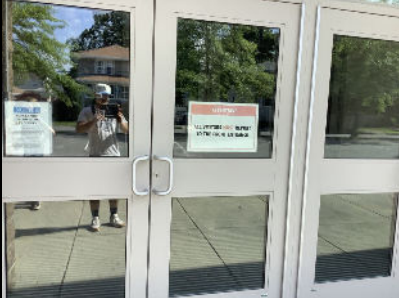
Non-glare finish and contrast not provided on sign		Relocate the sign onto the exterior side of the door to prevent glare on the sign from the glass.	1	Labor	Labor

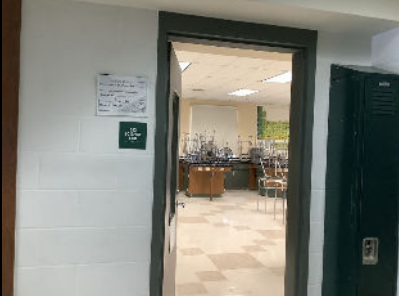
140	New Building, Science Laboratory Classroom	2	-	Signage	Designation

Location of tactile sign not compliant	-	Locate sign on the nearest adjacent wall.	1	Labor	Labor

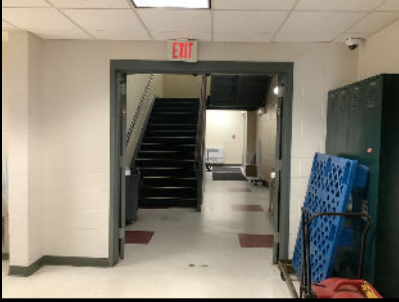
Signage is not provided	-	Locate compliant stairwell signage with raised characters and braille alongside the door on the right handed side of the right door.	1	250	\$250
142	New Building, Art Classroom	B	015	Signage	Designation

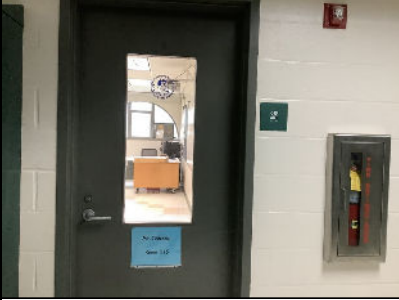
Location of tactile sign not compliant		Locate sign alongside the door on the latch side.	1	Labor	Labor
143	New Building, Ramp Going to Band Room/Next to Room 011	B	-	Signage	Designation

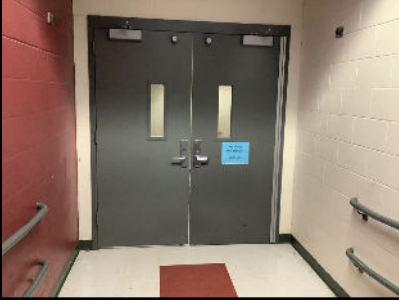
Raised characters not provided on sign Braille not provided on sign Location of tactile sign not compliant Non-glare finish and contrast not provided on sign Character style not compliant	- - - -	Provide text with raised characters duplicated in braille on the sign. Locate the sign to the right of the right-hand door. Install a sign with a non-glare finish with characters that have a high contrast to the background. Provide a sign with compliant characters. Characters should be sans serif.	1	250	\$250

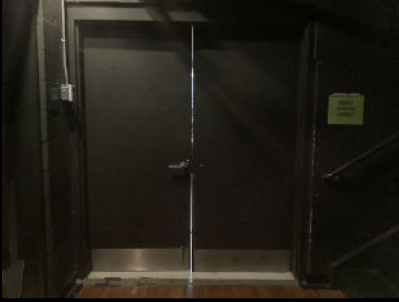
144	New Building, Auditorium Stage/ Entrance to Band Room 012	B	011	Signage	Designation

Signage is not provided	-	Locate compliant signage with raised characters and braille alongside the door on the latch side.	1	250	\$250
145	New Building, Band Room/ Entrance to Auditorium Stage 011	B	012	Signage	Designation

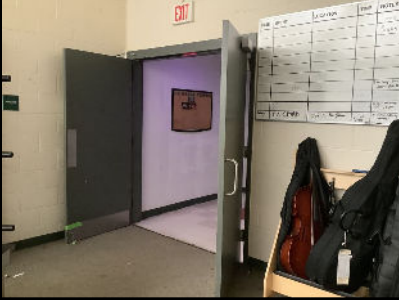
Signage is not provided	-	Locate compliant signage with raised characters and braille alongside the door on the latch side. Ensure the sign is outside of the door swing and that there is at least 18"x18" clear floor space at the sign.	1	Labor	Labor

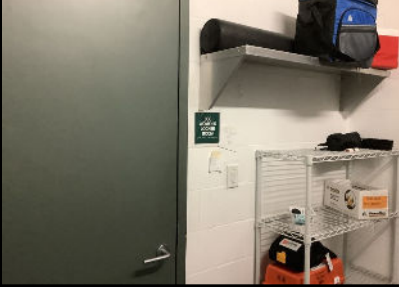
150	New Building, Training Room	B	-	Signage	Designation

Signage lacks 18" by 18" clear floor space		Relocate the shelf to provide a clear floor space of 18" min. by 18" min.  When the shelf is relocated, ensure it does not act as a protruding object. Otherwise, provide a cane-detectable barrier. Endure shelf is 80" clear above the finished floor.	1	500  500	\$500

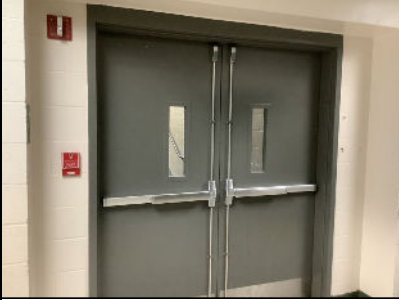
Signage is not provided	-	Locate compliant stairway designation signage with raised characters and braille alongside the door on the right handed side of the right door.	1	Labor	Labor
153	New Building, Stairwell on South Side of Gymnasium, Floor 2 and B	B	-	Signage	Designation

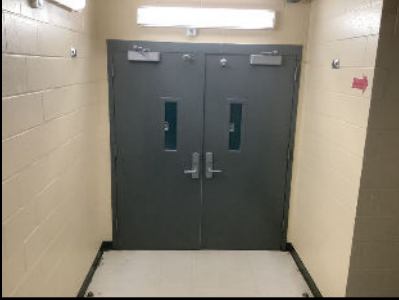
Signage is not provided		Locate compliant floor level signage with raised characters and braille alongside the door on the latch side.	2	Labor	Labor
154	New Building, Entrance to Stairwell on South Side of Gymnasium	B	-	Signage	Egress

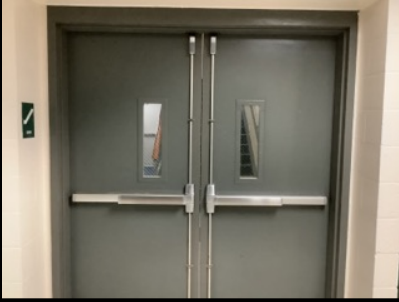
Location of tactile sign not compliant		Locate the stairwell sign to the right of the right-hand door, on the nearest adjacent wall.	1	Labor	Labor

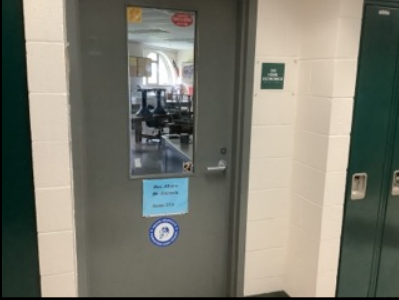
155	New Building, Special Education Classroom	B	016	Signage	Designation

Designation sign is incorrect		Provide a sign with the correct room designation. This sign reads "Home Economics," when it should read "Special Education Classroom."	1	250	\$250
											250
