# Fairhaven High School

## Town of Fairhaven ADA Transition Plan

January 2025

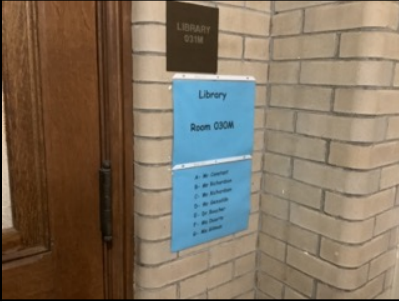
Designation sign is incorrect	-	If the library is Room 030M, provide an accessible designation sign with the correct room number.	1	250	\$250
											250	
158	Main Building, Special Education Classroom	B	001M	Signage	Designation

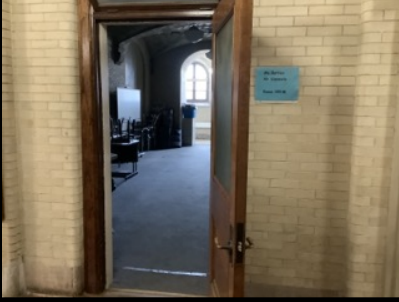
Signage is not provided		Locate compliant signage with raised characters and braille alongside the door on the latch side.	1	250	\$250
											250	
159	Main Building, Classroom 002M	B	002M	Signage	Designation

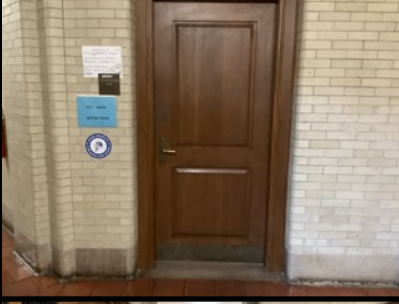
Designation sign is incorrect		Provide a sign with the correct room designation. This is a classroom, not a teacher's lounge.	1	250	\$250

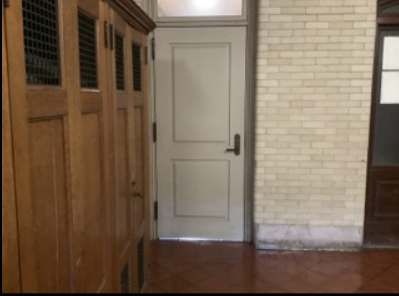
250	
160	Main Building, Door to Southwest Egress	B	-	Signage	Designation

Signage is not provided		If this doorway leads to Classroom 006M, provide compliant signage with raised characters and braille alongside the door on the latch side.	1	250	\$250
											250

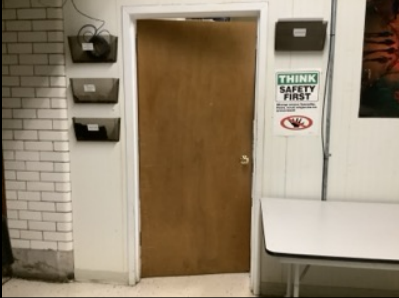
Signage is not provided		Locate compliant signage with raised characters and braille alongside the door on the latch side, indicating the designation of the computer lab.	1	250	\$250
											250	
163	Main Building, Classroom 006M to Picnic Tables (North Side)	B	006M	Signage	Designation

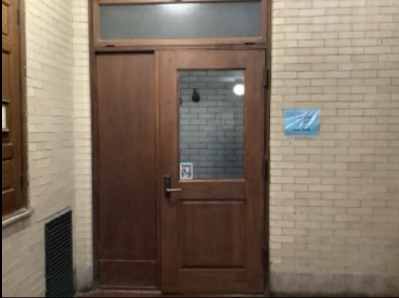
Raised characters not provided on sign Braille not provided on sign Location of tactile sign not compliant Non-glare finish and contrast not provided on sign	<ul style="list-style-type: none"><li>-</li><li>-</li><li>-</li><li>-</li></ul>	Install a sign with raised characters duplicated in braille on the sign, and with a non-glare finish with characters that have a high contrast to the background. Locate sign alongside the door on the latch side.	1	250	\$250

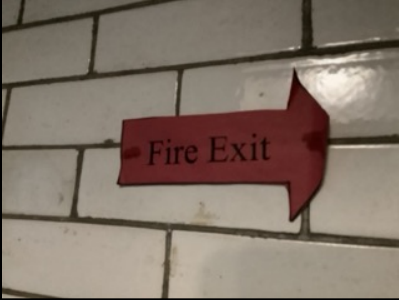
250	
164	Main Building, Classroom 006M to Picnic Tables (North Side)	B	006M	Signage	Egress

Non-glare finish and contrast not provided on sign Designation sign is incorrect Character style not compliant	<ul style="list-style-type: none"><li>-</li><li>-</li><li>-</li></ul>	Provide a directional egress sign that orients to the direction of the emergency fire egress, which would point in the opposite direction of the existing sign. When a new directional egress sign is provided, ensure there is light-to-dark or dark-to-light contrast between the text and the background, and that all characters are in sans serif.	1	250	\$250
											250	
165	New Building, Mabel Hoyle Knipe Auditorium Entrance by Room 209M	2	-	Signage	Designation

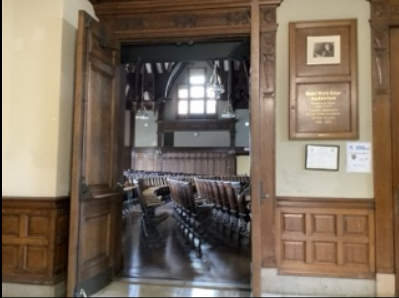
Signage is not provided		Locate compliant signage with raised characters and braille along the right side of the right handed door.	1	250	\$250
											250

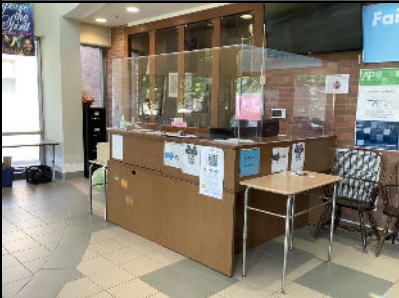
Counter > 36" high	44.75"	Provide a counter that is 36" max. above the ground or finished floor.	1	1144	\$1144
168	New Building, Administration	1	101	Service Counter	N/A

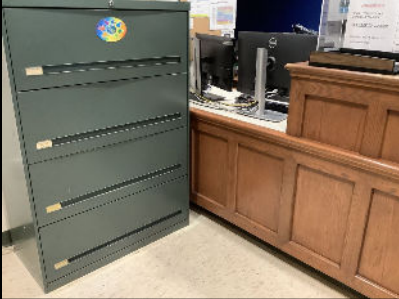
Parallel approach w/ part of counter surface < 36" long	23"	Relocate the cabinet to provide a portion of the counter surface that is 36" long min.	1	Labor	Labor

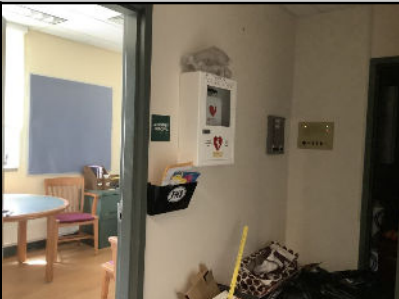
Operable Parts / Reach Range												
169	New Building, Administration	1	101	Operable Parts / Reach Range	Defibrillator

Reach < 15" or > 48"(forward/side approach)	58"	When the defibrillator is relocated, ensure it's operable part is located 48" max. above the finished floor and that it does not protrude into the circulation path.	1	Labor	Labor
170	New Building, Math Classroom Grades 9-12	1	104	Operable Parts / Reach Range	Paper Towel Dispensar

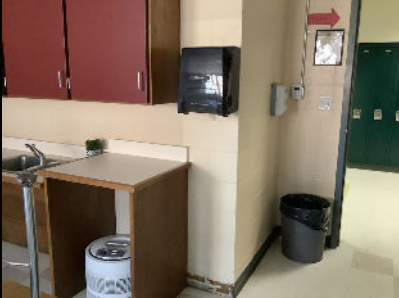
Reach < 15" or > 48"(forward/side approach)	50.5"	Relocate the paper towel dispenser so that controls are between 15"- 48" above the finished floor.	1	Labor	Labor

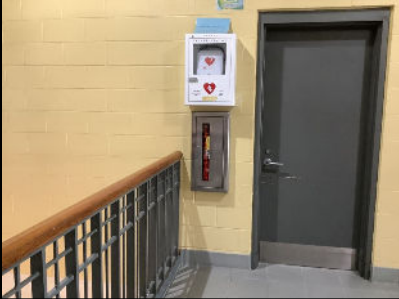
Reach < 15" or > 48"(forward/side approach)	65.75	Relocate the defibrillator so that controls are between 15"- 48" above the finished floor.	1	500	\$500
173	New Building, North Entrance	Ext.	-	Operable Parts / Reach Range	Intercom

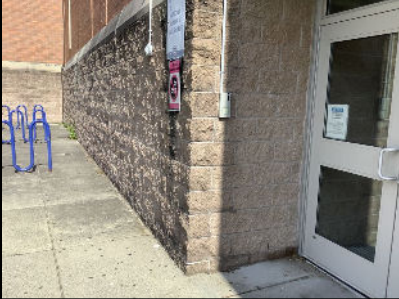
Reach < 15" or > 48"(forward/side approach)	55"	Relocate the intercom so that controls are between 15"- 48" above the finished floor.	1	Labor	Labor

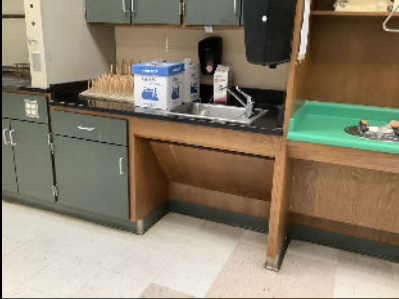
174	New Building, Science Laboratory Classroom	2	213	Operable Parts / Reach Range	Soap Dispensar

Forward reach if obstruction > 20"- 25" deep is > 44" high	49"	Relocate the soap dispenser so that it is not higher than 44" above the finished floor.  Recommend locating on the partition adjacent to the sink.	1	500	\$500
175	New Building, Cafeteria - Grades 9-11	B	-	Operable Parts / Reach Range	Food Storage

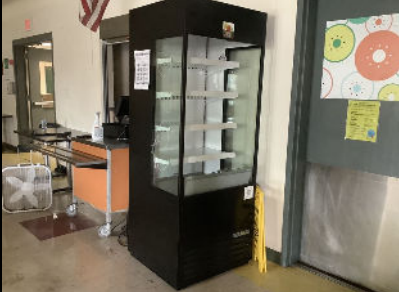
Reach < 15" or > 48"(forward/side approach)	64"	Relocate shelves so that controls are between 15"- 48" above the finished floor, or ensure that staff is available to assist visitors who need assistance.	1	Labor	Labor

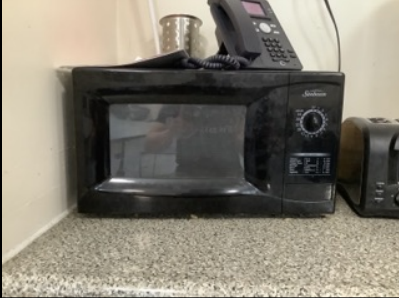
Not compliant	-	Provide a microwave with controls that can be operable with one hand and not require tight grasping, pinching, or twisting of the wrist.	1	-	-
Dining or Work Surfaces												
178	New Building, South Main Entrance	1	-	Dining or Work Surfaces	Work Surface

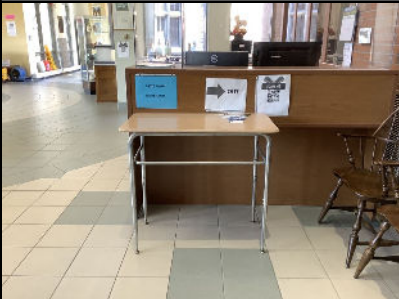
Knee clearance less than 19" deep	-	Rotate the desk 180 degrees so that the open side is facing away from the service counter, allowing a forward approach for a person in a wheeled mobility device.	1	Labor	Labor

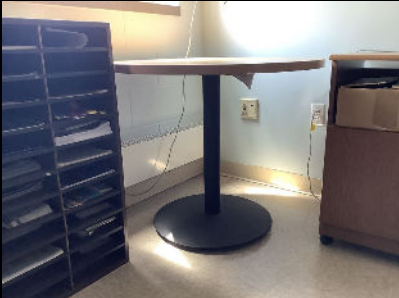
179	New Building, Exam Room in Health Suite	1	103	Dining or Work Surfaces	Work Surface

Knee clearance less than 19" deep	15.5"	Provide at least one work surface with knee clearance that is 19" deep min.	1	700	\$700
											700	
180	New Building, Administration	1	101	Dining or Work Surfaces	Work Surface

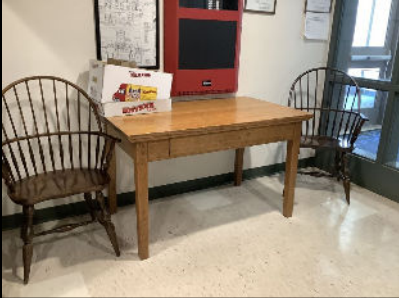
Knee or toe clearance not provided	23.5"	Provide at least one work surface with 27" min. high knee and toe clearance.	1	700	\$700
											700

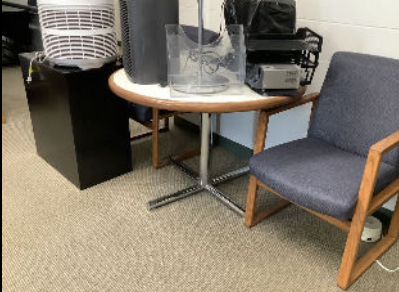
Knee clearance less than 19" deep	4"	Provide at least one work surface with knee clearance that is 19" deep min.	1	700	\$700
											700	
183	Main Building, Classroom 105M	1	105M	Dining or Work Surfaces	Work Surface

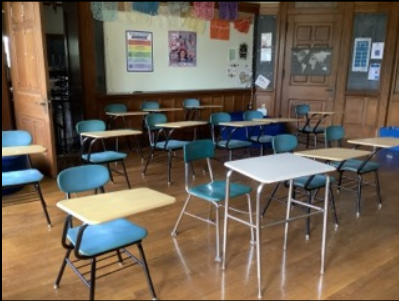
At least one or 5% accessible tables not provided	-	Ensure that at least one or 5% of work surfaces are accessible.  Applies to all classrooms in this condition with non-historic furniture and work surfaces. Unit cost is provided for one instance of this repetitive item.	1	700	\$700

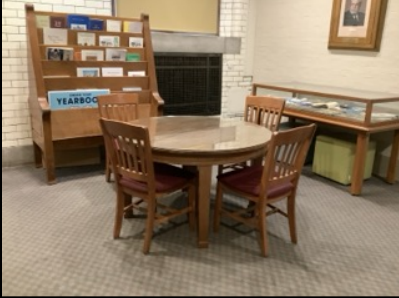
700	
184	Main Building, Library - Sitting Room	B	031M	Dining or Work Surfaces	Work Surface

At least one or 5% accessible tables not provided Knee or toe clearance not provided	- 24.5"	Provide at least one work surface with 27" min. high knee and toe clearance.	1	700	\$700
											700	
Assembly Area												
185	New Building, Gymnasium	1	108	Assembly Area	N/A

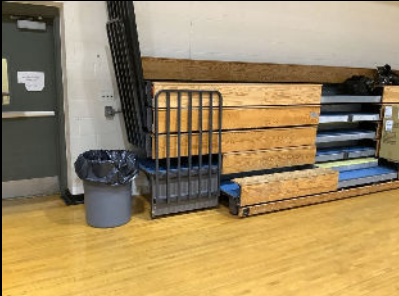
Wheelchair spaces < 36" x 48" (if front entrance)	33"	When bleachers are replaced, provide a 36" by 48" clear floor space at the wheelchair space.	6	-	-

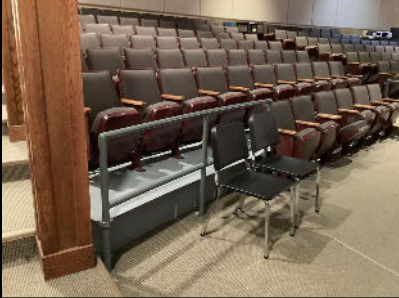
Minimum # wheelchair spaces not provided Companion seat not provided Designated aisle seats < 5%	5 - 3	Provide one additional wheelchair space. Provide one companion seat for each wheelchair space. At least 5% of the total number of aisle seats provided must be identified by a sign or marker and have folding or retractable armrests.	1	-	-
188	New Building, Auditorium		-	Assembly Area	N/A

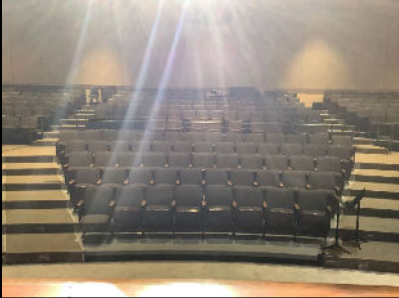
Assistive listening devices not provided	-	If audible communication is integral to the use of the space, provide an assistive listening system. <b>Note:</b> Assistive listening system receiver count was not confirmed. Ensure that assistive listening devices are provided based on the 2010 ADA Standards, Table 219.3.	1	-	-

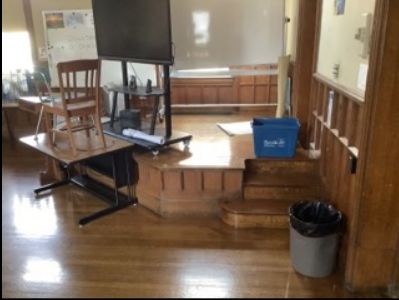
189	Main Building, Classroom 108M	1	108M	Assembly Area	N/A

Accessible route to stage not provided	-	If doing so will not fundamentally alter the historic nature of the classroom, provide an interior lift to the stage.	1	70000  70000	\$70000
190	Main Building, Knipe Auditorium	2	207M	Assembly Area

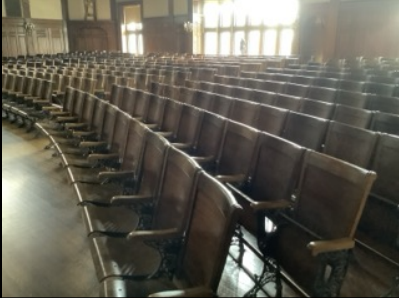
Minimum # wheelchair spaces not provided Companion seat not provided Designated aisle seats < 5%	0 - -	if used by students or members of the public, provide 6 compliant wheelchair spaces. Provide one companion seat for each wheelchair space. At least 4 (5%) of the total number of aisle seats provided must be identified by a sign or marker and have folding or retractable armrests.	1	-	-

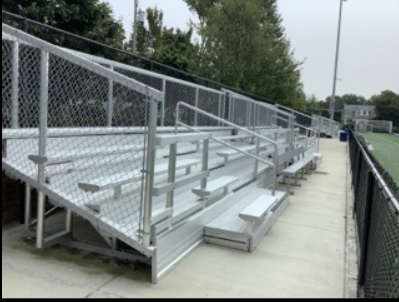
ID	Location	Floor	Room	Element	Type	Photo	Issues	Current Measure	Recommendations	Quantity	Price	Cost Estimation
191	Football Field, East Bleachers	Ext.	-	Assembly Area	N/A

Wheelchair spaces overlap circulation paths Wheelchair Space < 36" x 60" (if side entrance) Assistive listening devices not provided	- 29"x 48" -	Relocate seating area so that wheelchair spaces do not overlap circulation paths. Provide a 36" by 60" clear floor space at the wheelchair space. If audible communication is integral to the use of the space, provide an assistive listening system.	4	-	-
192	Football Field, East Bleachers	Ext.	-	Assembly Area	N/A

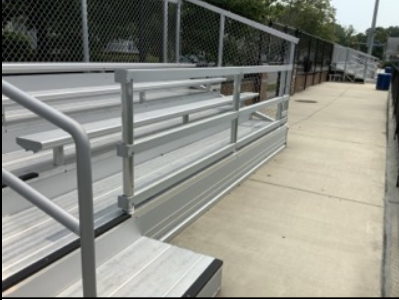
Companion seat not provided		Provide one companion seat for each of the 3 wheelchair spaces in this area of each bleacher section. Ensure assembly area seating complies with Table 221.2.1.1 Number of Wheelchair Spaces in Assembly Areas from the 2010 Standards for Accessible Design.	4	-	-

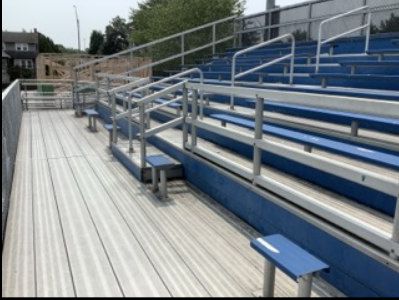
193	Football Field, West Bleachers - South Bleacher Set	Ext.	-	Assembly Area	N/A

Ensure the total number of wheelchair spaces at the home and visiting spectator bleacher sections are in accordance with Table 221.2.1.1 General Seating from the 2010 Standards for Accessible Design. Note: IHCD does not have an accurate number of the total seating count to determine an accurate amount of wheelchair spaces needed at both bleachers.	1	-	-
194	Main Building, Knipe Auditorium	2	207M	Assembly Area	N/A

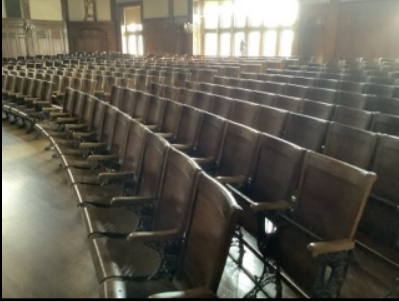
Assistive listening devices not provided	-	If audible communication is integral to the use of the space, provide an assistive listening system. <b>Note:</b> Assistive listening system receiver count was not confirmed. Ensure that assistive listening devices are provided based on the 2010 ADA Standards, Table 219.3.	1	-	-
Locker Room												
195	Men's and Women's Locker Room - All Locker Rooms	B	008	Locker Room	Men's and Women's

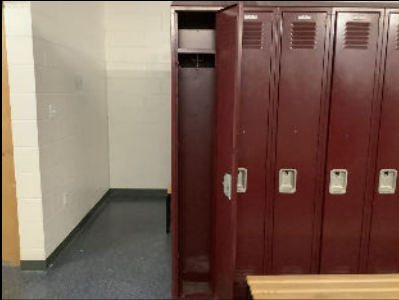
5% of lockers are not accessible Storage > 48" high Hook > 48" high	3 66.75" 63.75"	Ensure at least one or 5% of all lockers are accessible. When additional accessible lockers are provided, ensure all storage and coat hooks within these lockers are located no higher than 48 inches above the floor. Applies to all locker rooms where at least one or 5% of all lockers are not accessible. Unit cost is provided for one instance of this repetitive item.	1	660	\$660

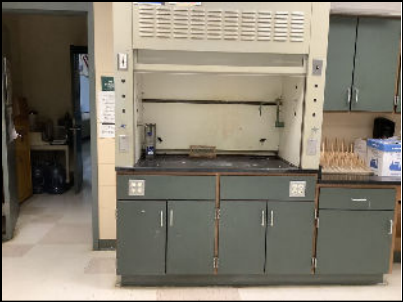
660	
Laboratory												
198	New Building, Science Laboratory Classroom	2	213	Laboratory	Other

At least one (or 5%) acc. fume hood not provided Environmental controls > 48"	- 66"	Provide one accessible fume hood with knee and toe clearance positioned at a forward approach.  When a new fume hood is provided, ensure controls between 15" and 48" above the finished floor.	1	3502	\$3502
											3502	
199	New Building, Science Laboratory Classroom	2	213	Laboratory	Other

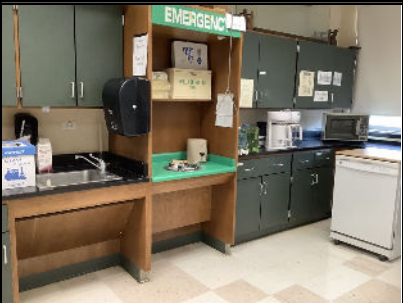
Emergency shower out of reach range Clear floor space is not provided	51.75" -	Provide an accessible emergency shower (lower the shower control to 48" max. above the finished floor).  Ensure a 30" by 48" clear floor space positioned for a parallel/forward approach is provided and that the shower control does not block access to the emergency eye wash.	1	Labor	Labor
200	New Building, Science Laboratory Classroom	2	213	Laboratory	Other

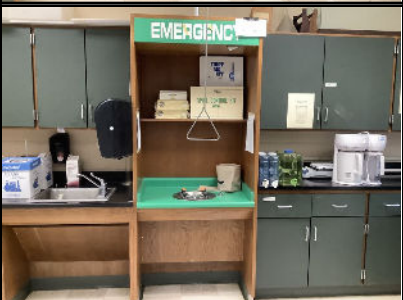
First aid kit out of reach range	75"	Lower the first aid kit so the operable parts are 48" max. above the finished floor.	1	Labor	Labor

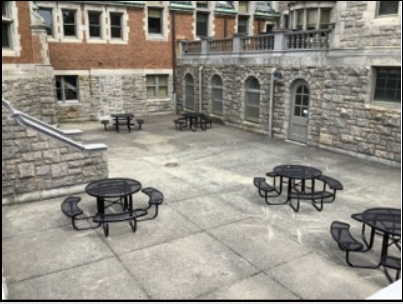
At least 5% accessible spaces not provided	-	Ensure that at least 5% (minimum one) of picnic tables are accessible.	1	1400	\$1400
Toilet & Bathing Rooms												
Overall Access												
203	Main Building, Boys' and Girls' Multi-User Toilet Rooms East	B	-	Overall Access	Toilet Room

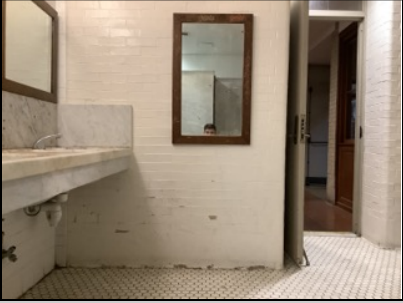
Mirror w/reflective surface > 35"	38.5"	Lower mirror so that the bottom surface is at 40" max. above the finished floor.	2	500	\$1000

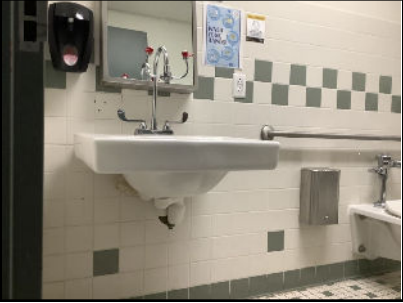
Lavatory												
204	New Building, Gender-Neutral Single-User Toilet Room in Health Suite	1	103	Lavatory	N/A

Plumbing underneath is exposed	-	Insulate pipes to prevent contact for at least one lavatory.	1	150	\$150

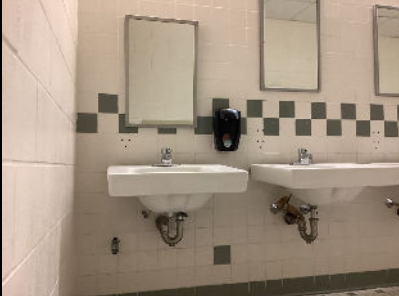
Toe or knee clearances not provided Faucet is not compliant Plumbing underneath is exposed	25" 10 lbs -	Provide at least one lavatory with knee and toe clearance positioned for a forward approach. Maintain the faucet to that it does not require more than 5 pounds of force to open. Insulate or otherwise configure pipes to prevent contact for at least one lavatory.	4	150	\$600
											600	
207	New Building, Women's Multi-User Toilet Room, Across From Room 201	2	-	Lavatory	N/A

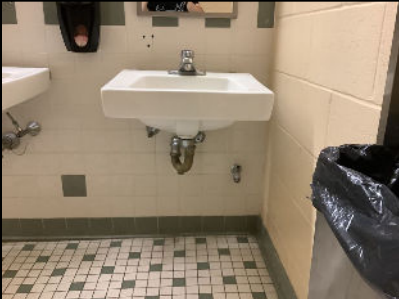
Toe or knee clearances not provided Faucet is not compliant Plumbing underneath is exposed	25"	Provide at least one lavatory with knee and toe clearance positioned for a forward approach. Repair the faucet, as it only operates while the faucet is being pushed. Insulate or otherwise configure pipes to prevent contact for at least one lavatory.	1	1282 Labor 150	\$1432

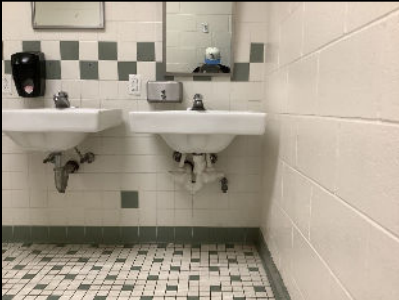
1432	
208	New Building, Multi-User Toilet Rooms in Men's and Women's Locker Rooms	B	008	Lavatory	N/A

Faucet is not compliant		Provide a faucet that can be operable with one hand and not require tight grasping, pinching, or twisting of the wrist for at least one lavatory.	4	1282	\$5128
											5128	
209	Main Building, Boys' and Girls' Multi-User Toilet Rooms East	B	-	Lavatory	N/A

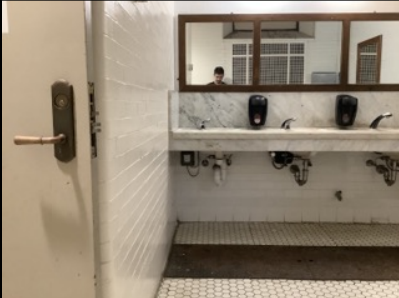
Mirror above lavatory w/reflective surface > 40"	48.25"	Lower mirror so that the bottom surface is at 40" max. above the finished floor at the accessible lavatory.	2	500	\$1000
											1000

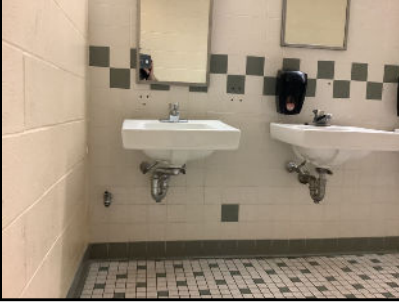
ID	Location	Floor	Room	Element	Type	Photo	Issues	Current Measure	Recommendations	Quantity	Price	Cost Estimation
210	New Building, Men's Multi-User - Toilet Room, Across From Room 201	B	-	Lavatory	N/A

Toe or knee clearances not provided Plumbing underneath is exposed	25" -	Provide at least one lavatory with knee and toe clearance positioned for a forward approach. Insulate or otherwise configure pipes to prevent contact for at least one lavatory.	1	2192 150	\$2342
Single-User Toilet												
211	New Building, Gender-Neutral Single-User Toilet Room in Health Suite	1	103	Single-User Toilet	N/A

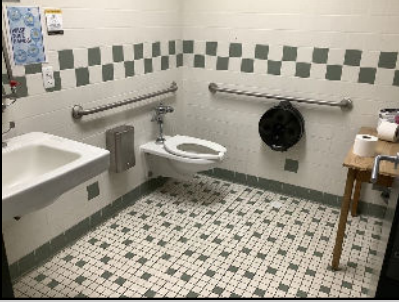
Clearance at toilet < 72" clear depth (MAAB)	59"	Relocate the table to provide 72" min. of clear depth at the toilet.	1	Labor	Labor
Toilet Compartment												
212	New Building, Men's Multi-User Toilet Room Across From Main Office	1	-	Toilet Compartment	Accessible Compartment

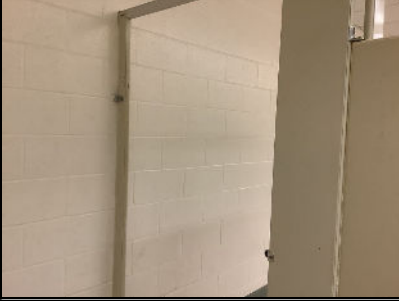
Door not provided	-	Ensure there is a door provided at the accessible compartment with compliant hardware and a self-closing hinge.	1	Labor	Labor

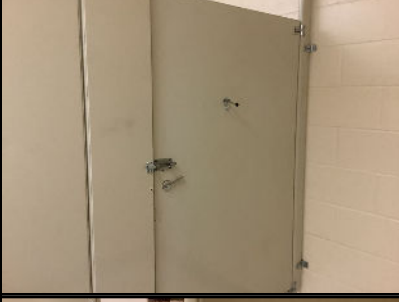
213	New Building, Women's Multi-User - Toilet Room Across From Room 201	2	-	Toilet Compartment	Accessible Compartment

Door has malfunctioning self-closing hinge Coat hook > 48" (2010 ADA) Door pull not provided	- 53" -	Repair hinge. Provide an additional coat hook no higher than 48" above the finished floor. Provide a door pull on each side of the door between 34" to 48" above the finished floor that does not require tight grasping, pinching or twisting of the wrist.	2	Labor 75 140	\$430
214	New Building, Women's Toilet Room Multi-User - Across From Main Office	1	-	Toilet Compartment	Accessible Compartment

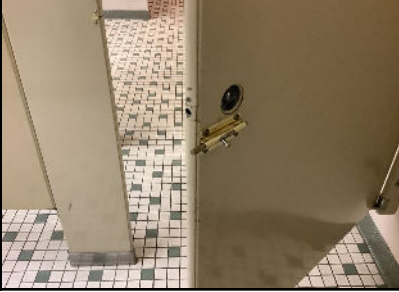
Door has noncompliant hardware Door has malfunctioning self-closing hinge Door pull not provided	- - -	Provide hardware that can be operable with one hand and not require tight grasping, pinching, or twisting of the wrist. Repair hinge. Provide a door pull on each side of the door between 34" to 48" above the finished floor that does not require tight grasping, pinching or twisting of the wrist.	1	70 Labor 140	\$210

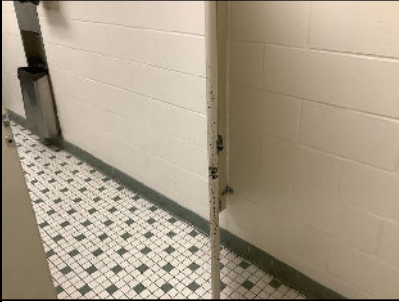
Door has noncompliant hardware Door has malfunctioning self-closing hinge Door pull not provided	- - -	Provide a compliant door lock that can be operable with one hand and not require tight grasping, pinching, or twisting of the wrist. Repair hinge. Provide a door pull on each side of the door between 34" to 48" above the finished floor that does not require tight grasping, pinching or twisting of the wrist. Applies to all toilet compartment doors in this condition.	1	70 Labor 140	\$210

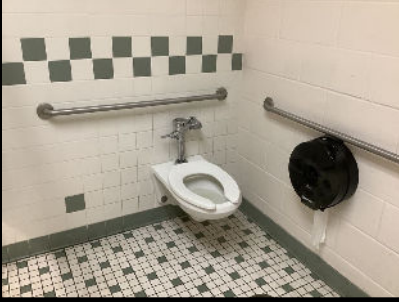
217	New Building, Multi-User Toilet Room in Men's Locker Room	B	009	Toilet Compartment	Accessible Compartment

Centerline < or > 18" (MAAB)	19.5"	Relocate toilet so the centerline is 18" from the side wall.	1	3676	\$3676	
218	New Building, Multi-User Toilet Room in Men's Locker Room	B	009	Toilet Compartment	Accessible Compartment

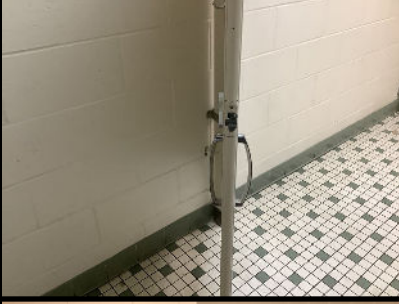
Door has noncompliant hardware		Provide a compliant door lock that can be operable with one hand and not require tight grasping, pinching, or twisting of the wrist.	1	Labor	Labor	
219	New Building, Men's and Women's Multi-User Toilet Room Across From Gymnasium	1	-	Toilet Compartment	Accessible Compartment

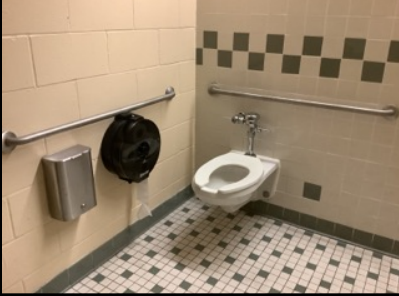
Dispenser/item located < 1 1/2" below the grab bar	1"	Relocate the toilet paper dispenser so that it is mounted 1 1/2" min. below the grab bar. Applies to toilet paper dispensers in the New Building, men's and women's multi-user toilet rooms across from main office, and the men's and women's multi-user toilet rooms across from Room 201.	6	500	\$3000

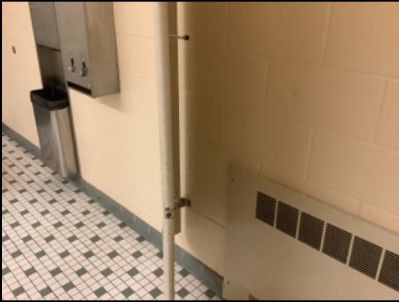
ID	Location	Floor	Room	Element	Type	Photo	Issues	Current Measure	Recommendations	Quantity	Price	Cost Estimation
220	New Building, Women's Multi-User Toilet Room Across From Gymnasium	1	-	Toilet Compartment	Accessible Compartment

Door has malfunctioning self-closing hinge Door pull not provided	- -	Repair hinge. Provide a door pull on each side of the door between 34" to 48" above the finished floor that does not require tight grasping, pinching or twisting of the wrist.	1	Labor 140	\$140
											140	
221	Main Building, Girls' Multi-User Toilet Room East	B	-	Toilet Compartment	Accessible Compartment

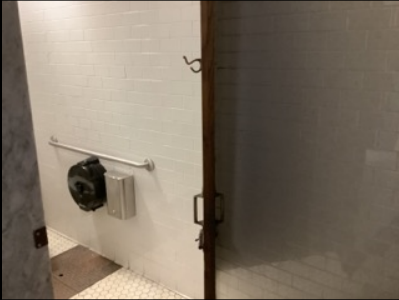
Door has noncompliant hardware Coat hook > 48" (2010 ADA)	- 58"	Provide a compliant slide lock that can be operable with one hand and not require tight grasping, pinching, or twisting of the wrist. Locate the coat hook no higher than 48" above the finished floor.	1	70	\$70
											70

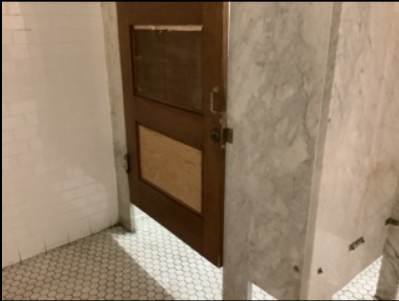
222	Main Building, Boys' Multi-User Toilet Room East	B	-	Toilet Compartment	Accessible Compartment

Door does not close fully		Repair the door, as it does not close fully.	1	Labor	Labor
223	Main Building, Boys' Multi-User Toilet Room East	B	-	Toilet Compartment	Accessible Compartment

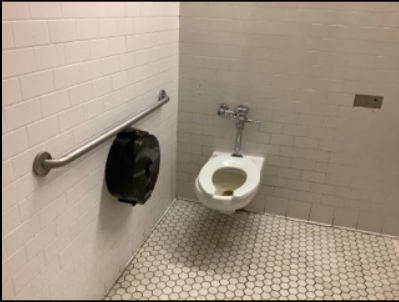
Grab bars not provided Dispenser/item located < 1½" below the grab bar	1.25"	Provide one compliant grab bar on the rear wall. Relocate the toilet paper dispenser so that it is mounted 1 1/2" min. below the grab bar.	1	750 500	\$1250
											1250	
Dispersers												
224	New Building, Men's Multi-User Toilet Room Across From Main Office	1	-	Dispersers	Paper Towel Dispenser

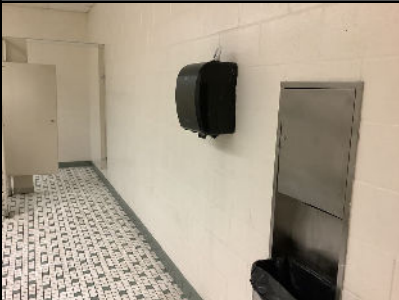
Dispenser acts as a protruding object	8.75"	Relocate dispenser out of the circulation path or provide a cane detectable barrier under the paper towel dispenser. When the dispenser is relocated, ensure it is located with the controls 48" max. high above the finished floor.  Applies to all dispensers in this condition. Unit cost is provided for one instance of this repetitive item.	1	500	\$500

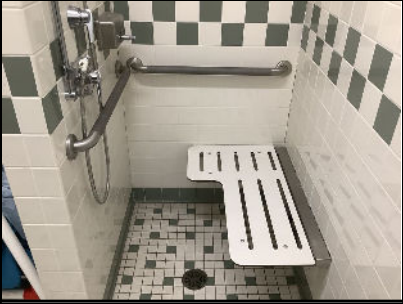
Seat is not padded (MAAB)	-	Provide a padded shower seat.	1	600 751	\$1351
227	New Building, Shower Room in Men's and Women's Locker Rooms	B	008	Shower Compartment	Transfer Type

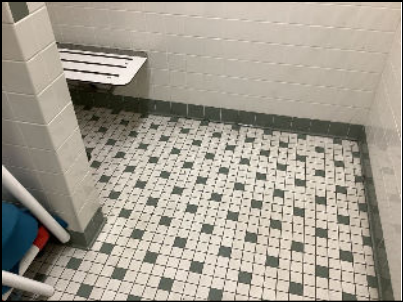
Clear space at transfer shower < 48" x 36" Noncompliant seat	42.5" -	Provide a 48" x 36" clear floor space for a transfer shower.	2	7894	\$15788

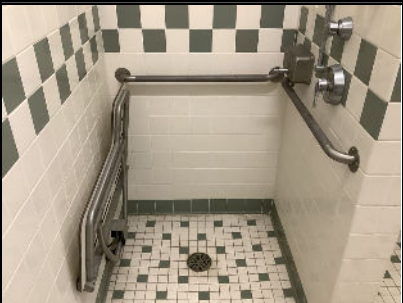
228	New Building, Shower Room in Men's Locker Room	B	009	Shower Compartment	Transfer Type

Noncompliant seat Seat is not padded (MAAB)	- -	Roll-in showers: If provided ensure that a folding type seat is provided adjacent to the controls. Transfer showers: Ensure the seat extends from the back wall to a point within 3" of the compartment entry. Provide a padded shower seat.	1	Labor 600 751	\$1351
Additional Access												
Drinking Fountains												
229	New Building, Fountain Near Room 104 and Room 206	1	-	Drinking Fountains	Low

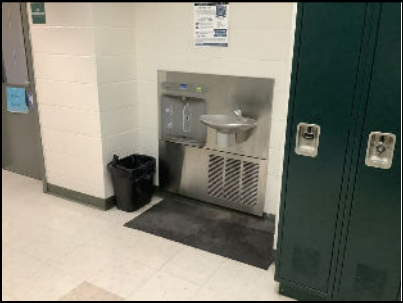
No drinking fountain provided for standing users Knee or toe clearance not provided	- 25.75"	Provide an additional drinking fountain for standing users. Relocate the drinking fountain for seated users to provide knee and toe clearance, 27" min. high above the finished floor.	2	4028 2028	\$12112

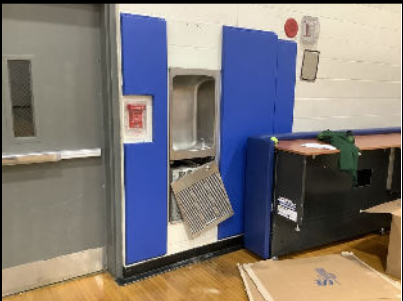
ID	Location	Floor	Room	Element	Type	Photo	Issues	Current Measure	Recommendations	Quantity	Price	Cost Estimation
230	New Building, Gymnasium	1	108	Drinking Fountains	High

Inadequate water flow No drinking fountain provided for seated users	-	Repair drinking fountain to provide adequate water flow. Provide an additional drinking fountain for seated users or install a Hi-Lo drinking fountain.	1	Labor 4028	\$4028
											4028	
231	New Building, Under Stairwell/Next to Ramp by North Entrance	B	-	Drinking Fountains	Hi-Lo

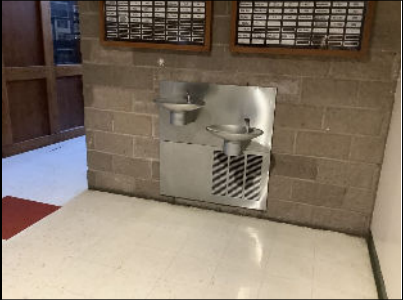
Standing height fountain does not have cane protection	-	Provide a cane-detectable barrier skirt under the high unit.	1	890	\$890
											890	
232	New Building, Men's and Women's Locker Rooms	B	008	Drinking Fountains	Low

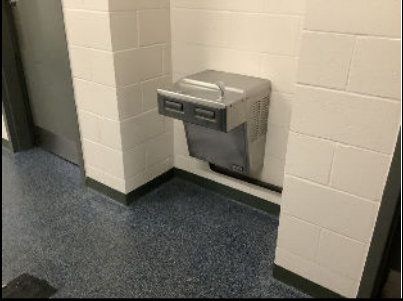
Inadequate water flow No drinking fountain provided for standing users	-	Repair drinking fountain to provide adequate water flow. Provide an additional drinking fountain for standing users.	2	Labor 4028	\$8056

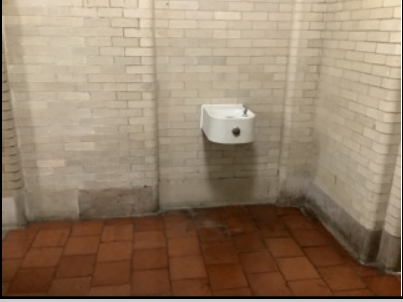
8056	
233	Main Building, Drinking Fountain in Basement Corridor	B	-	Drinking Fountains	Low

No drinking fountain provided for standing users		Provide an additional drinking fountain for standing users.	1	4028	\$4028
											4028	
Sink												
234	New Building, Art Classroom	B	015	Sink	N/A

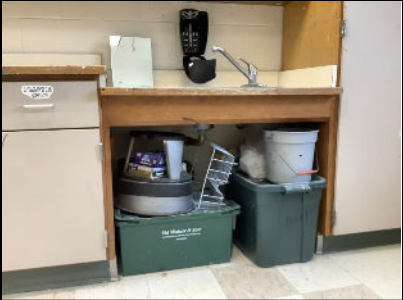
Clear floor space not provided at sink Toe and knee clearances not provided Exposed plumbing underneath sink	- - -	Relocate stored items to provide a 30" by 48" clear floor space positioned for a forward approach. Relocate stored items to ensure there is a 27" min. knee clearance positioned for a forward approach. Insulate or otherwise configure pipes at sink.	1	150	\$150
											150

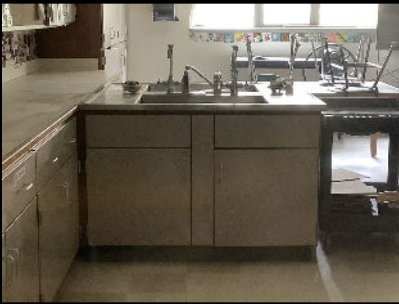
ID	Location	Floor	Room	Element	Type	Photo	Issues	Current Measure	Recommendations	Quantity	Price	Cost Estimation
235	New Building, Art Classroom	B	014	Sink	N/A

Toe and knee clearances not provided Noncompliant faucet	- -	If this sink is used by students or members of the public, ensure there is a 27" min. knee clearance positioned for a forward approach. Install faucets that do not require tight grasping, pinching, or twisting of the wrist.	1	1500 1282	\$2782
236	Main Building, Senior Cafeteria	B	009M	Sink	N/A

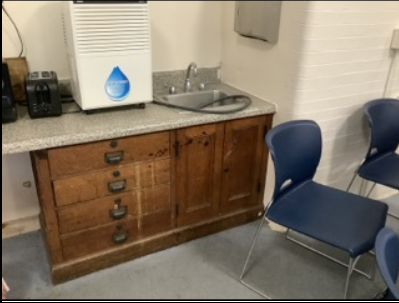
Toe and knee clearances not provided		If students or members of the public use this sink, ensure a sink in this area is available with 27" min. knee clearance positioned for a forward approach.	1	1500	\$1500
237	Main Building, TV Studio - Computer Lab	B	004M	Sink	N/A

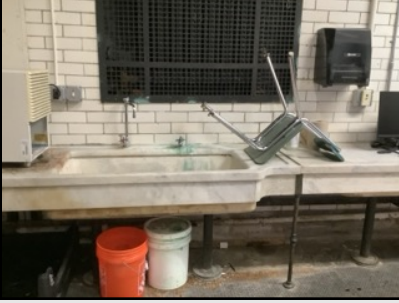
Toe and knee clearances not provided Dispenser not within reach range	22" 50"	If this sink is used by students or members of the public, ensure there is a 27" min. high knee clearance positioned for a forward approach. Ensure the height of the counter does not exceed 34". Relocate dispenser 48" max. above the finished floor or ground.	1	3094 500	\$3594

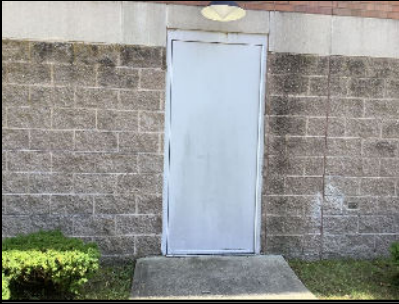
Recommend providing a directional sign indicating the location of the nearest accessible entrance.  Applies to all direct egress doors located on an accessible route.	1	-	-
239	Main Building, South Egress Door Next to Ramp	Ext.	-	Directional Sign

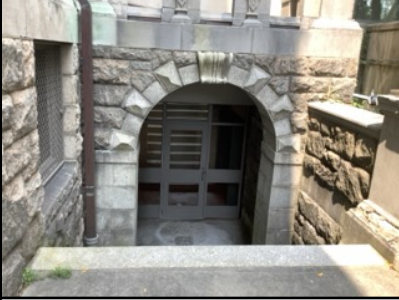
-	Recommend providing a directional sign indicating the location of the nearest accessible entrance.  Applies to all stairs that lead from inaccessible egress doors.	1	-	-

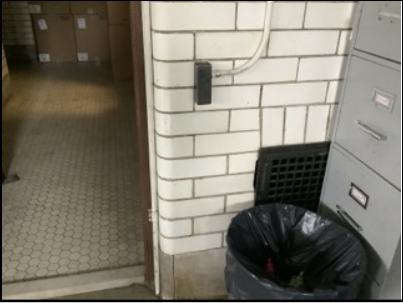
ID	Location	Floor	Room	Element	Type	Photo	Issues	Current Measure	Recommendations	Quantity	Price	Cost Estimation
Doors												
240	Main Building, Classroom 006M to Picnic Tables (North Side)	B	006M	Doors	N/A

Recommend providing a sign with the International Symbol of Accessibility (ISA) above the automatic door opener.	1	-	-
Exterior Routes												
241	Next to Staff Parking on East Side of Parking/Next to Football Field	Ext.	-	Exterior Routes

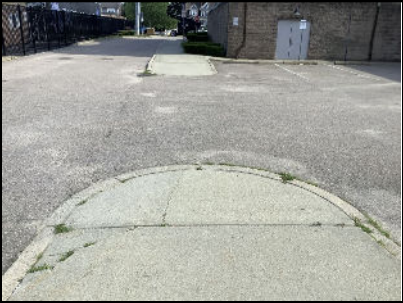
Recommend providing a ladder-style crosswalk between both ends of the walkway. Recommend providing a tactile warning platform at both ends of the walkway.	1	-	-
242	Visitor Parking on Southeast Corner of Building/Next to Football Field	Ext.	-	Exterior Routes

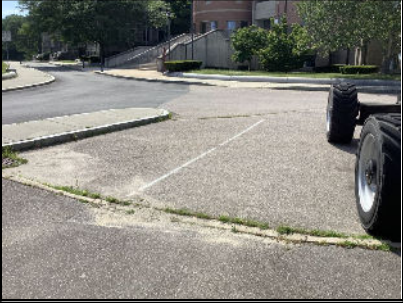
When striping at the access aisle is provided, recommend continuing the striping to the curb ramp.	1	-	-
243	Curb Ramp on South Bus Drop Off/ Adjacent to Building	Ext.	-	Exterior Routes

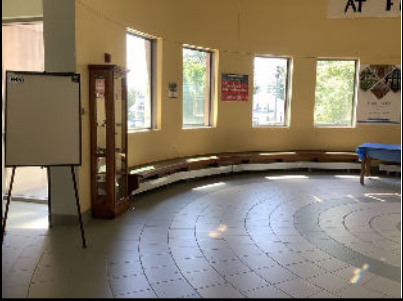
Furniture												
244	New Building, South Main Entrance	1	-	Furniture

Recommend relocating the cabinet next to the bench to provide 30" x 48" of clear floor space next to one end of the bench.	1	Labor	Labor

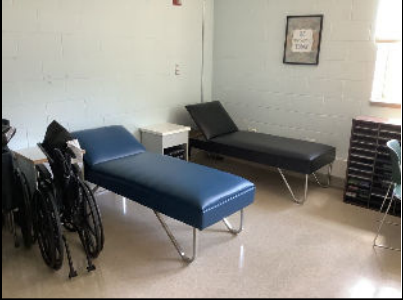
ID	Location	Floor	Room	Element	Type	Photo	Issues	Current Measure	Recommendations	Quantity	Price	Cost Estimation
245	New Building, Exam Room in Health Suite	1	103	Furniture

Recommend providing a height adjustable exam table.	1	-	-
246	New Building, Band Room	B	012	Furniture

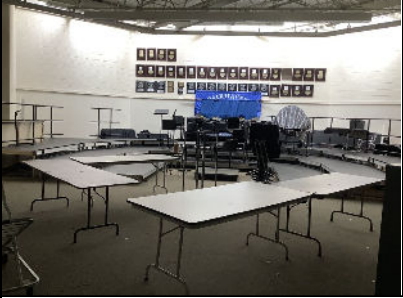
Recommend providing 30" x 48" clear floor space within one of the lower stage risers.	1	-	-
247	New Building, Training Room	B	-	Furniture

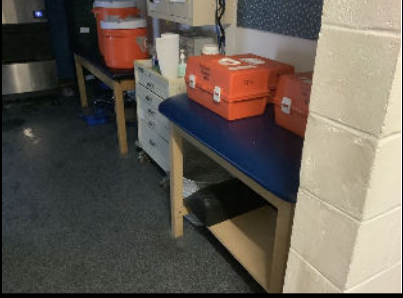
Recommend providing a height adjustable exam table.	1	-	-
248	Main Building, Library	B	031M	Furniture

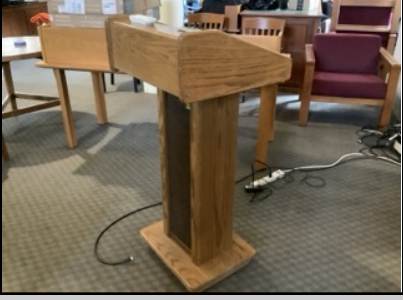
Recommend providing an adjustable height podium with knee and toe clearance.	1	-	-
Parking												
249	New Building, Larch Avenue/ Adjacent to Accessible Parking	Ext.	-	Parking

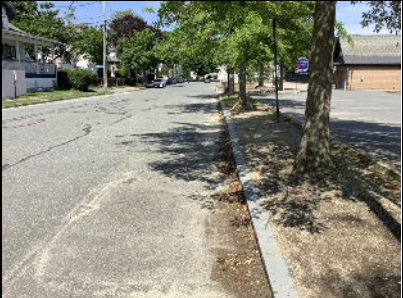
Recommend providing additional parallel parking spaces along Larch Avenue, on the side of the road adjacent to the school. IHCD was informed of this recommendation by a school resource officer.	1	-	-

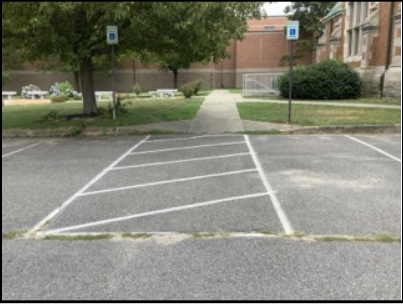
ID	Location	Floor	Room	Element	Type	Photo	Issues	Current Measure	Recommendations	Quantity	Price	Cost Estimation
250	Accessible Parking by Northwest Corner of Library	Ext.	-	Parking

Recommend realigning the access aisle and accessible parking spaces so that the center of the access aisle is aligned with the center of the curb ramp.	1	-	-
Safety												
251	Main Building, West Egress/ Between Office 015M and TV Studio 004M	Ext.	-	Safety

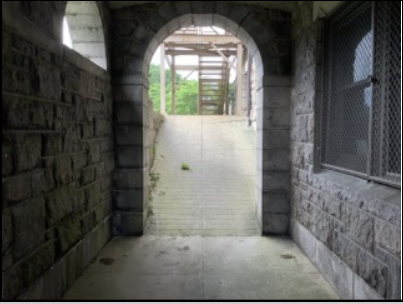
Recommend providing a safety barrier at the top of the ramp to prevent falls or injuries.	1	-	-
Sign												
252	Main Building, Classroom 105M	1	105M	Sign	N/A

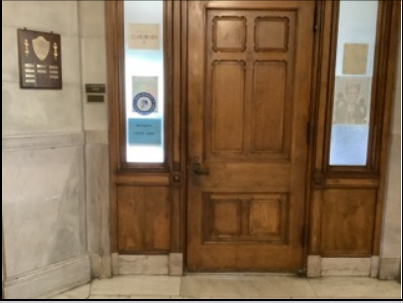
Recommend locating the sign on the glass panel so it is closer to the latch side of the door.	1	Labor	Labor
Signage												
253	New Building, South Main Entrance	1	-	Signage

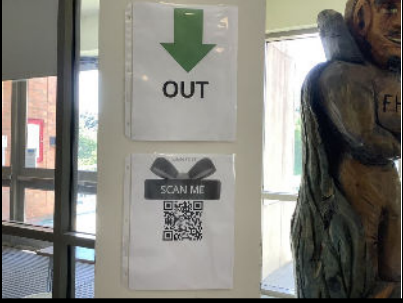
On the "Scan Me" sign, recommend enlarging the text that reads "Sign Out."  Applies to all signage in this condition.	1	Labor	Labor

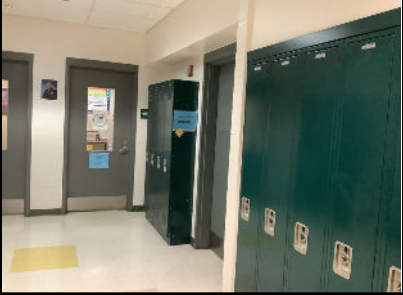
254	New Building, Health Suite	1	103	Signage

Recommend providing a blade sign to the Health Suite entrance. Ensure the blade sign is located 80" min. high above the finished floor.	1	-	-

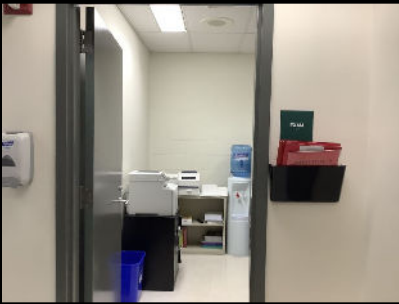
ID	Location	Floor	Room	Element	Type	Photo	Issues	Current Measure	Recommendations	Quantity	Price	Cost Estimation	
255	New Building, Principal/ Secretary Suite - Exam	1	-	Signage

Recommend providing an informational sign indicating that this is a staff only room.  Recommend relocating the storage container underneath the designation sign to provide 18" x 18" clear floor space at the designation sign.	1	-	-	
256	New Building, North Entrance, South/Main Entrance	Ext.	-	Signage

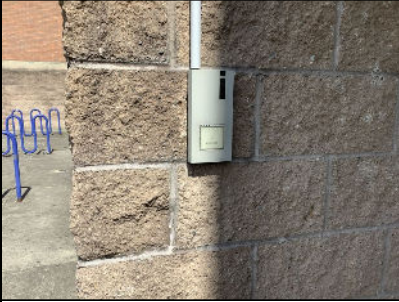
Recommend enlarging the text that reads "Push Here," and providing more light-to-dark or dark-to-light contrast between the text and the background.	2	Labor	Labor	
257	New Building, Cafeteria - Grades 9-11	B	-	Signage

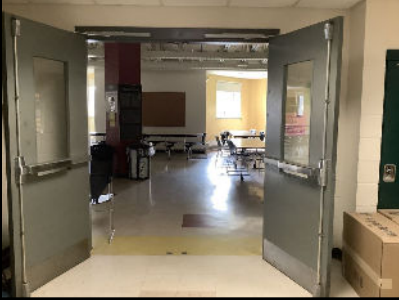
Recommend locating an additional compliant designation sign with raised characters and braille to the right of the right-hand door, outside of the full door swing when the door is left open.  Applies to all signage in this condition.	1	-	-

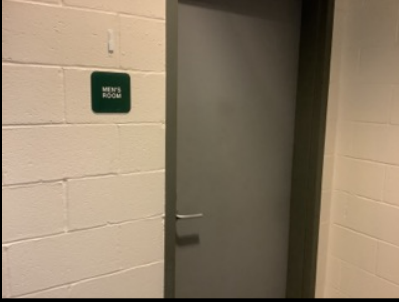
258	New Building, Men's Multi-User Across From Gymnasium	1	-	Signage

Since all toilet rooms in the school are accessible, signs with the International Symbol of Accessibility at toilet rooms are not required. However, IHCD recommends providing signs with the International Symbol of Accessibility (ISA) at all toilet rooms, since doing so helps inform new visitors to the school.	1	-	-	
259	Main Building, Lift to Knipe Auditorium (by Room 209M)	2	-	Signage

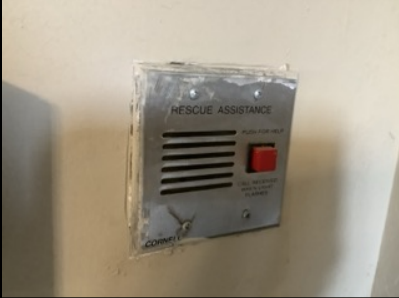
Recommend providing blade signage to indicate the presence of all rescue assistance buttons. Ensure the bottom edge of the sign is located 80" min. high above the finished floor.	1	-	-

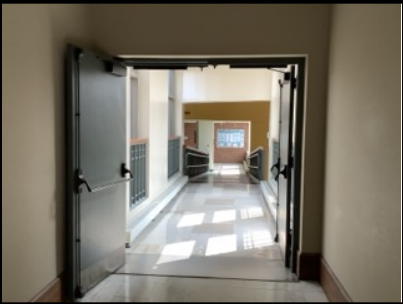
ID	Location	Floor	Room	Element	Type	Photo	Issues	Current Measure	Recommendations	Quantity	Price	Cost Estimation
260	Entrance to New Building From Main Building	2	-	Signage

Recommend providing directional signage to the New Building at all entrances from the Main Building.  Recommendation also applies at all entrances to the Main Building from the New Building.	1	-	-
Stairs												
261	New Building, North Stair Next to Auditorium	B	-	Stairs

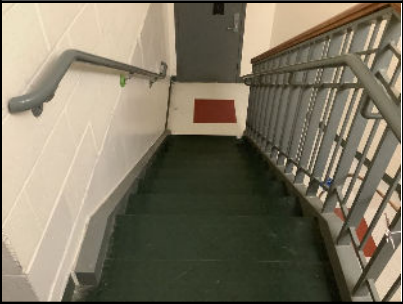
Recommend providing a solid and continuous stripe applied to the horizontal leading edge of each exterior stair tread so that each tread is readily apparent when viewed in descent at this exterior stair. Recommendation applies to all interior and exterior stairs that lack visual contrast on the stair nosings.	1	-	-
262	New Building, Staircase on South Side of Auditorium	B	011	Stairs

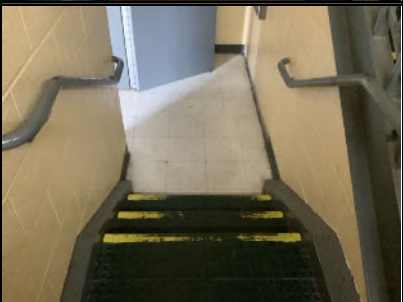
263	New Building, Stairwell on Northeast Corner of Building	B	-	Stairs

Recommend repairing the color contrasting stripes.  Applies to all stairs in this condition.	1	-	-
Walking Surface												
264	Main Building, South Staircases From Basement Egress Door by Teacher's Lounge	Ext.	-	Walking Surface	N/A

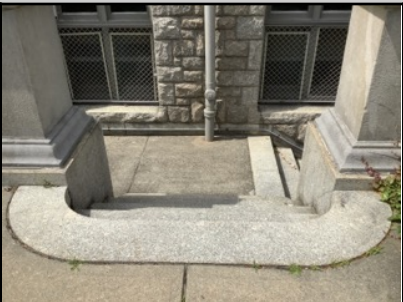
Recommend, as IHCD team thought certain granite and other surfaces were slippery and that the surfaces might be more slippery if wet, investigating the possibility of applying a commercial ant-slip coating designed for stone, concrete or asphalt surfaces.	1	-	-
