# LeRoy Wood Elementary School

## Town of Fairhaven ADA Transition Plan

October 2024

Institute for Human Centered Design

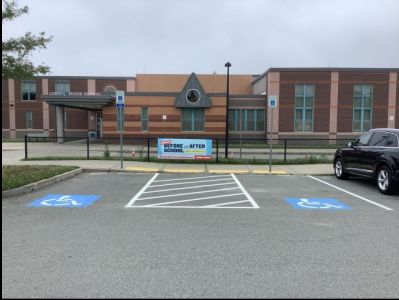
Sign top > 96" above finished grade	120"	Locate signs with the tops of the sign 96" above the ground.	2	Labor	Labor
14	Accessible Parking by Main Drop Off Entrance (North/West Spaces)	Ext.	-	Off-Street Parking Lot or Garage	Visitor

Sign top > 96" above finished grade		Locate sign with the top of the sign 96" above the ground.	2	Labor	Labor

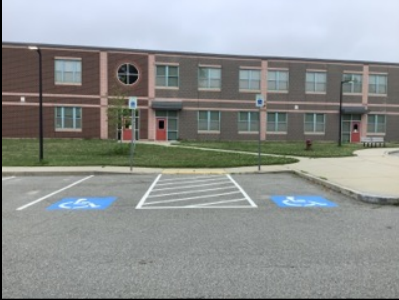
15	Accessible Parking by Bus Drop Off Entrance	Ext.	-	Off-Street Parking Lot or Garage	Visitor

Sign top > 96" above finished grade		Locate signs with the tops of the sign 96" above the ground.	2	Labor	Labor
Access to Goods and Services

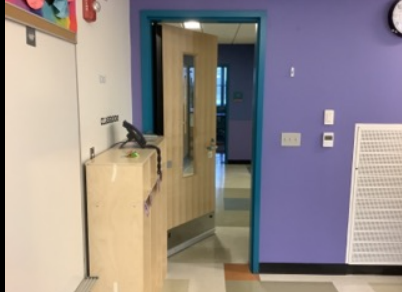
Surface not stable, firm, and slip-resistant		Secure the mat.	1	Labor	Labor
Doors, Doorways, & Gates												
20	Pre-K Classroom	1	131	Doors, Doorways, & Gates	Classroom

Clear width at door < 32"	29"	Move cubbies to provide 32" of clear width at the door.	1	Labor	Labor

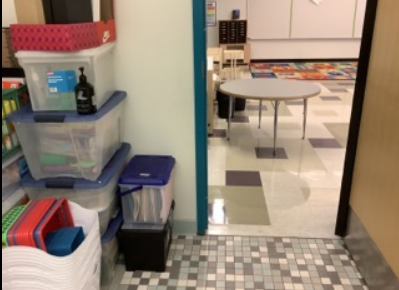
25	Single-User Toilet Room in Kindergarten Classroom	1	130	Doors, Doorways, & Gates	Classroom

Maneuvering clearance(s) not provided	-	Relocate the storage bins to provide 18" of pull side maneuvering clearance.	1	Labor	Labor

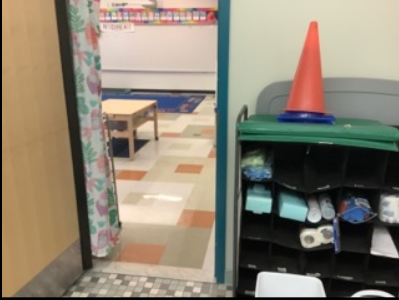
Maneuvering clearance(s) not provided	4"	Relocate the object underneath the designation sign to provide 12" of push side maneuvering clearance as well as 18" by 18" clear at the sign.	1	Labor	Labor
27	Single-User Toilet Room in Pre-K Classroom	1	131	Doors, Doorways, & Gates	Toilet Room

Maneuvering clearance(s) not provided	-	Relocate the storage cubbies out of the toilet room to provide 18" of pull side maneuvering clearance.	1	Labor	Labor
28	Bottom of Ramp Leading From Music/ Platform to Gymnasium	1	-	Doors, Doorways, & Gates	Classroom

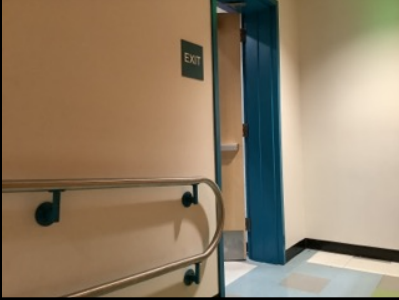
Maneuvering clearance not provided at recess > 6"	11"	Install an automatic door opener or rebuild the doors so that the doors are not recessed greater than 6" deep on the push or the pull side.  (Cost estimate is for an automatic door opener.)	1	6000	\$6000

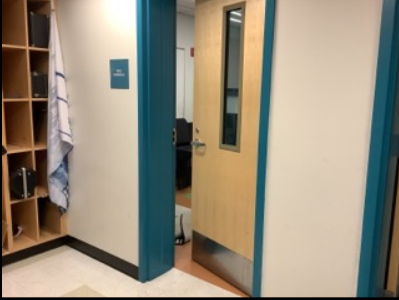
Maneuvering clearance not provided at recess > 6"	11.5"	Install an automatic door opener or rebuild the doors so that the doors are not recessed greater than 6" deep on the push or the pull side.  (Cost estimate is for an automatic door opener.)	1	6000	\$6000
											6000	
30	Ensemble Room, Practice Room 105 C	1	105 C	Doors, Doorways, & Gates	Classroom

Maneuvering clearance not provided at recess > 6"	11.5	Install an automatic door opener or rebuild the doors so that the doors are not recessed greater than 6" deep on the push or the pull side.  (Cost estimate is for an automatic door opener.)	2	6000	\$12000
											12000

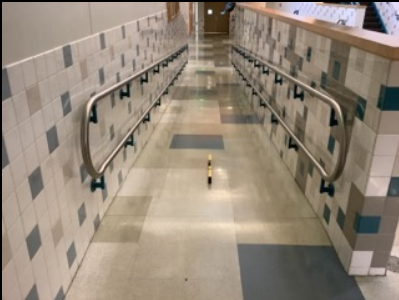
Ramps												
34	Ramp Leading From Main Entrance/ Gymnasium to Classrooms	1	-	Ramps	Interior

Running slope >1:12 (8.33%) Handrails do not extend 12" past top & bottom	9% 8"	Further study will be needed to determine whether it is technically feasible to bring the ramp into full compliance with the ADA Standards. Alter handrails to extend horizontally above the landing for 12" min. beyond the top and bottom of ramp runs.	1	-	-
Stairways												
35	Stage/ Gymnasium	1	-	Stairways	Interior

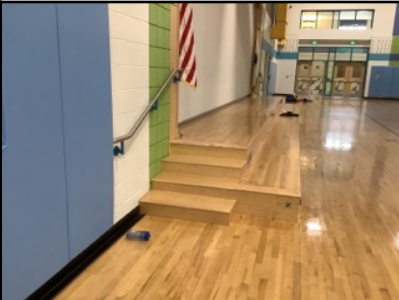
Handrail not provided on both sides		Provide a handrail on the right side.	1	-	-

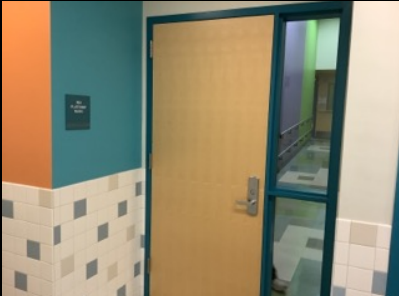
Braille not provided on sign	-	Relocate small sign on the tactile exit sign that obstructs the braille.	1	Labor	Labor
40	Ramp Leading From Cafeteria to Music/ Platform	1		Signage	Designation

Location of tactile sign not compliant		Locate sign alongside the door on the latch side.	1	Labor	Labor

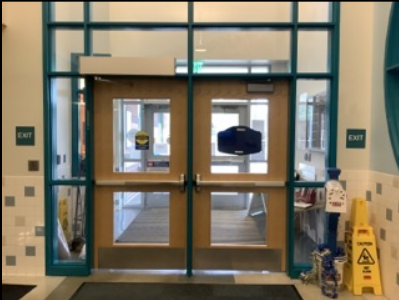
Location of tactile sign not compliant		Locate the designation sign to the gymnasium the right of the right-hand door. The sign that is located on the right currently is an occupancy sign.	1	Labor	Labor
42	Main Entrance	1		Signage	Egress

Signage lacks 18" by 18" clear floor space	-	Relocate stored items on the right side to provide a clear floor space of 18" min. by 18" min. at the egress sign on the right side of the door.	1	Labor	Labor
43	Speech Classroom	1	117	Signage	Designation

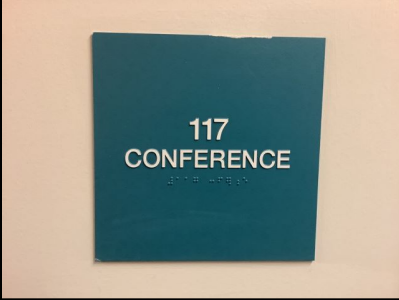
Designation sign is incorrect		Provide a sign with the correct room designation. This is the speech classroom, not a conference room.	1	250	\$250
											250	
44	School Psychologist Classroom	2	228	Signage	Designation

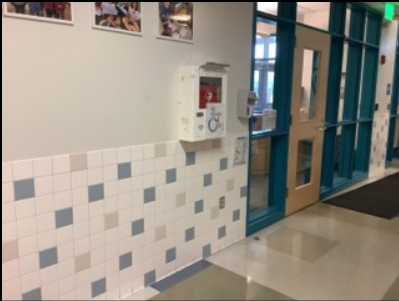
250	
Operable Parts / Reach Range												
45	Next to Main Office/Across From Nurse's Office	1		Operable Parts / Reach Range	Defibrillator

Reach < 15" or > 48"(forward/side approach)	52"	Relocate the defibrillator so that controls are between 15"- 48" above the finished floor.	1	500	\$500
											500

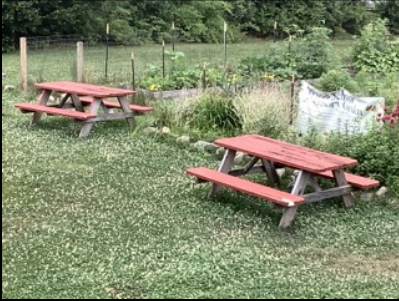
1400	
49	Next to Outdoor Garden	Ext.	-	Picnic Tables	N/A

At least 5% accessible spaces not provided Picnic table not on an accessible route		Ensure that at least 5% (minimum one) of picnic tables are accessible with knee and toe clearance. Ensure that the accessible picnic table is connected to an accessible route. (Cost estimate is for an accessible picnic table.)	1	1400 -	\$1400
											1400	
Toilet & Bathing Rooms

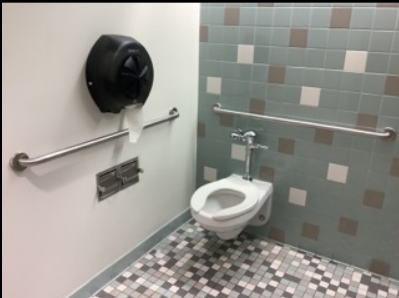
Remove the door closer that is placed in the hinge.	1	Labor	Labor
54	Men's Multi-User Toilet Room Next to Gymnasium	1		Toilet Compartment	Accessible Compartment

Noncompliant toilet paper dispenser	-	Relocate toilet paper so that it is 24" min high, located under the grab bar, and between 7" and 9" from the front of the toilet.	1	500	\$500
											500
