# Fairhaven Town Hall

## Town of Fairhaven ADA Transition Plan

February 2025

Institute for Human Centered Design

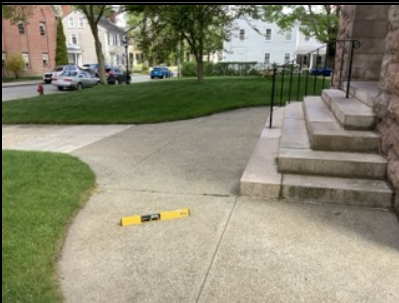
Cross slope > 1:50 (2.00%)	3%	Reduce cross slope to be no steeper than 1:50 (2.00%).	1	-	-
3	West Side	Ext.		Exterior Access Route	Walkway

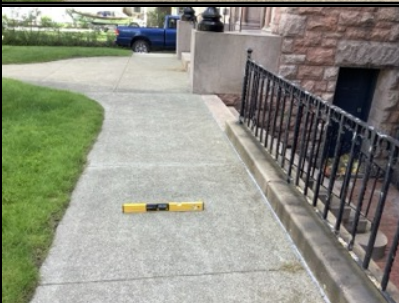
Cross slope > 1:50 (2.00%)	3%	Reduce cross slope to be no steeper than 1:50 (2.00%).	1	-	-
4	Main Entrance (South Side)	Ext.		Exterior Access Route	Walkway

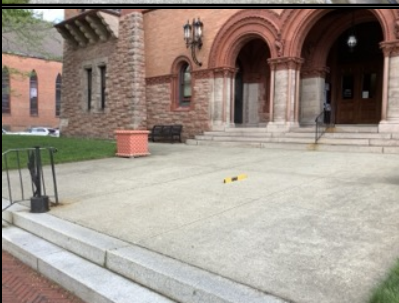
Running slope > 1:20 (5.00%)	6.8%	Reduce running slope to be no steeper than 1:20 (5.00%).	1	-	-
5	Exterior Ramp Northeast Side	Ext.		Exterior Access Route	Ramp

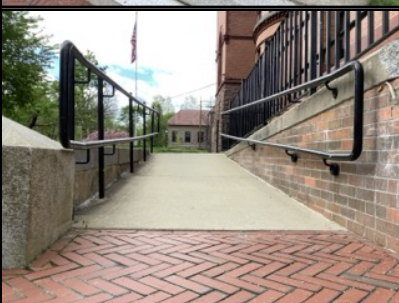
Level changes > 1/4"	0.5"	Alter change in level to be 1/4" high max. or 1/2" max. beveled.	1	-	-

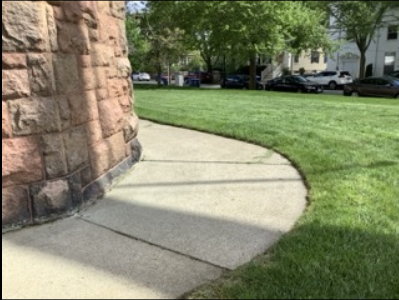
Level changes > 1/4"	0.5"	Alter change in level to be 1/4" high max. or 1/2" max. beveled.	1	-	-
8	Southwest Side - From Office	Ext.		Exterior Access Route	Walkway

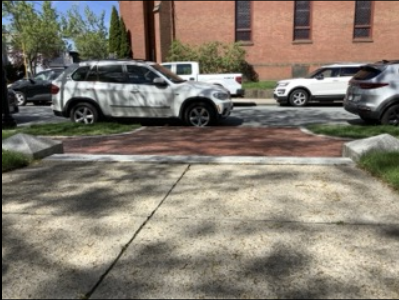
Level changes > 1/4"	0.5"	Alter change in level to be 1/4" high max. or 1/2" max. beveled.	1	-	-
9	East Side - Walnut Street	Ext.		Exterior Access Route	Sidewalk

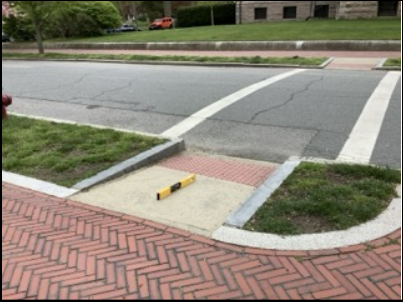
Running slope is > 1:12 (8.33%) Transition from curb ramp to street not flush	11.4% -	Reduce running slope to be no steeper than 1:12 (8.33%). Ensure transition from curb ramp to street is flush or free of changes in level.	1	-	-
13	Walnut Street at Northeast Corner of Building	Ext.		Curb Ramp	Perpendicular

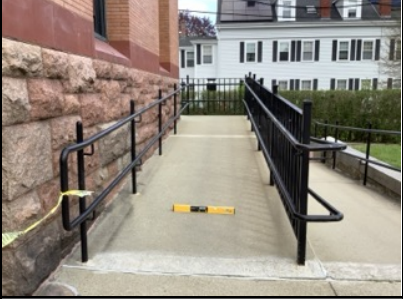
15	Exterior Ramp Northeast Side	Ext.		Exterior Ramp	N/A

Cross slope of ramp > 1:50 (2.00%)	2.6%	Reduce cross slope to be no steeper than 1:50 (2.00%).	1	-	-

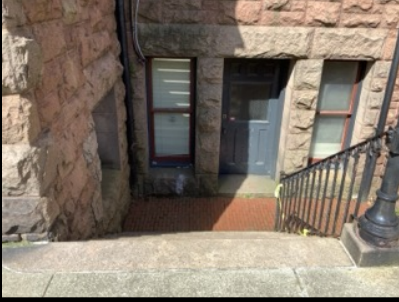
23	Southeast Egress From Lower Level Office	Ext.		Exterior Stair	N/A

Handrails do not extend 12" from stair at top Bottom handrail extends < 12" + one tread Handrail not provided on both sides Risers > 7" high	- - 8.25"	Top: Ensure handrails extend horizontally above the landing for 12" min. beginning above the first riser nosing. Bottom: Ensure that the sloped bottom extension extends one tread depth min. beyond last riser nosing in same direction as stair flight. Provide a handrail on each side. Further study will be needed to determine whether it is technically feasible to bring the stair risers into full compliance with ADA Standards.	1	-	-
24	Southwest Side - Office Egress	Ext.		Exterior Stair	N/A

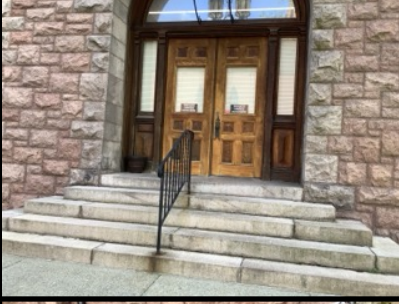
Handrails do not extend 12" from stair at top Bottom handrail extends < 12" + one tread Handrail not provided on both sides	- - -	Top: Ensure handrails extend horizontally above the landing for 12" min. beginning above the first riser nosing. Bottom: Ensure that the sloped bottom extension extends one tread depth min. beyond last riser nosing in same direction as stair flight. Provide a handrail on each side.	1	-	-

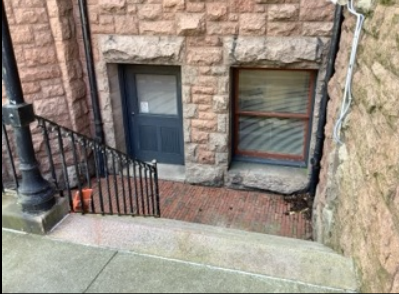
25	Southwest Side - Lower Level Office	Ext.		Exterior Stair	N/A

Handrails do not extend 12" from stair at top Bottom handrail extends < 12" + one tread Handrail not provided on both sides	- - -	Top: Ensure handrails extend horizontally above the landing for 12" min. beginning above the first riser nosing. Bottom: Ensure that the sloped bottom extension extends one tread depth min. beyond last riser nosing in same direction as stair flight. Provide a handrail on each side.	2	-	-

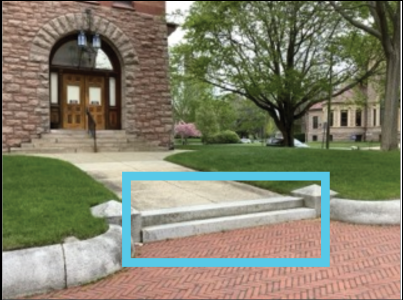
Directional sign to accessible entrance not provided	<ul style="list-style-type: none"><li>-</li></ul>	At the base of the stairway, provide a directional sign indicating the location of the nearest accessible entrance. Ensure sign is located in a manner to prevent backtracking.	1	450	\$450

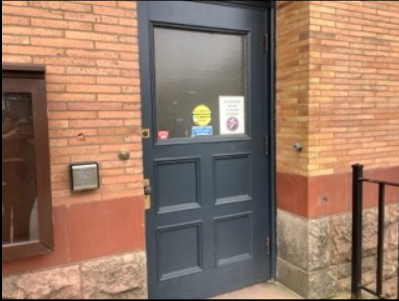
International Symbol of Accessibility not provided	-	Provide a sign with the International Symbol of Accessibility (ISA).	1	450	\$450
											450	
Access to Goods and Services												
Means of Egress												
33	Southeast Egress - From Lower Level	LL		Means of Egress	N/A

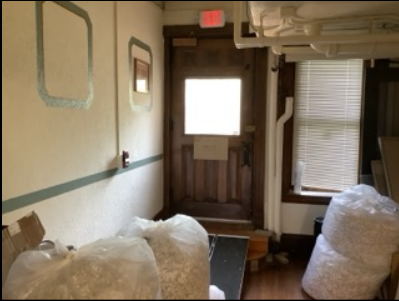
Tactile exit sign not provided	-	Ensure that a tactile exit sign with raised characters and braille is provided at the exit door. Mount the sign between 48"- 60" above the finished floor located on the latch side of the door.	1	250	\$250

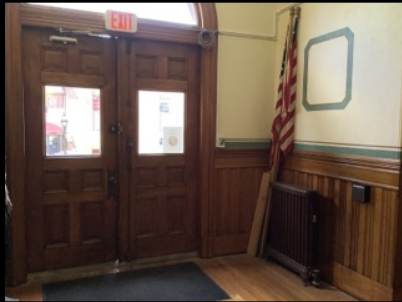
Tactile exit sign not provided Directional sign to accessible emergency exit not provided	- -	Ensure that a tactile exit sign with raised characters and braille is provided at the exit door. Mount the sign between 48"- 60" above the finished floor on the right side of the right door if both door leaves are active. Provide a directional sign indicating the location of the nearest accessible emergency exit.	1	250 250	\$500

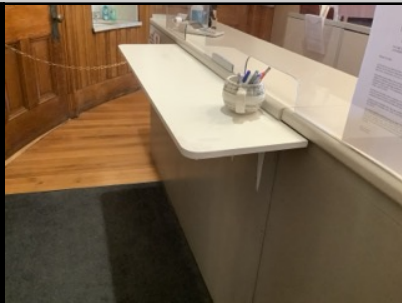
Interior Access Route													
38	Assessors Office	1		Interior Access Route	N/A

Obstructed by protruding objects	11.75"	Provide a cane-detectable barrier at both ends of the service counter.	2	398	\$796	
39	By Town Administratior and Select Board Office	0.5		Interior Access Route	N/A

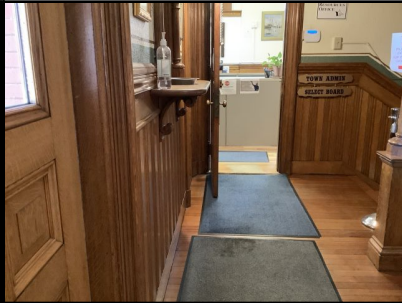
Obstructed by protruding objects Counter > 36" high	9" 42"	Provide a cane-detectable barrier. Provide a counter that is 36" max. above the finished floor.	1	398 1144	\$1542	
40	Near Women's Multi-User Toilet Room	LL		Interior Access Route	N/A

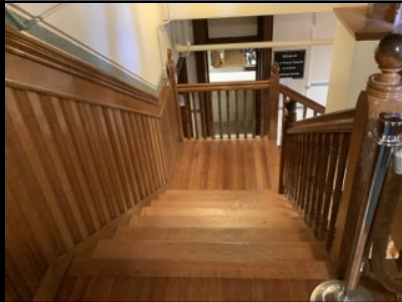
Accessible vertical route not provided	-	Provide accessible vertical access. <b>Note:</b> At the time of the survey the elevator only provided accessible vertical access to Floor 2 (including the Stage) and parts of Floor 1. Ensure accessible vertical access is provided to the third floor and to the entirety of the first floor, or relocate any programs or services provided at non-accessible locations to an accessible one in the building as needed until renovation occurs.	1	Labor	Labor

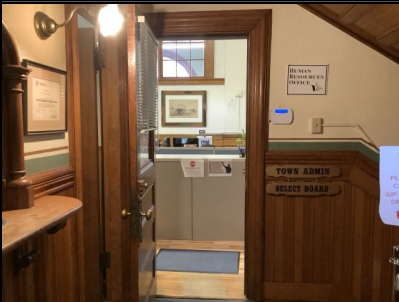
Clear width at door < 32" Threshold > 1/2" high Hardware not compliant	29.25" 1.25" -	Widen the door so that there is 32" min. clear width. Alter the threshold to be 1/2" high max. beveled Provide hardware that can be operable with one hand and not require tight grasping, pinching, or twisting of the wrist.	1	4376 1000 750	\$6126

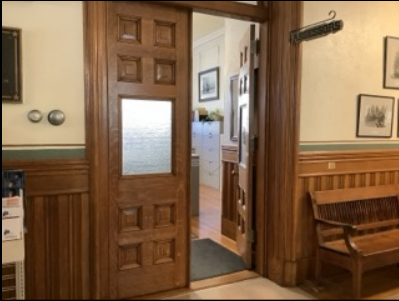
Clear width at door < 32" Threshold > 1/2" high Hardware not compliant	27.5" 0.75" -	Provide an automatic door opener that opens both doors simultaneously when activated. Alter the threshold to be 1/2" high max. Provide hardware that can be operable with one hand and not require tight grasping, pinching, or twisting of the wrist. Alternately, both doors can be left open at all times when the Town Hall is open for business.	1	6000 1000 750	\$7750
											<b>7750</b>	
44	Planning Department (Entry by Auditorium)	2		Doors, Doorways, & Gates	Office

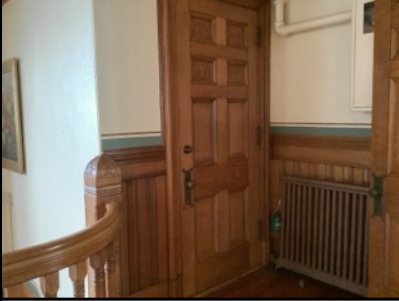
Clear width at door < 32" Threshold > 1/2" high Hardware not compliant	29" 0.75" -	Widen the door so that there is 32" min. clear width. Alter the threshold to be 1/2" high max. beveled. Provide hardware that can be operable with one hand and not require tight grasping, pinching, or twisting of the wrist.	1	4376 1000 750	\$6126

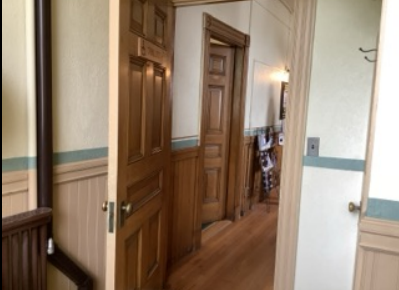
Maneuvering clearance(s) not provided	14"	Provide an automatic door opener.	1	6000	\$6000
											<b>6000</b>

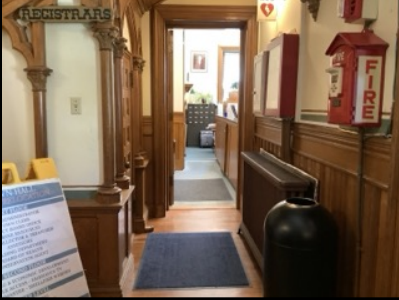
Mat not securely attached Threshold > 1/2" high	- 1.25"	Secure the mat. Alter the threshold to be 1/2" high max. beveled.	1	1000	\$1000
											1000	
48	Director of Finance/Treasurer, Accountant, and Retirement System	LL		Doors, Doorways, & Gates	Office

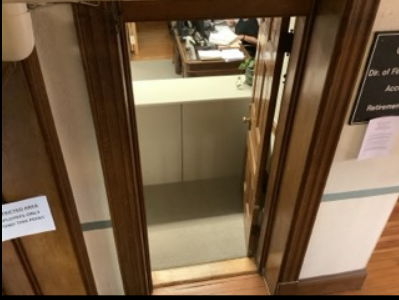
Mat not securely attached Threshold > 1/2" high	- 1.25"	Secure the mat. Alter the threshold to be 1/2" high max. beveled.	1	1000	\$1000
											1000	
49	Main Egress - South Side	0.5		Doors, Doorways, & Gates	Emergency Egress

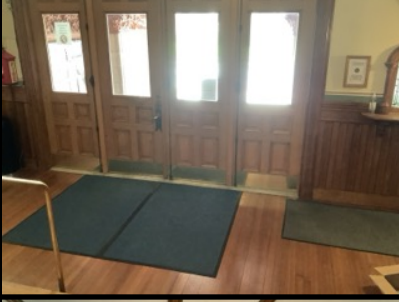
Mat not securely attached Hardware not compliant	- -	Secure the mat. Provide hardware that can be operable with one hand and not require tight grasping, pinching, or twisting of the wrist.	1	750	\$750

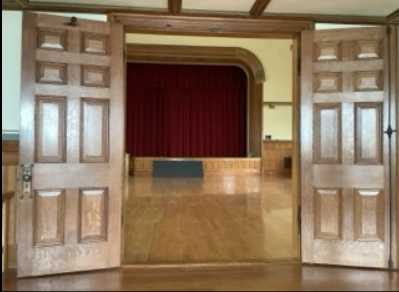
Threshold > 1/2" high	0.75"	Alter the threshold to be 1/2" high max. beveled.	1	1000	\$1000
											1000

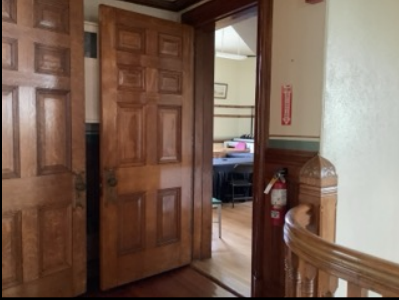
Threshold > 1/2" high	0.75"	Alter the threshold to be 1/2" high max. beveled.	1	1000	\$1000
											1000	
53	Stairway to Offices	LL		Doors, Doorways, & Gates	Circulation

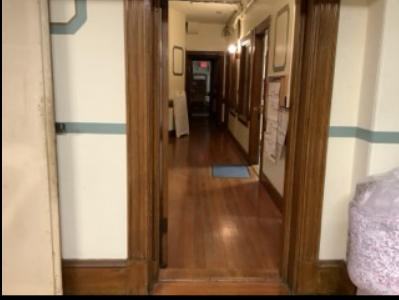
Threshold > 1/2" high	1.25"	Alter the threshold to be 1/2" high max. beveled.	1	1000	\$1000
											1000	
54	Tax Collector Office	1		Doors, Doorways, & Gates	Office

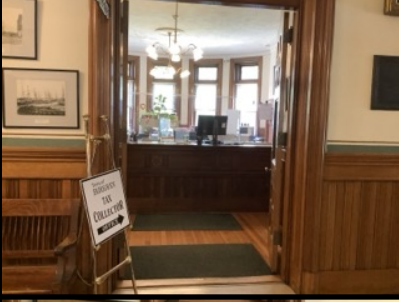
Threshold > 1/2" high Hardware not compliant	0.75" -	Alter the threshold to be 1/2" high max. beveled. Provide hardware that can be operable with one hand and not require tight grasping, pinching, or twisting of the wrist.	1	1000 750	\$1750

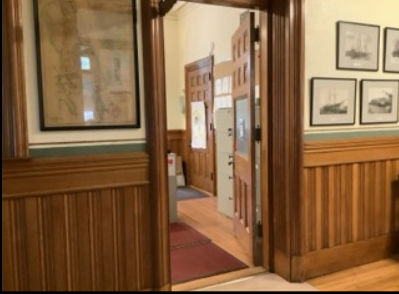
Threshold > 1/2" high Hardware not compliant	0.75" -	Alter the threshold to be 1/2" high max. beveled. Provide hardware that can be operable with one hand and not require tight grasping, pinching, or twisting of the wrist.	1	1000 750	\$1750
											1750

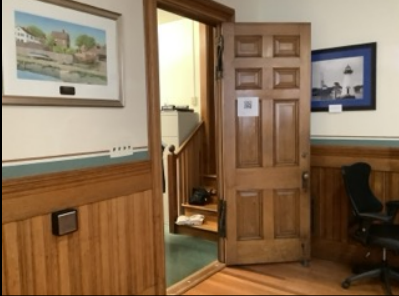
Threshold > 1/2" high Hardware not compliant	0.75" -	Alter the threshold to be 1/2" high max. Provide hardware that can be operable with one hand and not require tight grasping, pinching, or twisting of the wrist.	1	1000 750	\$1750
											1750	
58	Planning Department	2		Doors, Doorways, & Gates	Office

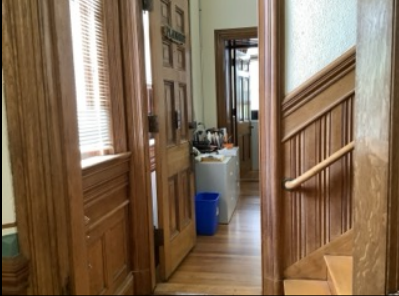
Threshold > 1/2" high Hardware not compliant	0.75" -	Alter the threshold to be 1/2" high max. Provide hardware that can be operable with one hand and not require tight grasping, pinching, or twisting of the wrist.	1	1000 750	\$1750

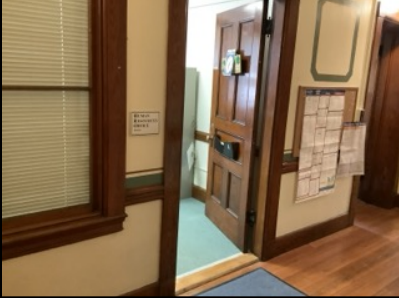
1750	
59	Human Resources Office	LL		Doors, Doorways, & Gates	Office

Threshold > 1/2" high Hardware not compliant	1.25" -	Alter the threshold to be 1/2" high max. Provide hardware that can be operable with one hand and not require tight grasping, pinching, or twisting of the wrist.	1	1000 750	\$1750
											1750	
60	East Egress	LL		Doors, Doorways, & Gates	Emergency Egress

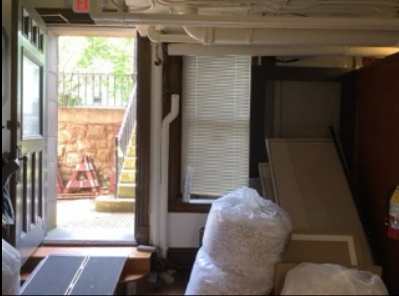
Threshold > 1/2" high Hardware not compliant	2" -	Alter the threshold to be 1/2" high max. beveled. Provide hardware that can be operable with one hand and not require tight grasping, pinching, or twisting of the wrist.	1	1000 750	\$1750
											1750

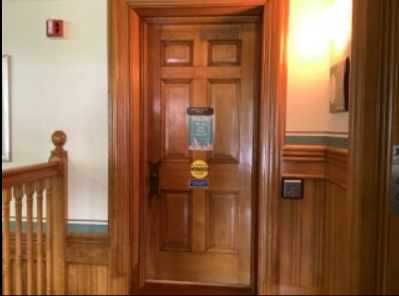
Hardware not compliant	-	Provide hardware that can be operable with one hand and not require tight grasping, pinching, or twisting of the wrist.	1	750	\$750
62	Board of Health, by Elevator	1		Doors, Doorways, & Gates	Office

Hardware not compliant	-	Provide hardware that can be operable with one hand and not require tight grasping, pinching, or twisting of the wrist.	1	750	\$750
63	Single-User Toilet Room	1		Doors, Doorways, & Gates	Toilet Room

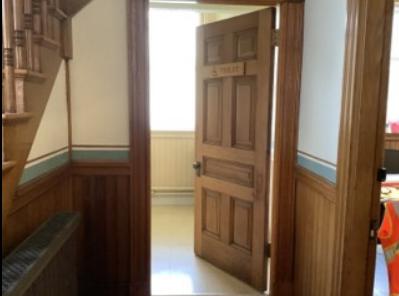
Hardware not compliant	-	Provide hardware that can be operable with one hand and not require tight grasping, pinching, or twisting of the wrist.	1	750	\$750
64	Cable Access Department	1.5		Doors, Doorways, & Gates	Office

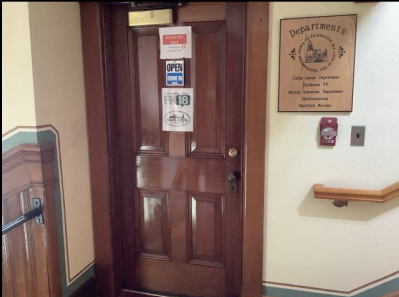
Hardware not compliant	-	Provide hardware that can be operable with one hand and not require tight grasping, pinching, or twisting of the wrist.	1	750	\$750

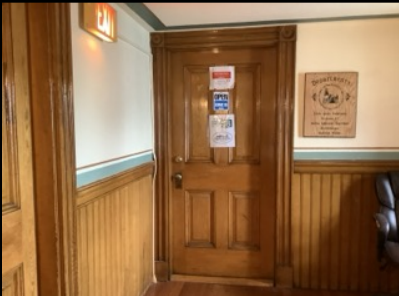
65	Cable Access and Harbormaster Offices	1.5		Doors, Doorways, & Gates	Office

Hardware not compliant	-	Provide hardware that can be operable with one hand and not require tight grasping, pinching, or twisting of the wrist.	1	750	\$750

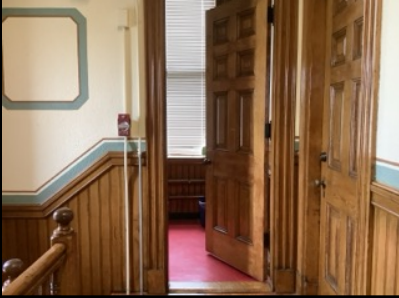
Hardware not compliant	-	Provide hardware that can be operable with one hand and not require tight grasping, pinching, or twisting of the wrist.	1	750	\$750	
											750		
67	Single-User Toilet Room by Auditorium Stage	S		Doors, Doorways, & Gates	Toilet Room

Hardware not compliant	-	Provide hardware that can be operable with one hand and not require tight grasping, pinching, or twisting of the wrist.	1	750	\$750	
											750		
68	To Accessible Entrance/Exit	1		Doors, Doorways, & Gates	Circulation

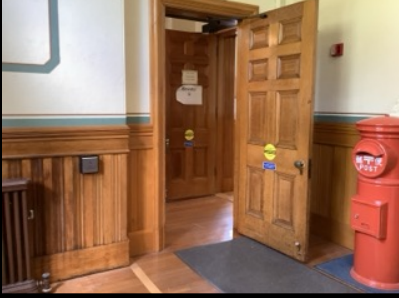
Hardware not compliant Door requires > 5 lbs. of force to open	- 15 lbs.	Provide hardware that can be operable with one hand and not require tight grasping, pinching, or twisting of the wrist. Adjust closers so doors do not require more than 5 pounds of force to open.	1	750 Labor	\$750

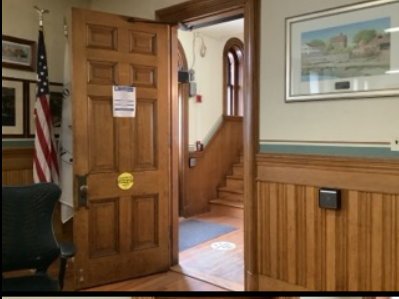
750		
69	To Accessible Entrance/Exit	1		Doors, Doorways, & Gates	Circulation

Hardware not compliant Door requires > 5 lbs. of force to open	- 15 lbs.	Provide hardware that can be operable with one hand and not require tight grasping, pinching, or twisting of the wrist. Adjust closers so doors do not require more than 5 pounds of force to open.	1	750	\$750	
											750		
70	Accessible Entrance Lobby to Elevator Lobby	1		Doors, Doorways, & Gates	Circulation

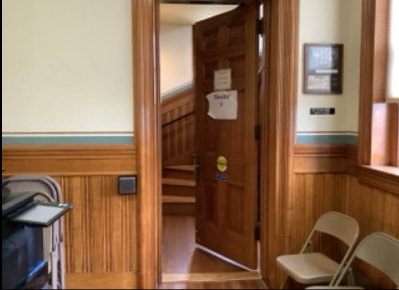
Door requires > 5 lbs. of force to open	15 lbs.	Adjust closers so doors do not require more than 5 pounds of force to open.	1	Labor	Labor

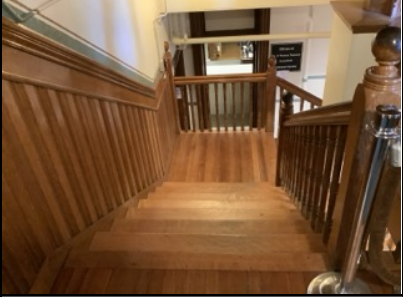
Handrail not provided on both sides	-	Provide a compliant handrail on one side.	1	-	-

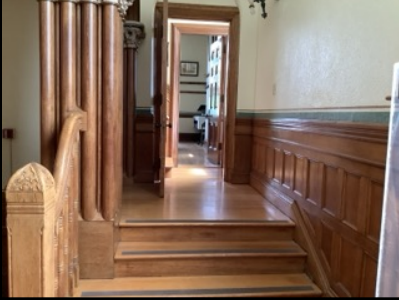
Handrail not provided on both sides	-	Provide a compliant handrail on one side.	1	-	-
77	To East Room	2		Stairways	Interior

Handrail not provided on both sides	-	Provide a compliant handrail on one side.	1	-	-
78	Planning Department	2		Stairways	Interior

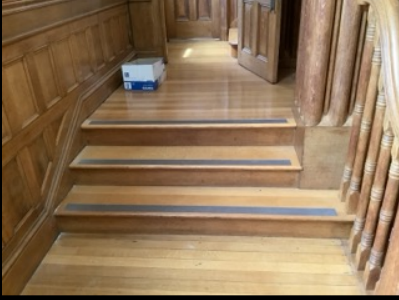
Handrail not provided on both sides	-	Provide a compliant handrail on one side.	1	-	-
79	Northeast Stairway	2		Stairways	Egress

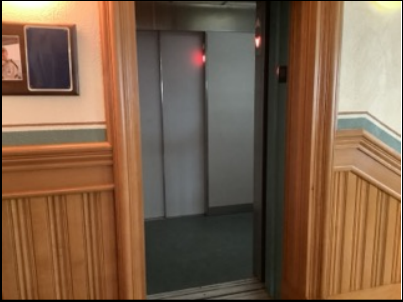
Handrails not provided	-	Provide compliant handrails.	1	-	-
Elevator												
82	Elevator - Entry by Board of Health	1		Elevator	Interior

Elevator reopening device not provided	-	Provide an elevator reopening device.	1	-	-
83	Elevator	1		Elevator

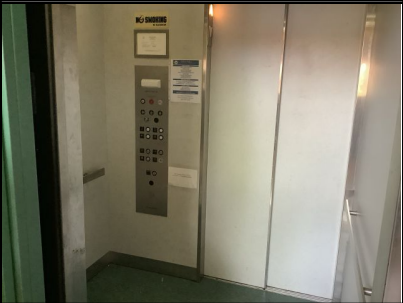
Illumination levels are lower than 54 lux (5 ft. candles)	-	If the light levels inside the elevator car are less than 5 foot candles, increase illumination level to 5 foot candles min.	1	Labor	Labor
Signage												
84	Town Clerk's Office	Ext.		Signage	Informational

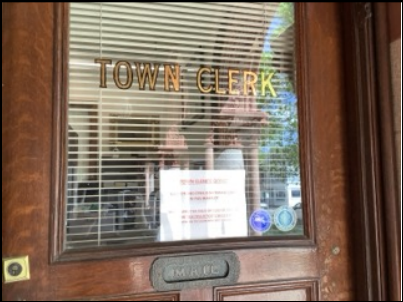
-	Provide accessible town clerk's office drop-off boxes for ballots and for census forms located on an accessible route near the Town Hall.	1	Labor	Labor
85	Cable Access and Harbormaster Offices	1.5		Signage	Designation

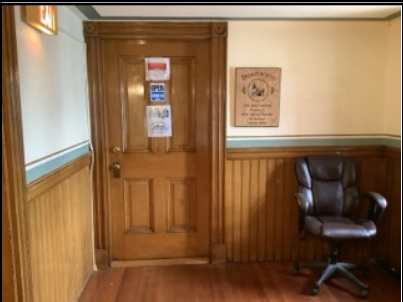
Signage is not provided	-	Locate compliant signage with raised characters and braille alongside the door on the latch side.	1	250	\$250

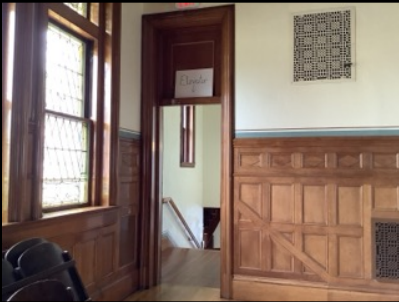
Signage is not provided	-	Locate compliant signage with raised characters and braille alongside the door on the latch side.	1	250	\$250
											250	
87	Auditorium to Northwest Stairway and Elevator	2		Signage	Egress

Signage is not provided	-	Locate compliant egress stair signage with raised characters and braille alongside the door on the latch side.	1	250	\$250
											250	
88	East Room	2		Signage	Designation

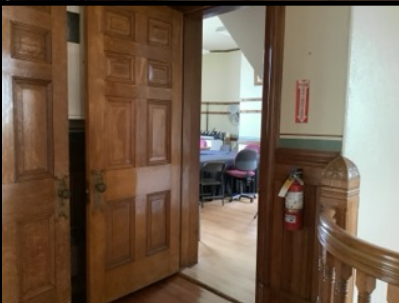
Signage is not provided	-	Locate compliant signage with raised characters and braille alongside the door on the latch side.	1	250	\$250
											250	
89	East Room	2		Signage	Designation

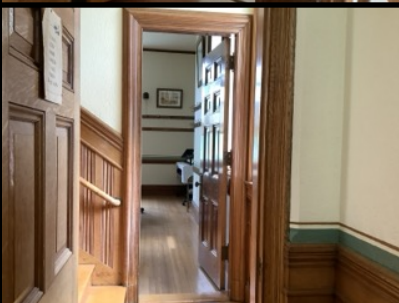
Signage is not provided	-	Locate compliant signage with raised characters and braille.	1	250	\$250
											250

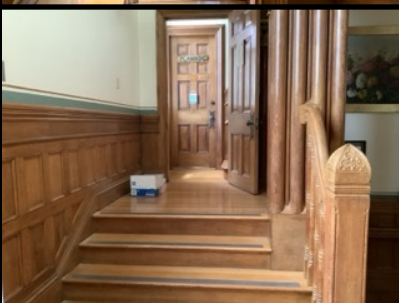
90	Planning Department	2		Signage	Designation

Signage is not provided		Locate compliant signage with raised characters and braille alongside the door on the latch side.	1	250	\$250
											250

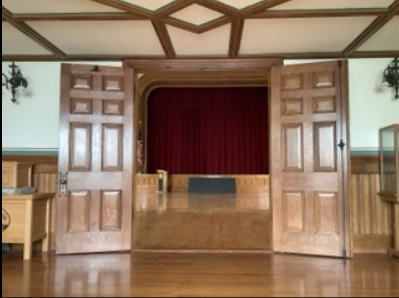
Signage is not provided	-	Locate compliant signage with raised characters and braille alongside the door on the latch side.	1	250	\$250
											250	
92	Auditorium	2		Signage	Designation

Signage is not provided Location of tactile sign not compliant	-	Provide compliant signage with raised characters and braille. Where a tactile sign is provided at double door with two active leafs, locate the sign to the right of the right-hand door.	1	250	\$250
											250	
93	East Room, Single-User Toilet Room	2		Signage	Designation

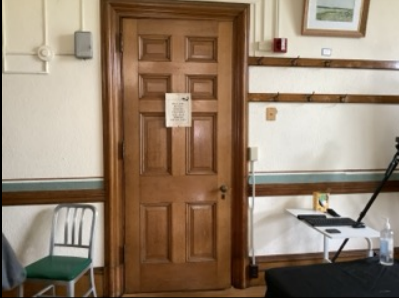
Signage is not provided International Symbol of Acc. not provided	- -	Locate compliant signage with raised characters and braille alongside the door on the latch side. When the toilet room is renovated and brought up to compliance, ensure the sign contains the International Symbol of Accessibility (ISA).	2	250	\$500

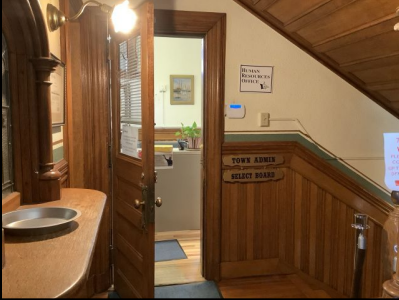
500	
94	Town Administrator and Select Board Office Designation Signs	0.5		Signage	Designation

Raised characters not provided on sign Raised characters < 48" or > 60" above ground Braille not provided on sign Character style not compliant	- 37" - -	Provide text with raised characters duplicated in braille on the sign. Mount the sign so that the baseline of the lowest tactile character is 48" min. above finished floor and the baseline of the highest tactile character is 60" max. above the finished floor. Provide a sign with compliant characters. Characters should be sans serif.	2	250	\$500
											500	
95	Registrar's and Town Clerk's Office	0.5		Signage	Designation

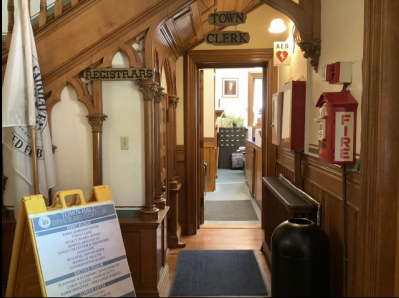
Raised characters not provided on sign Raised characters < 48" or > 60" above ground Braille not provided on sign Location of tactile sign not compliant Character style not compliant	- 78", 90" - - -	Provide text with raised characters duplicated in braille on the sign. Mount the sign so that the baseline of the lowest tactile character is 48" min. above finished floor and the baseline of the highest tactile character is 60" max. above the finished floor. Locate sign alongside the door on the latch side. Provide a sign with compliant characters. Characters should be sans serif. <b>Note:</b> Applies to all designation signs of this type	1	250	\$250

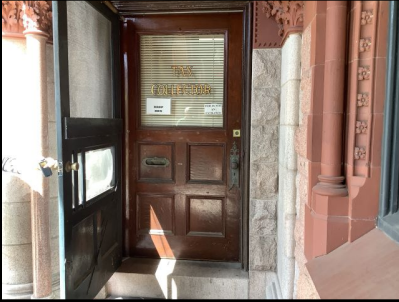
Raised characters not provided on sign Braille not provided on sign	- -	Provide text with raised characters duplicated in braille on the sign. Provide braille on the sign.	1	250	\$250
											250	
97	Tax Collector	Ext.		Signage	Designation

Raised characters not provided on sign Braille not provided on sign	-	Provide text with raised characters duplicated in braille on the sign. Provide a sign located on the latch side of the door.	1	450	\$450
											450	
98	Human Resources Office	LL		Signage	Designation

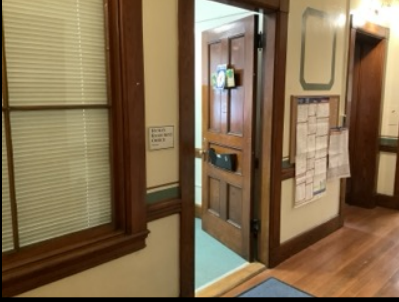
Raised characters not provided on sign Braille not provided on sign	- -	Provide text with raised characters duplicated in braille on the sign.	1	250	\$250
											250	
99	Assessors Office	1		Signage	Designation

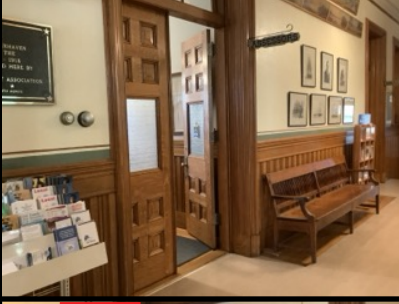
Raised characters not provided on sign Braille not provided on sign Location of tactile sign not compliant	- - -	Provide text with raised characters duplicated in braille on the sign. Locate sign alongside the door on the latch side. Where a tactile sign is provided at double doors with one active leaf, locate the sign on the inactive leaf. Where a tactile sign is provided at double door with two active leafs, locate the sign to the right of the right-hand door. Where there is no wall space, locate sign on the nearest adjacent wall.	1	250	\$250

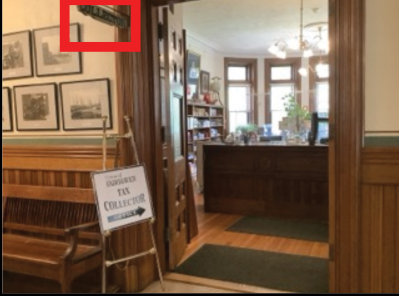
250	
100	Tax Collector Office	1		Signage	Designation

Raised characters not provided on sign Braille not provided on sign Location of tactile sign not compliant	- - -	Provide text with raised characters duplicated in braille on the sign. Locate sign alongside the door on the latch side.	1	250	\$250
											250

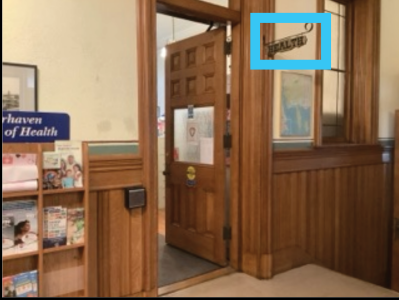
Raised characters not provided on sign Braille not provided on sign Location of tactile sign not compliant	- - -	Provide text with raised characters duplicated in braille on the sign. Locate sign alongside the door on the latch side.	1	250	\$250
											250	
103	Board of Health, by Elevator	1		Signage	Designation

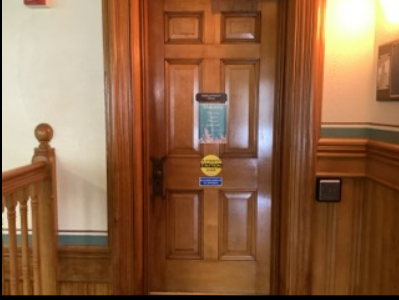
Raised characters not provided on sign Braille not provided on sign Location of tactile sign not compliant	- - -	Provide text with raised characters duplicated in braille on the sign. Locate sign alongside the door on the latch side.	1	250	\$250

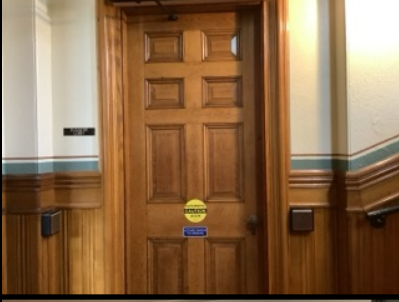
250	
104	To Elevator Lobby by Northwest Entry/Exit	1		Signage	Designation

Raised characters not provided on sign Braille not provided on sign Location of tactile sign not compliant	- - -	Provide text with raised characters duplicated in braille on the sign. Locate sign alongside the door on the latch side.	1	250	\$250
											250	
105	Office of Conservation and Sustainability	1		Signage	Designation

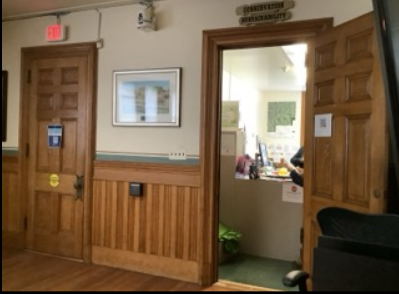
Raised characters not provided on sign Braille not provided on sign Location of tactile sign not compliant	- - -	Provide text with raised characters duplicated in braille on the sign. Locate sign alongside the door on the latch side.	1	250	\$250
											250

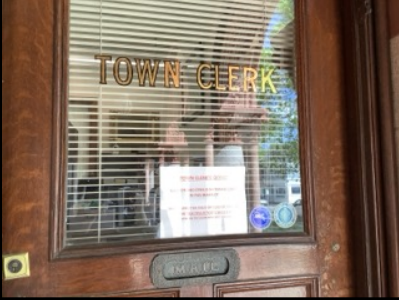
Raised characters not provided on sign Braille not provided on sign Non-glare finish and contrast not provided on sign	- - -	Provide text with raised characters duplicated in braille on the sign. Install a sign with a non-glare finish with characters that have a high contrast to the background.	1	450 Labor	\$450

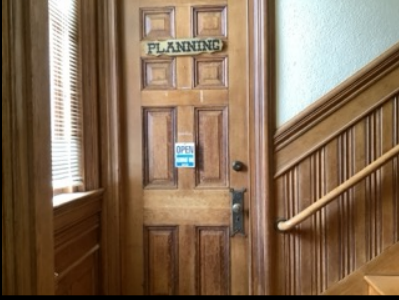
108	Planning Department	2		Signage	Designation

Braille not provided on sign Location of tactile sign not compliant Hardware not compliant	- -	Provide braille on the sign. Locate sign alongside the door on the latch side. Provide hardware that can be operable with one hand and not require tight grasping, pinching, or twisting of the wrist.	1	250 750	\$1000	
109	Accessible Entry/Exit to Lobby	1		Signage	Directional

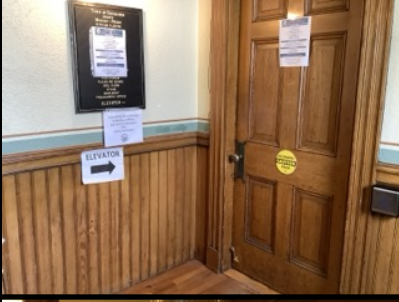
Visual characters < 40" above ground	38.5"	Mount the sign so that the baseline of the lowest visual character is 40" min. above the finished floor or ground.	1	Labor	Labor	
110	By Town Administrator and Select Board Office	0.5		Signage	Directional

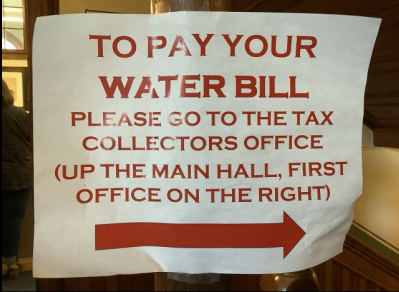
Non-glare finish and contrast not provided on sign	-	Install a sign with a non-glare finish with characters that have a high contrast to the background.	1	Labor	Labor

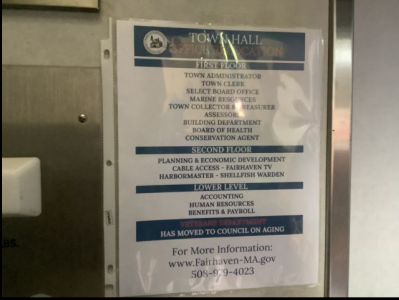
Non-glare finish and contrast not provided on sign	-	Install a sign with a non-glare finish with characters that have a high contrast to the background.	1	Labor	Labor
113	Accessible Entry/Exit to Lobby	1		Signage	Informational

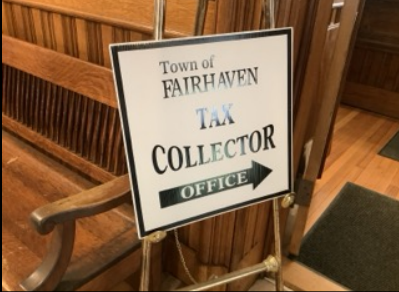
115	Tax Collector Office	1		Signage	Directional

Non-glare finish and contrast not provided on sign Character style not compliant	- -	Install a sign with a non-glare finish with characters that have a high contrast to the background. Provide a sign with compliant characters. Characters should not have an unusual form.	1	Labor	Labor

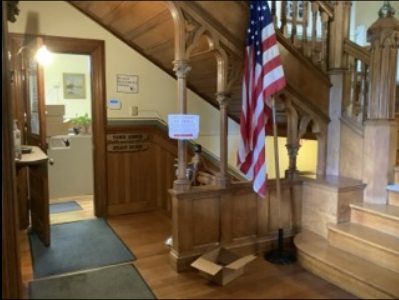
Signage not located on an accessible route	-	Relocate directional sign to an accessible route such as to an area near the elevator.	1	Labor	Labor
118	Main Entrance - South Side	Ext.		Signage	Informational

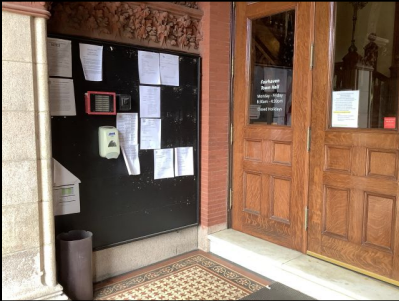
Signage not located on an accessible route	-	Relocate signs with notices of town meetings and similar information to an accessible location such as to the informational signage area by the accessible entry on the north side of the building.	1	Labor	Labor
Service Counter

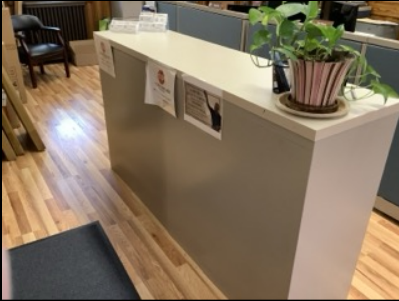
119	Town Administrator and Select Board Office	0.5		Service Counter	N/A

Counter > 36" high	40.5"	Provide a counter that is 36" max. above the finished floor.	1	1144	\$1144
											1144	
120	Registrar's and Town Clerk's Office	0.5		Service Counter	N/A

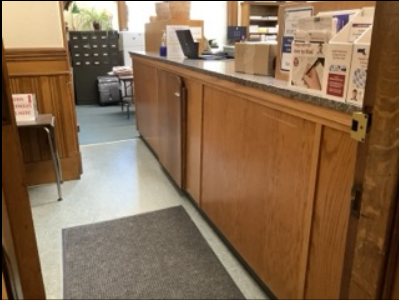
Counter > 36" high	43.75"	Provide a counter that is 36" max. above the finished floor.	1	1144	\$1144
											1144

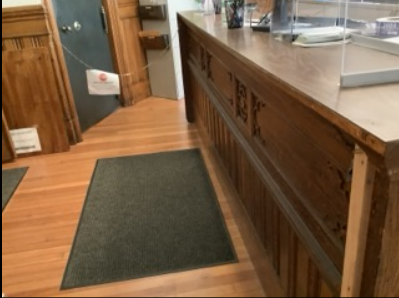
Counter > 36" high	42.75"	Provide a counter that is 36" max. above the finished floor.	1	1144	\$1144
123	Building Department	1		Service Counter	N/A

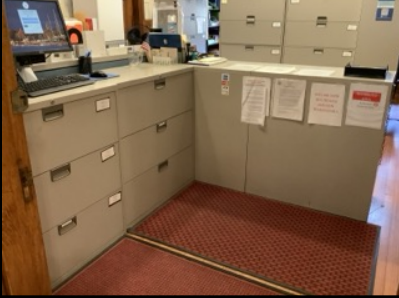
Counter > 36" high	39"	Provide a counter that is 36" max. above the finished floor.	1	1144	\$1144
124	Board of Health	1		Service Counter	N/A

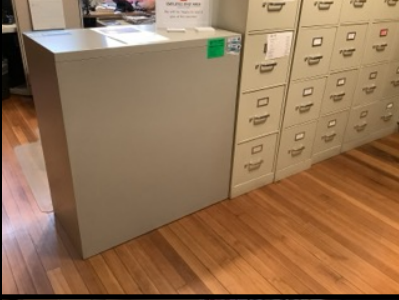
Counter > 36" high	39"	Provide a counter that is 36" max. above the finished floor.	1	1144	\$1144
125	Office of Conservation and Sustainability	1		Service Counter	N/A

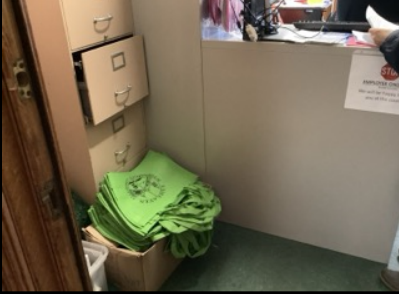
Counter > 36" high	39"	Provide a counter that is 36" max. above the finished floor.	1	1144	\$1144

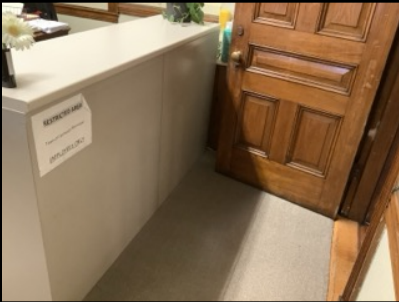
Counter > 36" high	41.75"	Provide a counter that is 36" max. above the finished floor.	1	1144	\$1144
											1144	
Operable Parts / Reach Range												
128	Tax Collector	Ext.		Operable Parts / Reach Range	Drop-Off Slot in Door

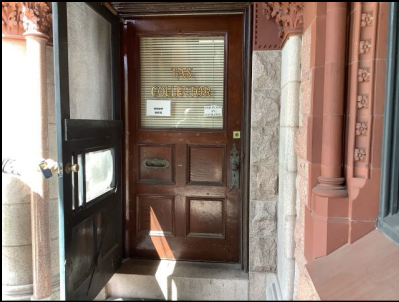
Element not on an accessible route	-	Provide an accessible tax collectors office drop-off box located on an accessible route near the town hall.	1	Labor	Labor
129	By Registrar's and Town Clerk's Office	0.5		Operable Parts / Reach Range	Equipment

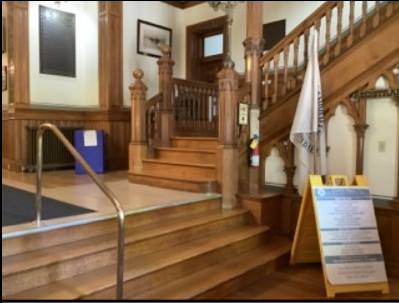
Element not on an accessible route Clear floor space is not provided Reach < 15" or > 48"(forward/side approach)	- - 59"	Ensure fire extinguisher is located on an accessible route. Provide a 30" min. by 48" min. clear floor space at the fire extinguisher Relocate fire extinguisher so that controls are between 15"- 48" above the finished floor.	1	Labor	Labor

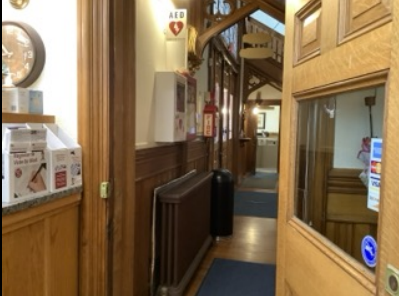
130	Registrar's and Town Clerk's Office	0.5		Operable Parts / Reach Range	Equipment

Reach < 15" or > 48"(forward/side approach)	60"	Relocate the AED so that controls are 48" above the finished floor.	1	Labor	Labor

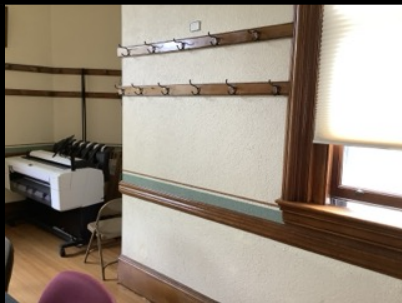
Reach < 15" or > 48"(forward/side approach)	66"	Provide a coat hook located between 15"- 48" above the finished floor.	1	75	\$75
Dining or Work Surfaces												
133	Building Department	1		Dining or Work Surfaces	Work Surface

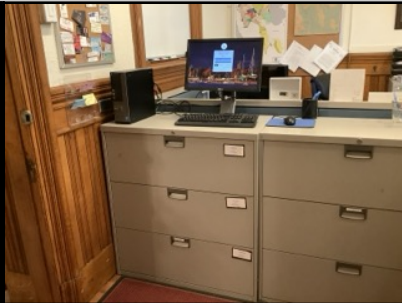
Top of dining/work surface < 28" or > 34"	39"	If the computer is used by members of the public provide at least one comparable computer on a work surface with tops between 28"- 34" above the floor and 27" clear height underneath.	1	700	\$700
Assembly Area												
134	Auditorium, Gallery Seating	3		Assembly Area	N/A

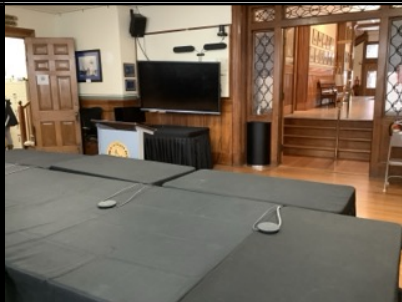
135	Lobby by Accessible Entrance	1		Assembly Area	N/A

Assistive listening devices not provided	-	If audible communication is integral to the use of the space, provide an assistive listening system.  <b>Note:</b> Cost for a transmitter, receiver, ear speaker, neck loop and USB charger - Capacity: 50 or less.	1	1578	\$1578

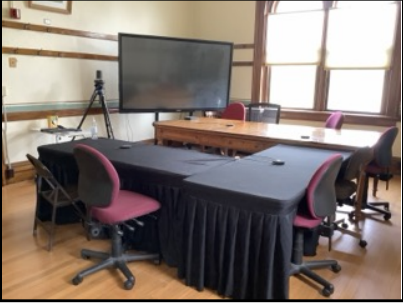
Assistive listening devices not provided	-	If audible communication is integral to the use of the space, provide an assistive listening system.  <b>Note:</b> Cost for a transmitter, receiver, ear speaker, neck loop and USB charger - Capacity: 50 or less.	1	1578	\$1578
											<b>1578</b>	
Picnic Tables												
138	Northwest - Near Elevator Entry	Ext.		Picnic Tables	N/A

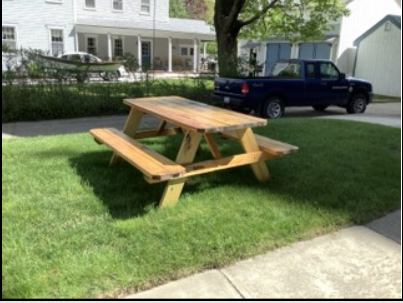
At least 5% accessible spaces not provided Picnic table not on an accessible route Clear floor space not provided Knee clearance less than 19" deep	- - - 7"	Ensure that at least 5% (minimum one) of picnic tables are accessible and that the picnic table is connected to an accessible route. Ensure that at a 30" by 48" firm, stable and slip resistant clear floor space positioned for a forward approach is provided at the picnic table. Provide at least one picnic table with knee clearance that is 19" deep min.	1	1400	1400

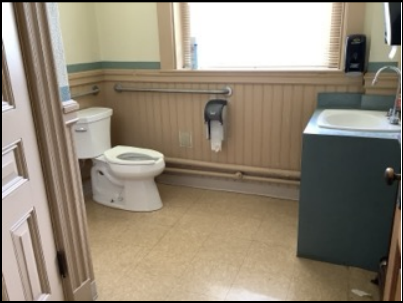
Toilet & Bathing Rooms												
Overall Access												
139	Single-User Toilet Room	1		Overall Access	Toilet Room

Turning space not provided	34.5"	Add an accessible single-user toilet room.	1	31985	\$31985
											<b>31985</b>	
140	East Room, Single-User Toilet Room	2		Overall Access	Toilet Room

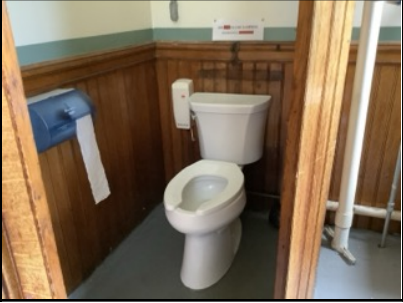
Turning space not provided Accessible plumbing fixtures or stalls not provided	- -	Add an accessible single-user all gender toilet room. <b>Note:</b> One of the two single-user toilet rooms on this floor should be made accessible and designated as all-gender. The other single-user toilet room on this floor should also be designated as all-gender, and it should have a sign directing users to the accessible single-user all-gender toilet room on this floor once that renovation is complete.	1	31985	\$31985
											<b>31985</b>

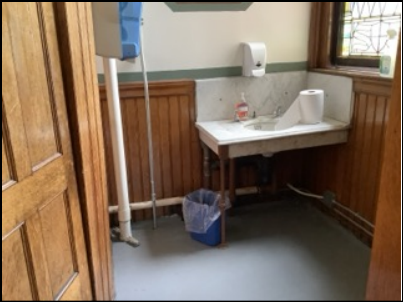
143	East Room, Single-User Toilet Room	2		Lavatory	N/A

Toe or knee clearances not provided Dispenser acts as a protruding object	-	Provide at least one lavatory with knee and toe clearance positioned for a forward approach. Relocate paper towel dispenser out of the circulation path or provide a cane-detectable barrier under the paper towel dispenser. <b>Note:</b> Cost to renovate sink and the dispenser are covered in ID #140.	1	-	-
Single-User Toilet												
144	Single-User Toilet Room	1		Single-User Toilet	N/A

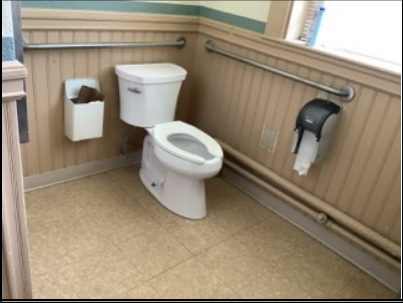
Centerline < or > 18" (MAAB) Side grab bar < 54" from back wall	19.25" 47"	Relocate toilet so that the centerline is 18" from the side wall. Provide a side wall grab bar that is 42" long min. located 12" max. from the rear wall. <b>Note:</b> Costs to make the referenced renovations in this toilet room are included in ID #139.	1	-	-
145	Single-User Toilet Room	1		Single-User Toilet	N/A

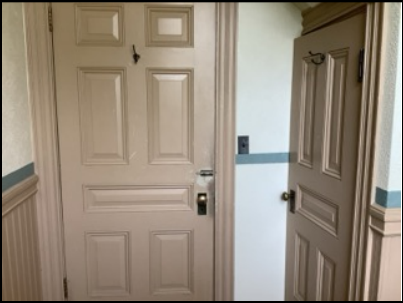
Hook located > 54" high	66", 68.75"	Locate and additional coat hook no higher than 48" above the finished floor.	1	150	\$150

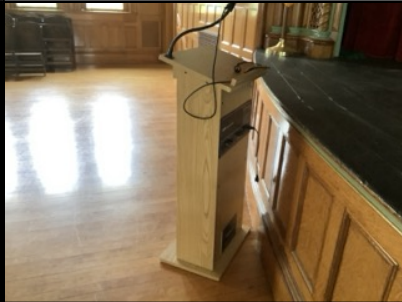
-	Recommend an adjustable height podium with knee and toe clearance positioned for a forward approach.	1	-	-
Signage												
152	Registrar's and Town Clerk's Office	0.5		Signage	Informational

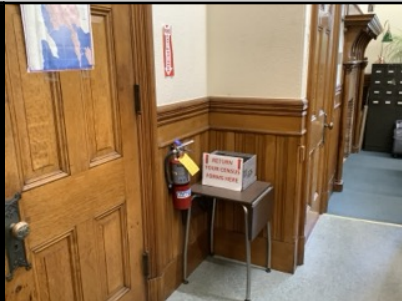
-	Recommend providing a blade sign indicating the location of the fire extinguisher as it would not be immediately visible when looking from one direction down this hall.	1	-	-
153	Board of Health	1		Signage	Informational

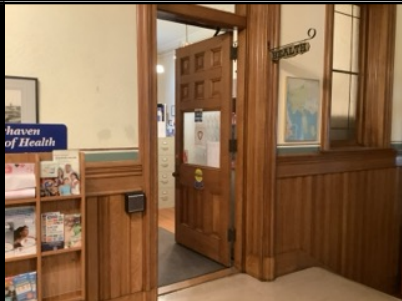
-	Recommend providing a sign indicating that the elevator is located through the Board of Health office.	1	-	-
154	Board of Health to Elevator	1		Signage	Informational

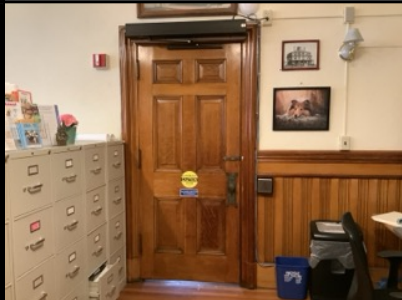
-	Recommend providing a sign indicating that the elevator is located through the Board of Health office.	1	-	-

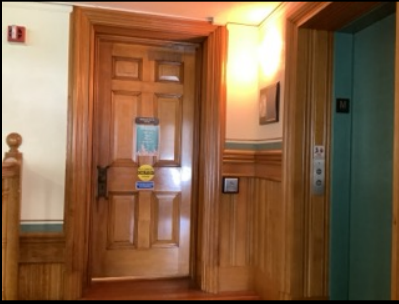
ID	Location	Floor	Room	Element	Type	Photo	Issues	Current Measure	Recommendations	Quantity	Price	Cost Estimation
155	Board of Health, by Elevator	1		Signage	Informational

-	Recommend providing a sign indicating that access to the offices for the Assessors, Tax Collector and Building Department are located through this door for the Board of Health office.	1	-	-
156	Elevator	1		Signage	Informational

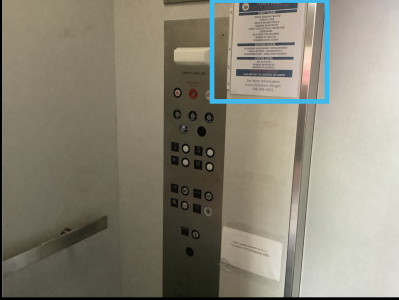
-	Recommend providing an informational sign indicating the location of offices with identical floor-level designations as the elevator car. <b>Note:</b> The offices of the Board of Health, Building Department, Assessors, and Town Collector and Treasurer are located on the mezzanine level, but the current directory sign incorrectly indicates they are located on Floor 1.	1	-	-
157	Office of Conservation and Sustainability	1		Signage	Informational

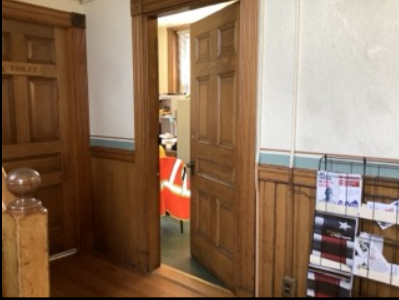
-	Recommend providing an Employee Only sign at this entry.	1	-	-

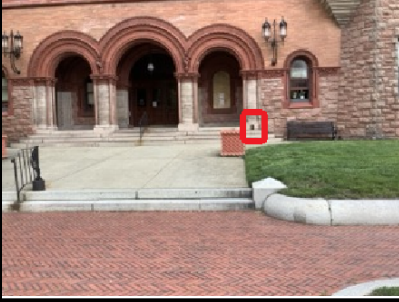
158	Main Entrance (South Side)	Ext.		Signage	Directional

-	Recommend relocating the directional sign with the International Symbol of Accessibility (ISA) that directs visitors to the accessible entrance to the walkway at the base of the stairs. <b>Note:</b> The sign with the ISA is located where the red-outlined rectangle has been drawn in the image.	1	-	-
159	Northeast Side - Exterior Ramp	Ext.		Signage	International Symbol of Accessibility

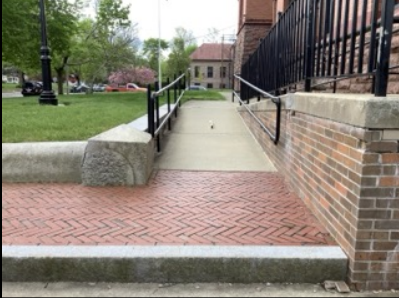
-	Recommend providing a sign with the International Symbol of Accessibility (ISA), indicating the location of the accessible route and entrance to Town Hall.	1	-	-

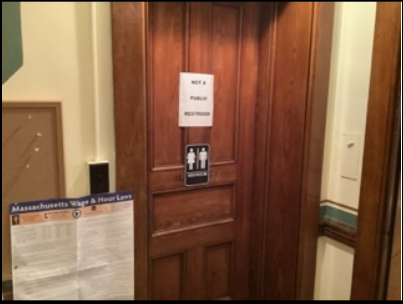
ID	Location	Floor	Room	Element	Type	Photo	Issues	Current Measure	Recommendations	Quantity	Price	Cost Estimation
160	Staff Toilet Room	LL		Signage	Designation

-	Recommend, although this toilet room is not used by members of the public so it is outside of the scope of this survey, locating the designation sign on the latch side of the door between 48 and 60 inches from the floor to the baseline of the lowest tactile character (raised lettering or braille).	1	-	-
161	By Director of Finance/Treasurer, Accountant, and Retirement	LL		Signage	Informational

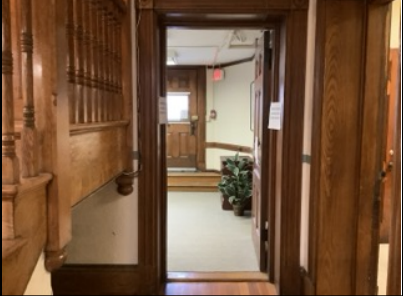
-	Recommend a more prominent informational sign indicating that the visitor is heading toward a restricted "Employee Only" area.	1	-	-
