| Facility Name | Location | BMP/Feature Description | Inspection Date | Recommended Maintenance | Action Taken |

Town of Fairhaven

**STORM WATER BMP INSPECTION FORM**

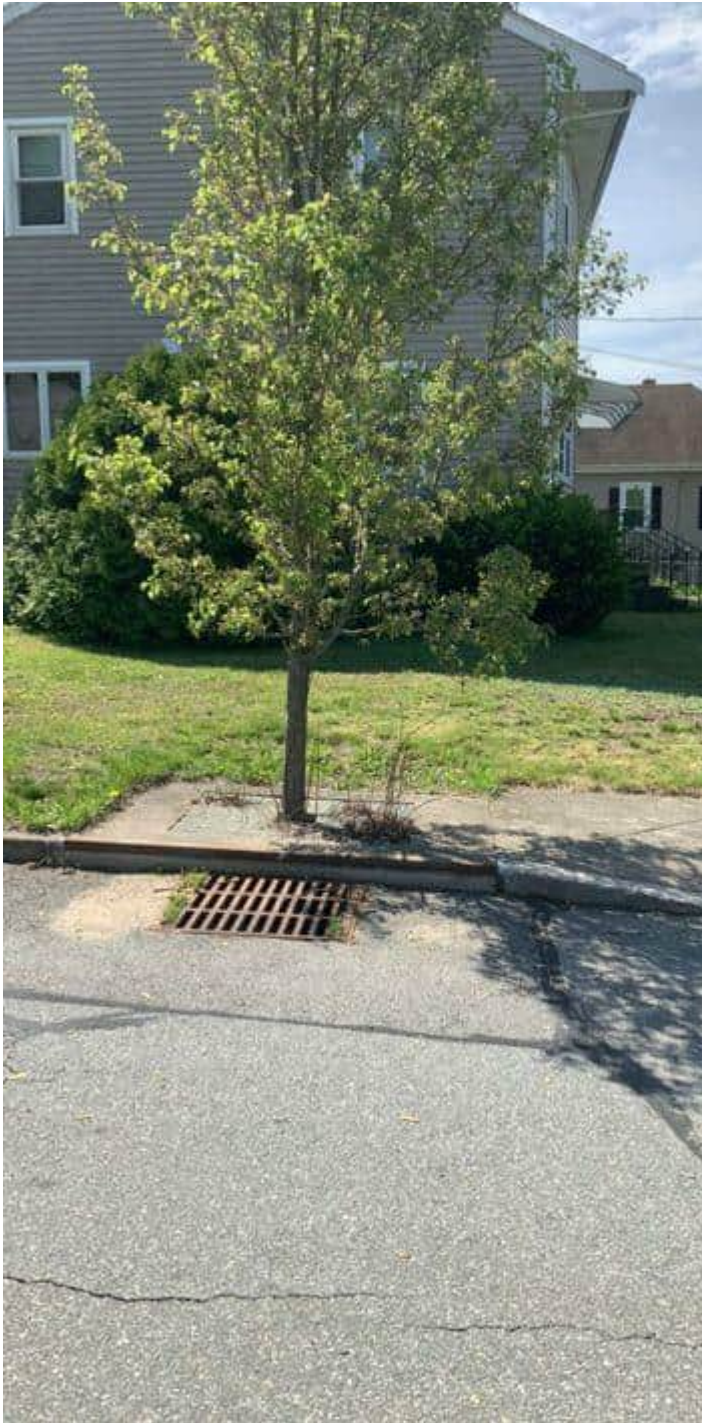
Outside tree box filter 1

| Problem | Description | Quantity | Completed (by) | Date |
|---|---|---|---|---|
| Sediment/Debris | Remove debris, trash and vegetation | | | |

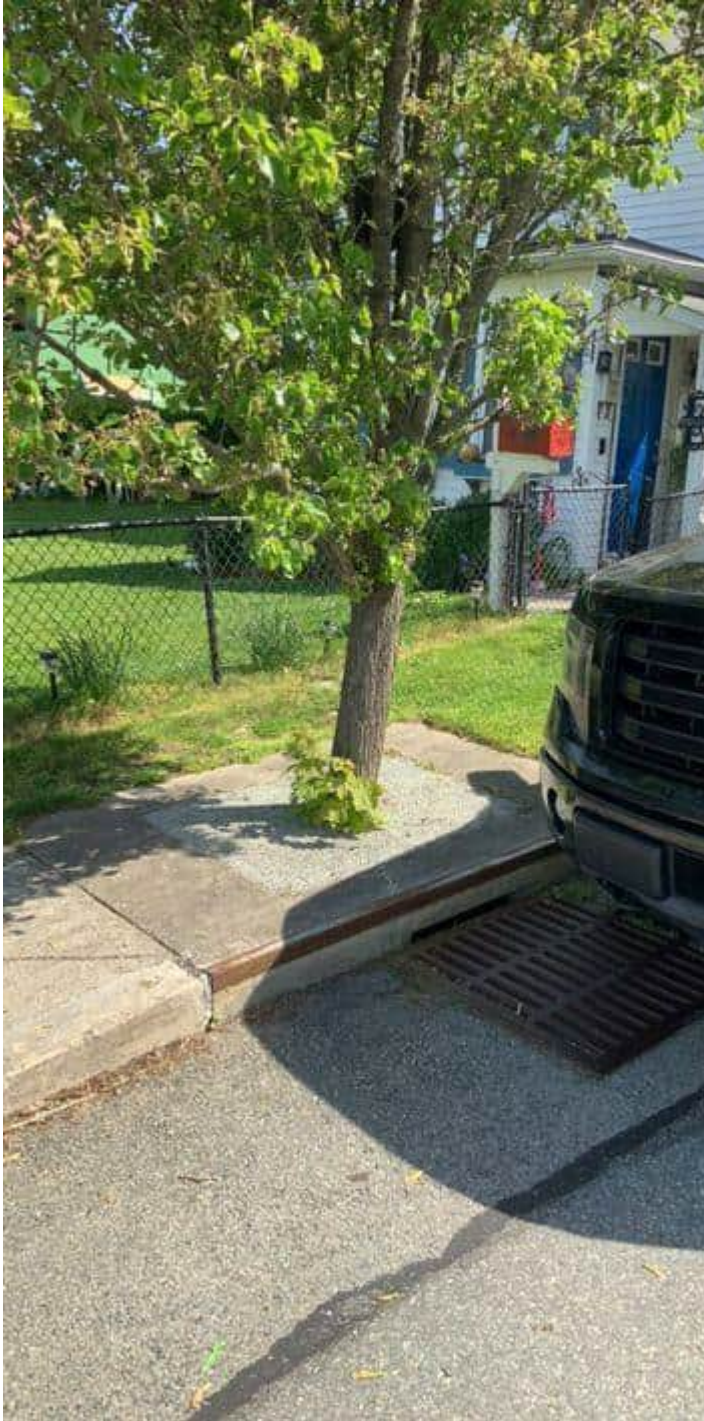
Outside tree box filter 2

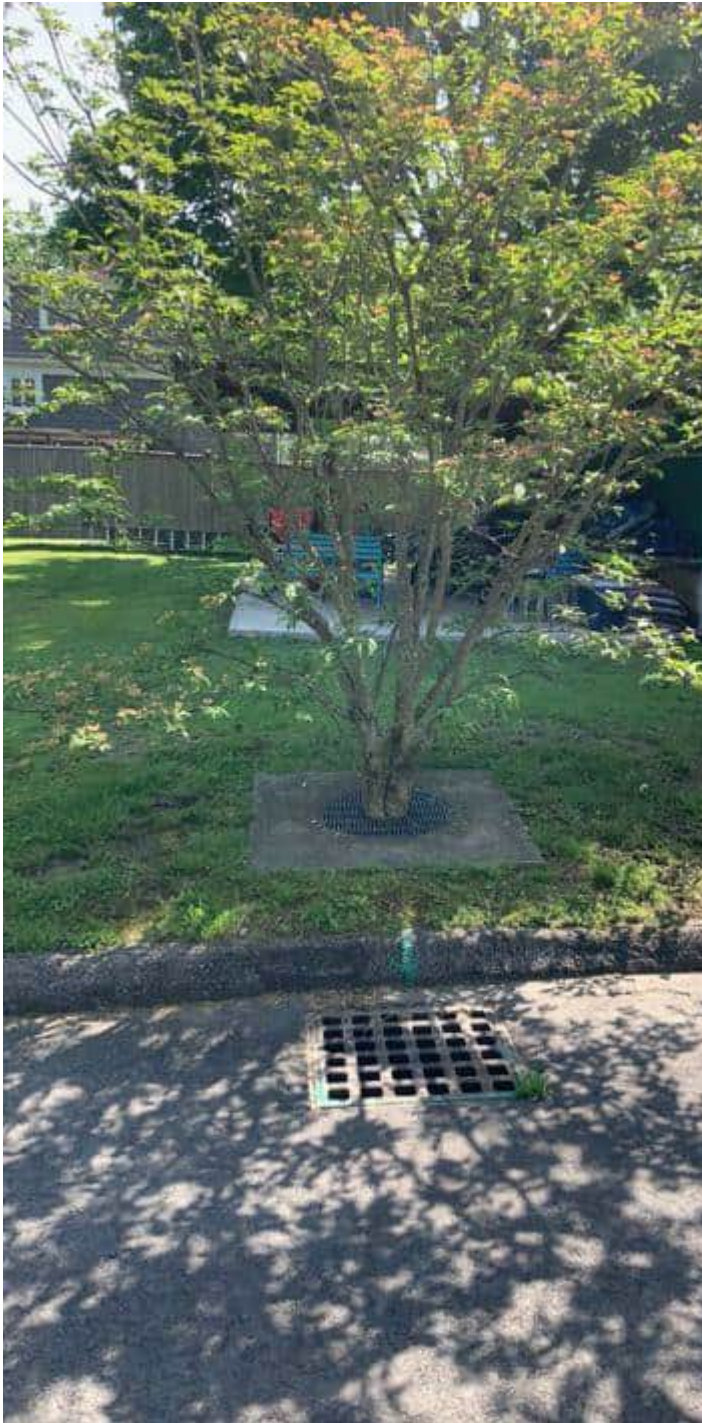
Outside tree box filter 1

| Problem | Description | Quantity | Completed (by) | Date |
|---|---|---|---|---|
| Sediment/ Debris | Remove debris inside tree box | | | |

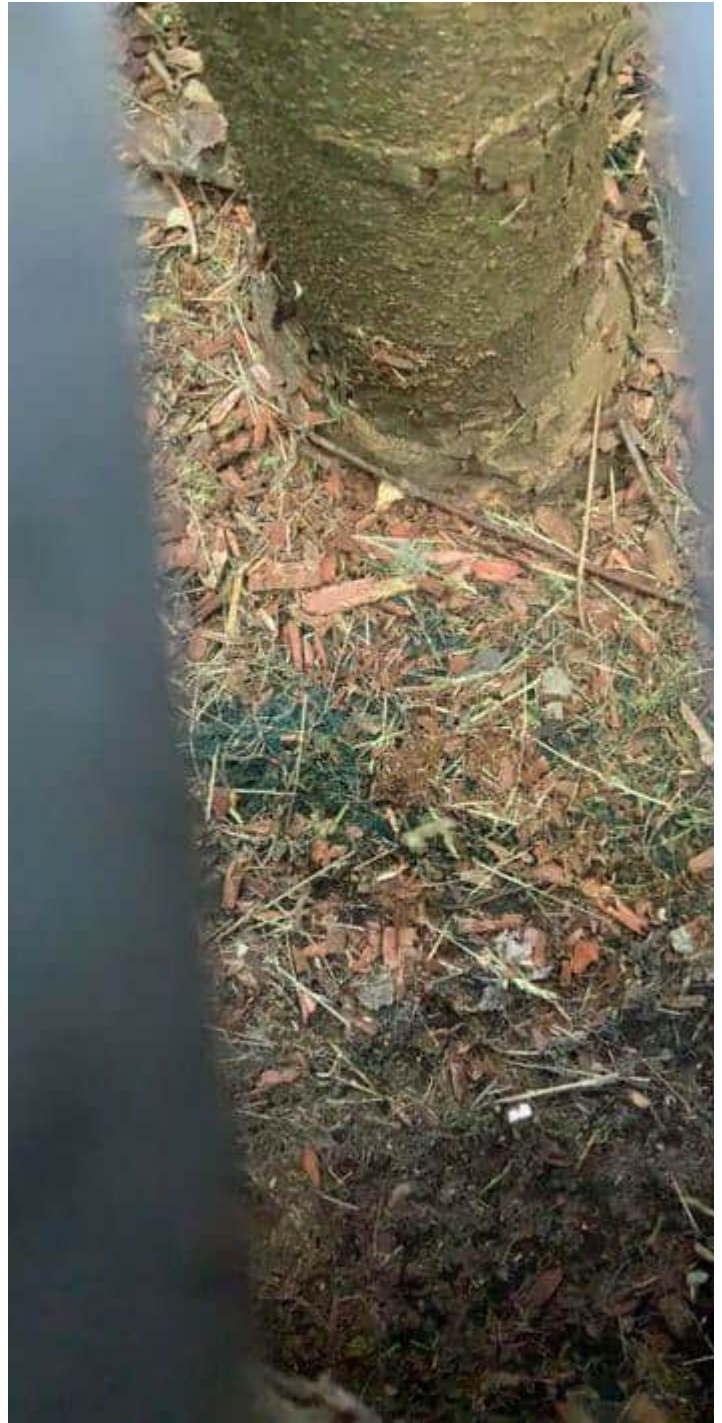
Inside tree box filter 1

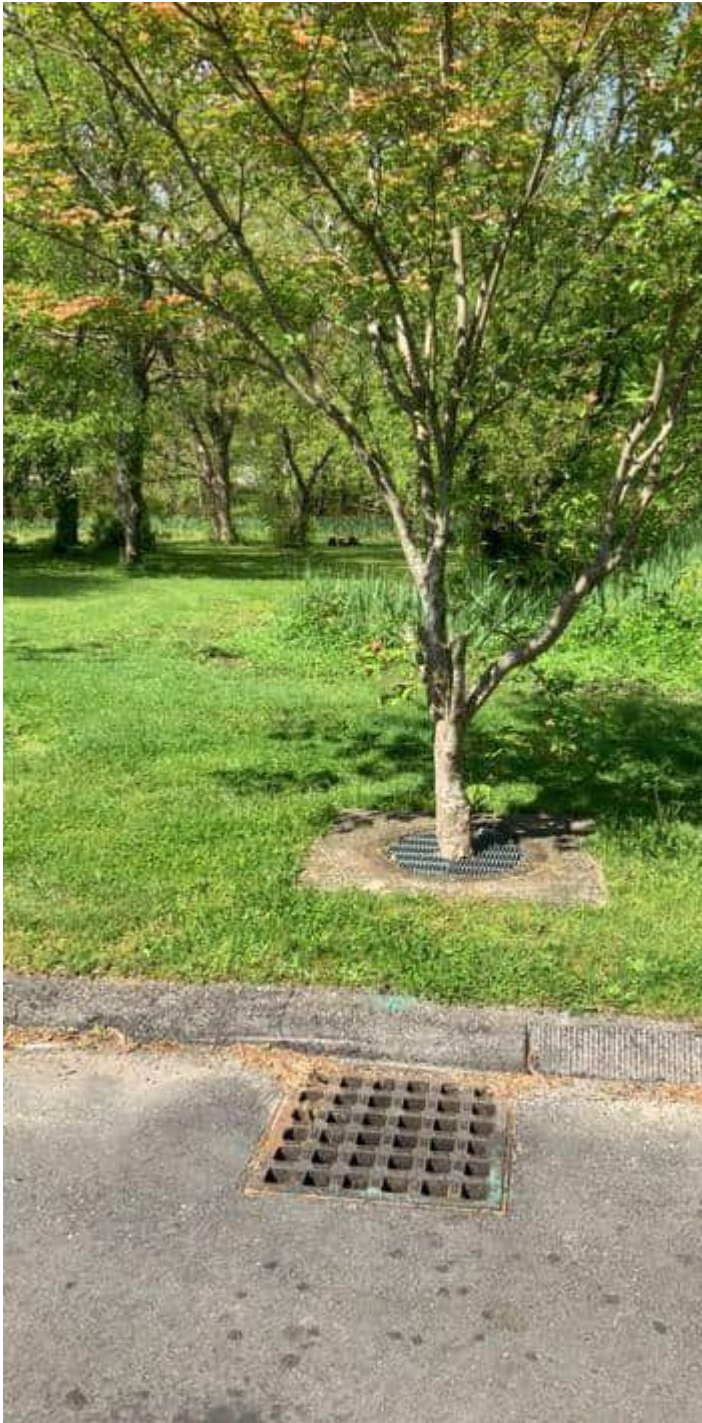
Outside tree box filter 2

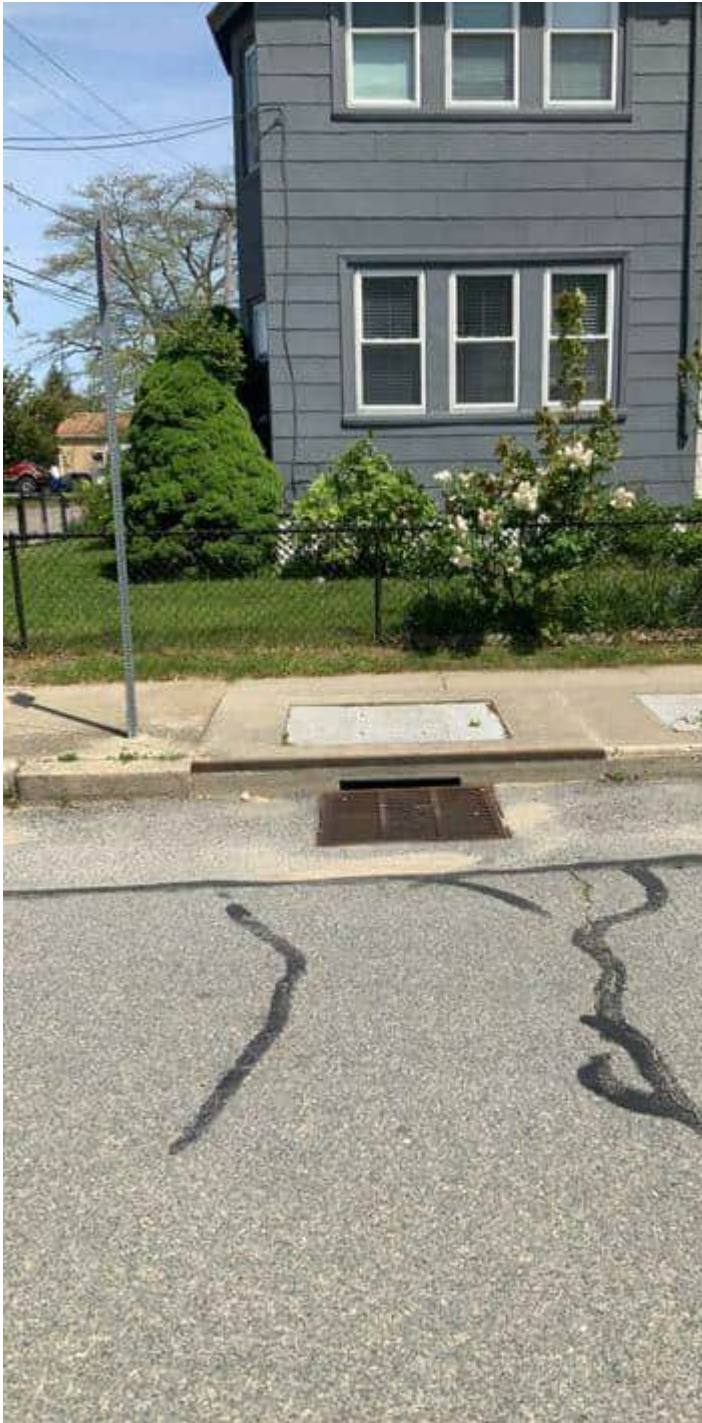
Outside tree box filter 1

| Problem | Description | Quantity | Completed (by) | Date |
|---|---|---|---|---|
| Vegetation/ Roots | Remove vegetation from inside tree boxes and sediment from grate | | | |
| Grate/ Cover | Clear grates of sediment and vegetation | | | |

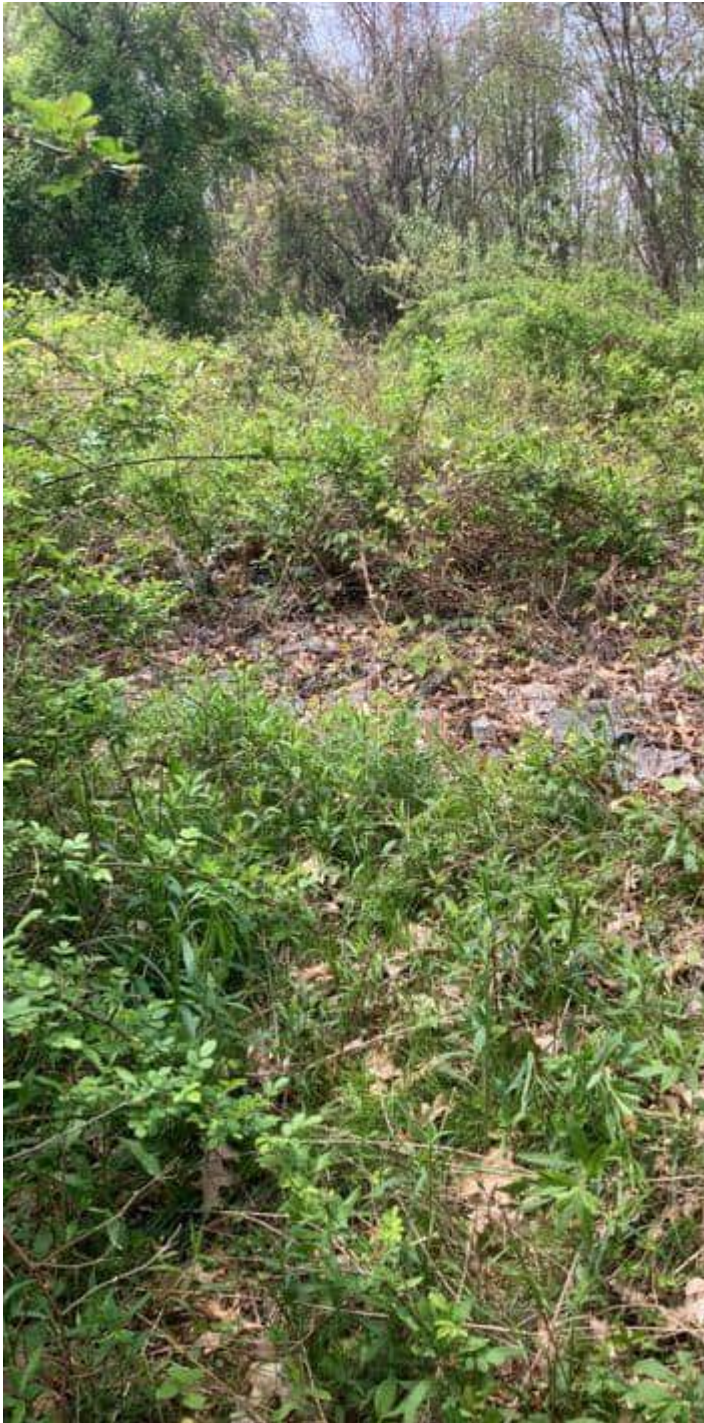
Basin outlet emergency spillway

| Problem | Description | Quantity | Completed (by) | Date |
|---|---|---|---|---|
| Vegetation | Severe overgrowth clear crush Ana vegetation | | | |

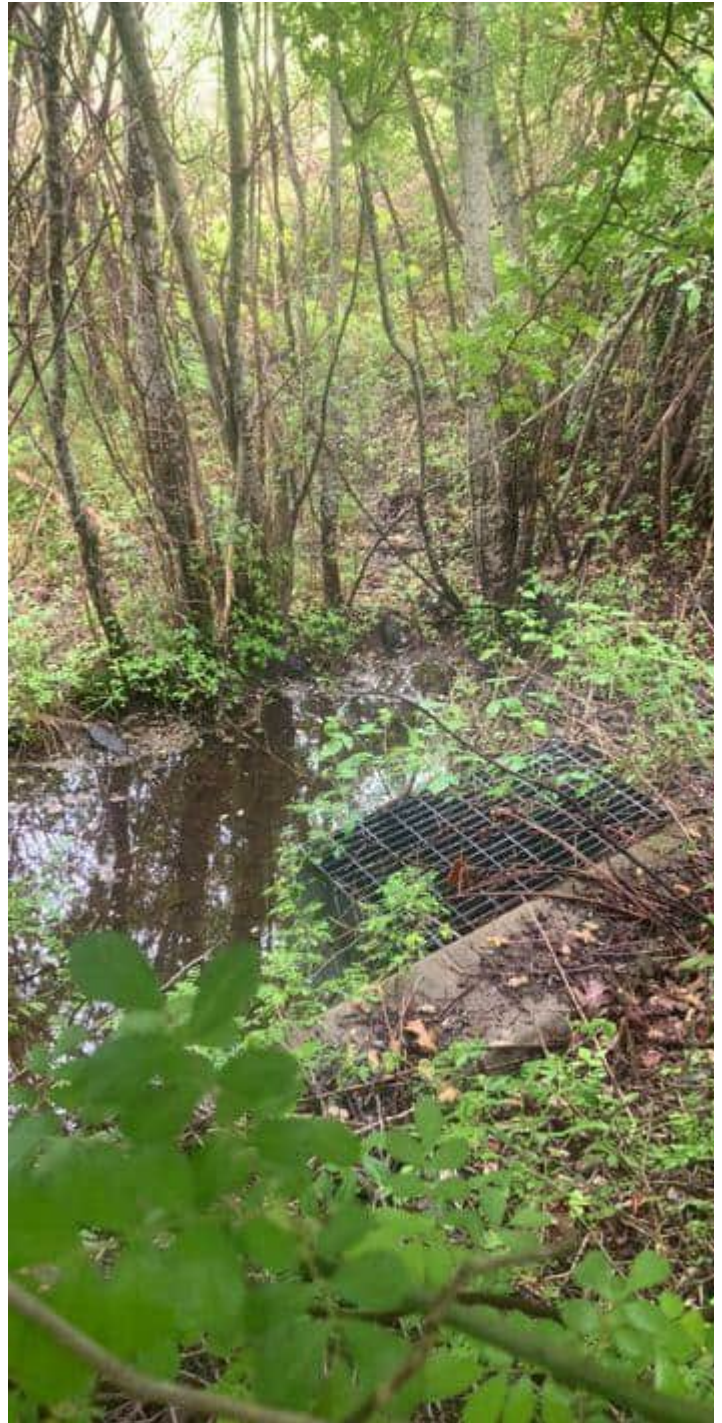
Basin Outfall Structure

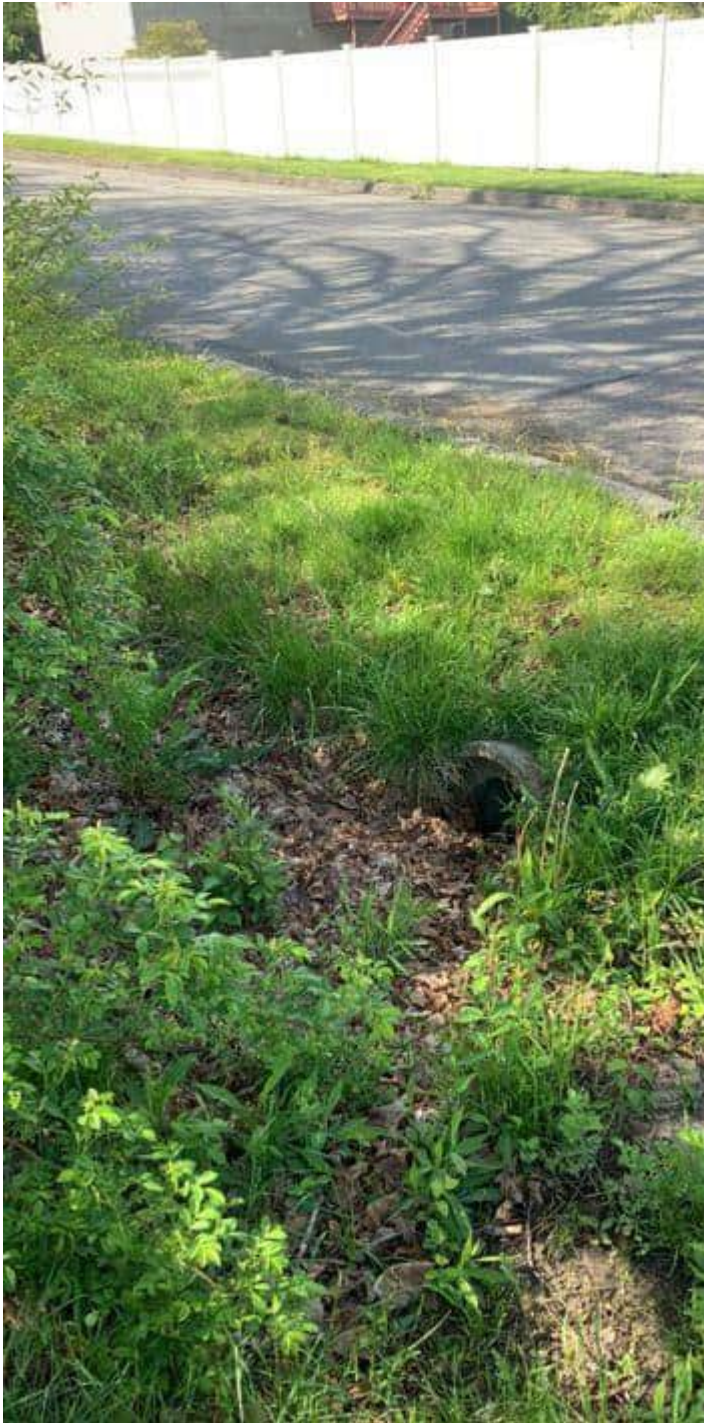
Infiltration trench outlet

| Problem | Description | Quantity | Completed (by) | Date |
|---|---|---|---|---|
| Sediment/ Debris | Remove debris and vegetation | | | |

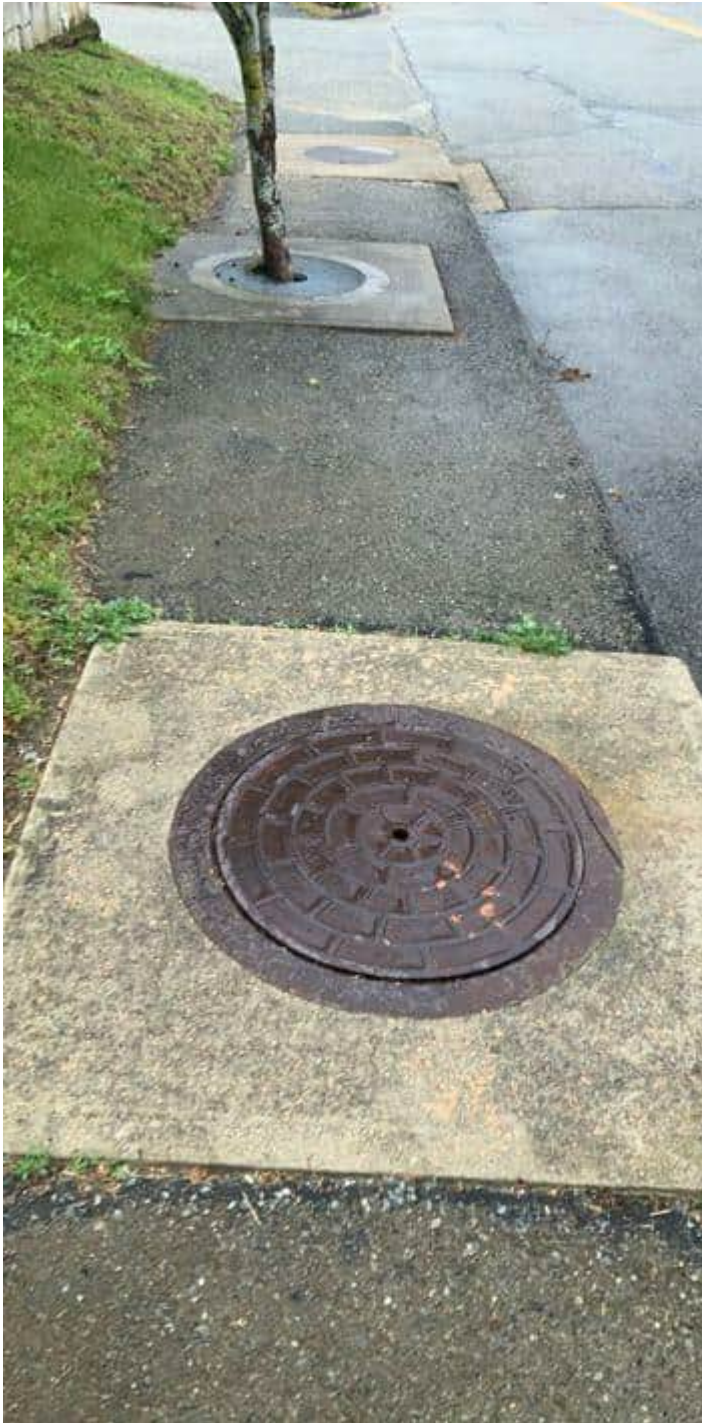
| Problem | Description | Quantity | Completed (by) | Date |
|---|---|---|---|---|
| Other | Foamy water and grey sheen | | | |

Outside pretreatment sump

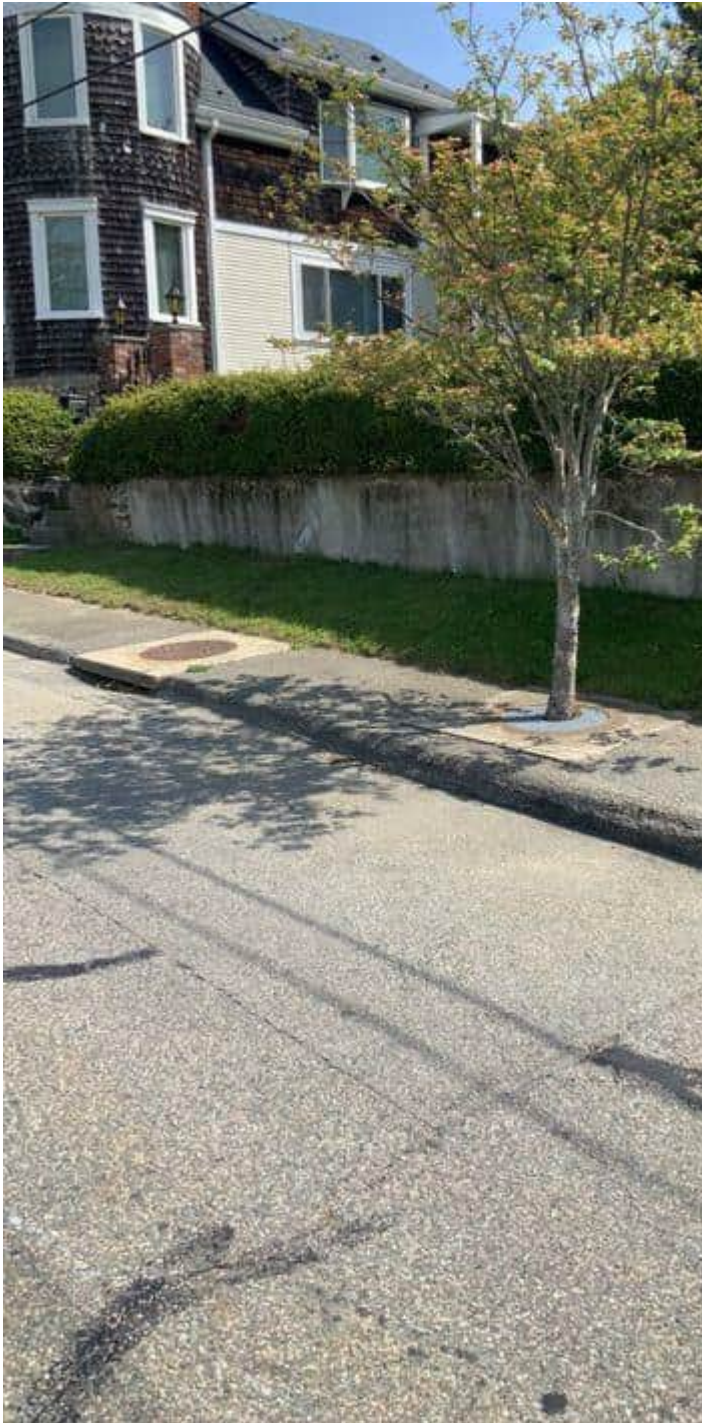
| Problem | Description | Quantity | Completed (by) | Date |
|---|---|---|---|---|
| Sediment/ Debris | Remove debris | | | |

Outside tree box filter

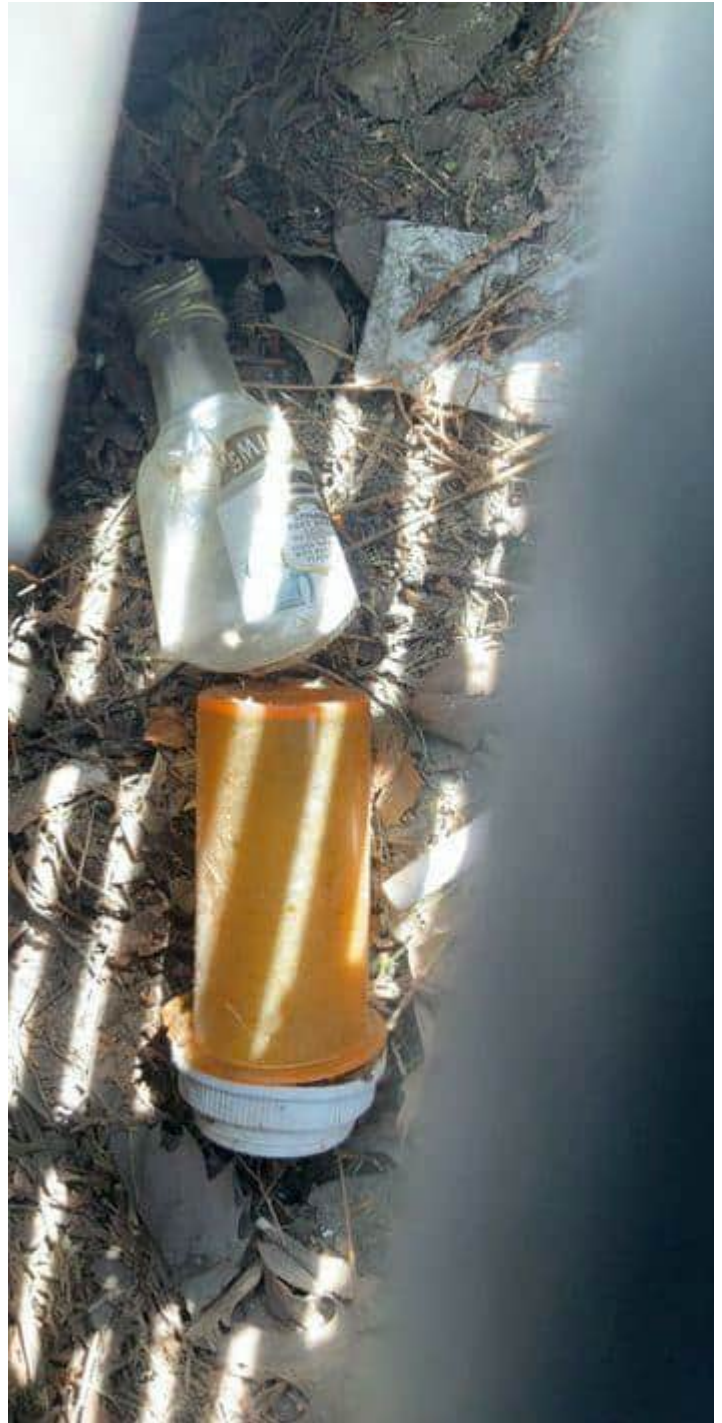
Inside tree box filter

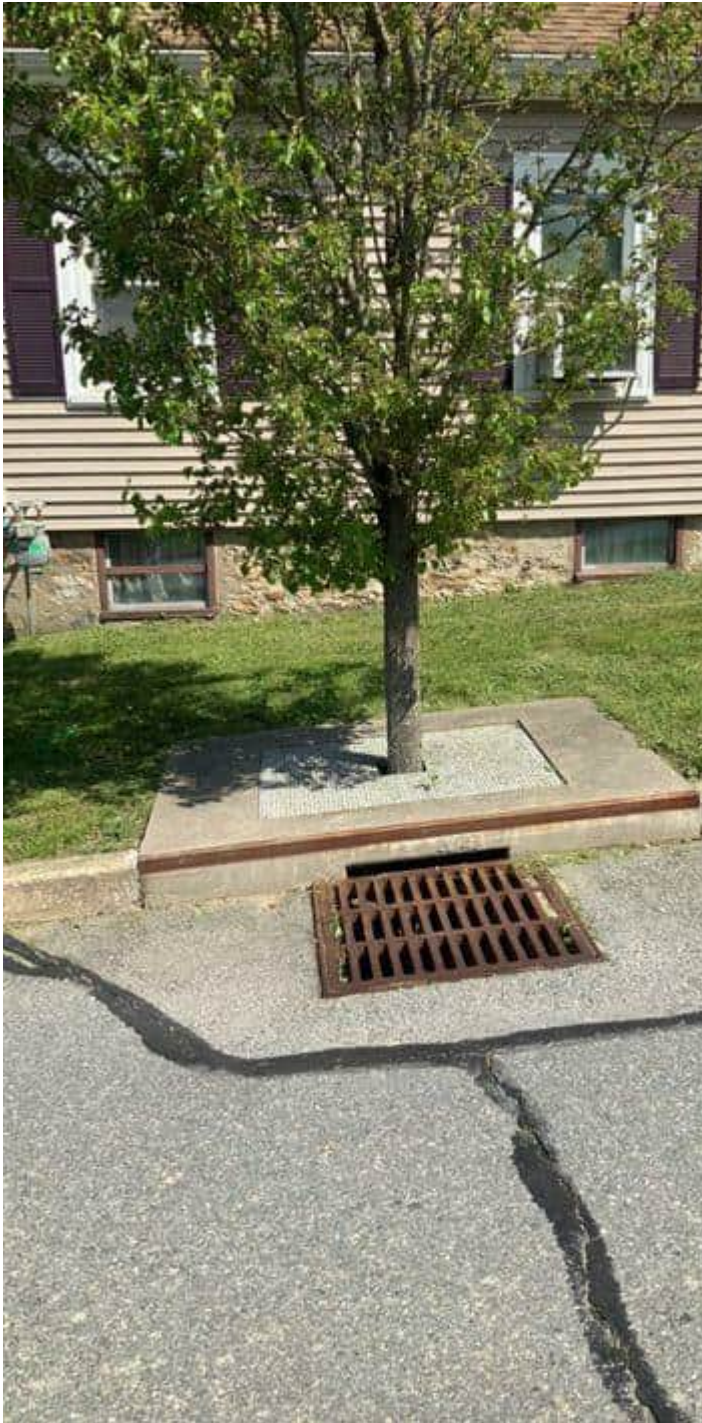
| Problem | Description | Quantity | Completed (by) | Date |
|---|---|---|---|---|
| Sediment/ Debris | Clean debris and sediment | | | |

Outside tree box filter

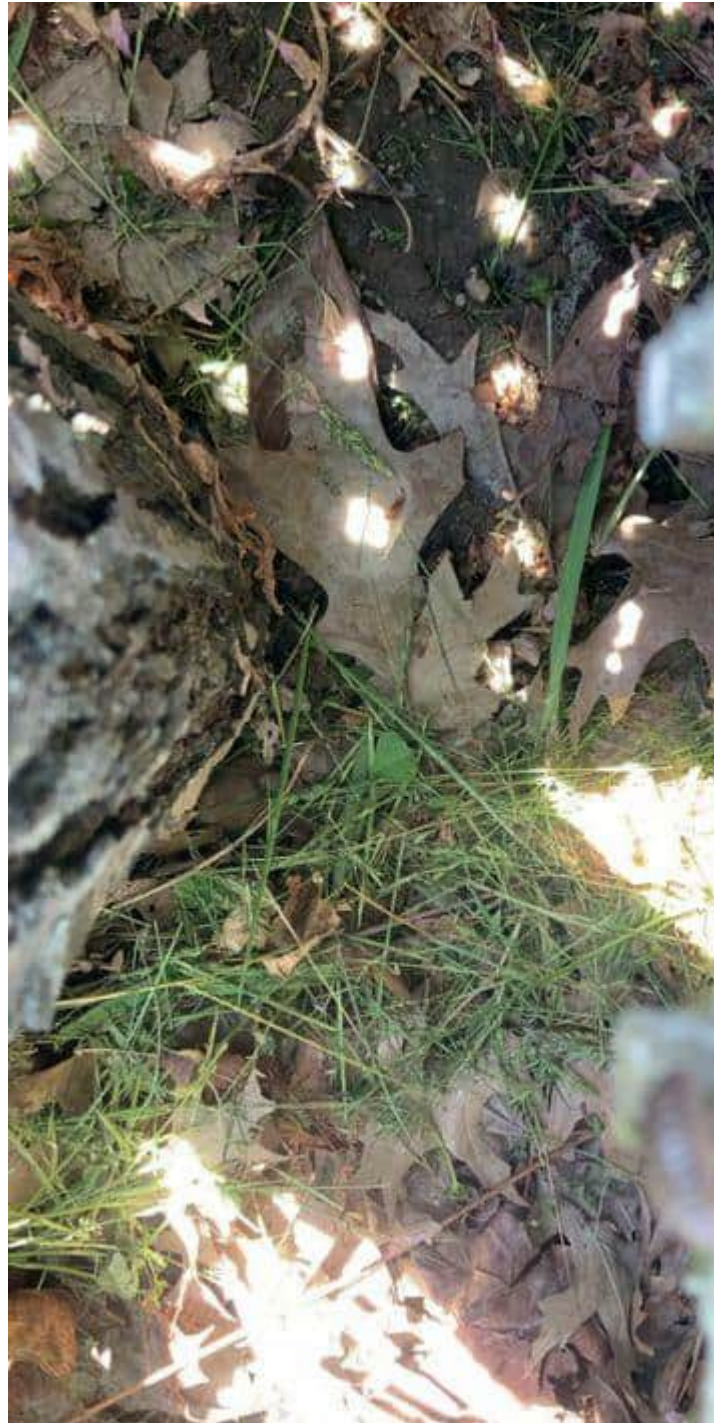
Inside tree box filter

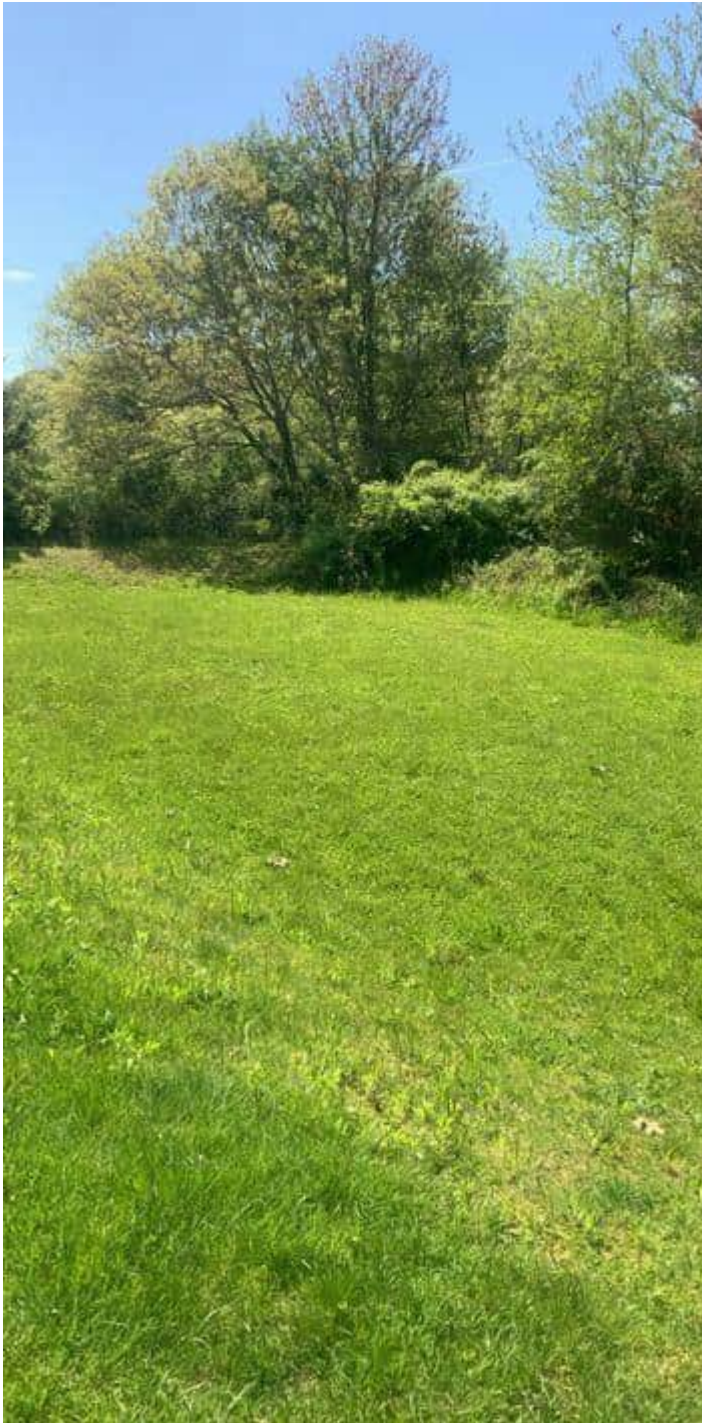
| Problem | Description | Quantity | Completed (by) | Date |
|---|---|---|---|---|
| Sediment/Debris | Remove leaves and tree debris | | | |

End of basin

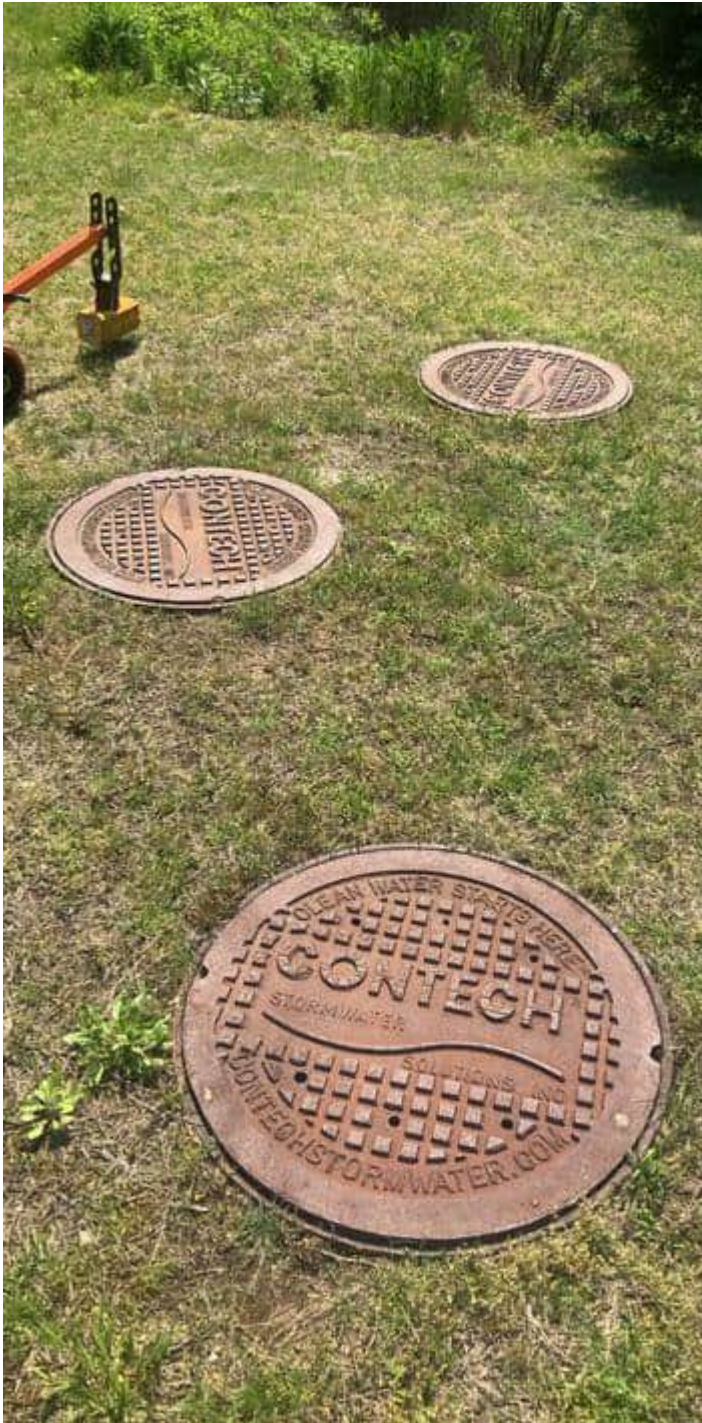
| Problem | Description | Quantity | Completed (by) | Date |
|---|---|---|---|---|
| Sediment/ Debris | Remove trash | | | |

Outside water quality unit

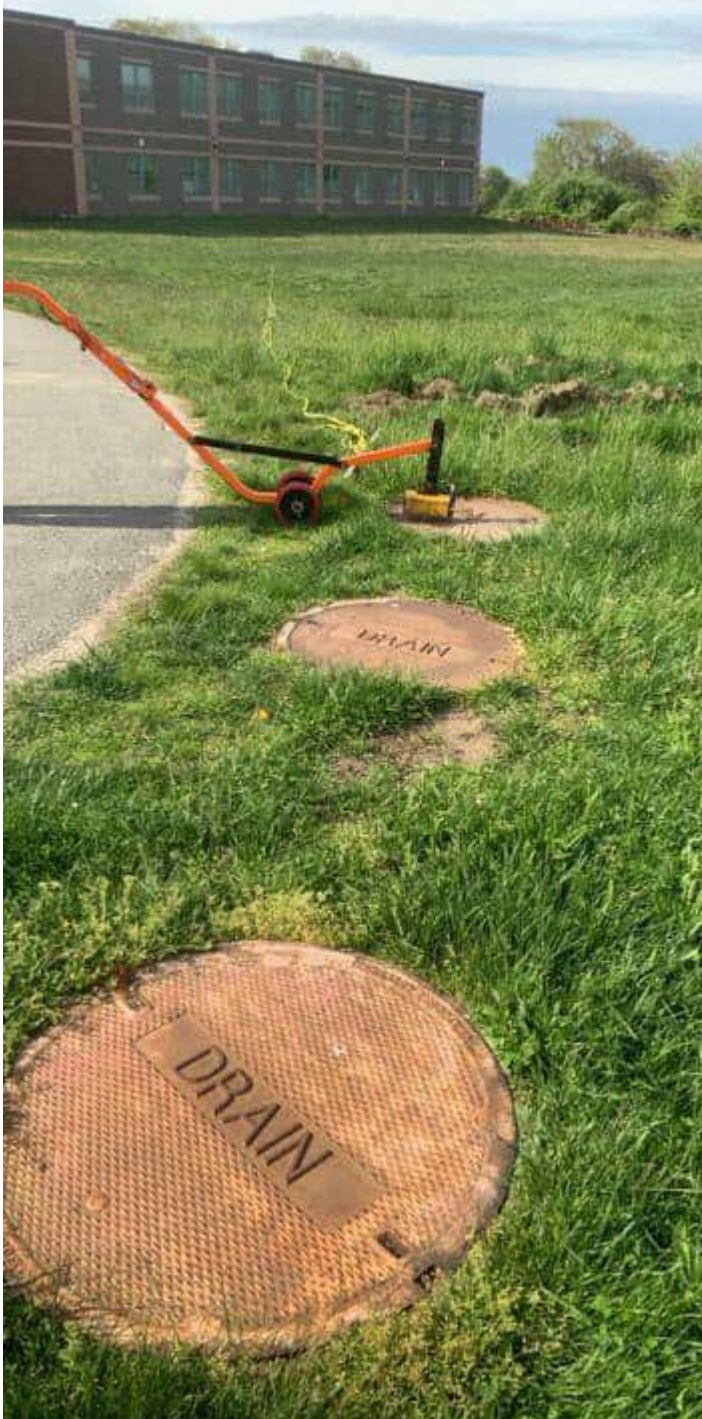
| Problem | Description | Quantity | Completed (by) | Date |
|---|---|---|---|---|
| Structure | Reset frame and cover | | | |

3 manholes of the water quality unit

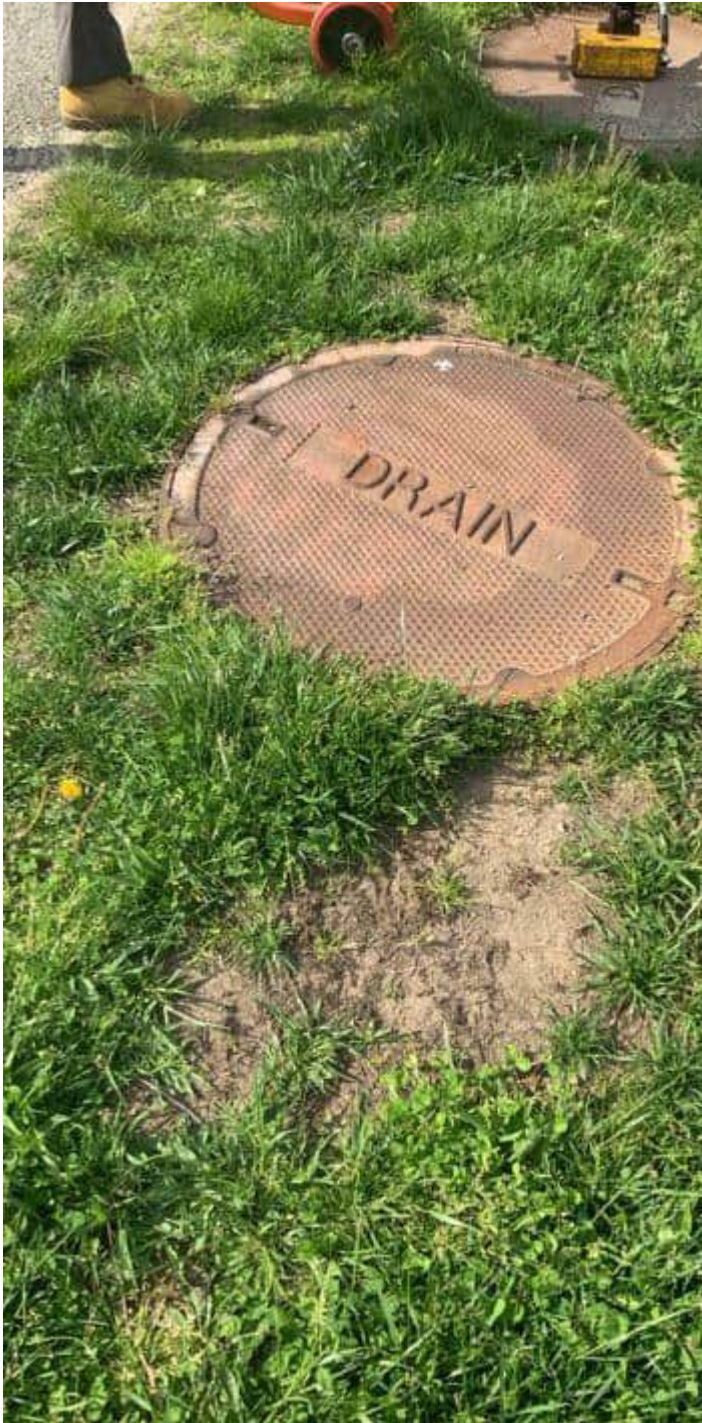
Outside second manhole

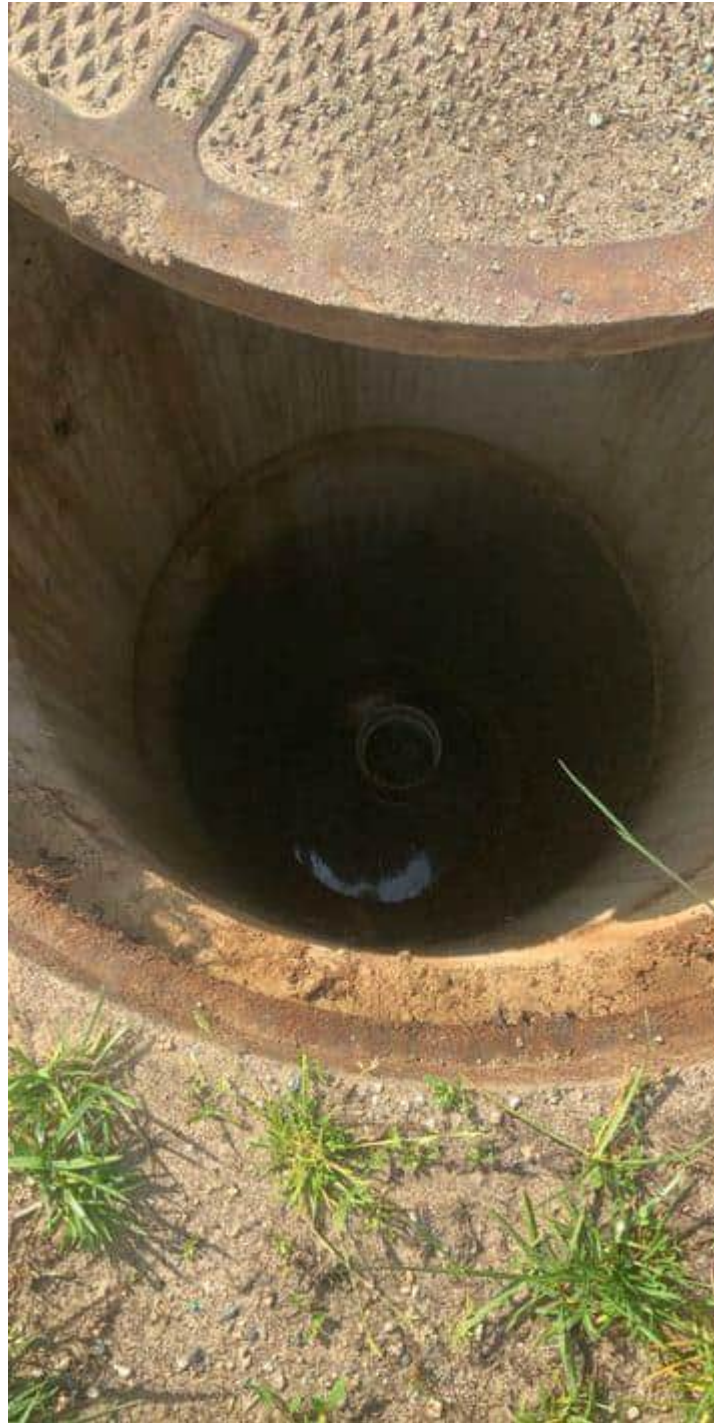
Inside outlet manhole

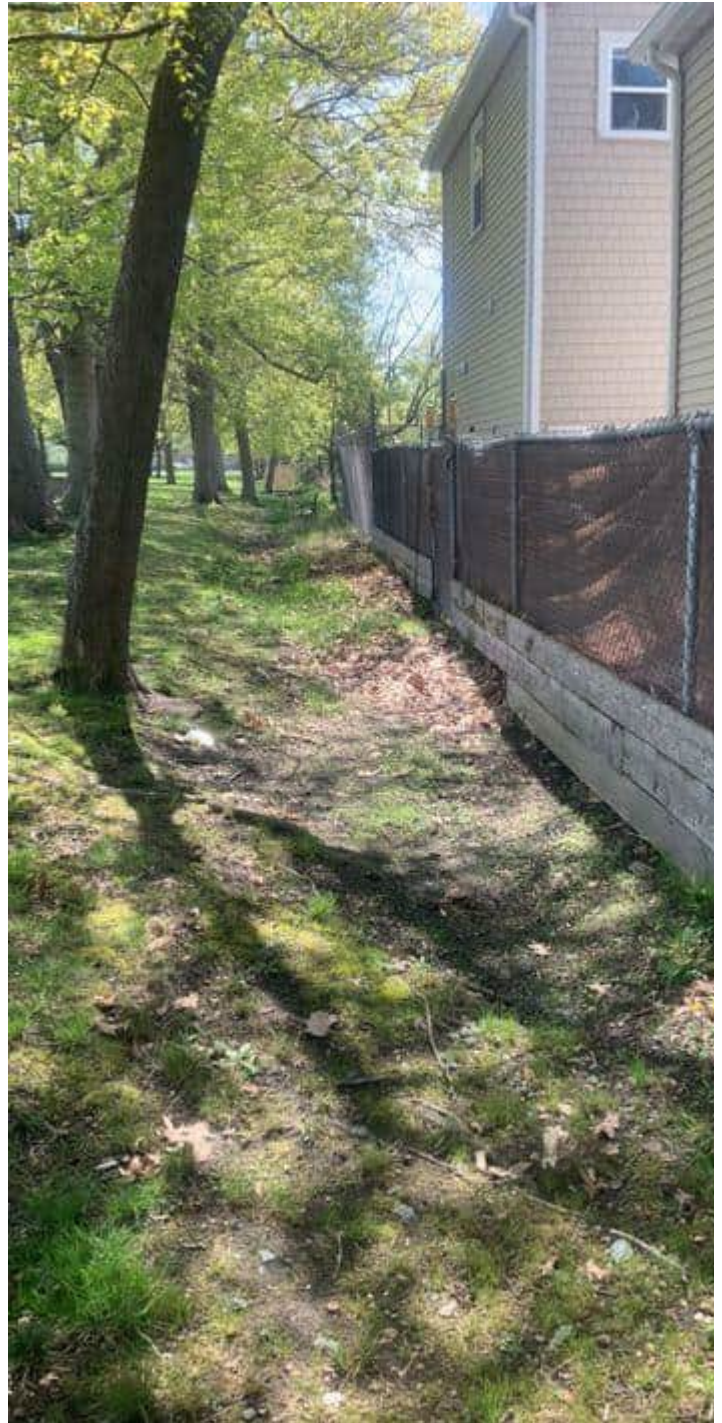
Section of swale leading to infiltration basin

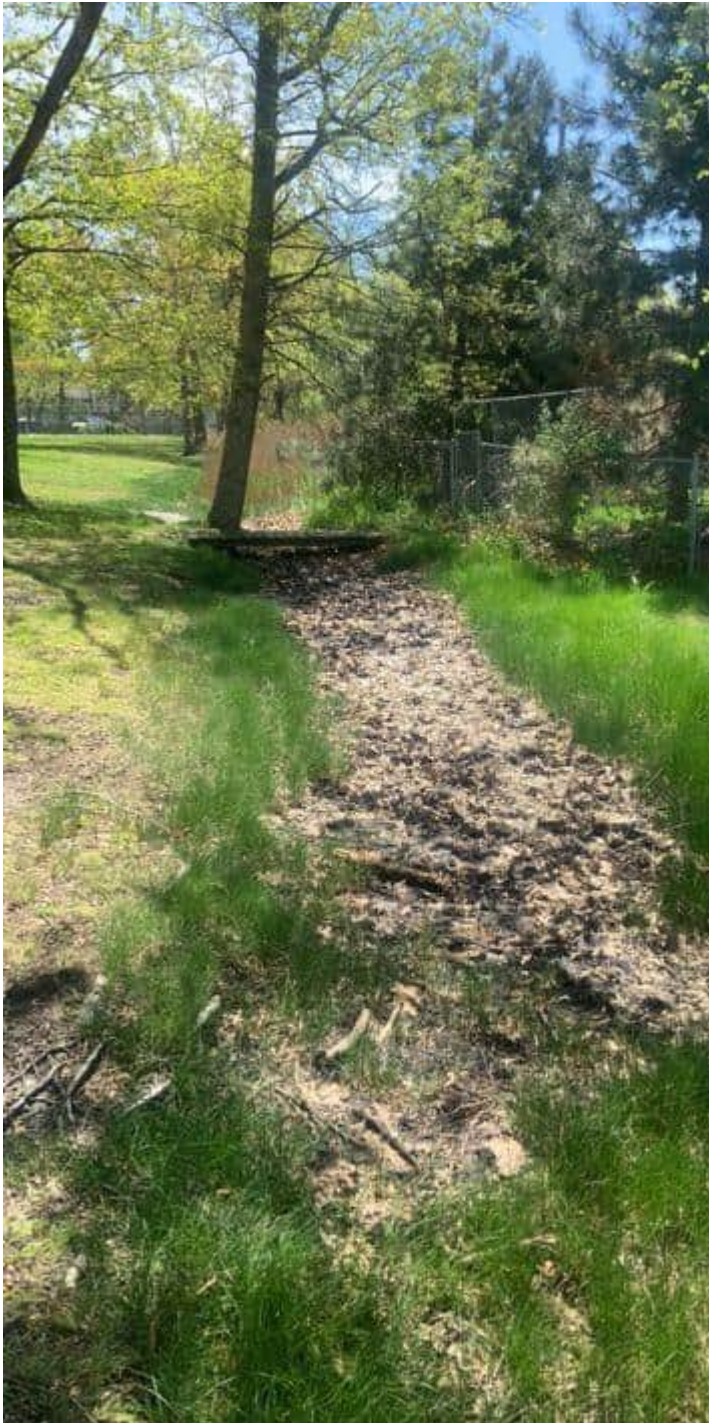
Section of swale leading to infiltration basin

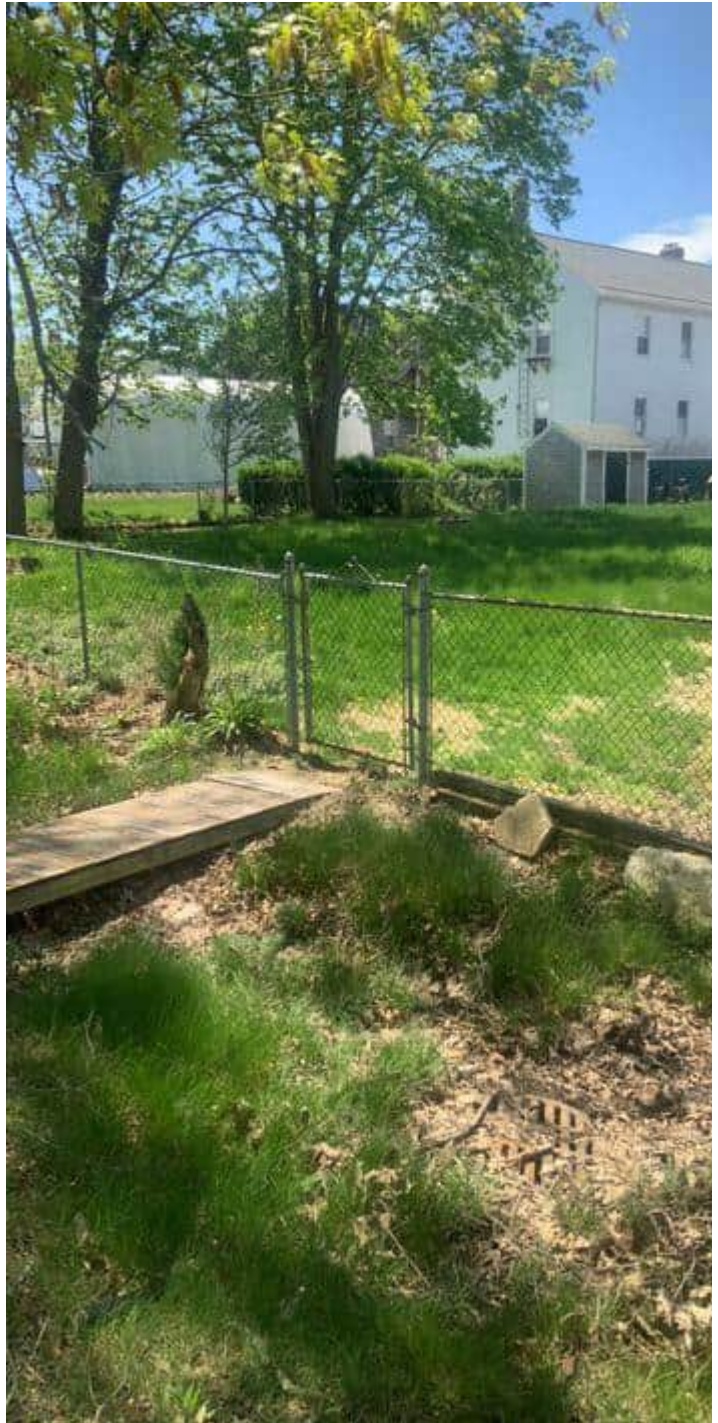
Leaching catch basin in swale
