| Facility Name | Location | BMP/Feature Description | Inspection Date | Recommended Maintenance | Action Taken |

Town of Fairhaven

**STORM WATER BMP INSPECTION FORM**

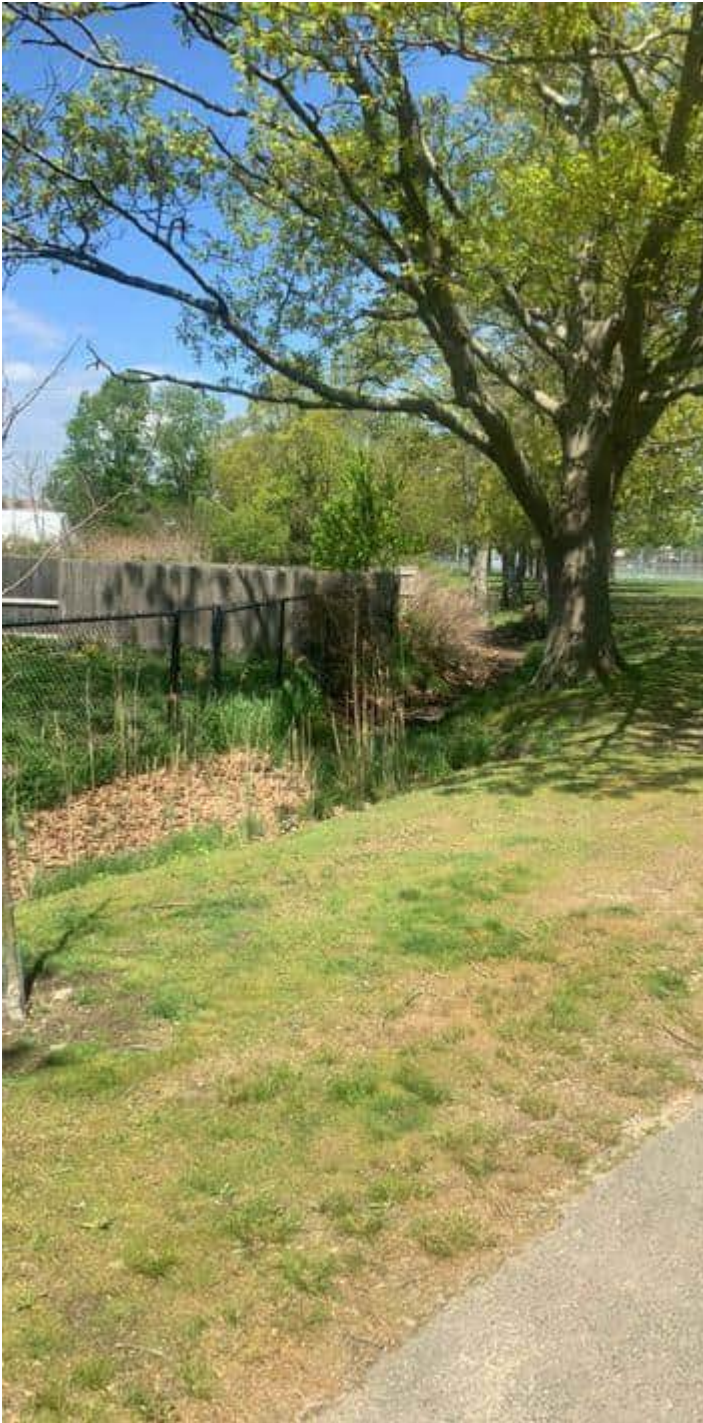
Section of swale leading to infiltration basin

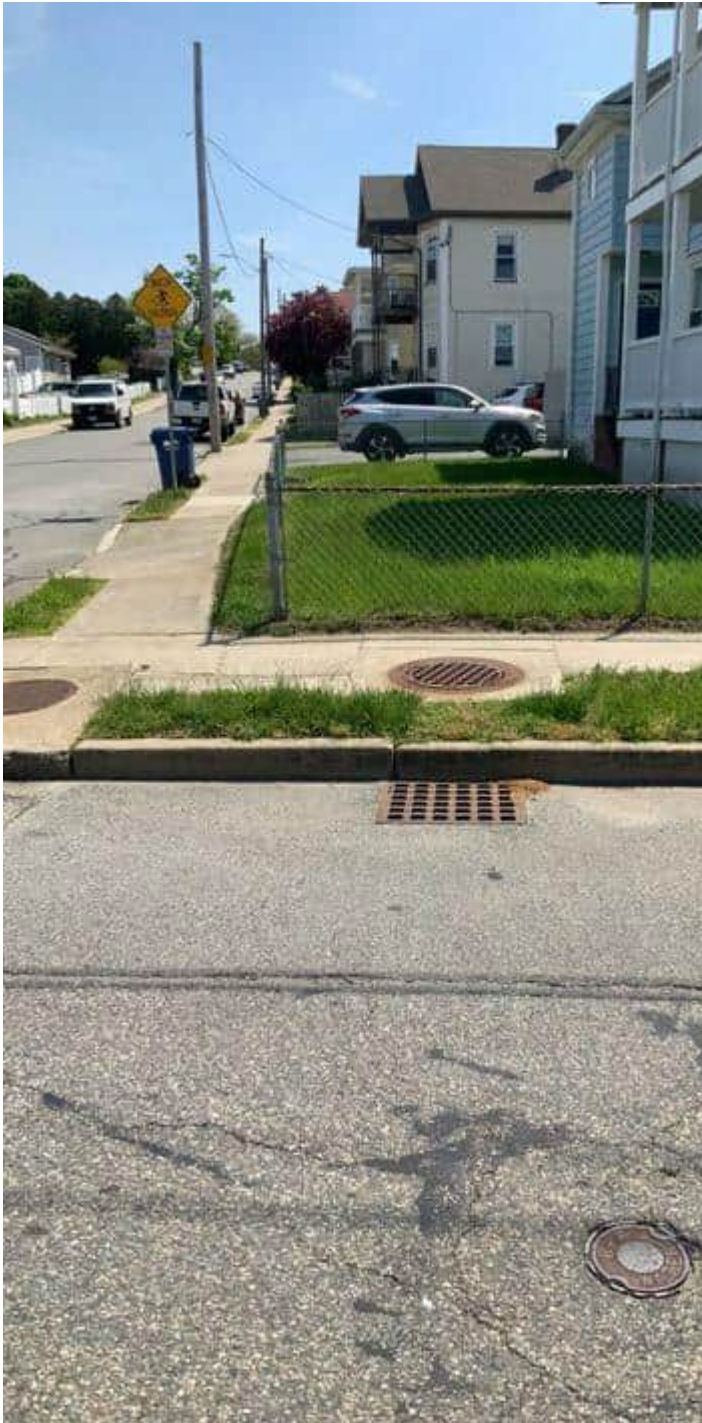
| Problem | Description | Quantity | Completed (by) | Date |
|---|---|---|---|---|
| Sediment/Debris | Remove sediment and debris from structures | | | |

Outside tree box filter

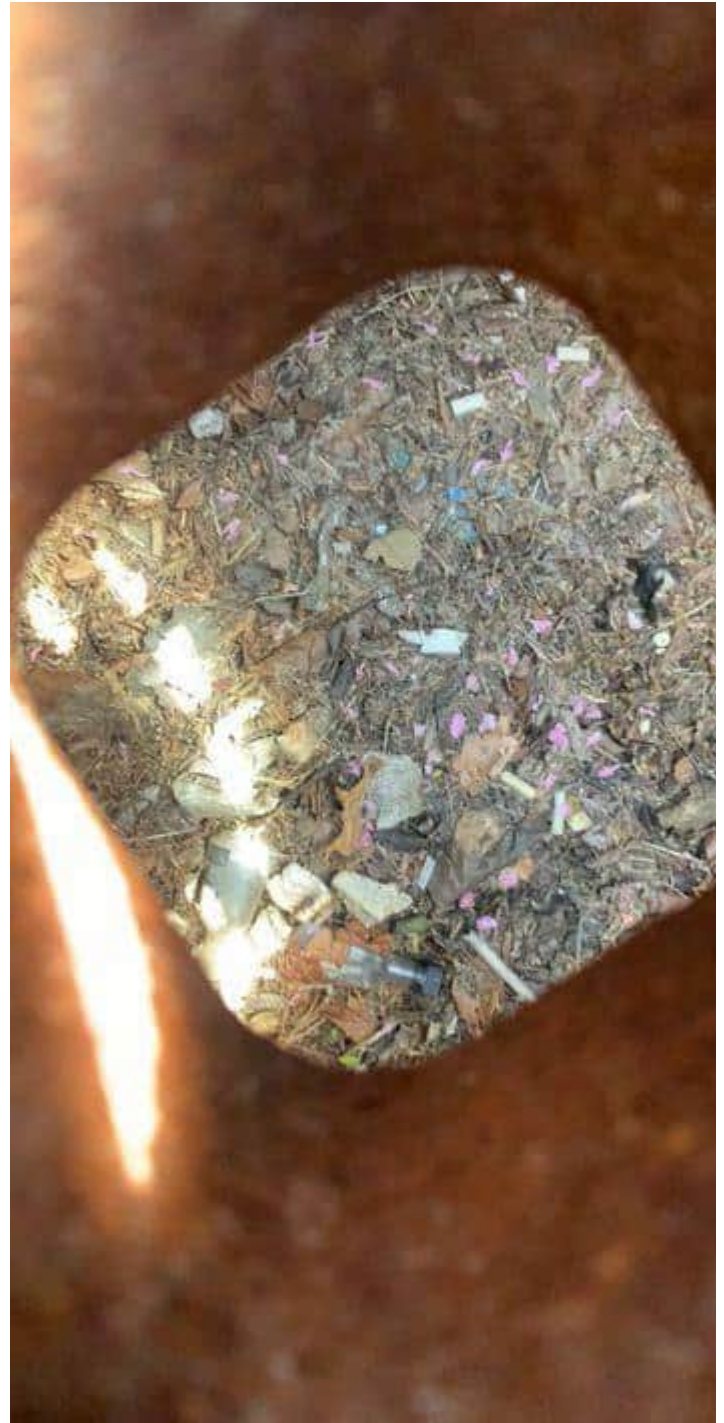
Inside tree box filter

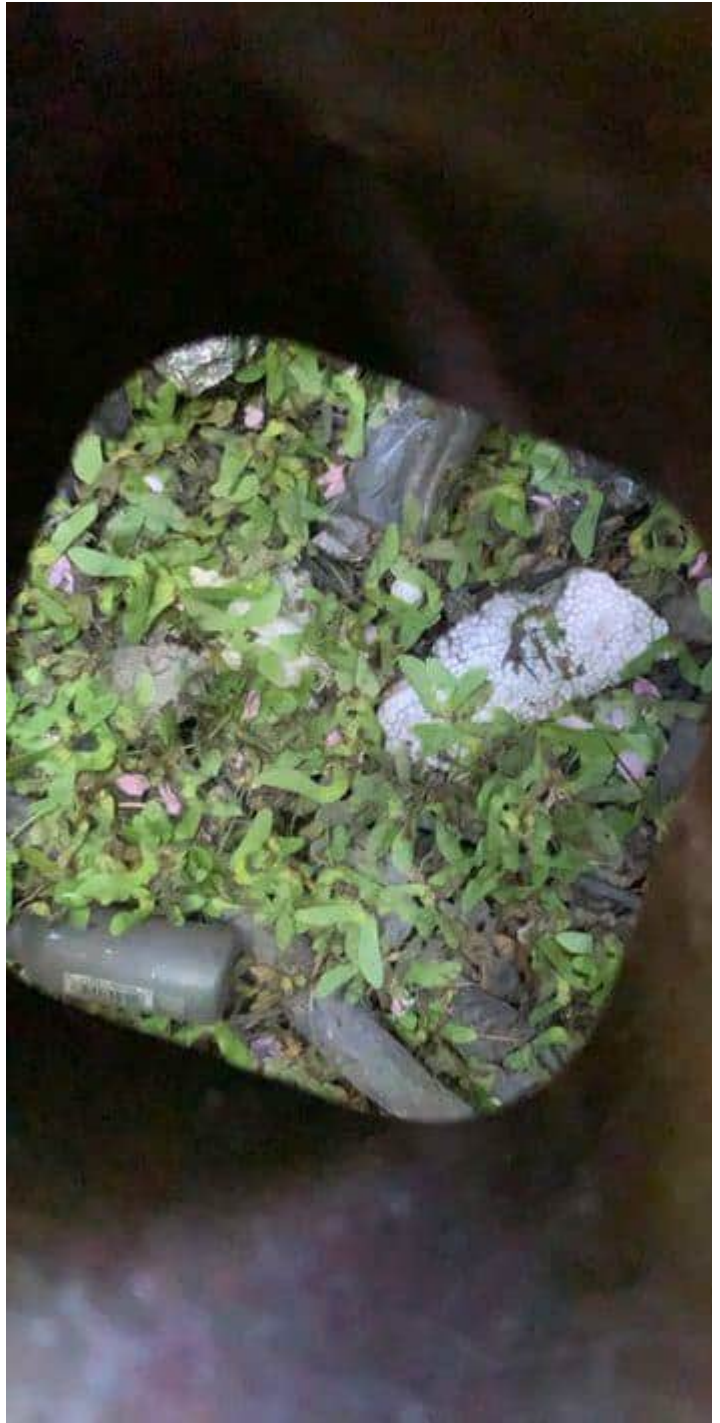
| Problem | Description | Quantity | Completed (by) | Date |
|---|---|---|---|---|
| Sediment/Debris | Remove sediment and debris from structures | | | |

Inside tree box filter
