**PUBLIC FACILITIES IMPROVEMENT PLAN
FAIRHAVEN, MA
JANUARY 23, 2018**

MASTER PLANNING PROCESS: PUBLIC SAFETY

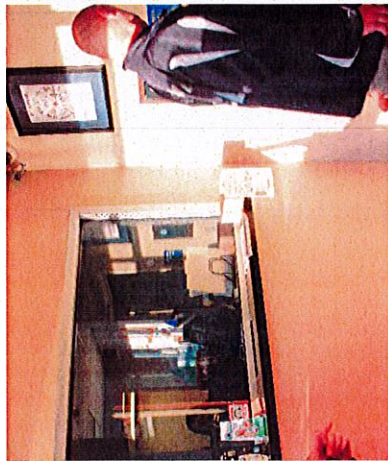
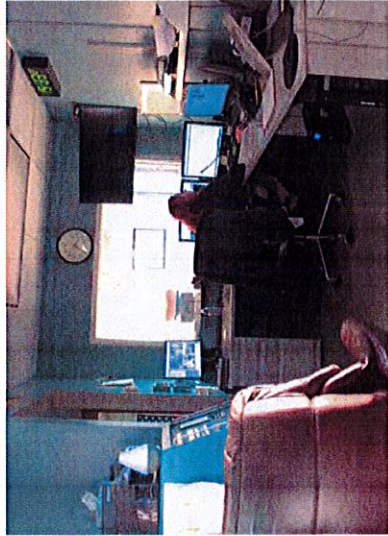
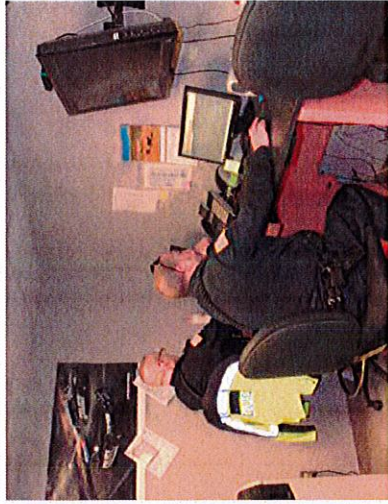
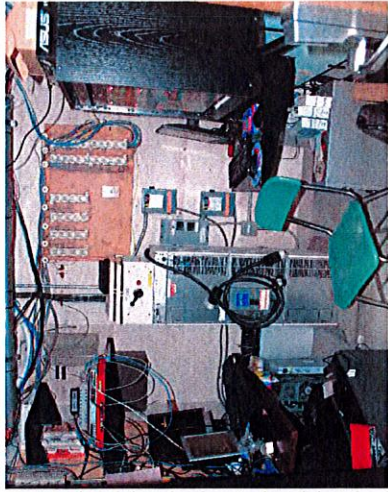
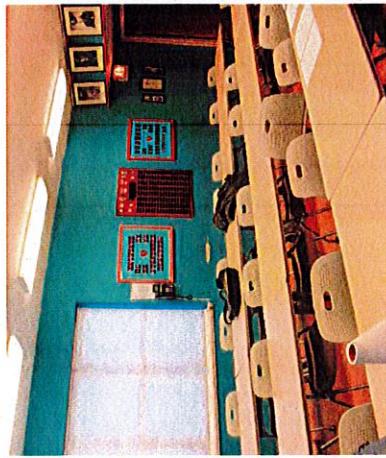
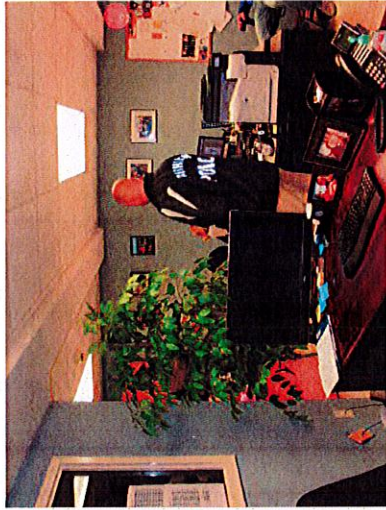
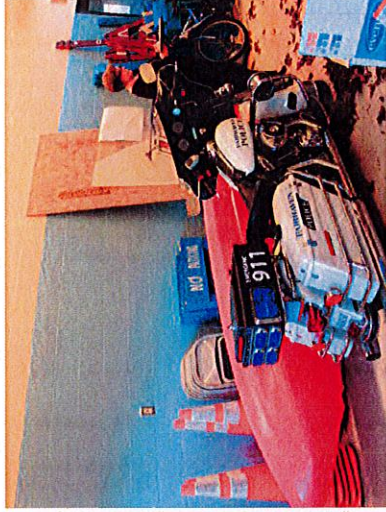
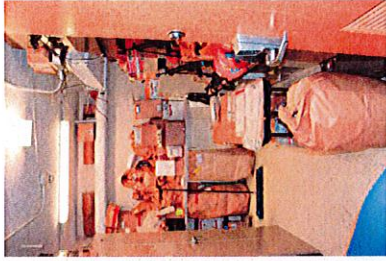
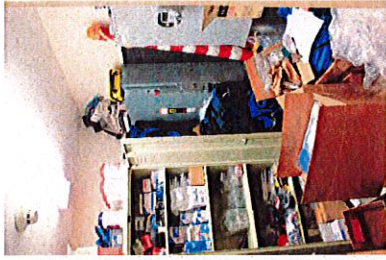
MASTER PLANNING PROCESS: PUBLIC SAFETY – ARCHITECTURAL EXISTING CONDITIONS

- **Exterior Envelope:**
 - Brick in excellent condition.
 - Some rotting of wood trim; soffits in good condition.
 - Insulation in additions is indicated; original building unknown.
 - Some rusting of lintels and HM doors at grade.
 - Stairs/ramp at PD entry show signs of settling; expansion joint deteriorating; lack of flashings.
- **Interior Finishes:**
 - Latest addition in very good condition.
 - Finishes in existing building in good to fair condition; some ponding of floors and stained ceilings indicate issues.
 - Some flooding in PD basement.
 - Some non-compliant hardware, service counters and stair/railing assemblies.
 - Spaces are generally too small to fit current programmatic needs.
