| Facility Name | Location | BMP/Feature Description | Inspection Date | Recommended Maintenance | Action Taken |

Town of Fairhaven

**STORM WATER BMP INSPECTION FORM**

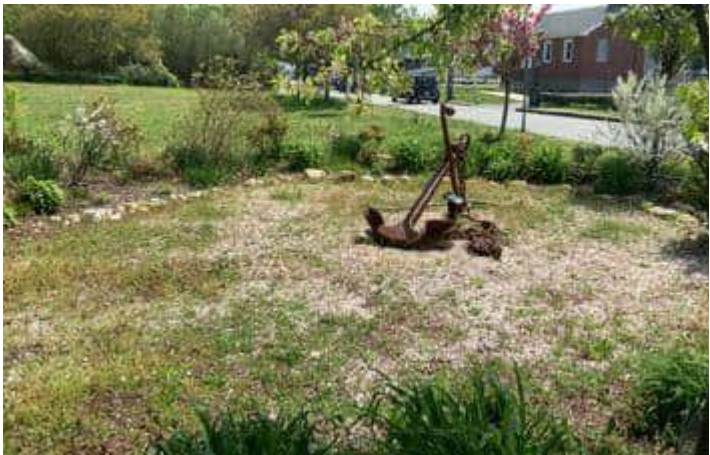
Bioretention

| Problem | Description | Quantity | Completed (by) | Date |
|---|---|---|---|---|
| Sediment/ Debris | Clean sediment and debris from inlet channel | | | |

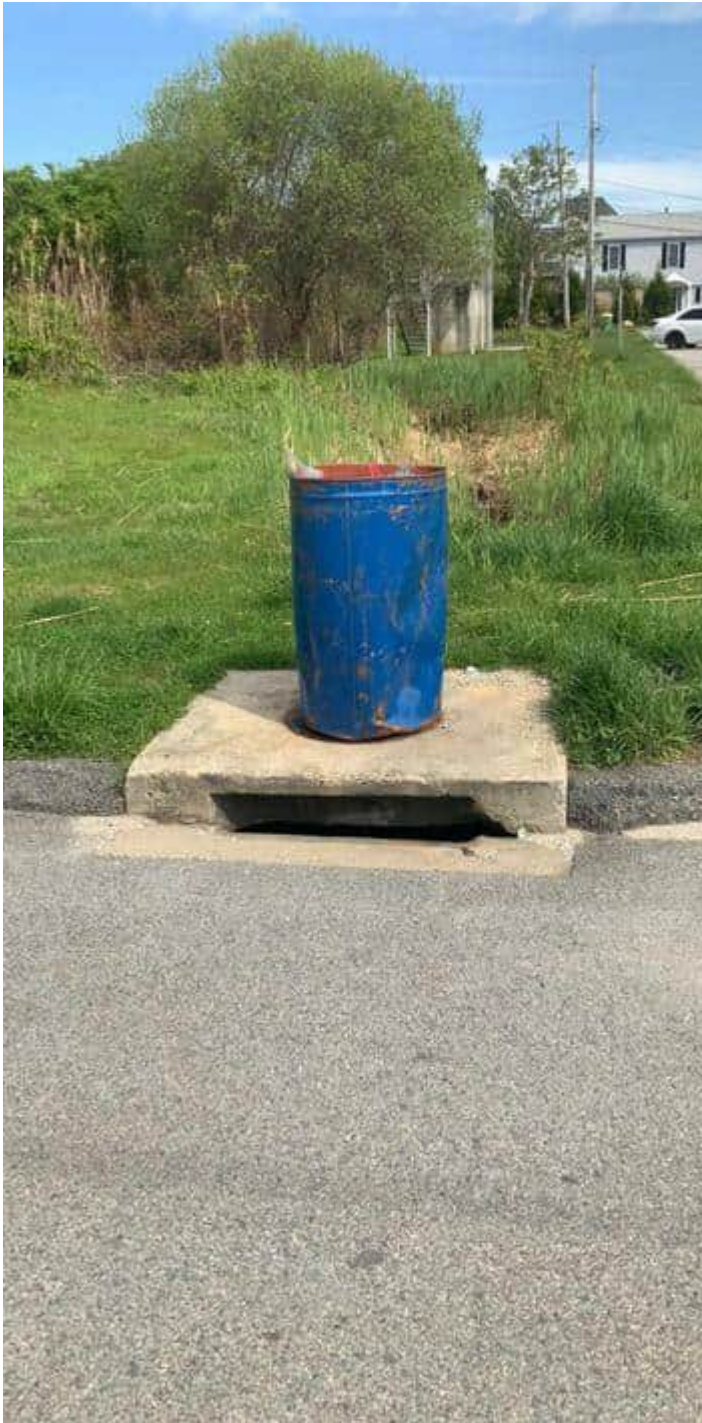
Clean inlet to Swale

| Problem | Description | Quantity | Completed (by) | Date |
|---|---|---|---|---|
| Other | Clean vegetation and sediment swale | | | |

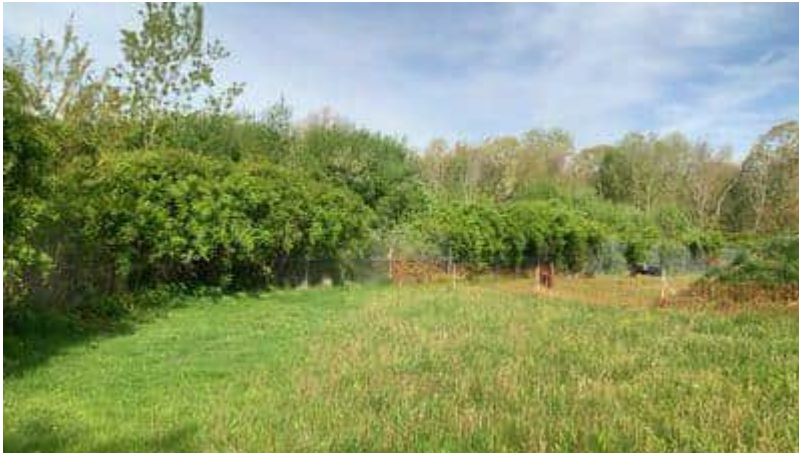
Detention basin

| Problem | Description | Quantity | Completed (by) | Date |
|---|---|---|---|---|
| Fence | Cannot access due to excess vegetation | | | |

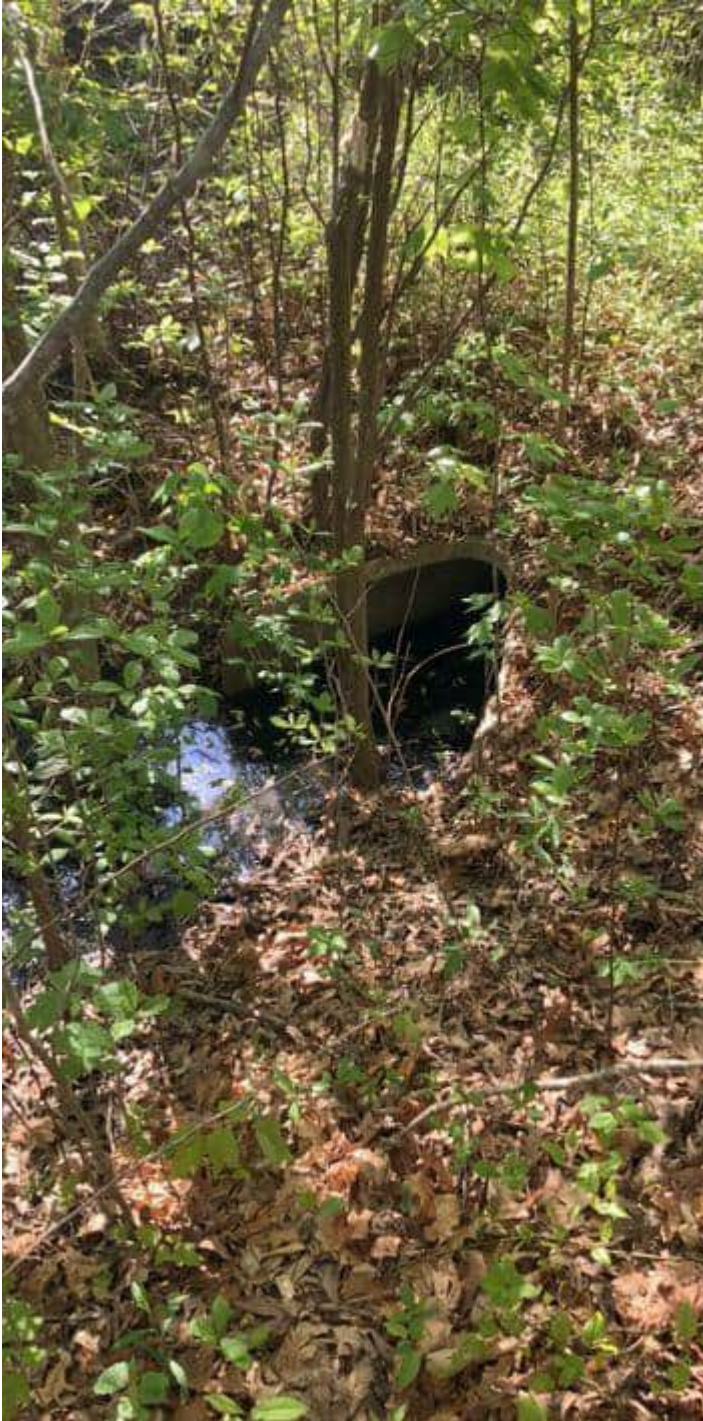
Basin outlet

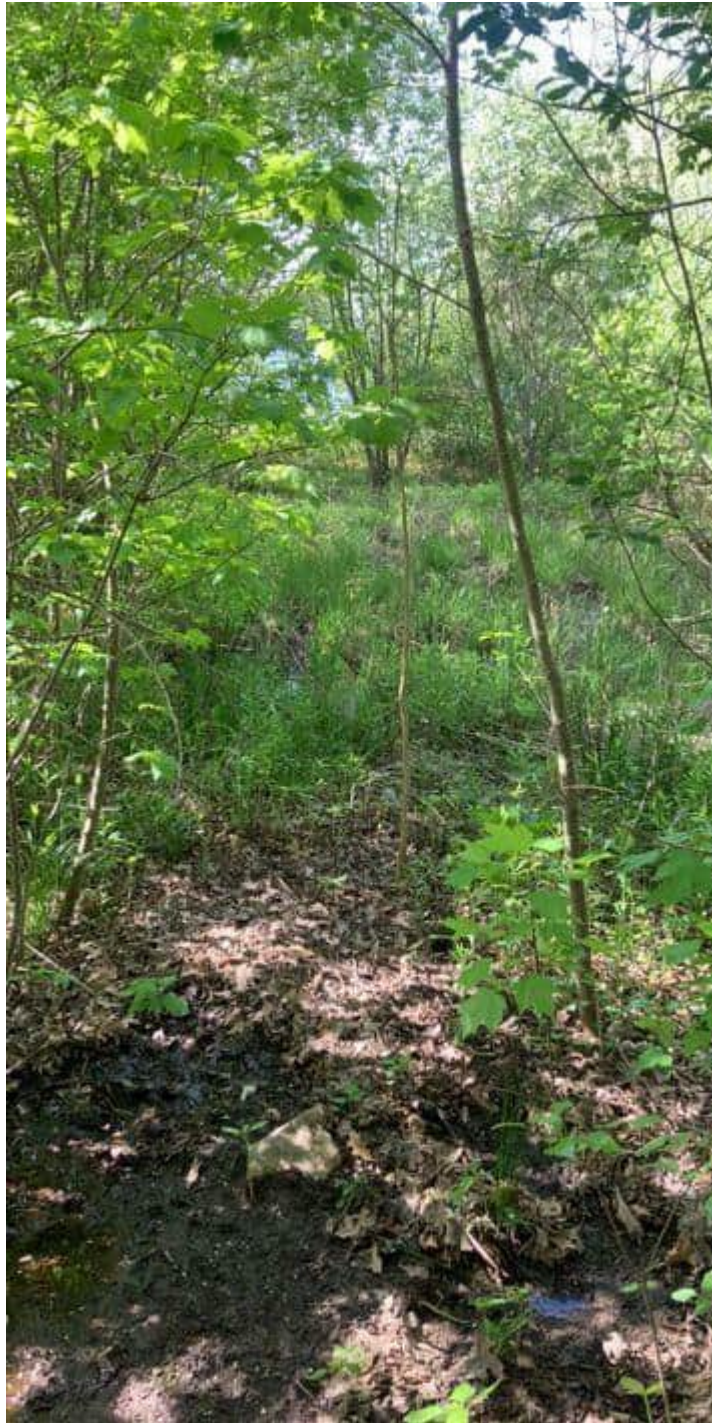
Detention basin

| Problem | Description | Quantity | Completed (by) | Date |
|---|---|---|---|---|
| Inlet | Clear trees and sediment | | | |

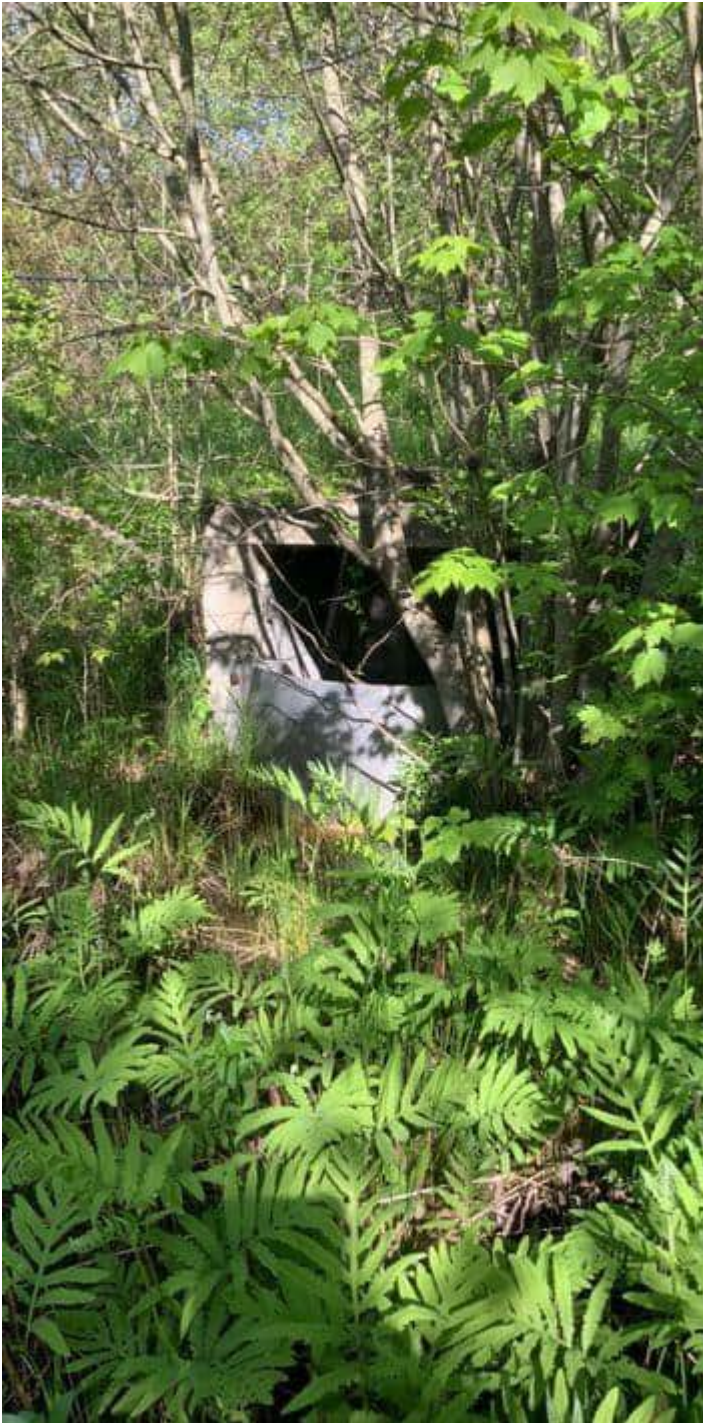
Basin outlet

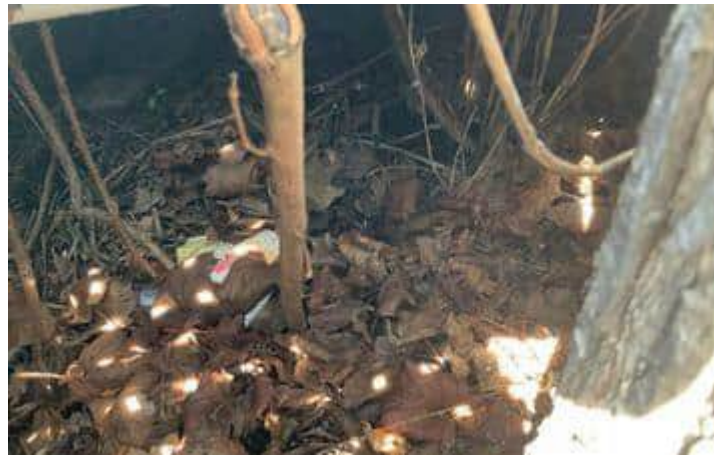
Inside tree box filter 1

| Problem | Description | Quantity | Completed (by) | Date |
|---|---|---|---|---|
| Sediment/Debris | Remove debris, trash and vegetation | | | |

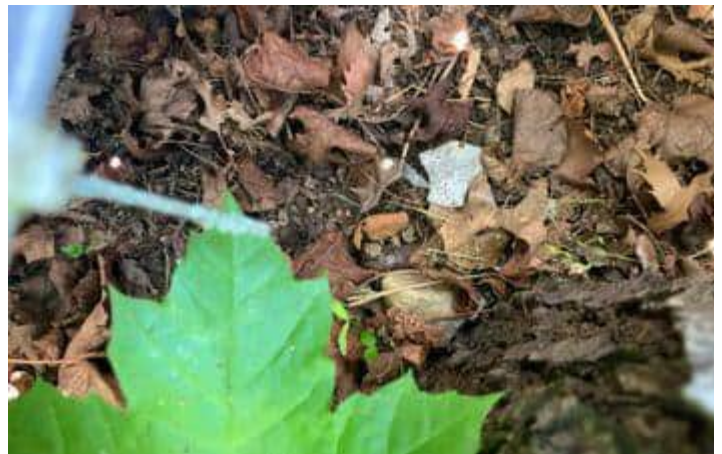
Inside tree box filter 2

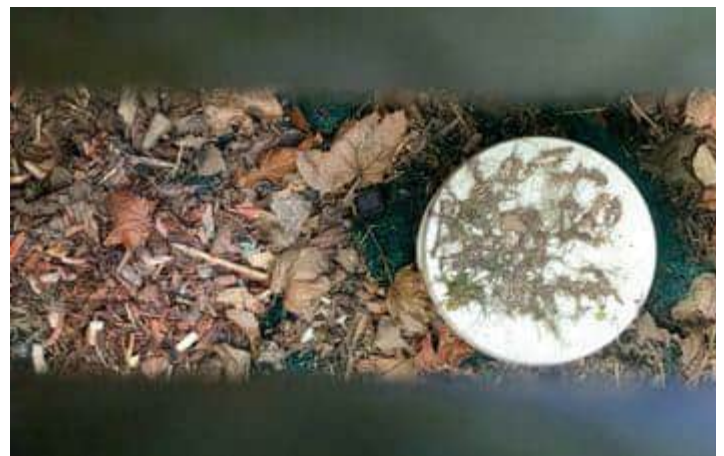
Inside tree box filter 2

| Problem | Description | Quantity | Completed (by) | Date |
|---|---|---|---|---|
| Sediment/ Debris | Remove debris inside tree box | | | |

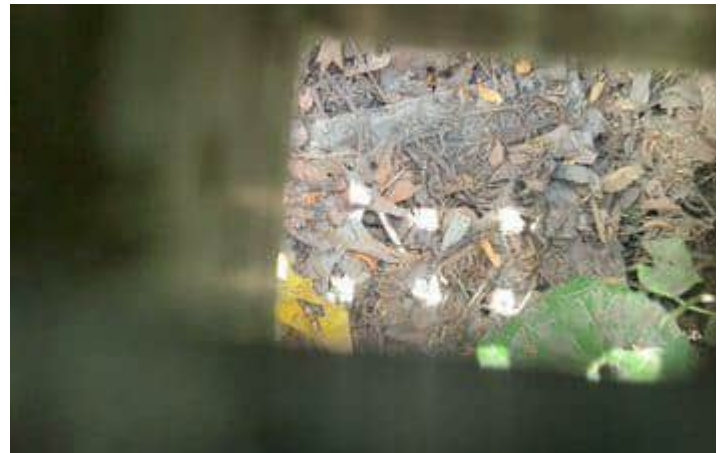
Inside tree box filter 1

| Problem | Description | Quantity | Completed (by) | Date |
|---|---|---|---|---|
| Vegetation/ Roots | Remove vegetation from inside tree boxes and sediment from grate | | | |
| Grate/ Cover | Clear grates of sediment and vegetation | | | |

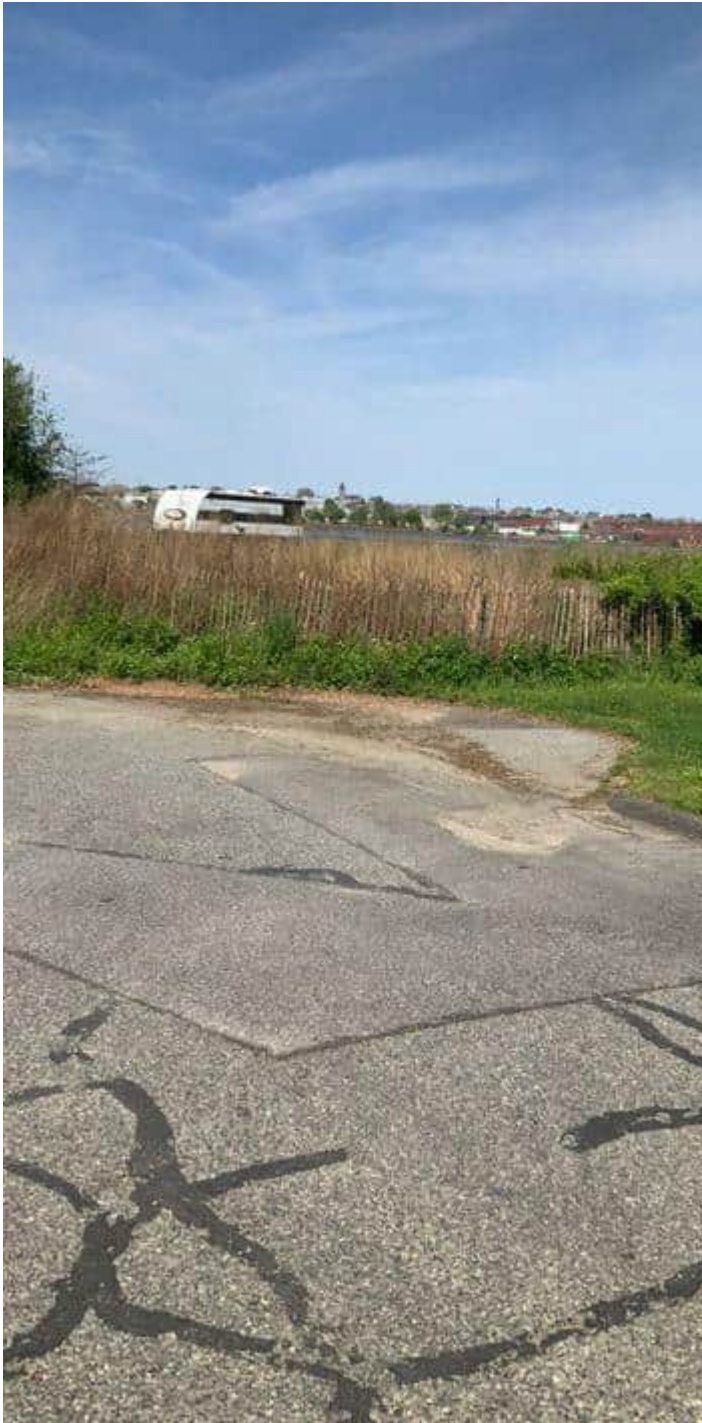
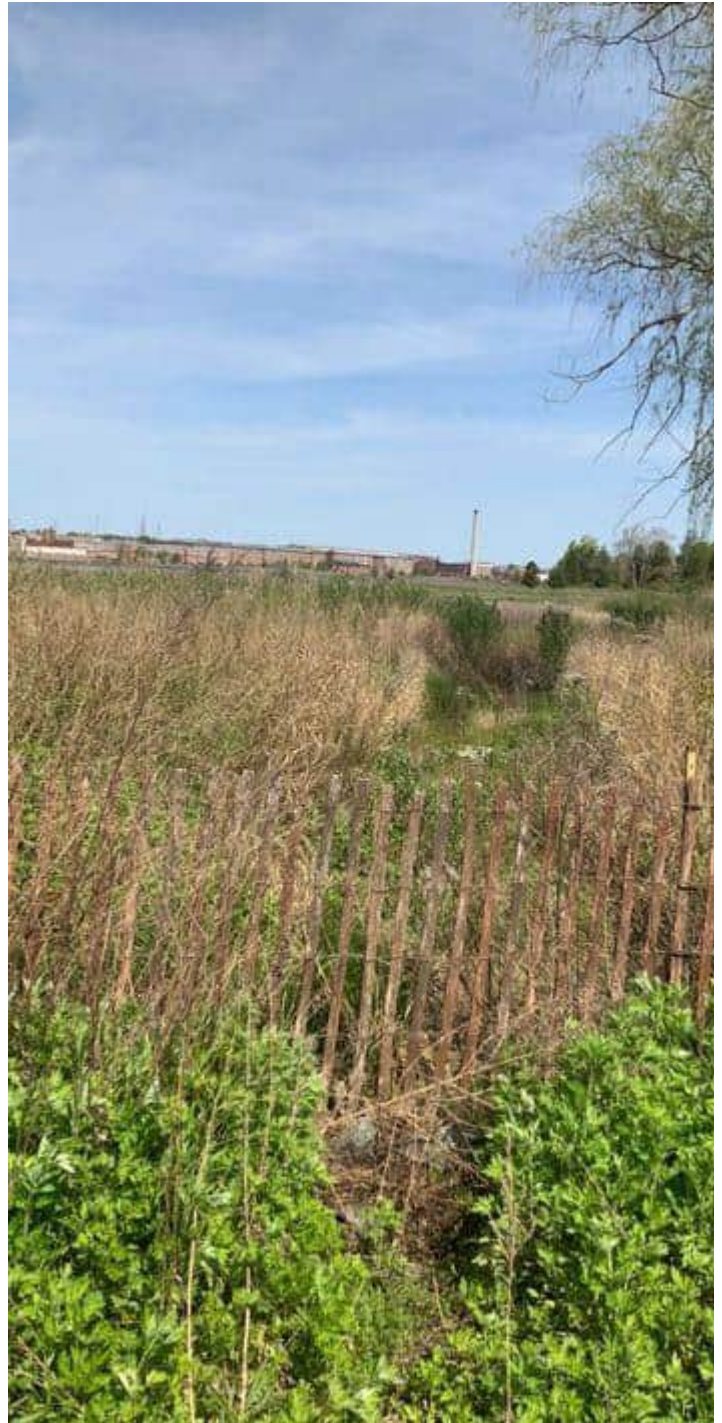
Swale entrance

| Problem | Description | Quantity | Completed (by) | Date |
|---|---|---|---|---|
| Vegetation | Clean vegetation from Swale | | | |

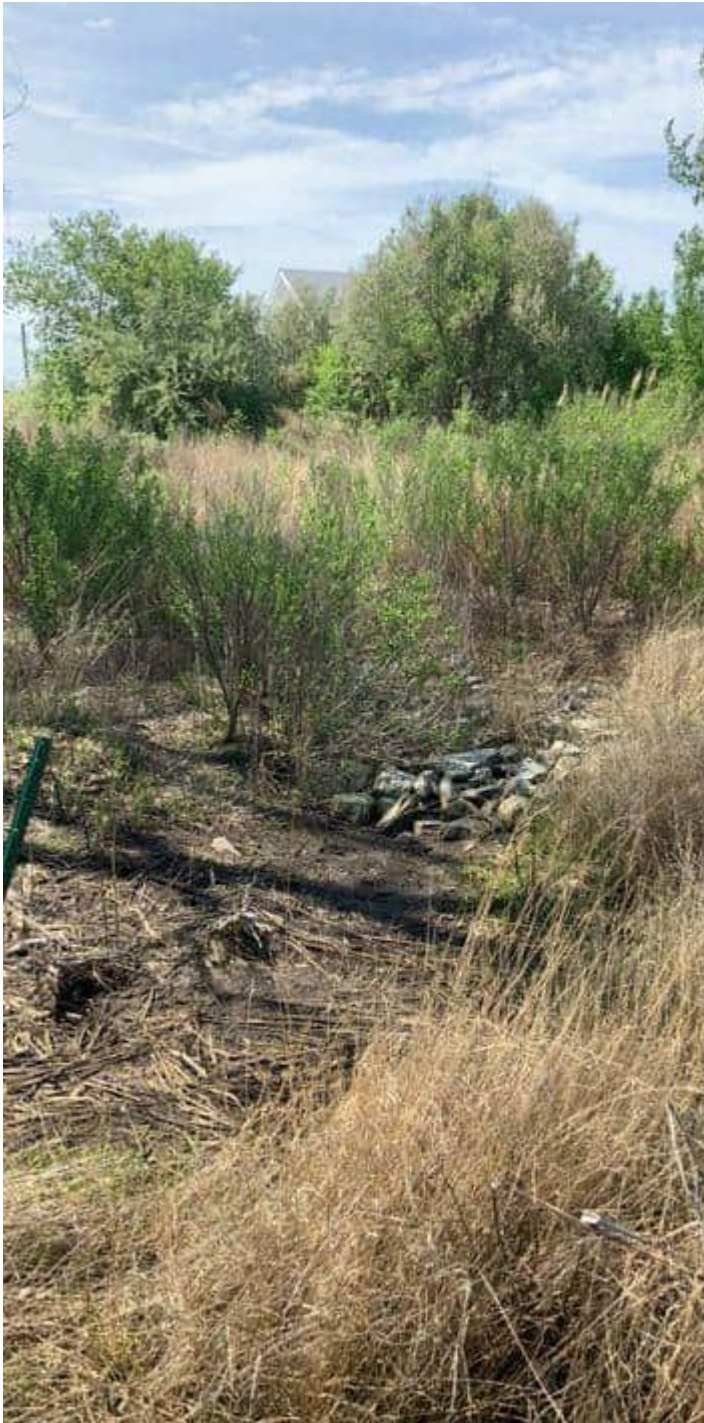
Swale exit

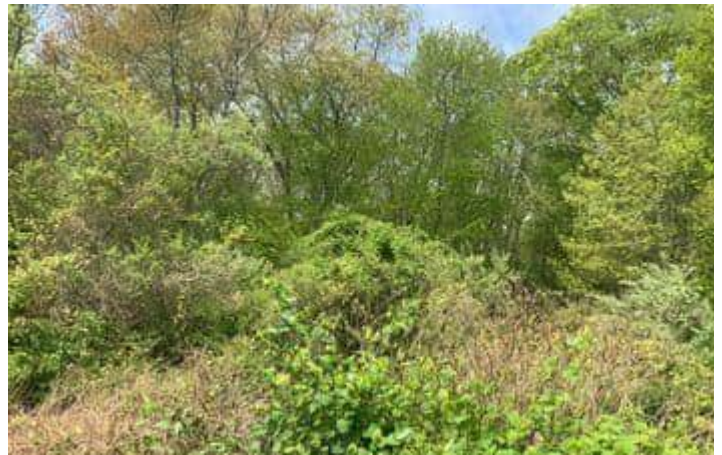
Detention basin

| Problem | Description | Quantity | Completed (by) | Date |
|---|---|---|---|---|
| Vegetation | Severe overgrowth clear crush Ana vegetation | | | |

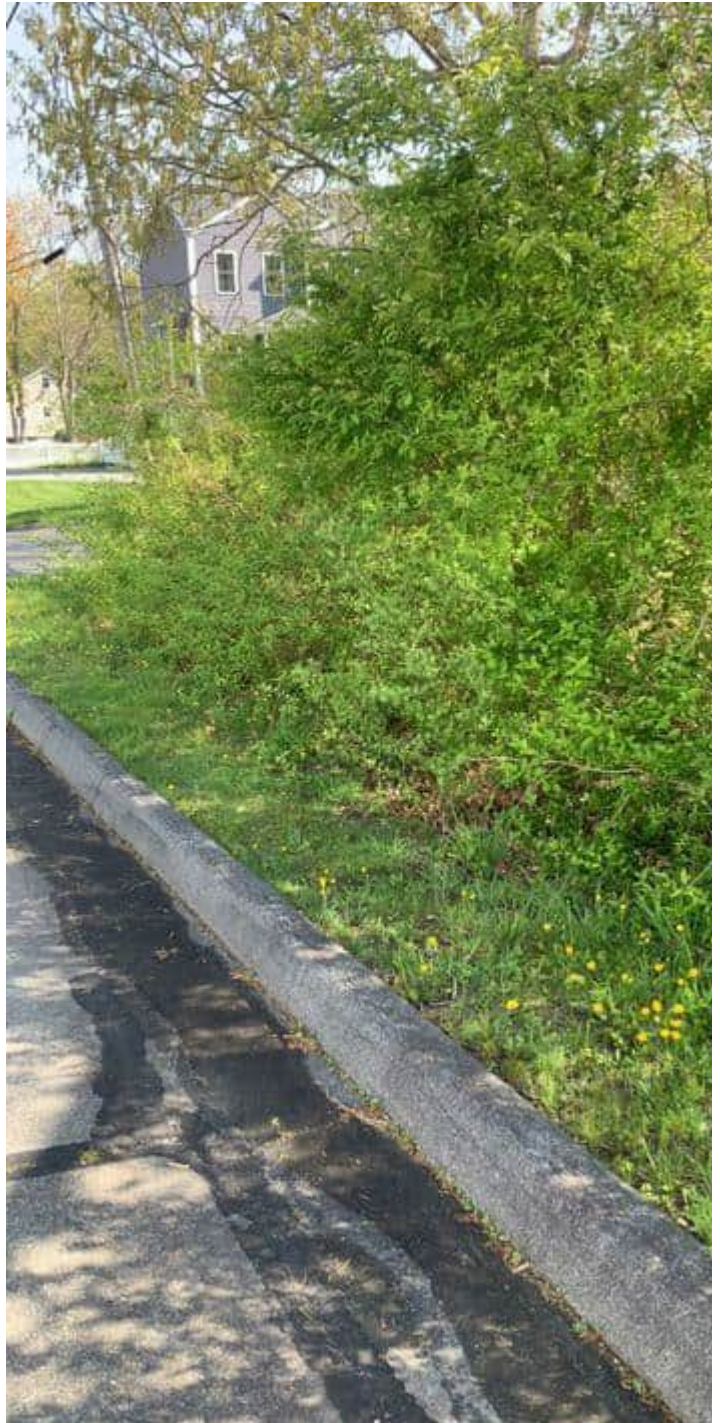
Infiltration trench

| Problem | Description | Quantity | Completed (by) | Date |
|---|---|---|---|---|
| Sediment/ Debris | Remove debris and vegetation | | | |

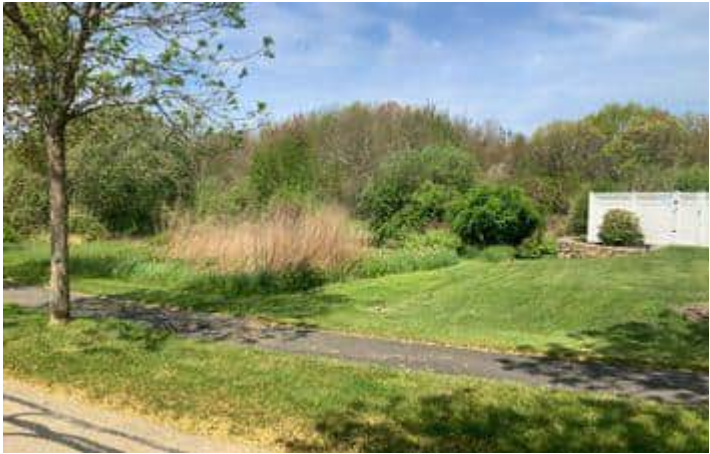
Overgrown

| Facility Name | Location | BMP/Feature Description | Inspection Date | Recommended Maintenance | Action Taken |
|---|---|---|---|---|---|
| Roadway Stormwater Management System | BEHIND 24 RIVARD STREET<br>BMP-30 | Stormceptor | 5/13/2025 | Clear vegetation from basin | BBC had as Stormceptor instead of an infiltration bed |

| Problem | Description | Quantity | Completed (by) | Date |
|---|---|---|---|---|
| | Clear vegetation from basin | | | |

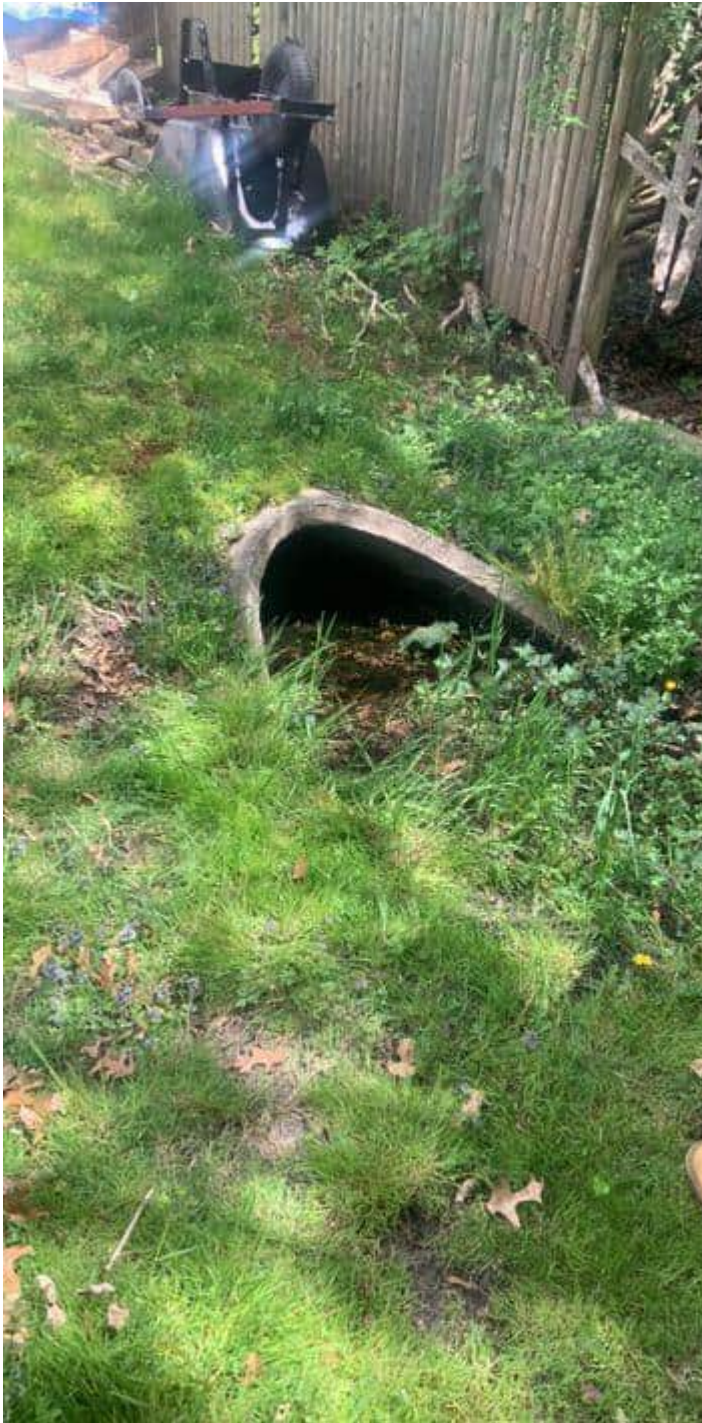
Swale inlet

| Problem | Description | Quantity | Completed (by) | Date |
|---|---|---|---|---|
| Access | Remove garden blocking swale, clean out channel | | | |

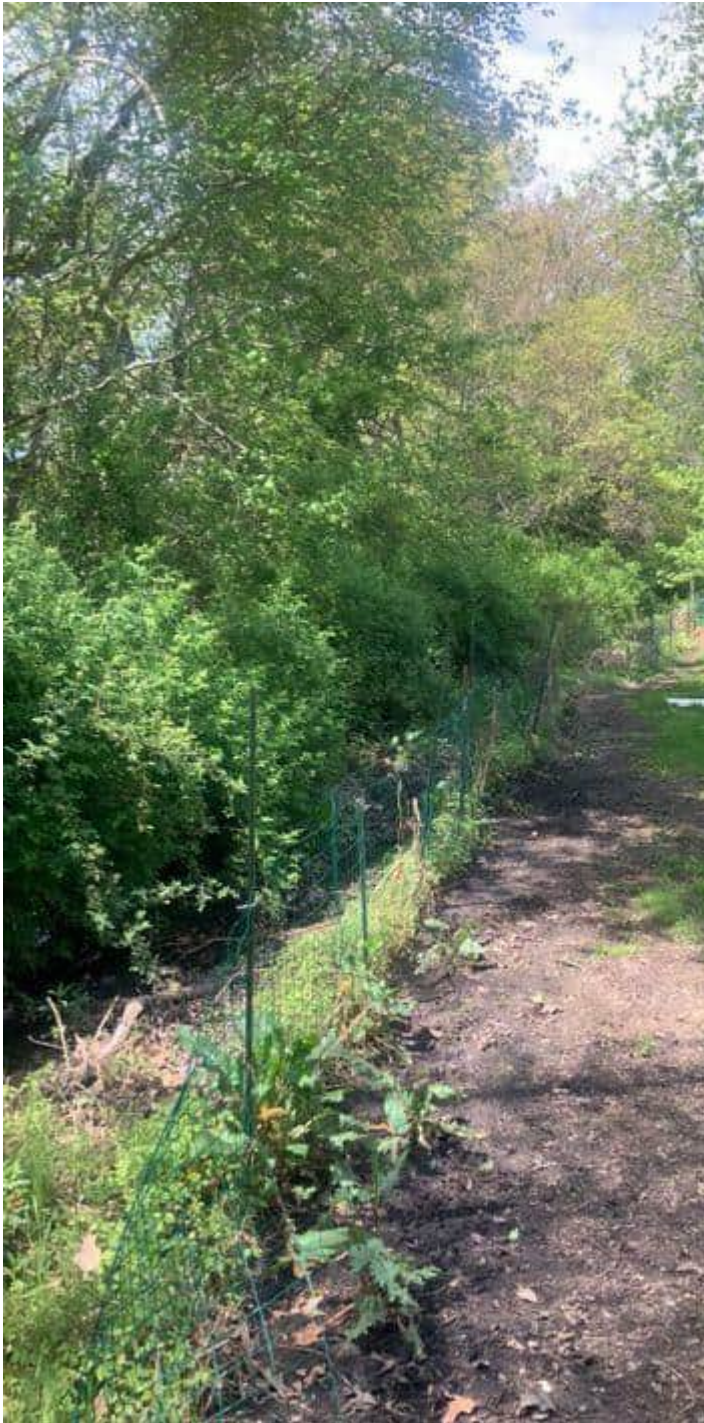
Swale outlet

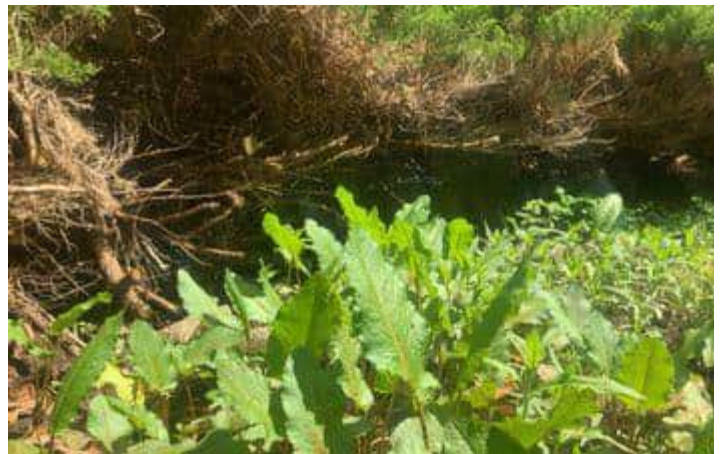
Swale behind 5 Suvenchy Drive

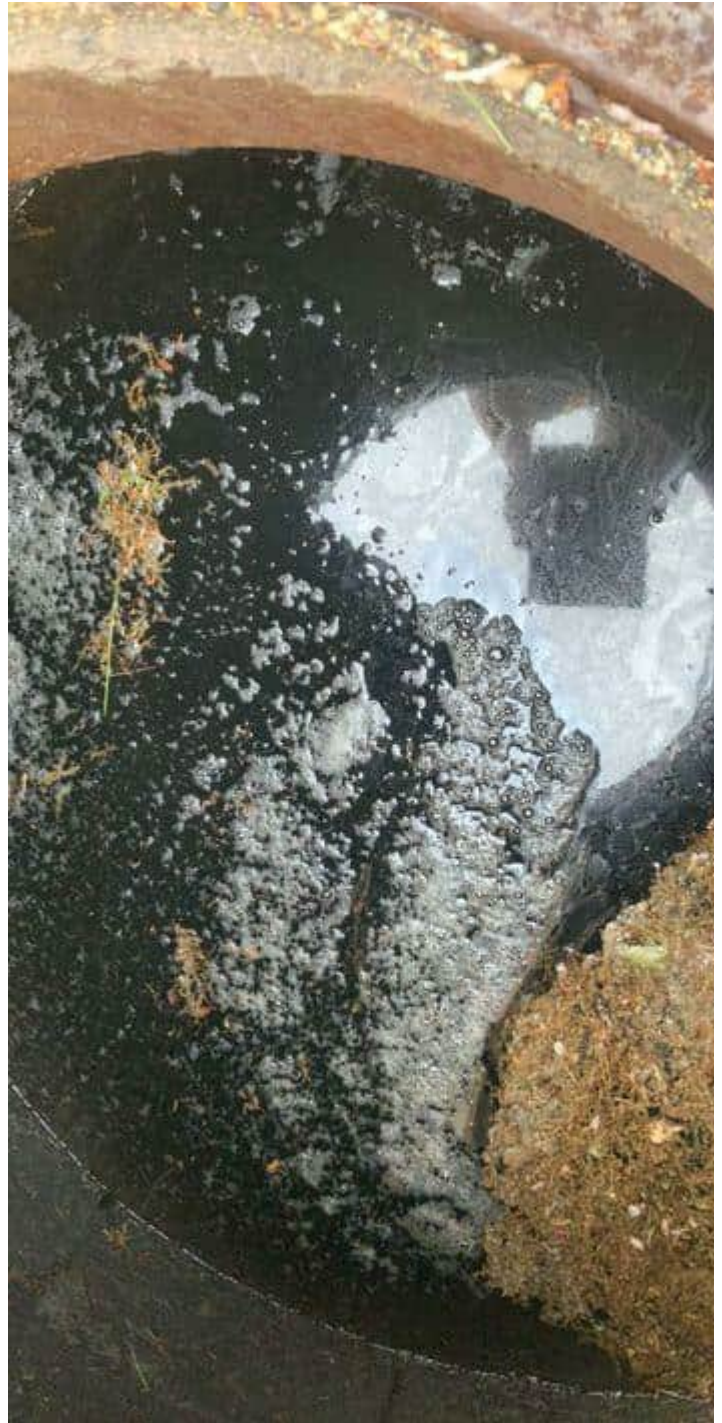
| Problem | Description | Quantity | Completed (by) | Date |
|---|---|---|---|---|
| Other | Foamy water and grey sheen | | | |

Inside pretreatment sump

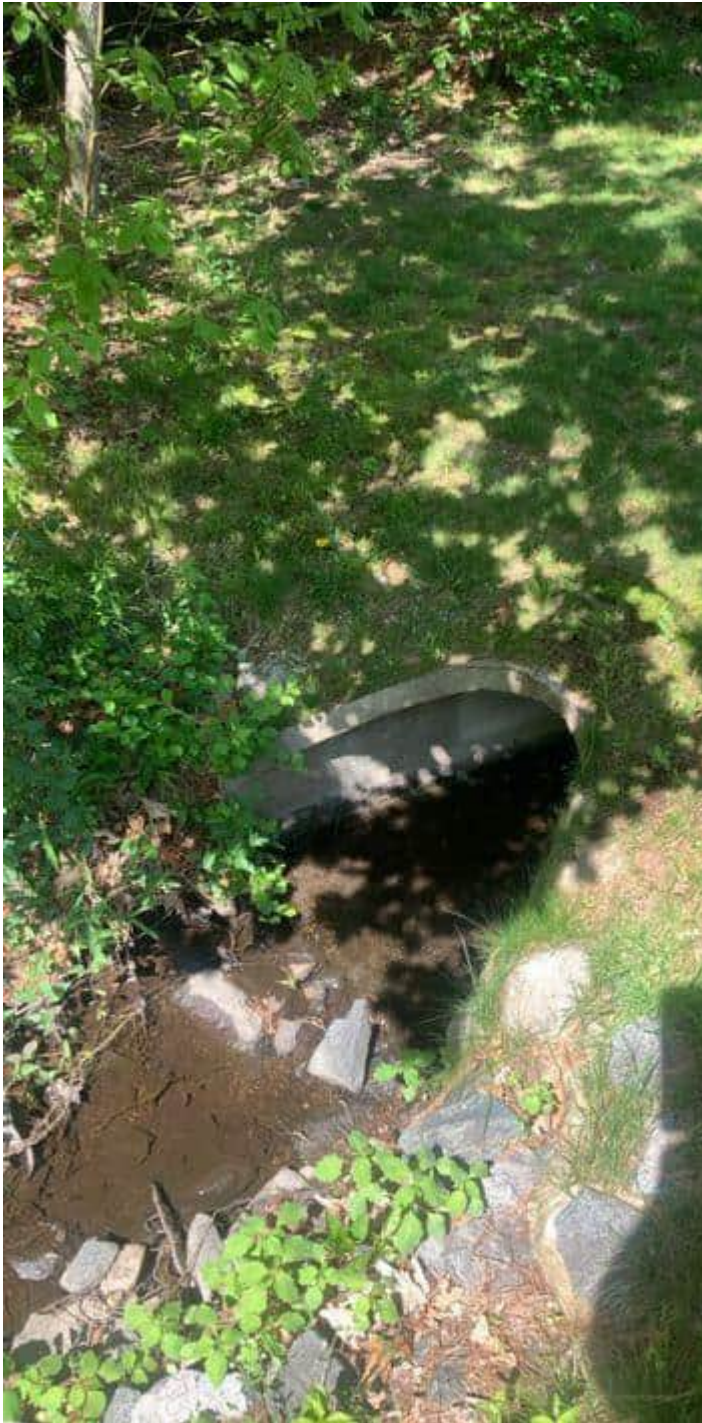
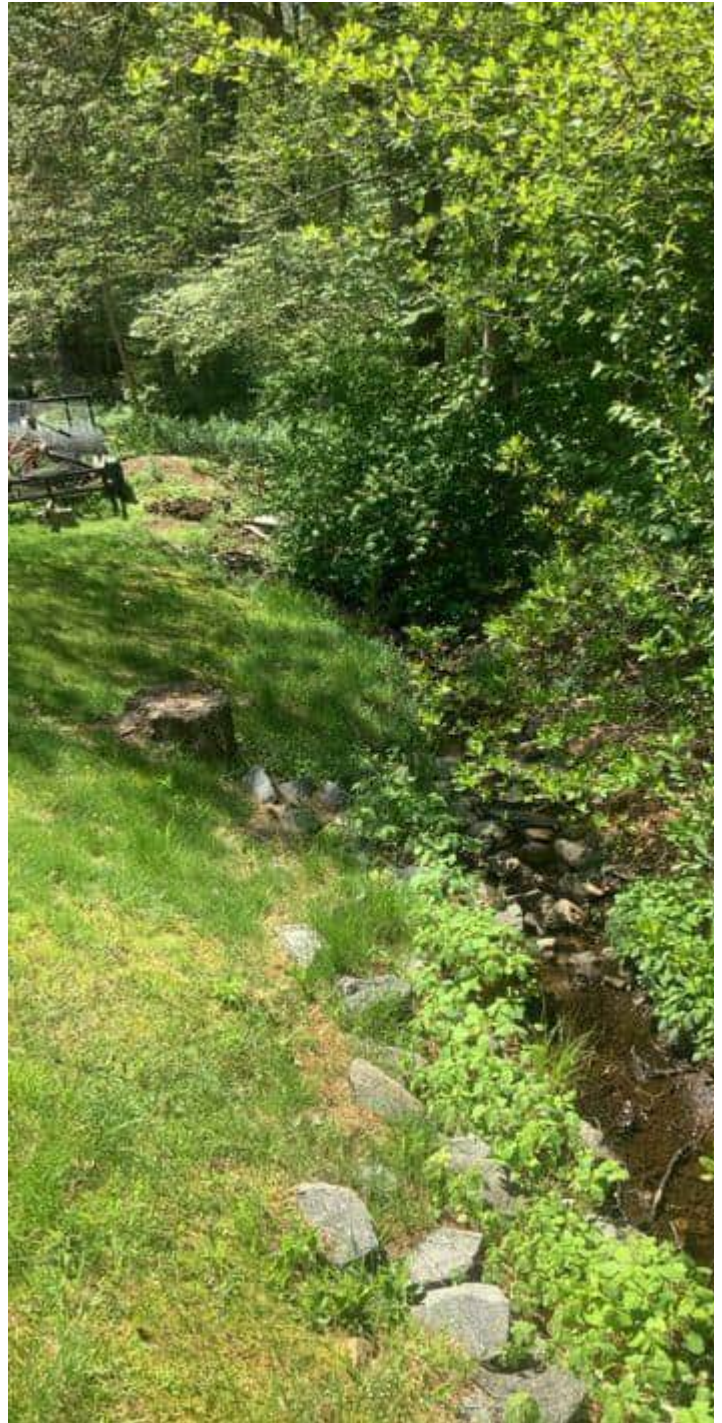
Swale

| Facility Name | Location | BMP/Feature Description | Inspection Date | Recommended Maintenance | Action Taken |
|---|---|---|---|---|---|
| Roadway Stormwater Management System | 19 TANNER LANE<br>BMP-35 | Infiltration basin | 5/14/2025 | Undefined rip rap swale (Needs Attention)<br>Potential gray water coming from unknown upstream source | |

| Problem | Description | Quantity | Completed (by) | Date |
|---|---|---|---|---|
| Other | Undefined rip rap swale (NEEDS ATTENTION) | | | |
| Other | Potential gray water coming from unknown upstream source | | | |

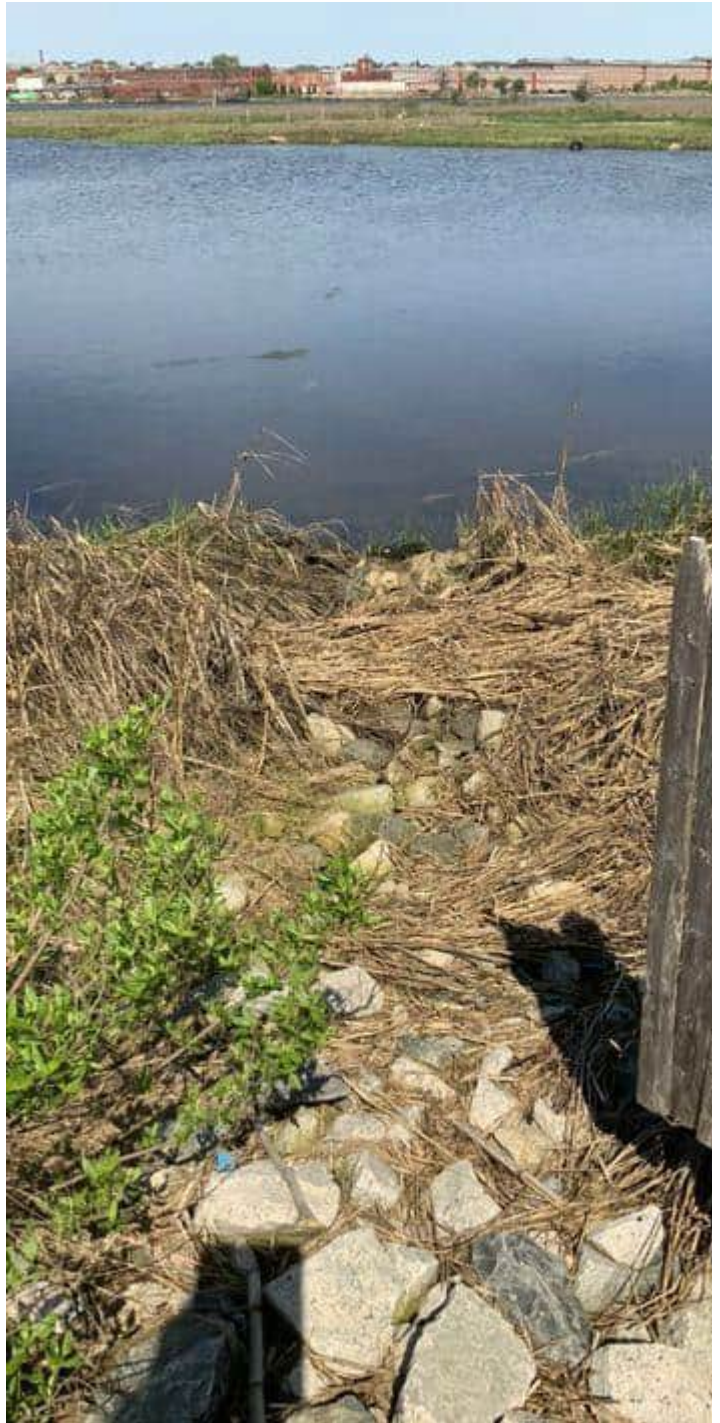
| Problem | Description | Quantity | Completed (by) | Date |
|---|---|---|---|---|
| Vegetation | Clear vegetation from swale | | | |

Swale exit

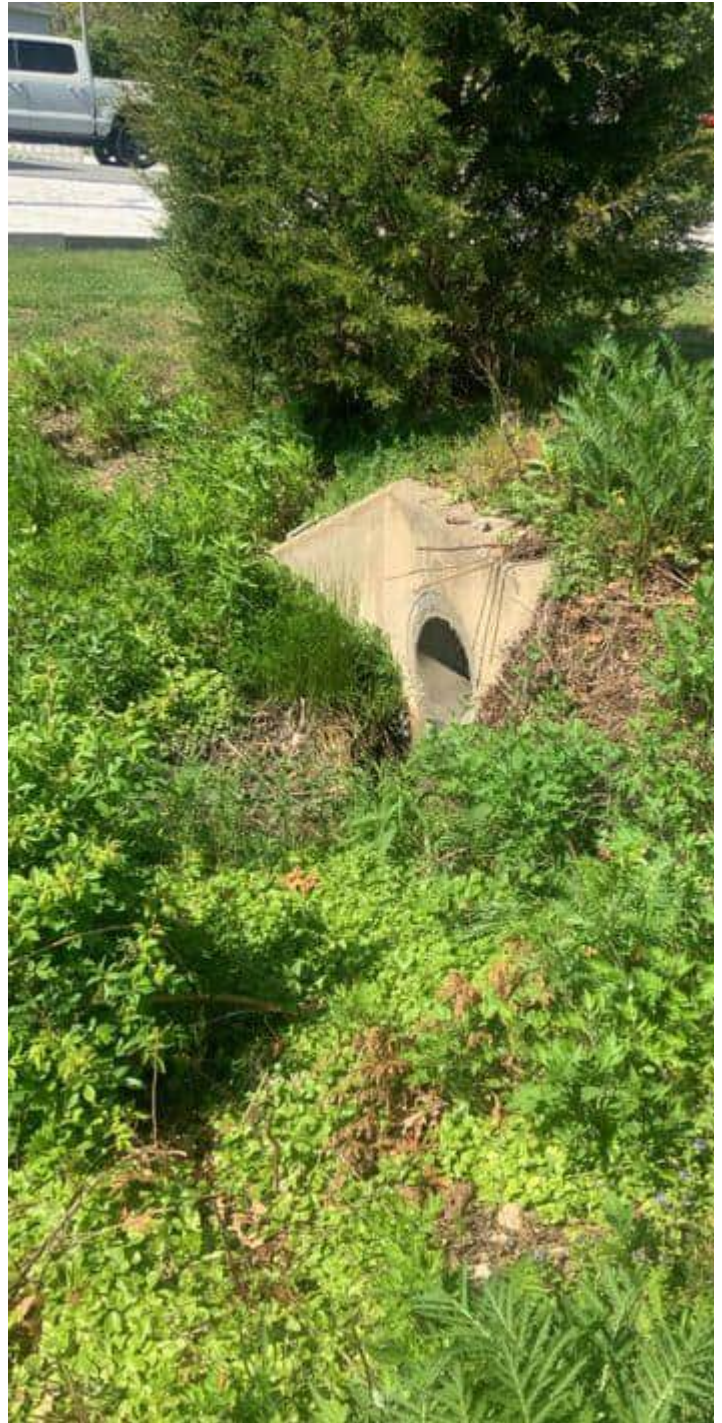
| Problem | Description | Quantity | Completed (by) | Date |
|---|---|---|---|---|
| Sediment/Debris | Remove leaves and tree debris | | | |

Entrance of basin

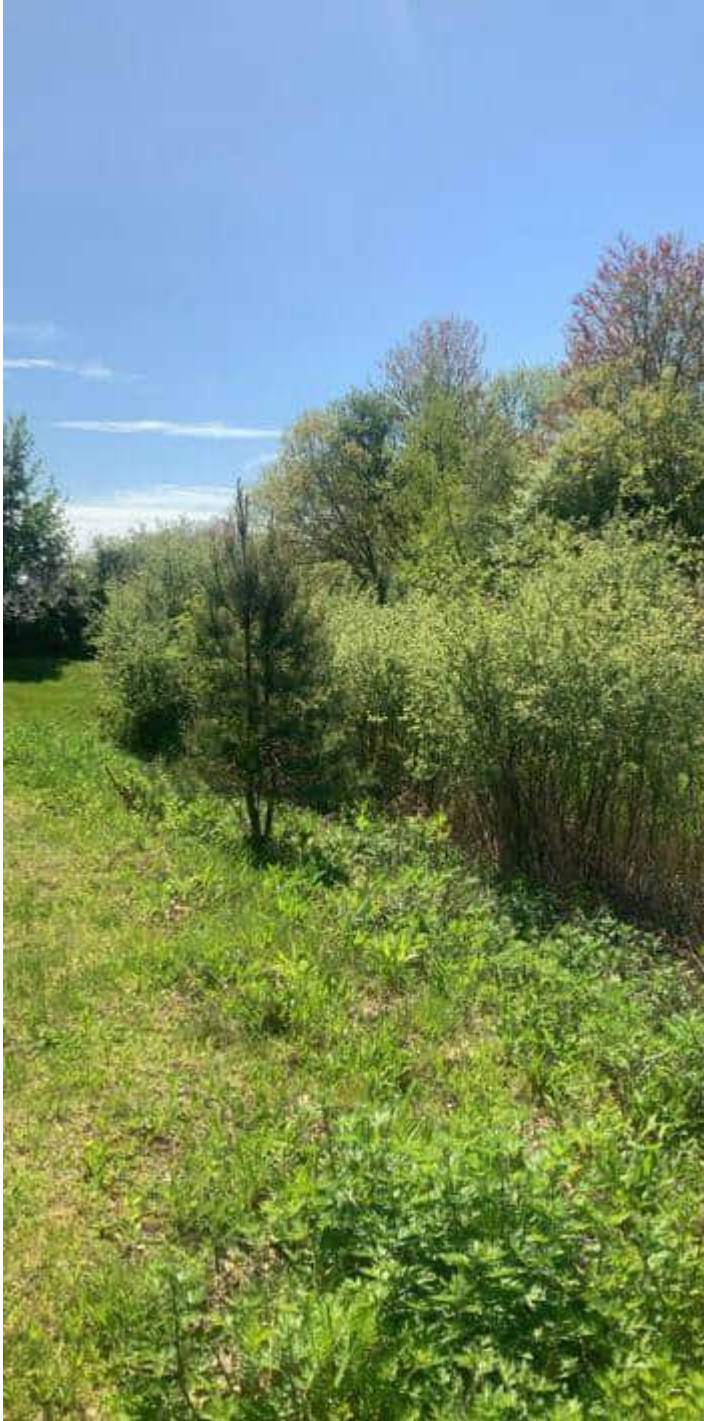
Basin

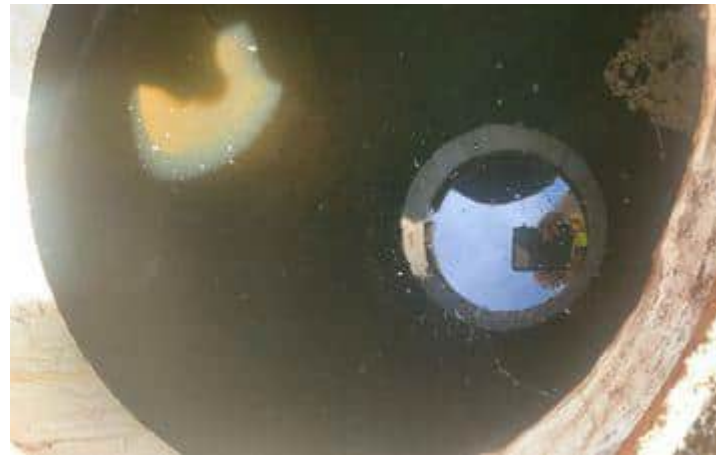
Inside manhole 1

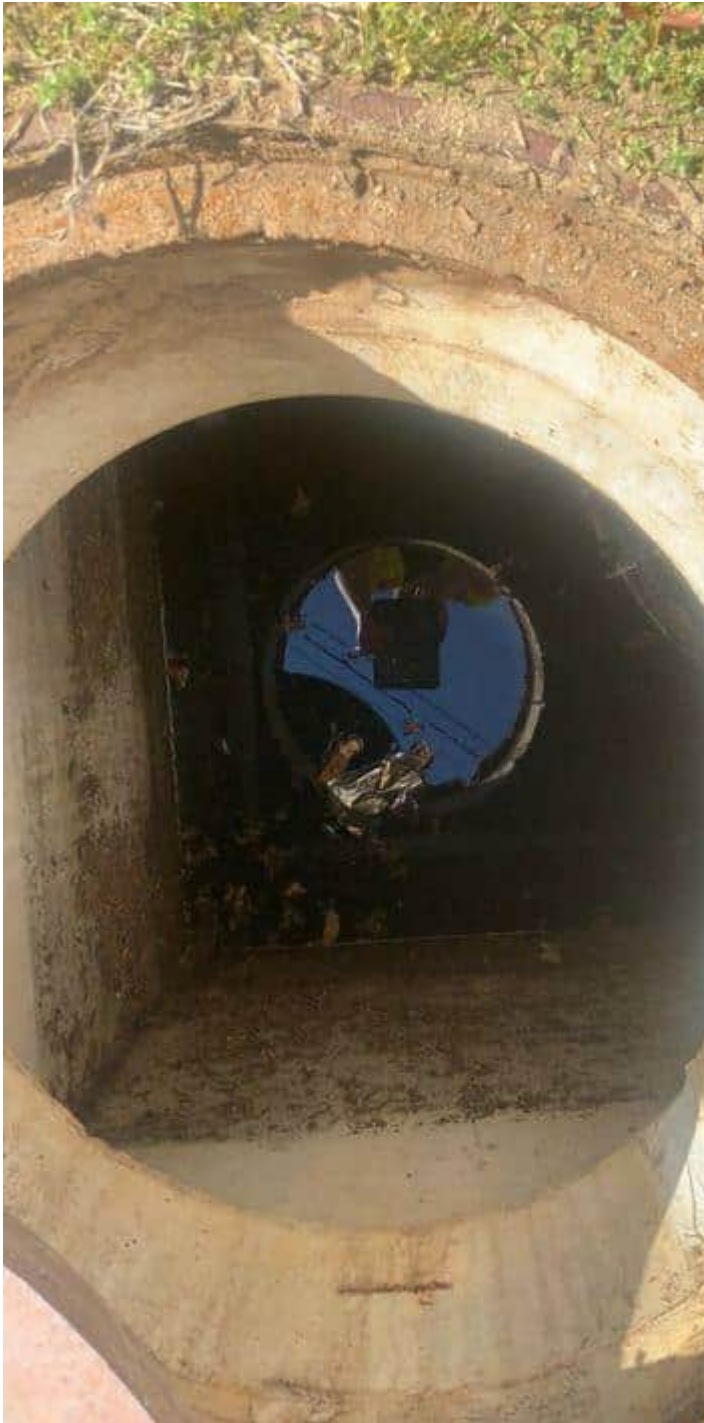
Inside manhole 2

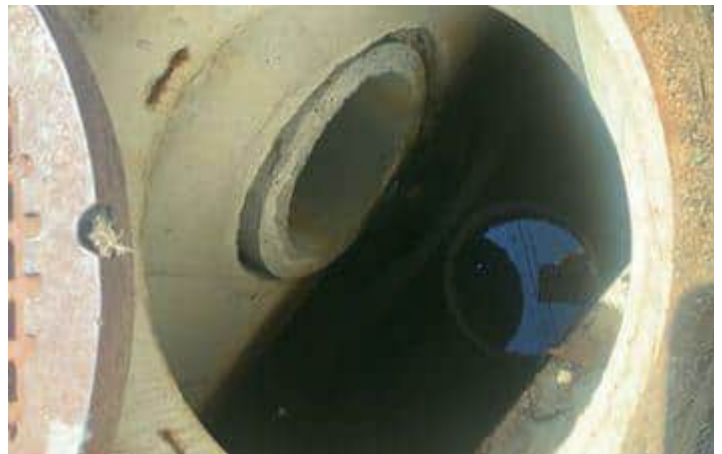
Inside manhole 3 (exit)

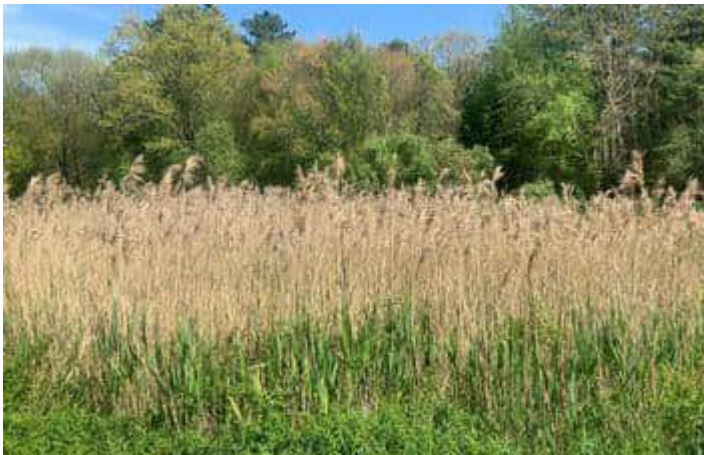
Detention basin

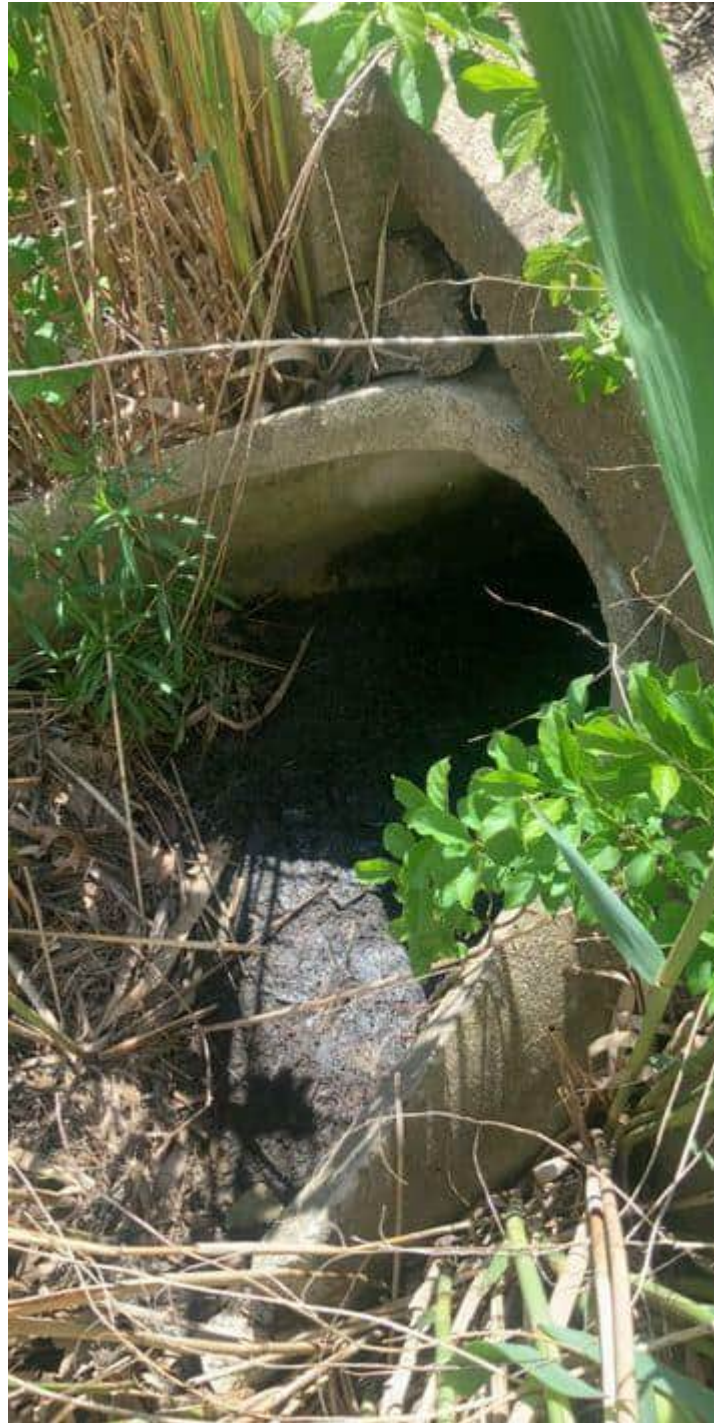
| Problem | Description | Quantity | Completed (by) | Date |
|---|---|---|---|---|
| Vegetation | Remove vegetation from inlet | | | |

Basin inlet
