| Facility Name | Location | BMP/Feature Description | Inspection Date | Recommended Maintenance | Action Taken |

Town of Fairhaven

**STORM WATER BMP INSPECTION FORM**

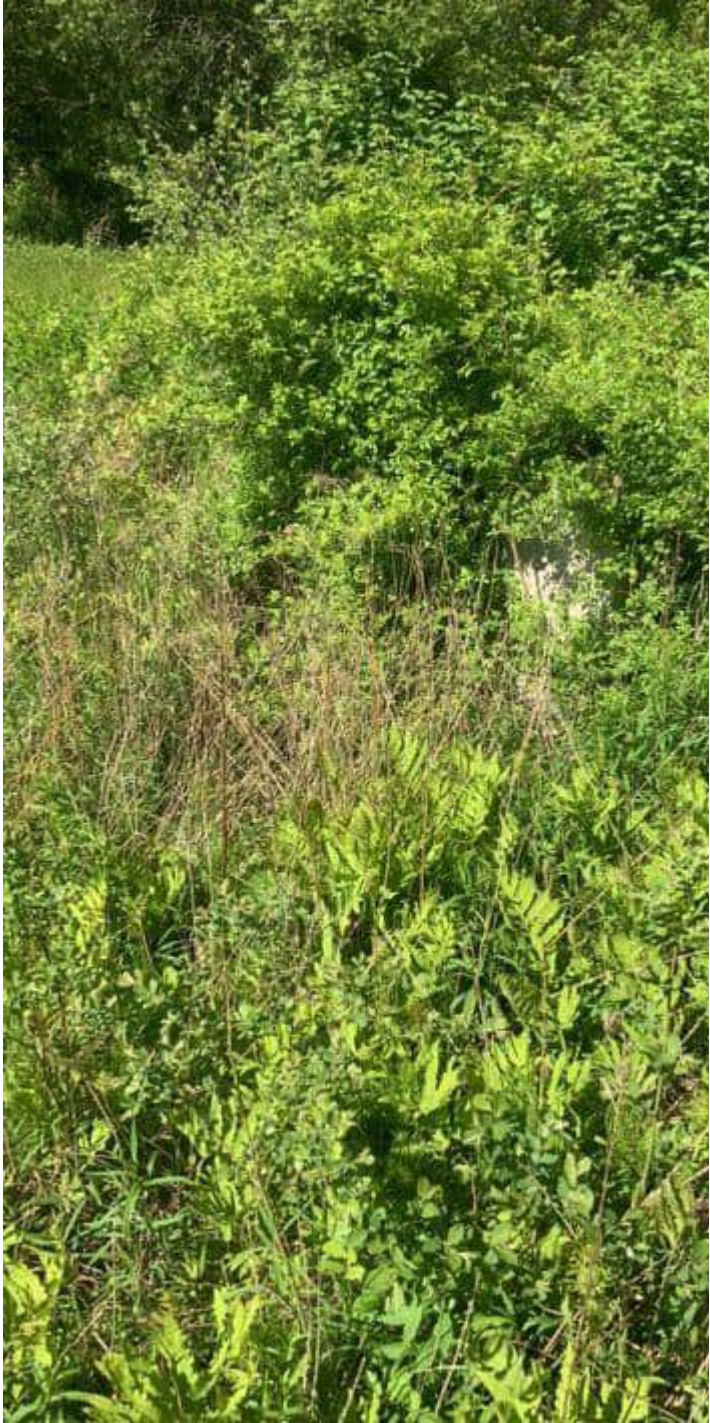
| Problem | Description | Quantity | Completed (by) | Date |
|---|---|---|---|---|
| Vegetation | Remove Vegetation by Outlet | | | |

Basin outlet

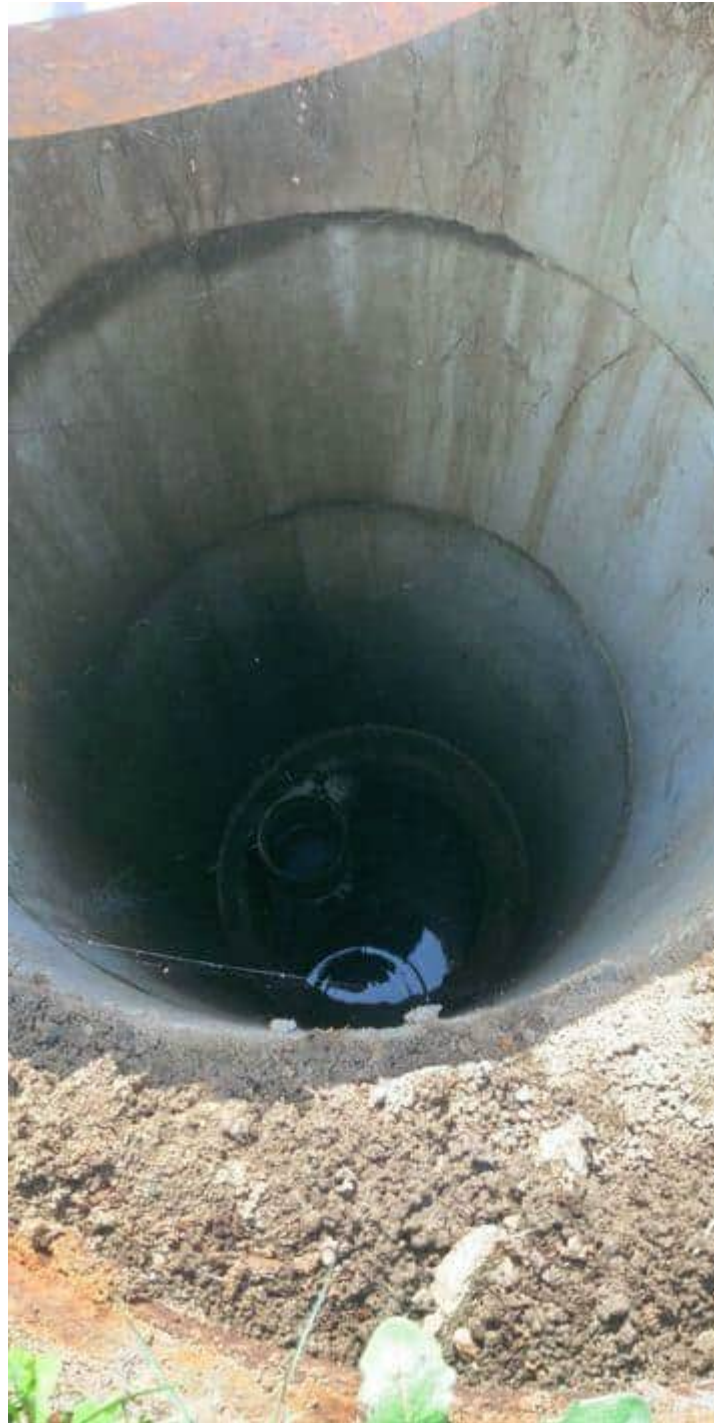
Inside inlet manhole

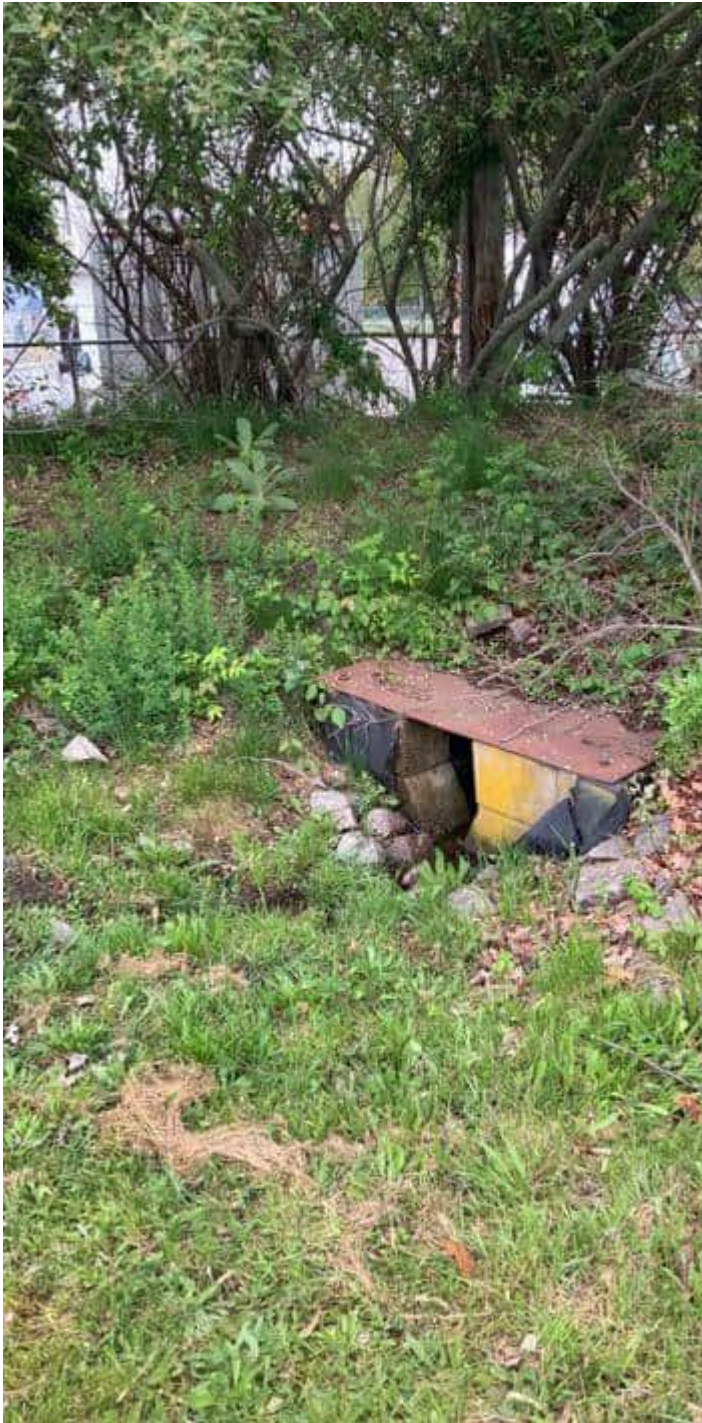
Basin outlet

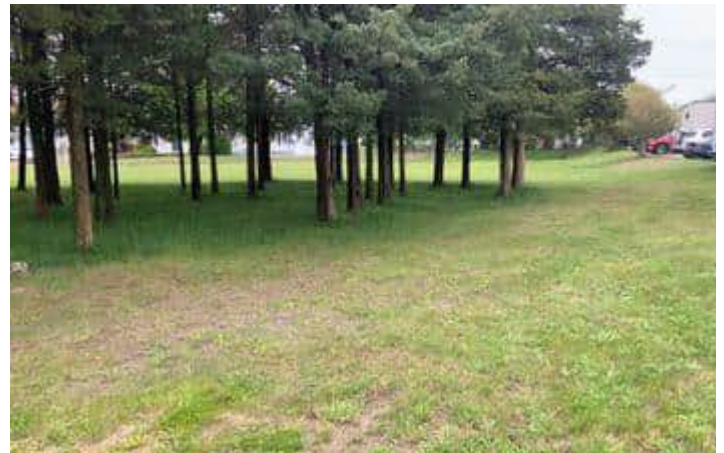
Detention basin

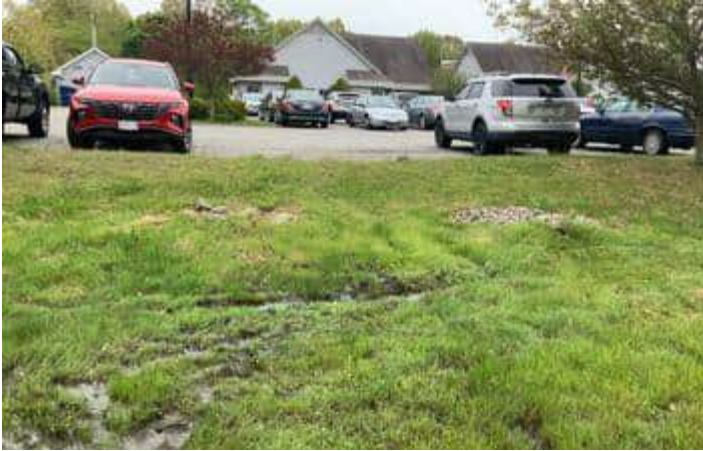
| Problem | Description | Quantity | Completed (by) | Date |
|---|---|---|---|---|
| Inlet | Clear Inlets | | | |

Basin inlets

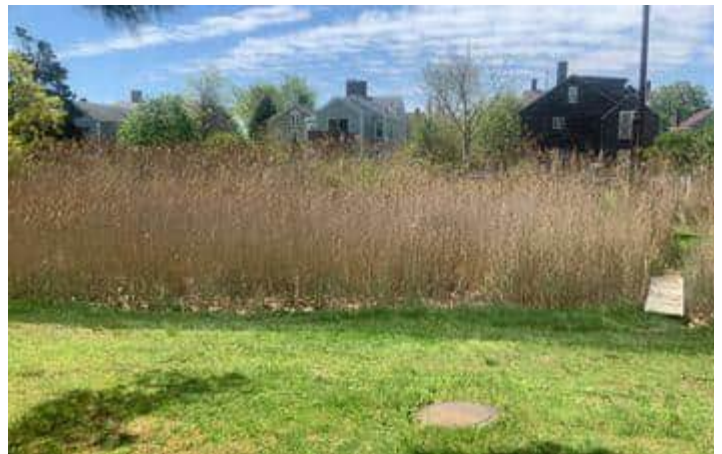
Entrance to infiltration basin

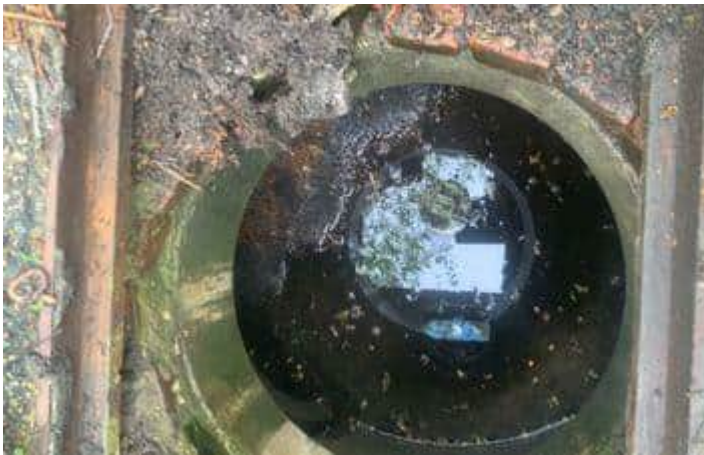
| Problem | Description | Quantity | Completed (by) | Date |
|---|---|---|---|---|
| Sediment/Debris | Remove sediment | | | |
| Other | Clean pipe outfall | | | |

Inside WQS

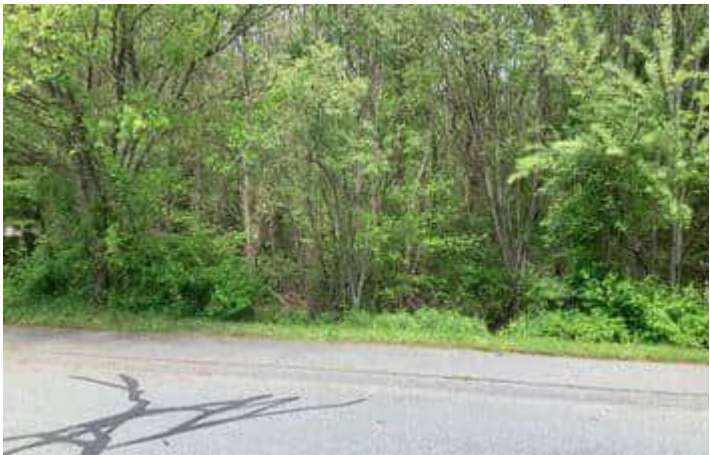
Basin

| Problem | Description | Quantity | Completed (by) | Date |
|---|---|---|---|---|
| Inlet | Clear trees and debris from inlets | | | |
